# Building Inspection Report

Client: Harcourts Whangarei  
Location: 10 Louisa Lane, Kamo  
Whangarei

Inspection Date: 06/05/2020

RE: Building Inspection Report, 10 Louisa Lane, Kamo, Whangarei.

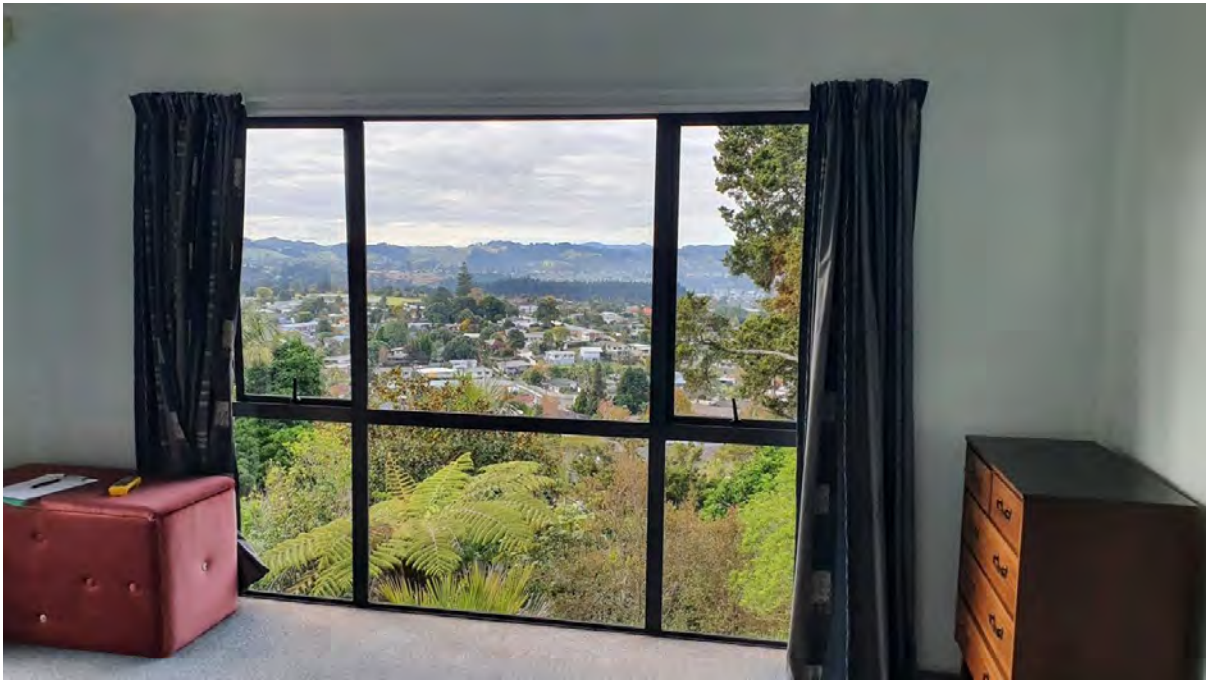
Master bedroom window: Under current building requirements, this glass would be safety glass. Recommendation is to swap out and replace the existing glass panel to safety glass.

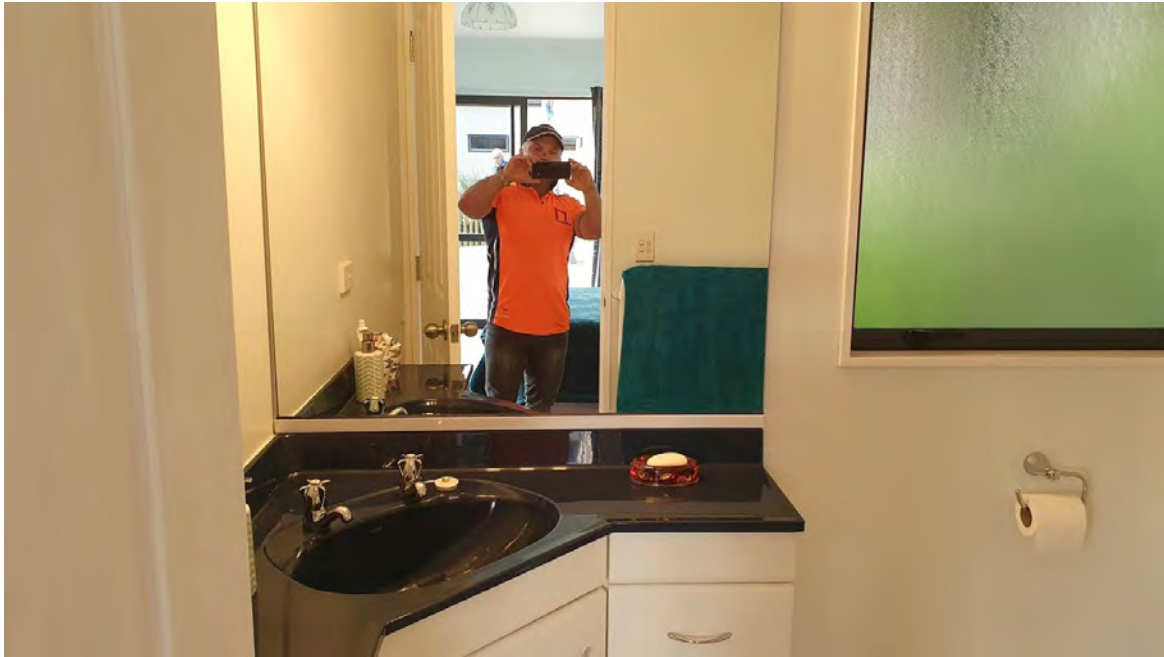
Ensuite window requires security stays to protect from falling- a simple fix for a builder or Aluminium joiner to comply with today's building standards

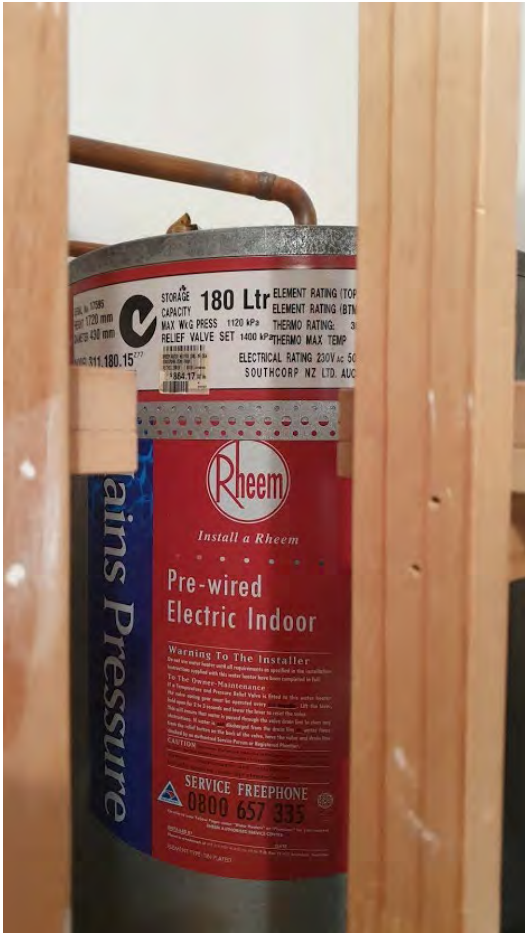
For best practice, hot water cylinder should be on a tray in case it ever leaks

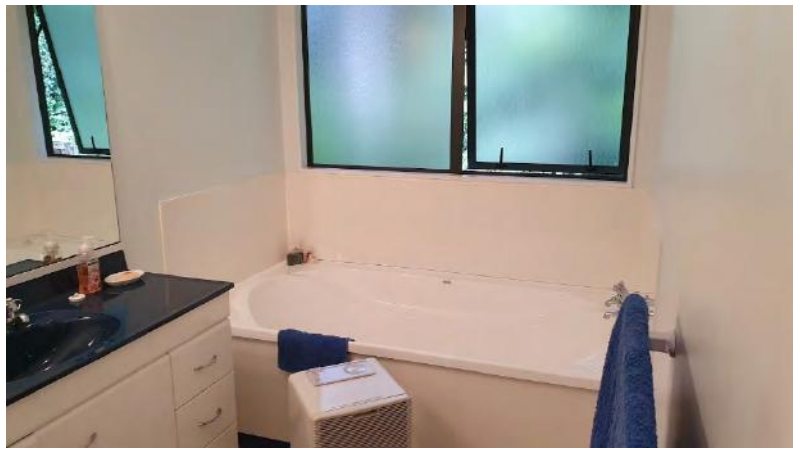
Looks to be a dehumidifier in bathroom on day of inspection.

Moisture meter readings were in acceptable range for a bathroom

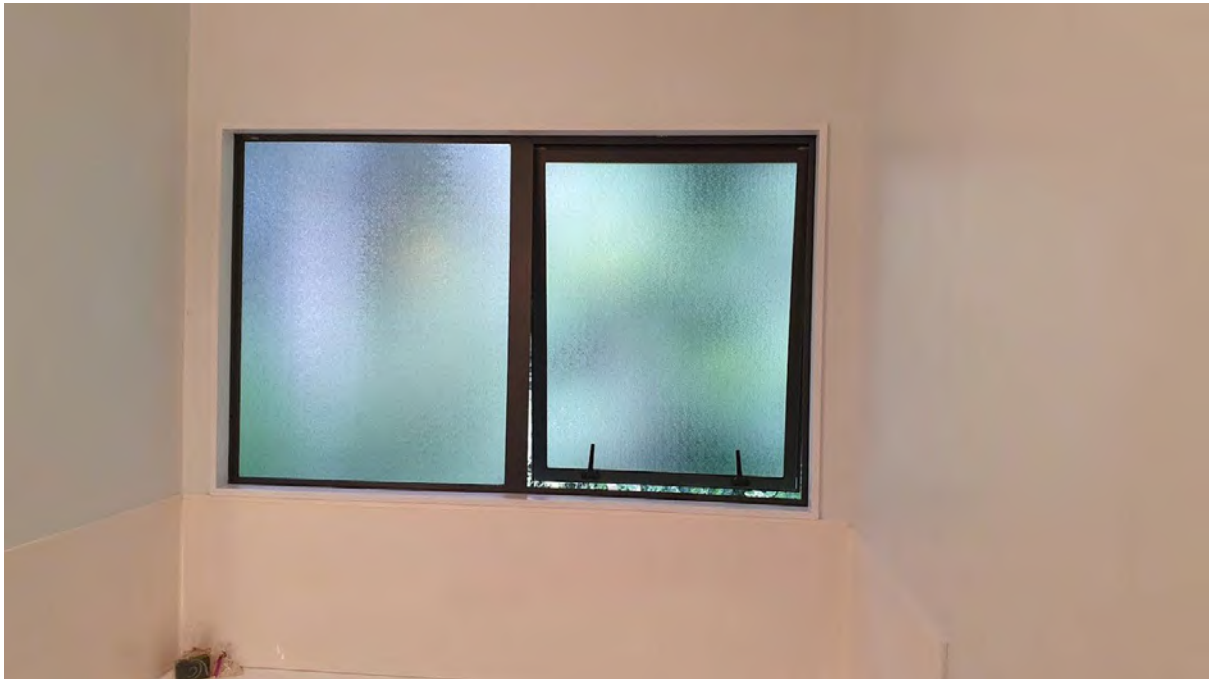
Main bathroom window requires security stays to protect from falling- a simple fix for a builder or Aluminium joiner to comply with today's building standards

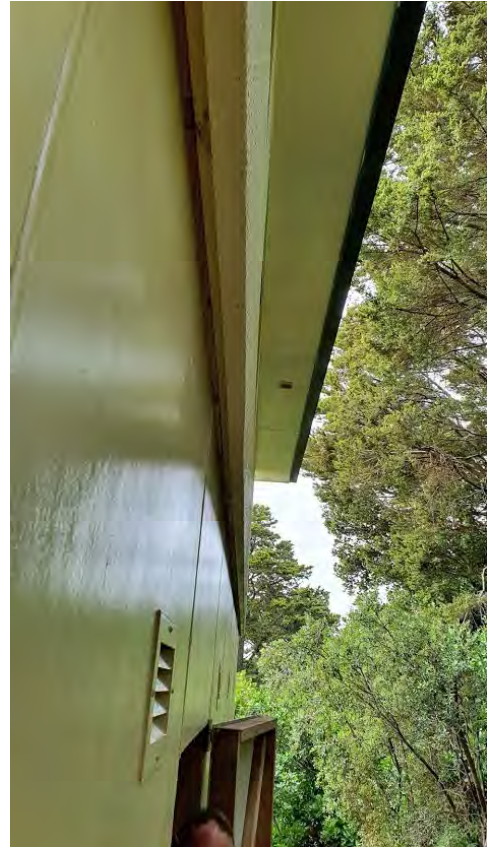
Insuclad does not sit on a cavity. This is how these homes were built late 90s early 2000s. Current standards, you would have a cavity. Visually, I cannot see any problems with moisture ingress.

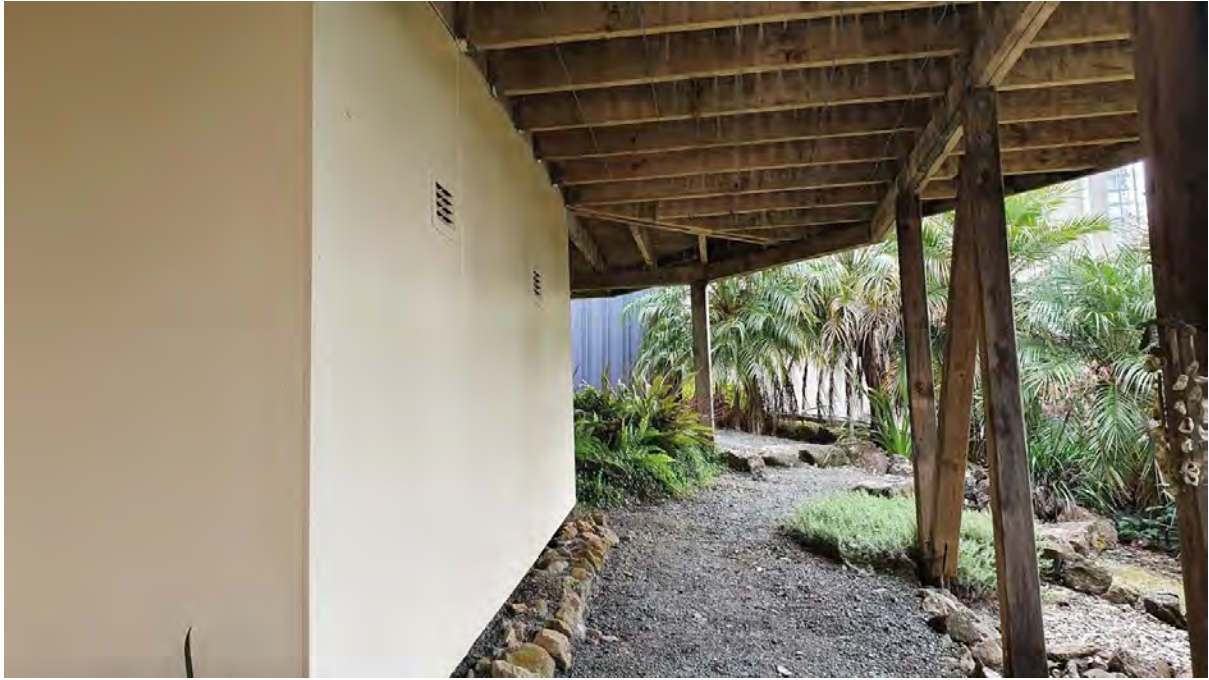
Deck posts to rear have twisted and recommend replacing.
