Building Inspection Report

Client: Paul Sumich - Bayleys Real Estate
Location: 1 Butler Place, Kamo
Whangarei

Inspection Date: 22/03/2021

RE: Building Inspection Report, 1 Butler Place, Kamo, Whangarei.

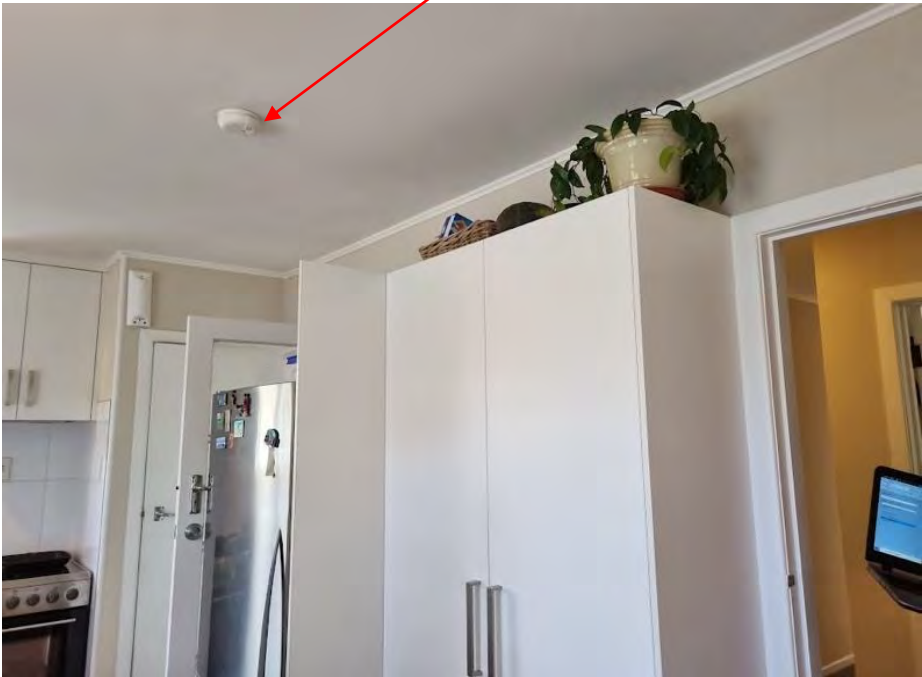
Smoke alarm present in kitchen

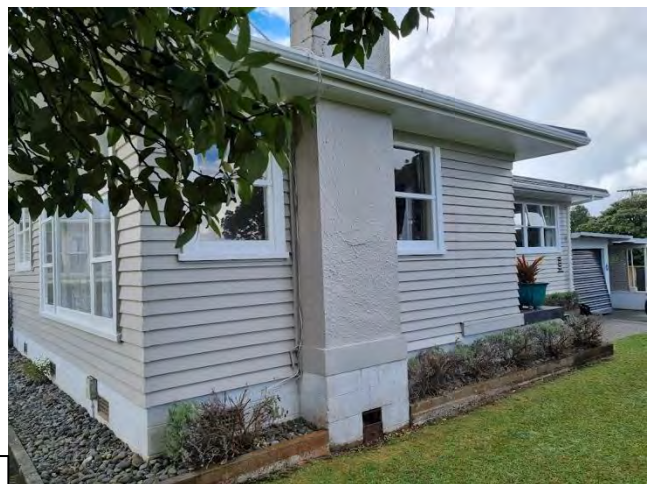
Exterior weather boards need some maintenance

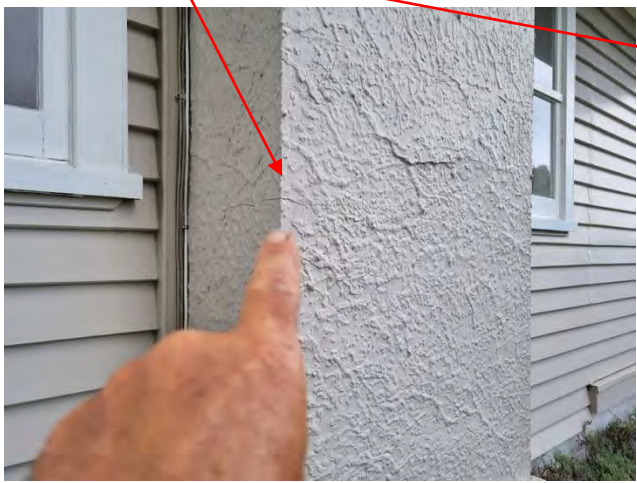
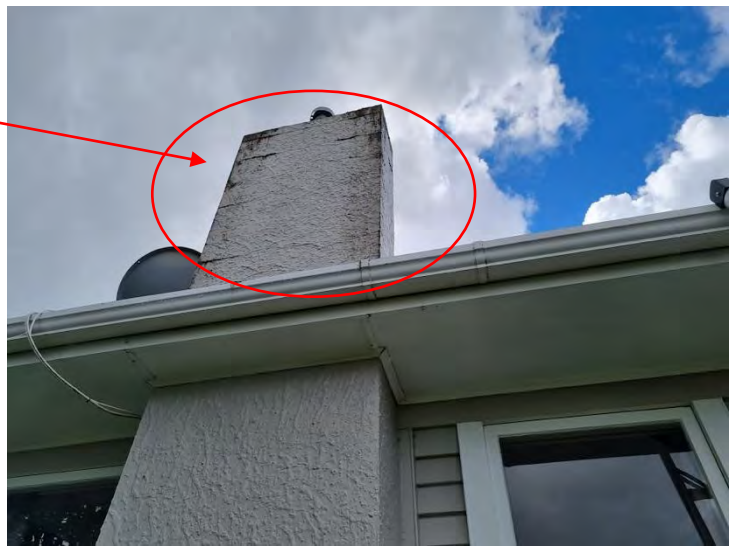
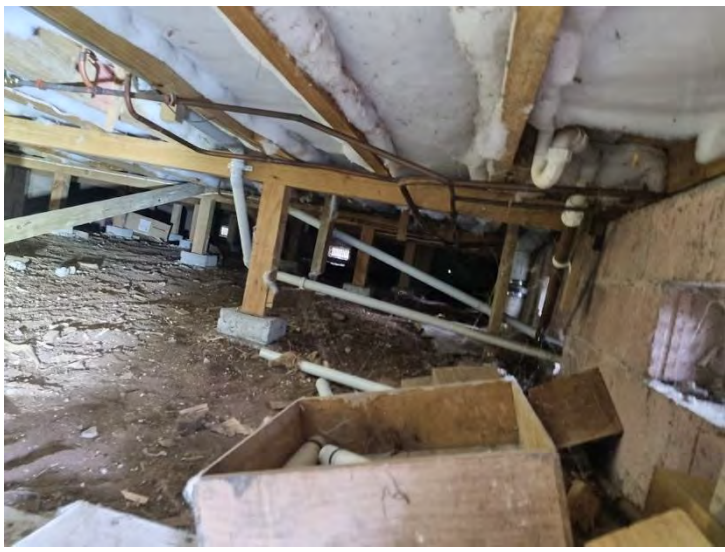
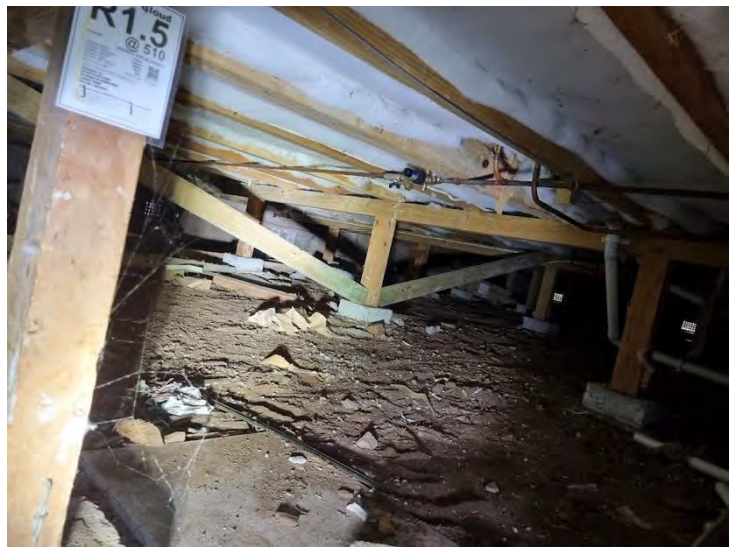
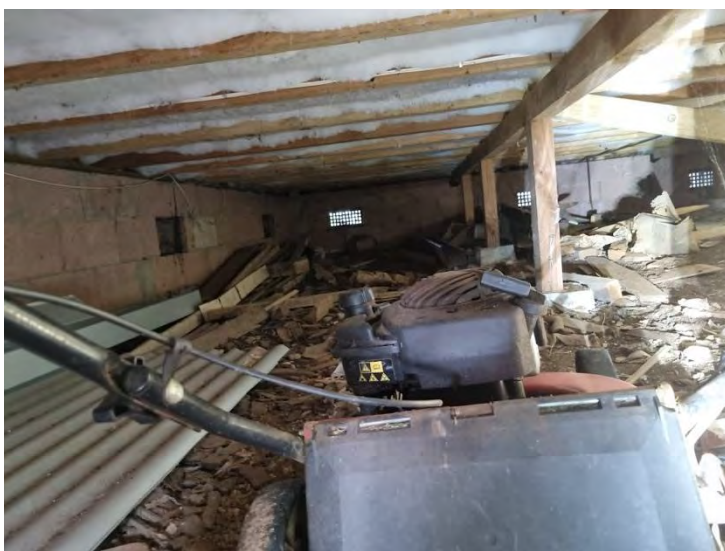
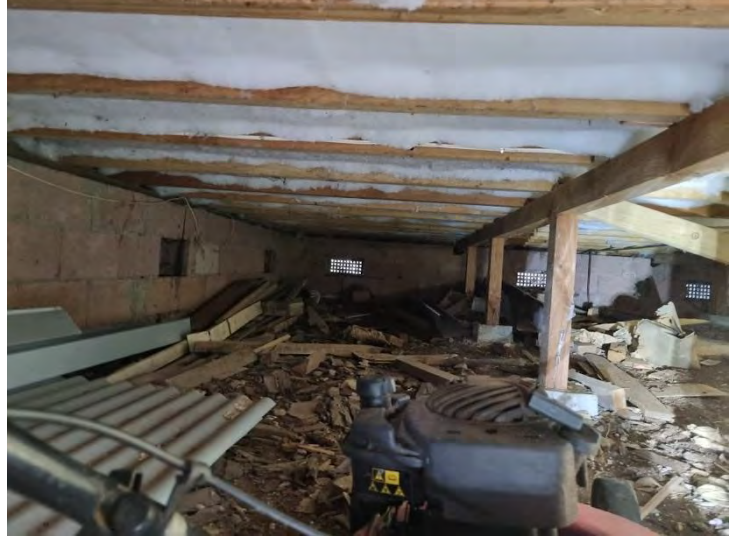
Chimney stack has a few cracks and further investigation required

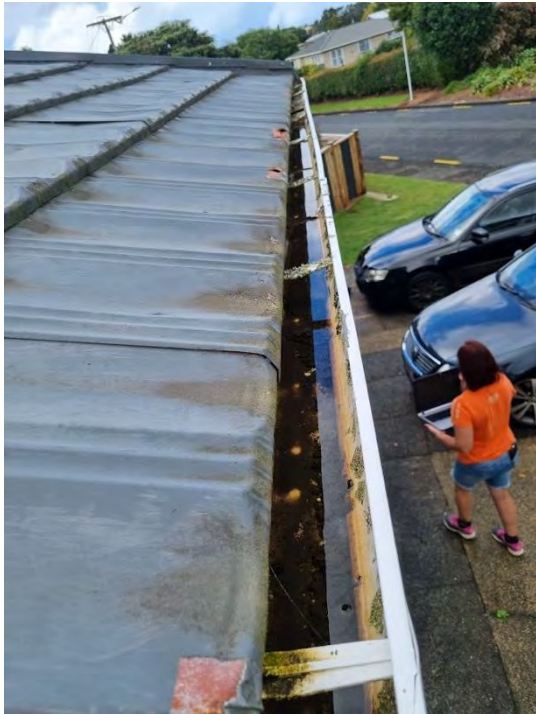
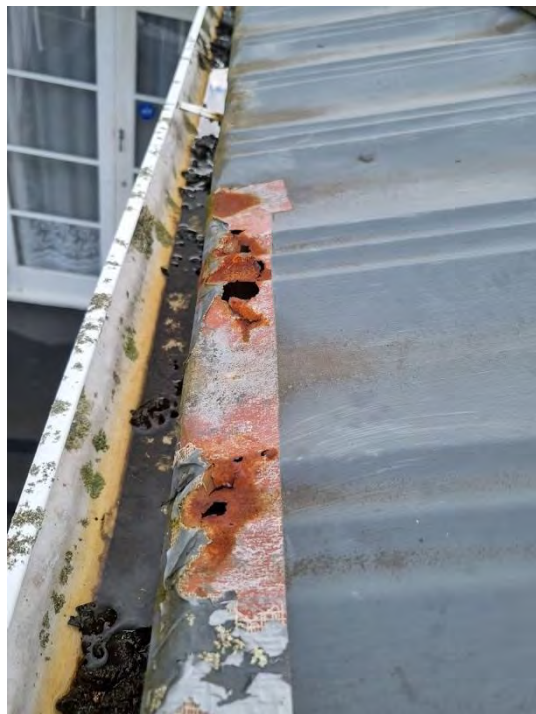
Some roofing tiles are showing signs of rust and need maintenance. Further investigation is required.

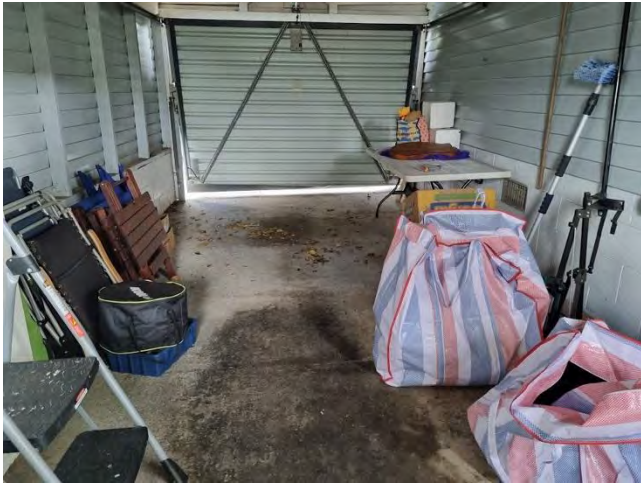
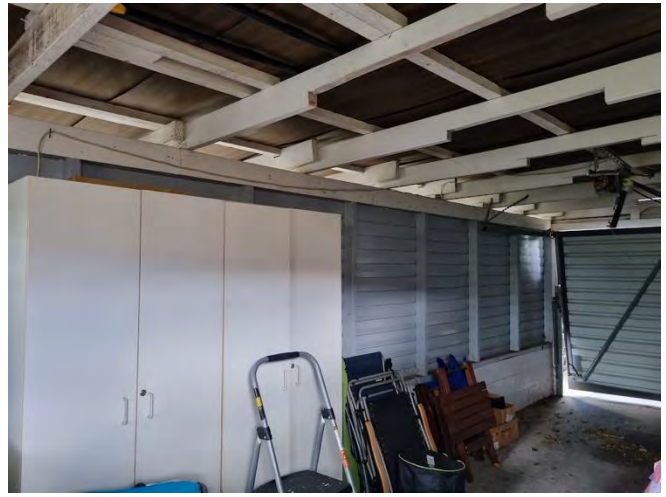
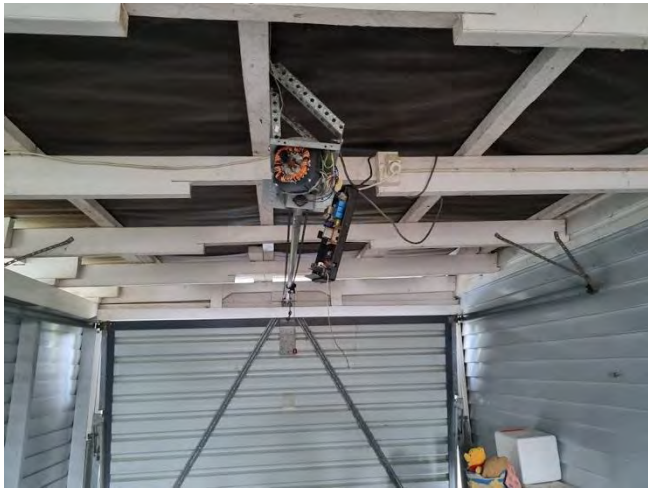
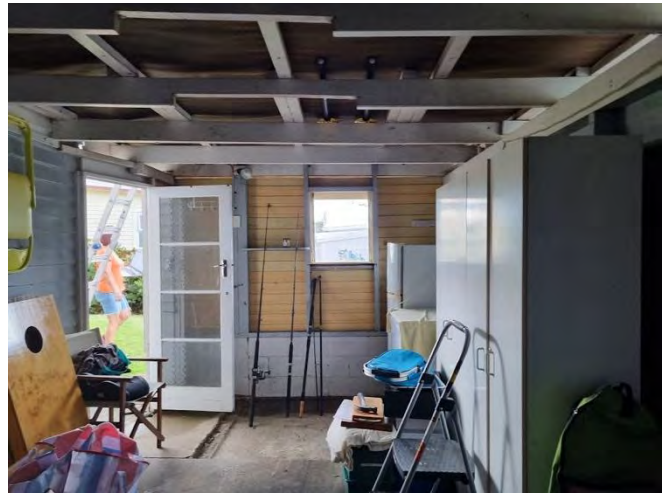
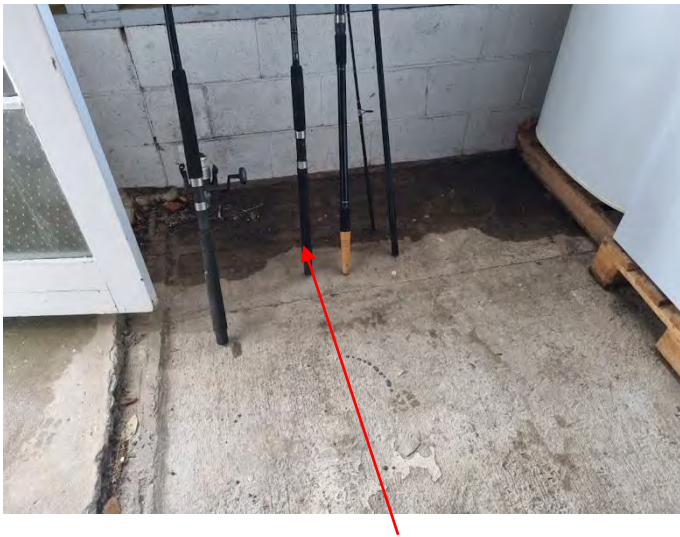
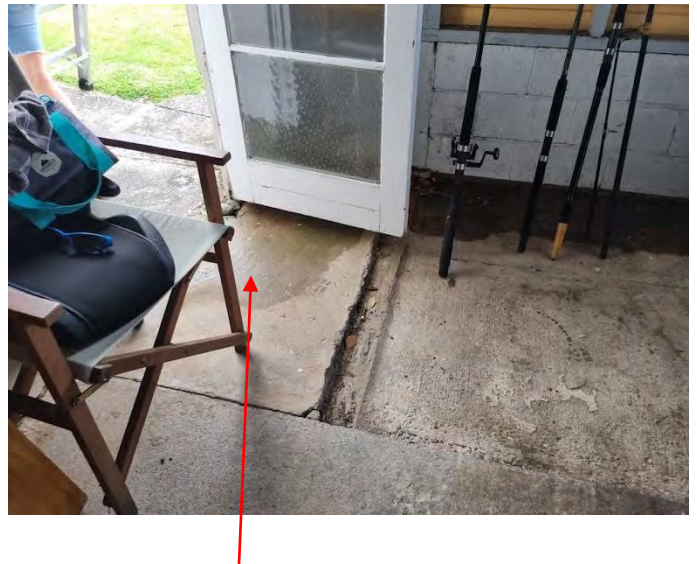
Garage showing signs of water ingress when it rains to the concrete floor.
