# **Building Inspection Report**

Client: Harcourts Whangarei Location: 25F Tutukaka Block Road,

Inspection Date: 05/05/2021

RE: Building Inspection Report, 25F Tutukaka Block Road, Tutukaka, Whangarei.

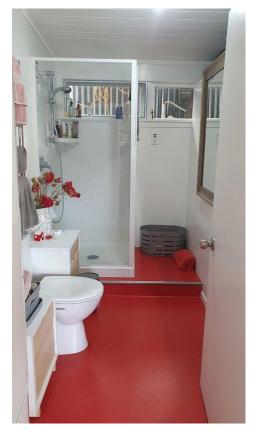
# Bathroom 1 Main dwelling

- Main dwelling
  - Walls assumed painted gib board throughout, painted ceilings are a mix of timber sarking and pinex board
  - High moisture meter reading beside shower was noted.
  - High moisture meter reading to right hand side, bench kitchen window also noted.
  - $\circ$   $\;$  The Inspector was advised that the dwelling was water blasted only the day before the inspection

High moisture meter reading beside shower was noted.

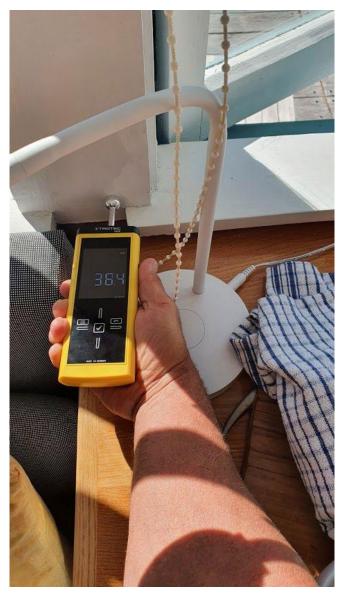
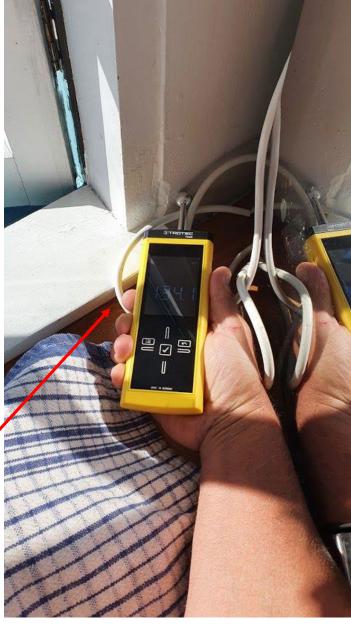
High moisture meter reading to right hand side, bench kitchen window also noted
