Pre-sale Building Inspection Report

RED LBP PRE-PURCHASE REPORT

PRE-PURCHASE BUILDING REPORT

Property Address	33 Kotare Crescent, Maunu, Whangarei, Northland, 0110, NZL		
Client	Tam Whitehorn		
Date of Inspection	29th February 2024	Time	1:00 pm
Inspector	Jamie Mackintosh Licensed Building Practitioner Brick & Block		
LBP Number	116085		
Additional Information			
People Present	Inspector, Owner		
House Occupied	Yes

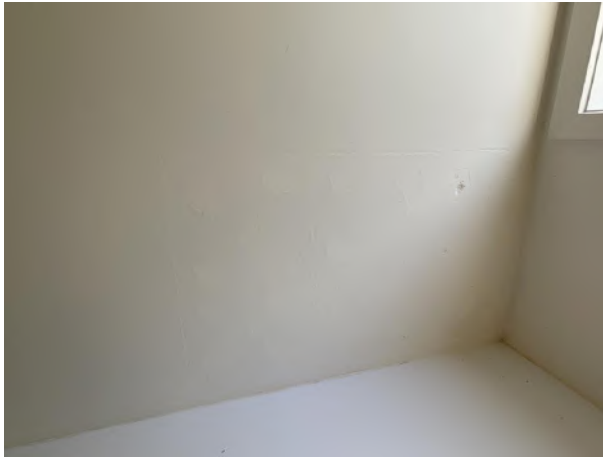
Photo 14

Historic repair above the benchtop.

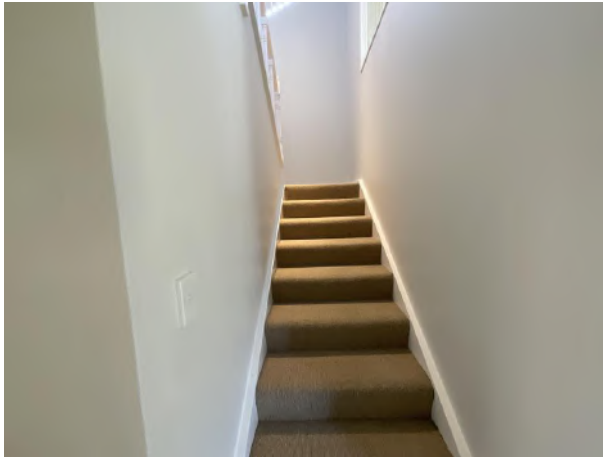
Photo 16

Stairway. Recommend installing a handrail to the bottom section.

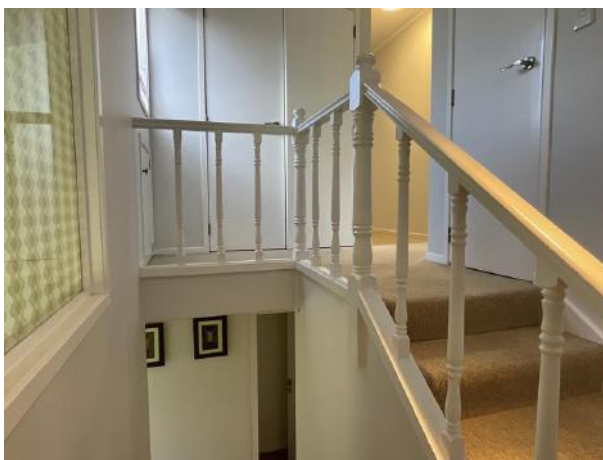
Photo 17

Timber balustrade on the top section. Recommend upgrading the balustrade to the current standards.

Although the balustrade would have complied at the time of construction, in the interest of safety, it is recommended to be upgraded/replaced with a current code-compliant version.

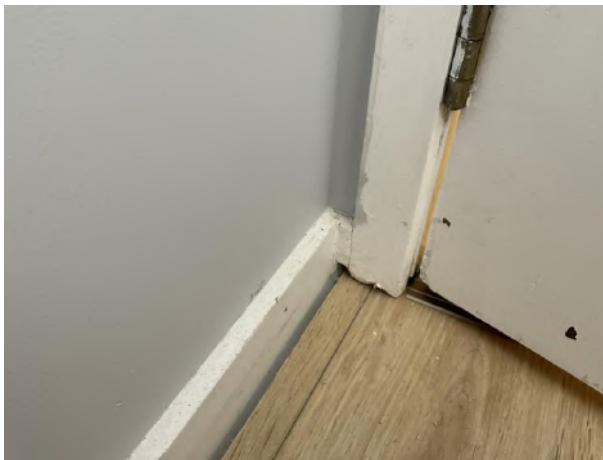
Photo 22

Historic moisture damage to the bottom of the architrave and skirting.

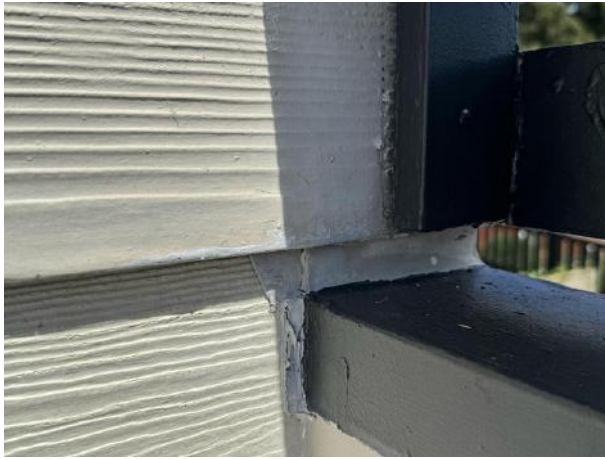
Photo 29

Metal saddle flashing on the bottom rail. Recommend re-sealing around the flashing.

Recommend sealing around all balustrade to cladding junctions to maintain weather-tightness.

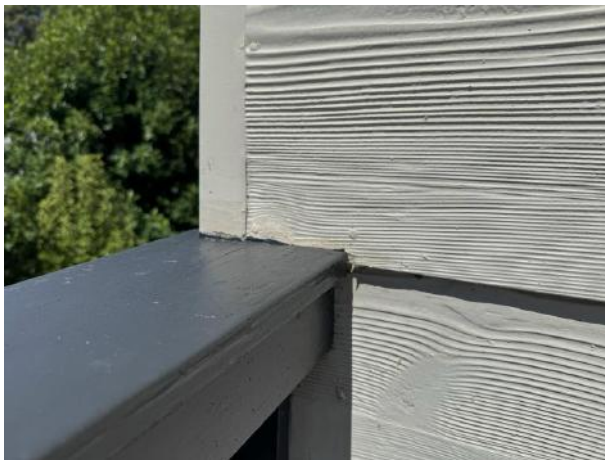
Photo 30

No saddle flashing on the top rail. Recommend sealing around the rail.

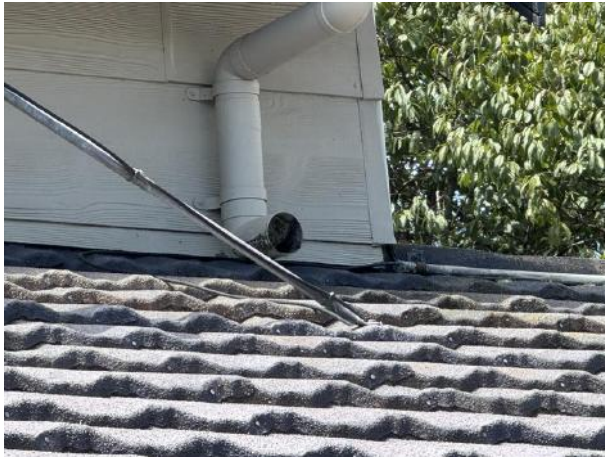
Photo 46

Recommend installing spreaders.

It is recommended to install spreaders to downpipes that discharge onto lower roofs. This installation helps to distribute the flow of water evenly, preventing excessive water concentration in specific areas and reducing the risk of damage to the lower roofs.

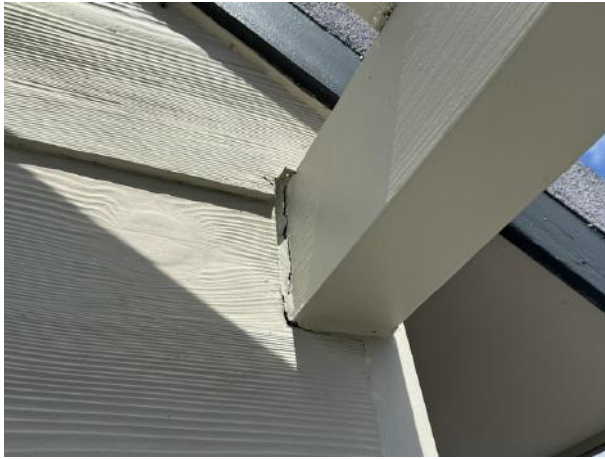
Photo 49

Recommend sealing around the timber beams above the first floor balcony.

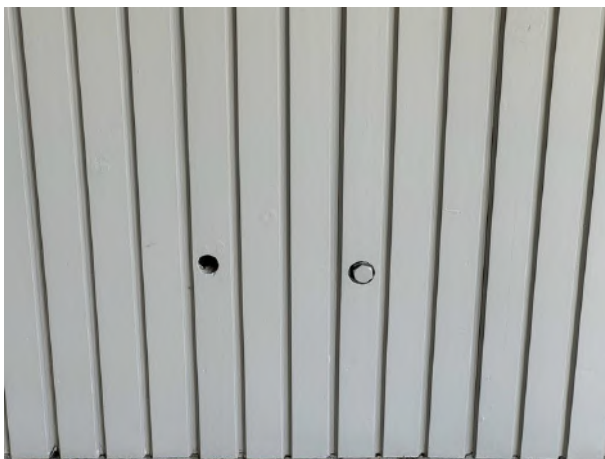
Photo 51

Recommend sealing the holes by the front door.

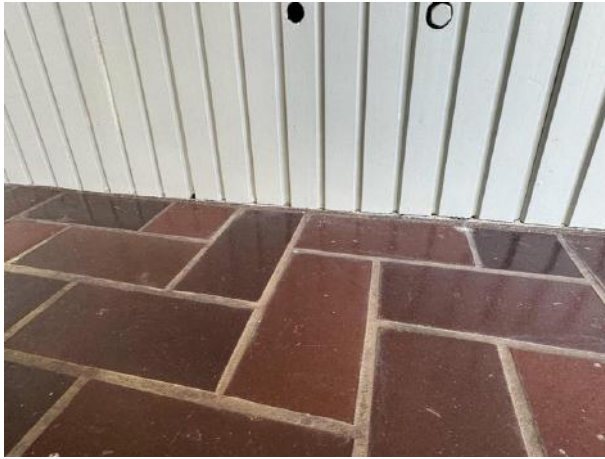
Photo 52

The tiled patio by the front door has no clearance to the exterior cladding, While there was no issues observed during the inspection. This configuration may lead to moisture issues due to capillary action. It is advisable to regularly monitor this area for potential issues and ensure it remains free of debris.

No clearance on the entrance timber cladding to tile junctions. Recommend monitoring and keeping this area free from debris.

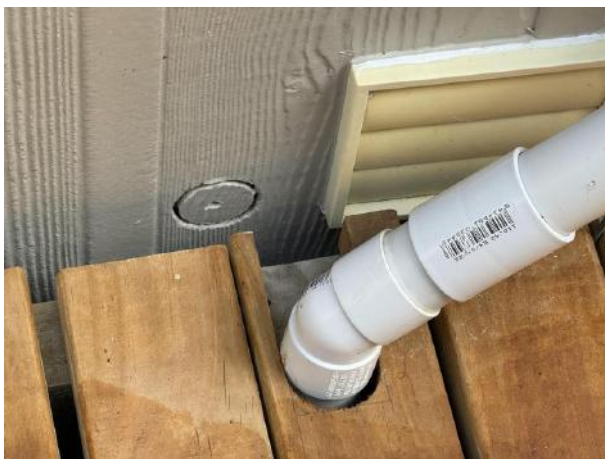
Photo 57

Recommend sealing the hole by the gully trap.

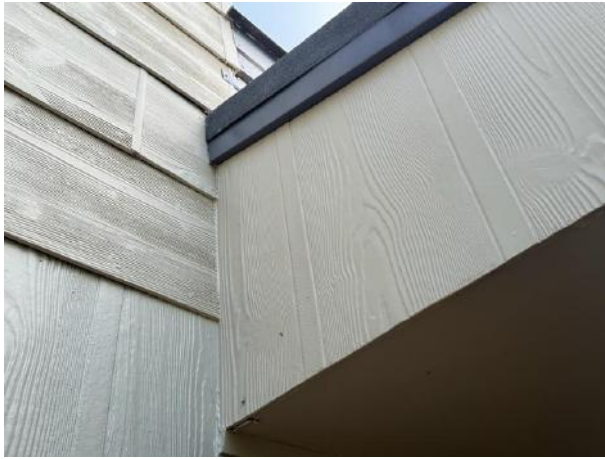
Photo 58

Example of a roof to wall junction. Recommend monitoring and maintaining the sealer.

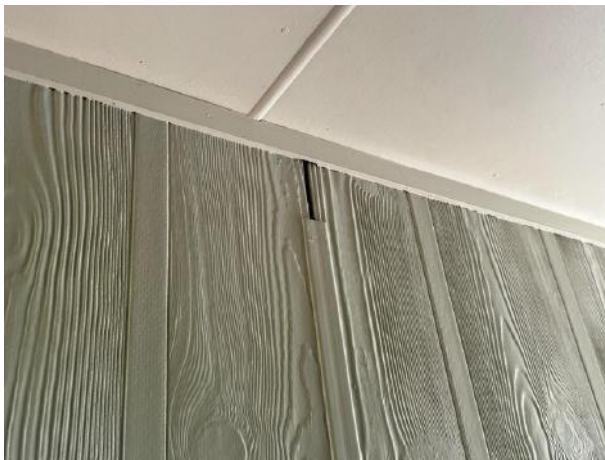
Photo 59

Jointer has slipped down on the east wall by the gate.

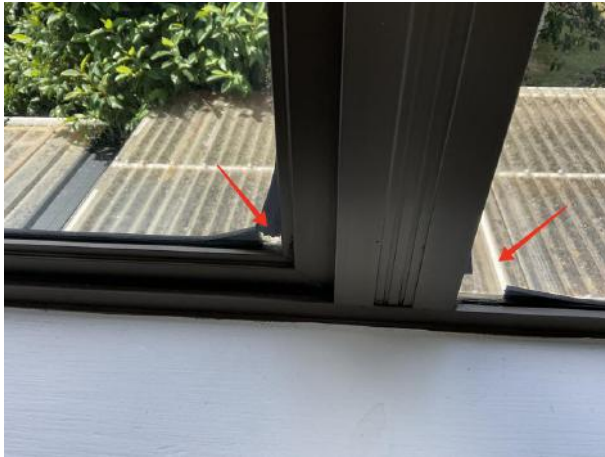
Photo 61

Example of stretched and broken joinery rubbers.

To prevent water & draughts from entering, it is recommended to replace or properly re-seat the rubber seals on the exterior of the joinery. By doing so, you can ensure a tight seal that effectively safeguards against water & draught ingress.

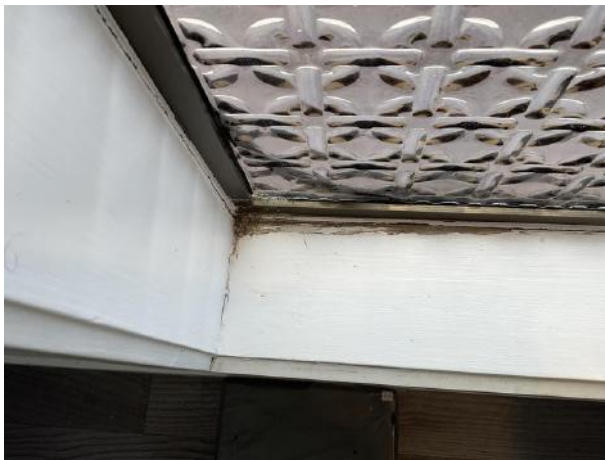
Photo 62

Paint flaking on the ensuite window sill. Recommend correct preparation and decoration.

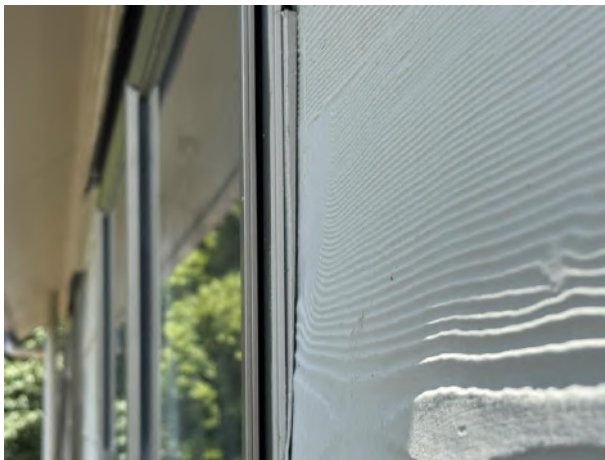
Photo 65

Visible gaps on a number of the sides of the first floor joinery units. Recommend sealing.

Any incomplete or damaged exterior side seals at the cladding to the exterior joinery units need to be repaired to stop water ingress.

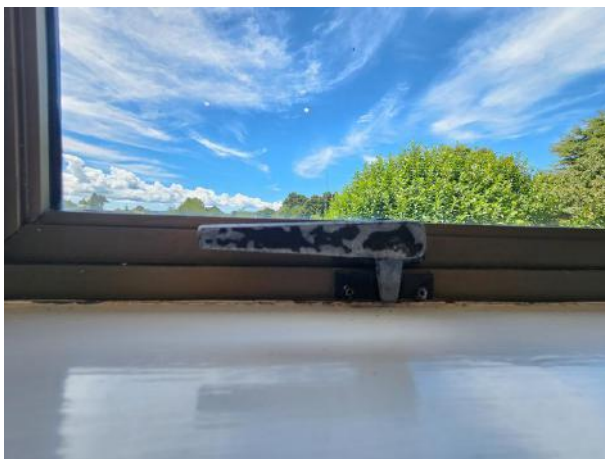
Photo 66

Example of damage to the coating of a number of first floor joinery handles. Some handles were tight and would benefit from lubricating.

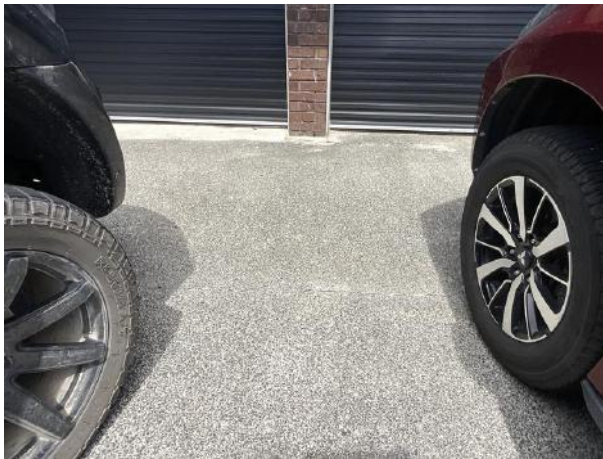
Photo 67

Concrete driveway with visible cracking.

General upkeep and maintenance of driveway by cleaning and keeping free of debris.

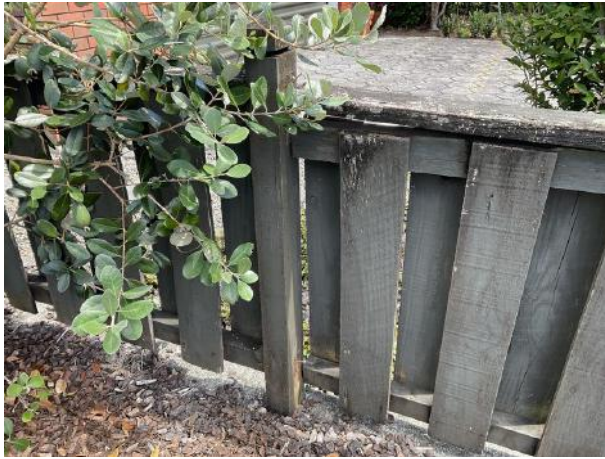
Photo 70

The panel in front of the second Feijoa tree has come away from the post. Recommend re-fixing both rails.

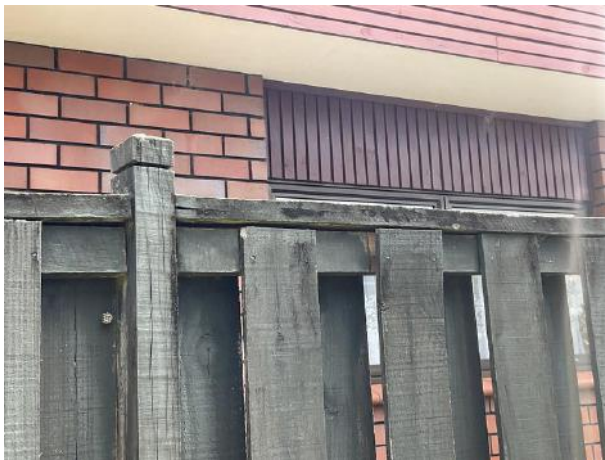
Photo 71

The top capping rail has twisted and some of the palings requiring re-nailing.

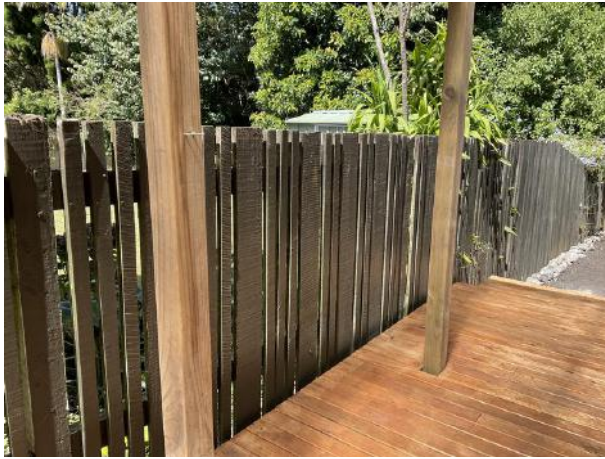
Photo 73

Eastern boundary timber paling fence has a large rotation and is quite loose. Fence would benefit from additional posts.

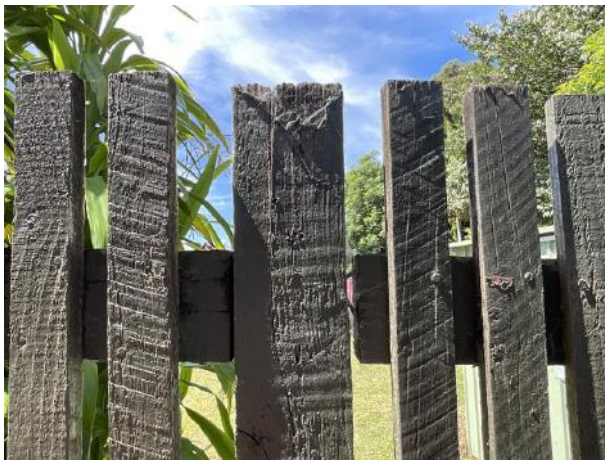
Photo 74

Top rail has detached.

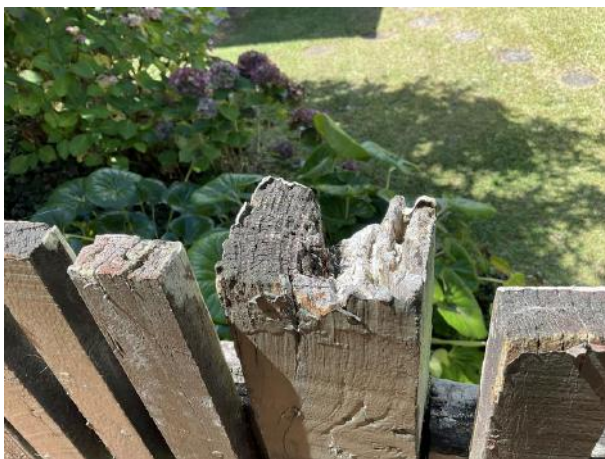
Photo 75

Visible rot in the top of some of the timber posts.

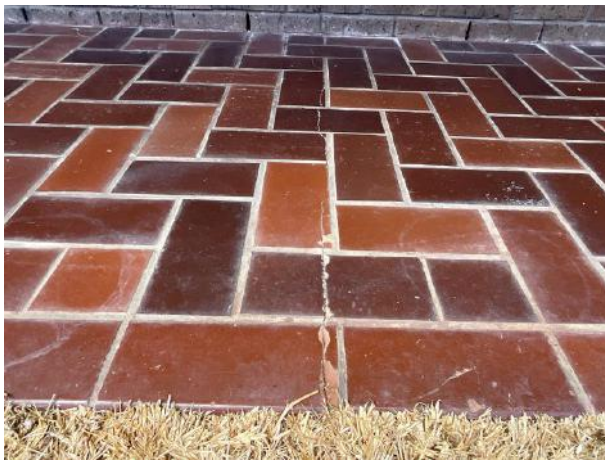
Photo 80

Example of cracking through the tiles.

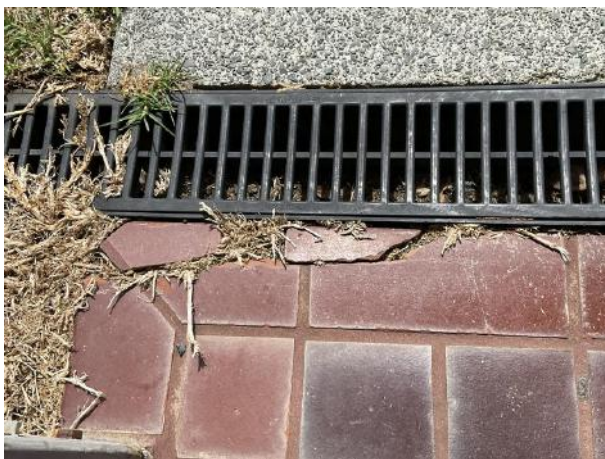
Photo 81

Tiles have broken at the end of the path by the driveway.

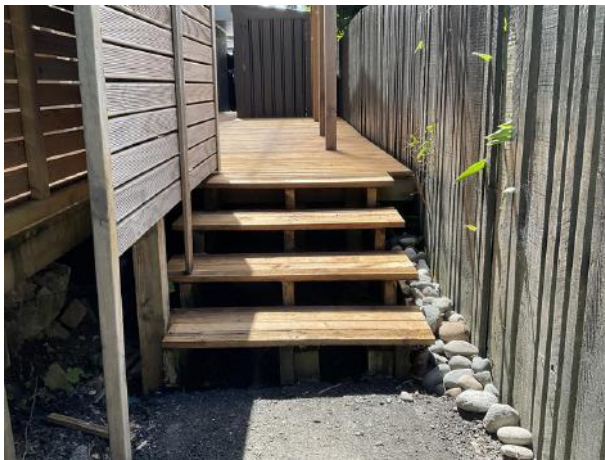
Photo 86

Timber stairs leading to the eastern deck. Recommend installing a handrail.

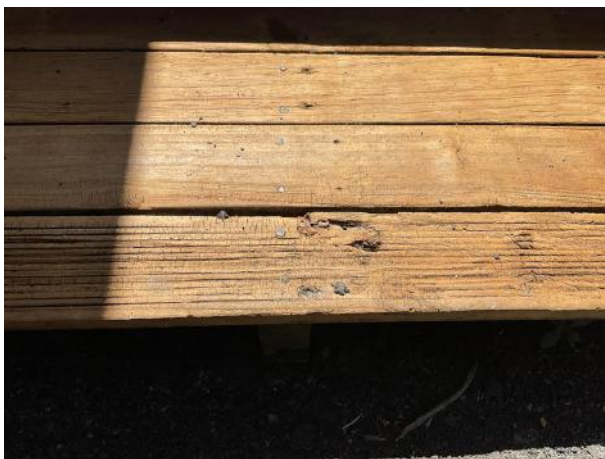
Photo 87

Visible rot in the decking timber on the bottom step.

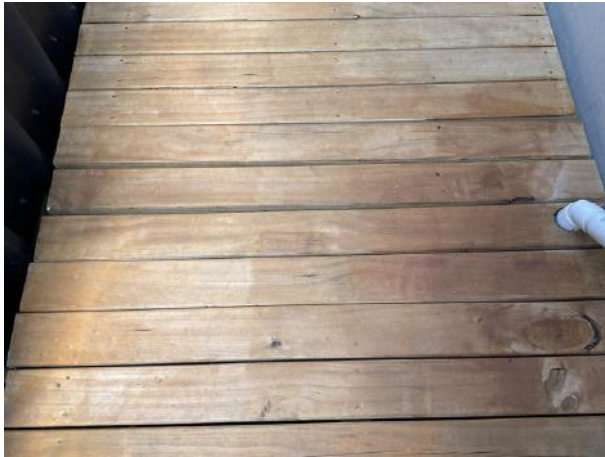
Photo 88

Loose decking timbers by the gully trap. Removable to view gully trap.

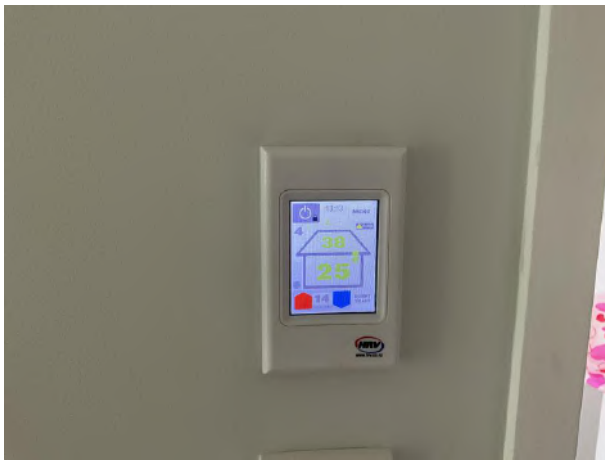
Photo 103

HRV ventilation control panel located in the first floor hallway. Replace Filter light is on.
