Property Condition Report

**94 Cemetery Road
Maunu
Whangarei District**

Inspection Date: 13/02/2021

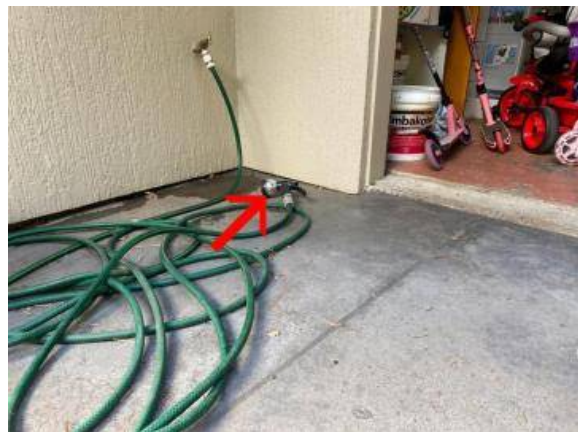
Paved ground level in close proximity to cladding base. A clearance of 100mm is recommended from cladding base to paved ground level to allow adequate cladding drainage. We recommend modifying paving height to meet minimum recommendations and reduce the risk of damage to cladding. Unable to confirm the condition of internal framing in this area at the time of inspection.

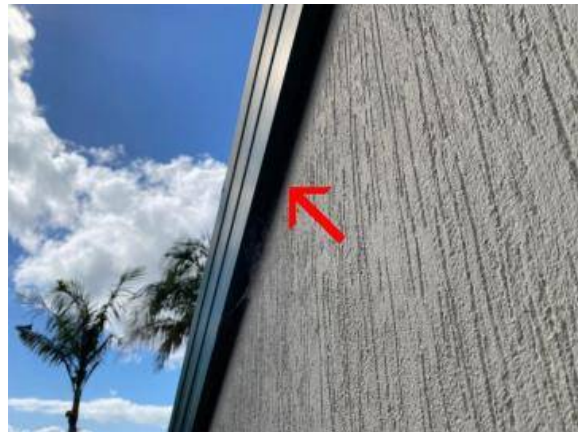
Void between cladding and metal barge board. This may increase the risk of moisture ingress or vermin entry. We recommend engaging the services of a suitably qualified contractor to modify or repair this detail as required.

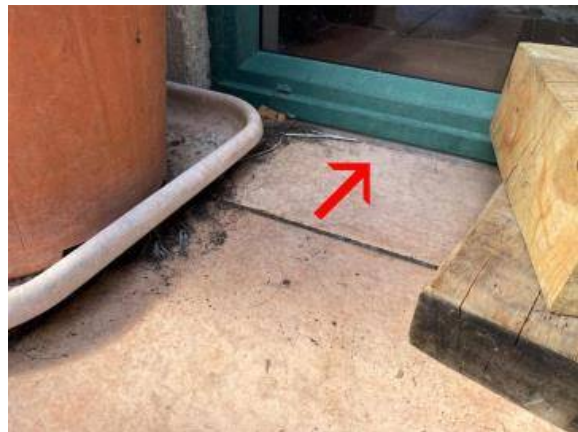
Poor threshold to joinery/patio junction. Joinery base has been sealed against tiles. This is considered a high risk moisture ingress point. We recommend engaging the services of a suitably qualified contractor to modify this detail as required.

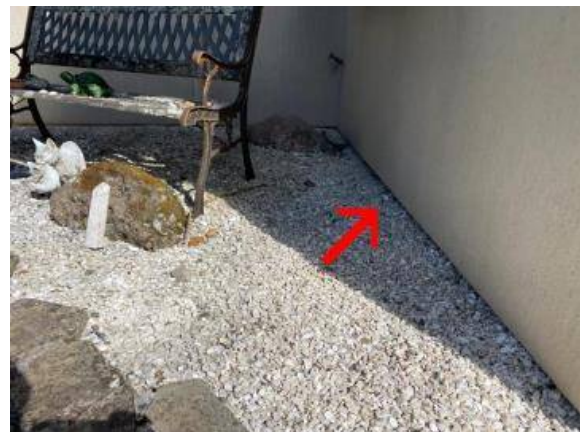
Unpaved ground level in close proximity to cladding base. A clearance of 180mm is recommended from cladding base to unpaved ground to allow adequate cladding drainage. We recommend modifying finished ground level to meet minimum recommendations and reduce the risk of damage to cladding. Unable to confirm the condition of internal framing in this area at the time of inspection.

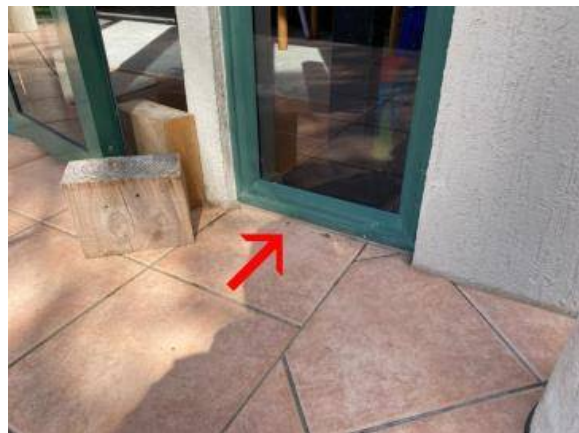
Poor threshold to joinery/patio junction. Joinery base has been sealed against tiles. This is considered a high risk moisture ingress point. We recommend engaging the services of a suitably qualified contractor to modify this detail as required.

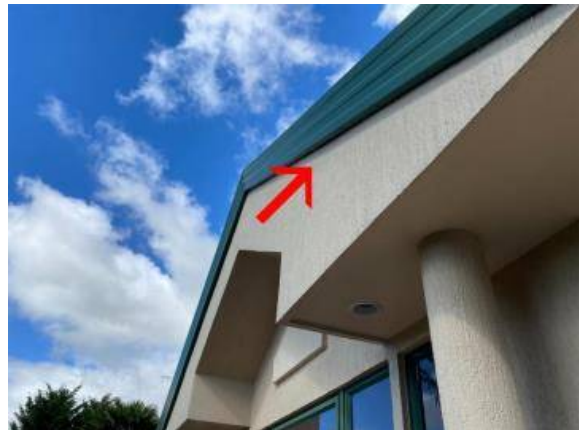
Void between cladding and metal barge board. This may increase the risk of moisture ingress or vermin entry. We recommend engaging the services of a suitably qualified contractor to modify or repair this detail as required.

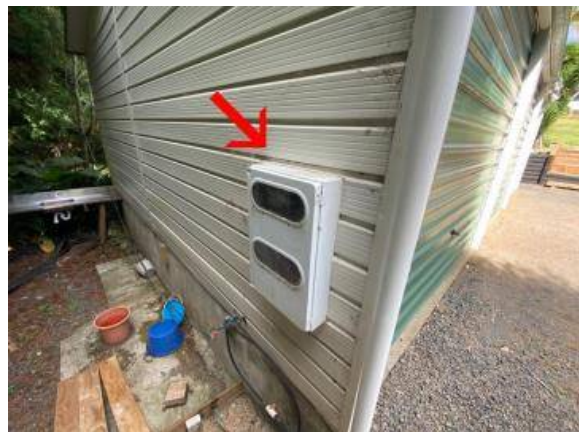
Meter box penetrates exterior cladding. No head flashing detail. This is considered a high risk detail. Where possible we recommend engaging the services of a suitably experienced cladding specialist to modify this detail and ensure the appropriate flashing details are installed.

Meter box penetrates exterior cladding. No head flashing detail. This is a considered a high risk detail. Where possible we recommend engaging the services of a suitably experienced cladding specialist to modify this detail and ensure the appropriate flashing details are installed.

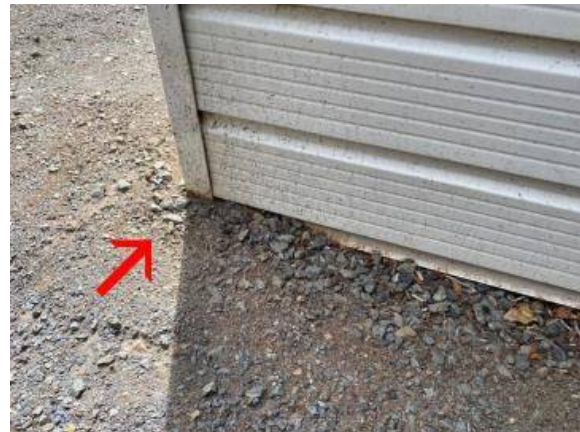
Unpaved ground level in close proximity to cladding base. A clearance of 180mm is recommended from cladding base to finished ground level to allow adequate cladding drainage. Finished ground level should be adjusted to meet minimum recommendations and reduce the risk of damage to cladding.

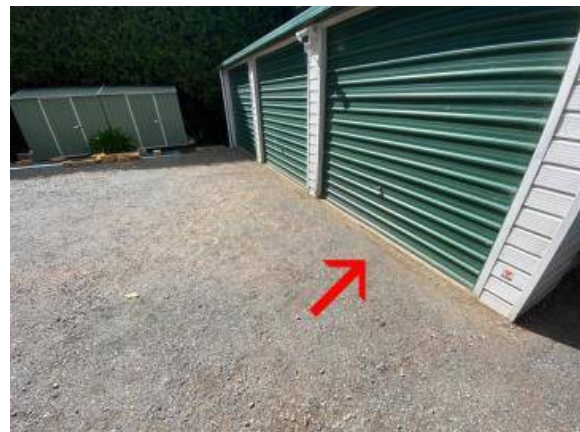
Poor clearance from finished floor level to unpaved ground. Driveway falls towards garage. This may increase the risk of moisture ingress. We recommend modifying the level of finished driveway or the installation of a suitable strip drain to ensure surface water is diverted away from the building.
