Pre-sale Building Inspection Report

PRE-PURCHASE BUILDING REPORT

Property Address	956D Whangarei Heads Road, Parua Bay, Northland, 0174, NZL		
Client	Penny Bradford		
Date of Inspection	17th March 2024	Time	1:00 pm
Inspector	Jamie Mackintosh Licensed Building Practitioner Brick & Block		
LBP Number	116085		
Additional Information			
People Present	Inspector, Agent		
House Occupied	Yes

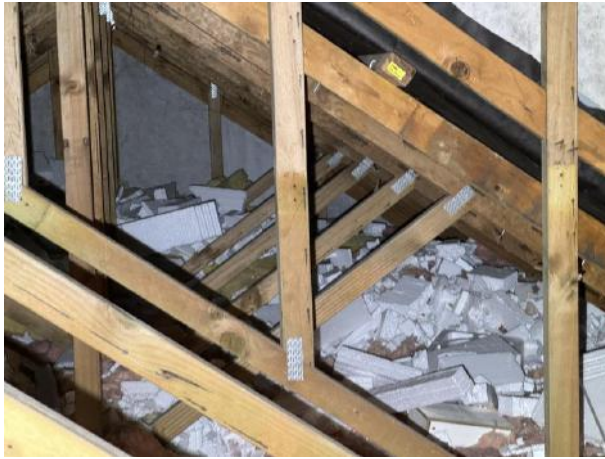
Photo 12

Large amount of broken polystyrene insulation on top of the glass wool, above the garage. Recommend removing.

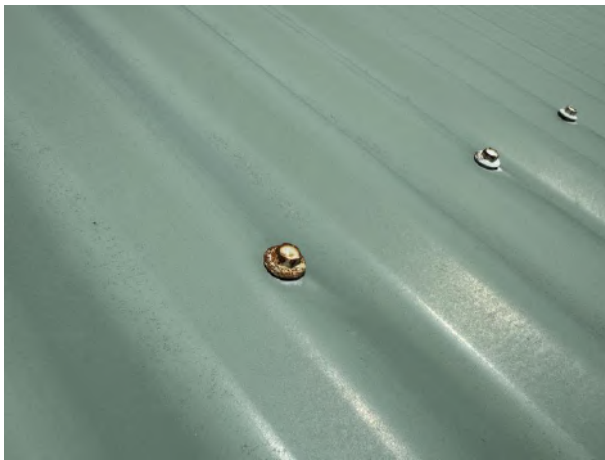
Photo 28

Visible rusting to some screw heads. Recommend replacing where required.

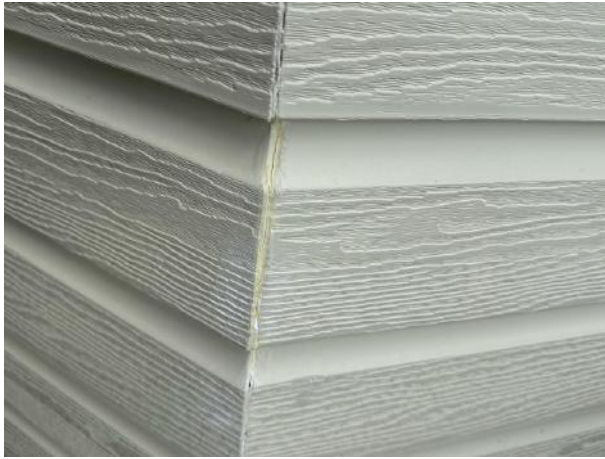
Photo 38

Seperation in the sealer on the angle junctions by the front door. Recommend re-sealing.

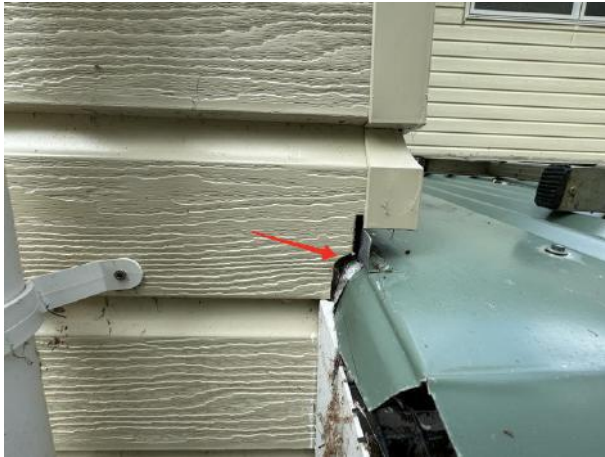
Photo 41

Recommend sealing the cladding to roof junction on the west side.

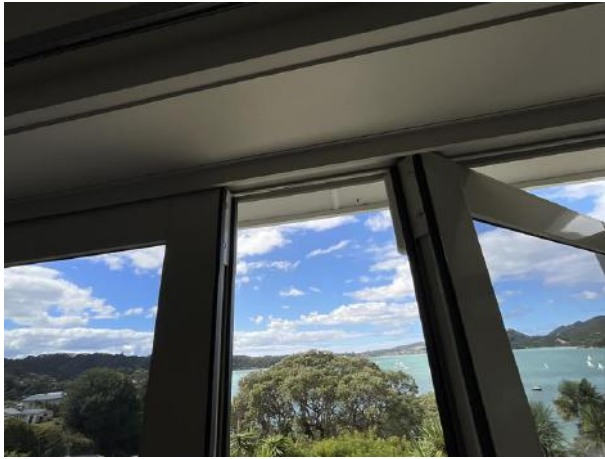
Photo 47

Bedroom one bi-fold window is scraping along the top. Recommend adjusting the lower hinge to suit.

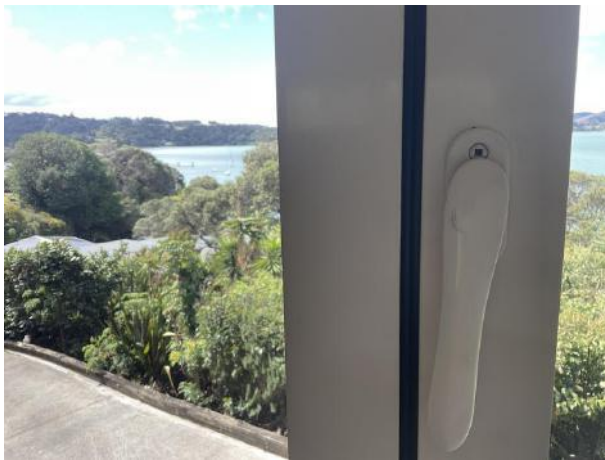
Photo 48

Damage to the window handle on bedroom one bi-fold.

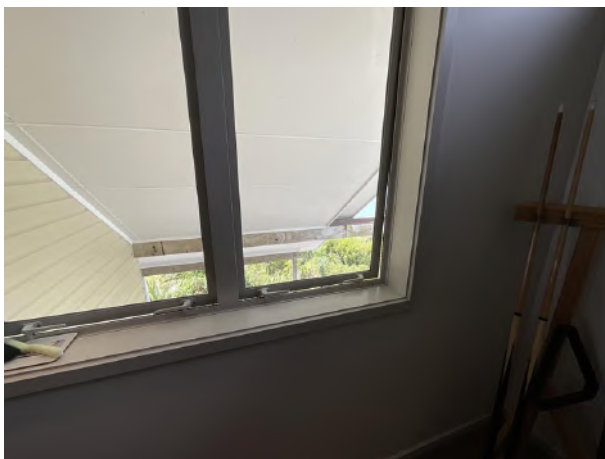
Photo 49

Recommend installing security stays to the second floor joinery.

Recommended that security stays are installed on any second story opening windows with a sill height lower than 900mm to reduce fall hazard.

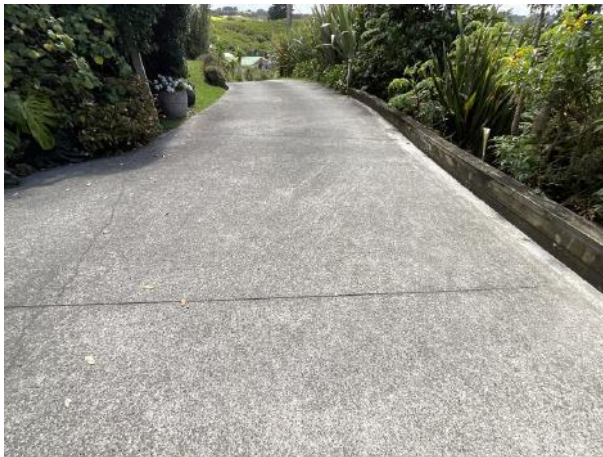
Photo 51

Concrete driveway with visible cracking.

General upkeep and maintenance of driveway by cleaning and keeping free of debris.

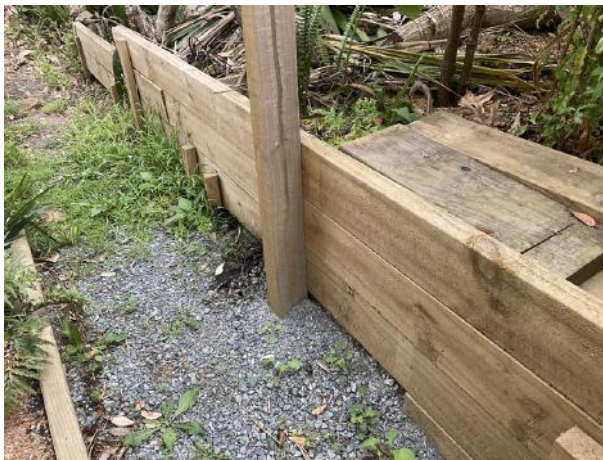
Photo 61

Timber retaining wall located on the west side of the house. Recommend installing sufficient posts to the lower end.

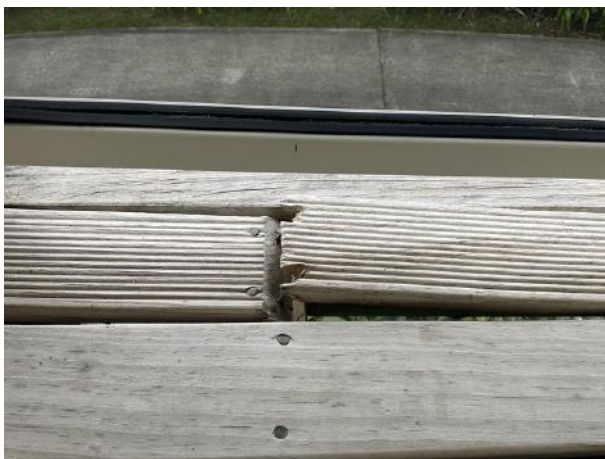
Photo 68

Lifted timber paling under the eastern balustrade. Recommend re-fixing.

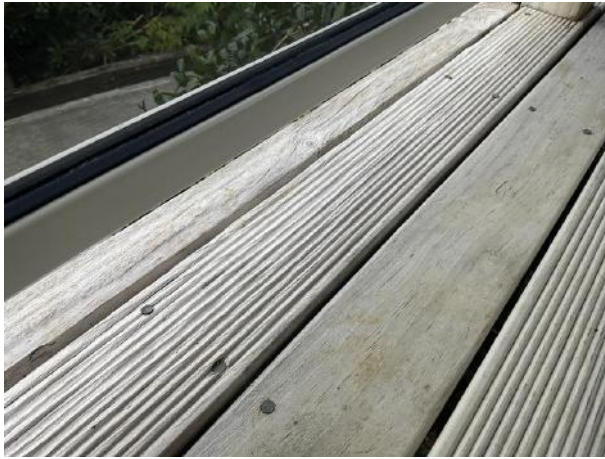
Photo 69

Visible weather damage to exposed timber under the balustrade.

Recommend painting/sealing the decking timbers.

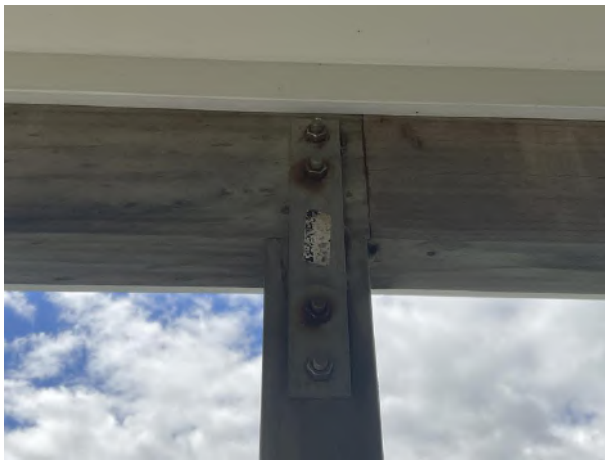
Photo 70

Visible rust in the strap bracket on top of the timber posts.

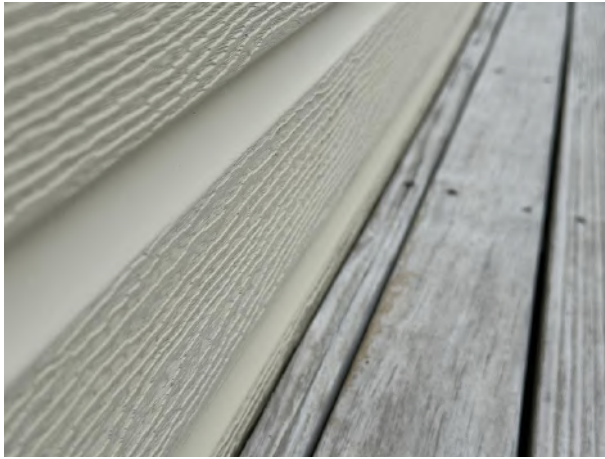
Photo 72

Minimal clearance between the cladding and deck junctions. Recommend trimming back.

Trim back the decking from the wall cladding, the decking should be a minimum of 12mm off the wall cladding to prevent water pooling against the cladding and deteriorating the building elements.

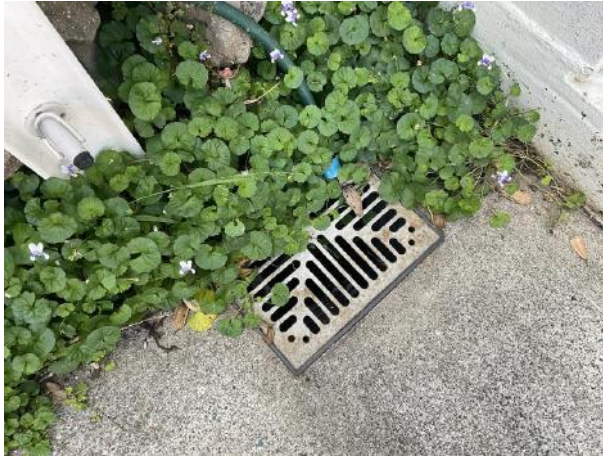
Photo 75

Stormwater grate located outside the garage on the south side of the house. Recommend clearing the vegetation.

Keep vegetation and soils clear of drainage.
