Building Inspection Report

Client: Paul Sumich
Location: 25 Tapper Crescent, Tikipunga
Whangarei

Inspection Date: 09/11/2021

RE: Building Inspection Report, 25 Tapper Crescent, Tikipunga, Whangarei.

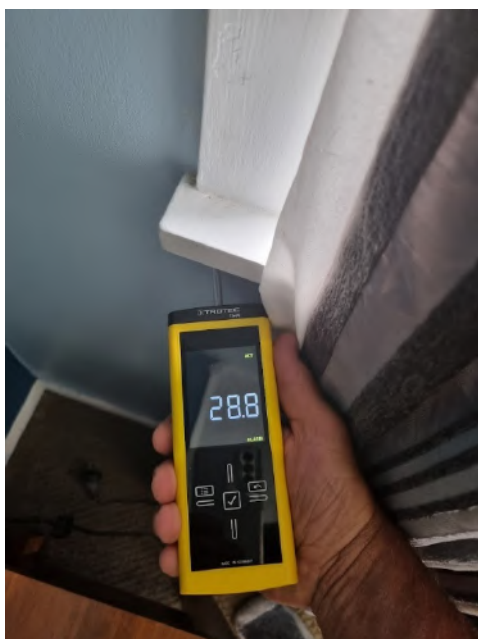
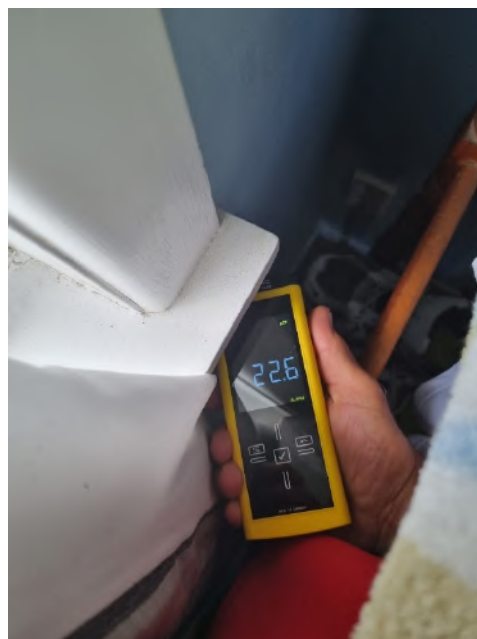
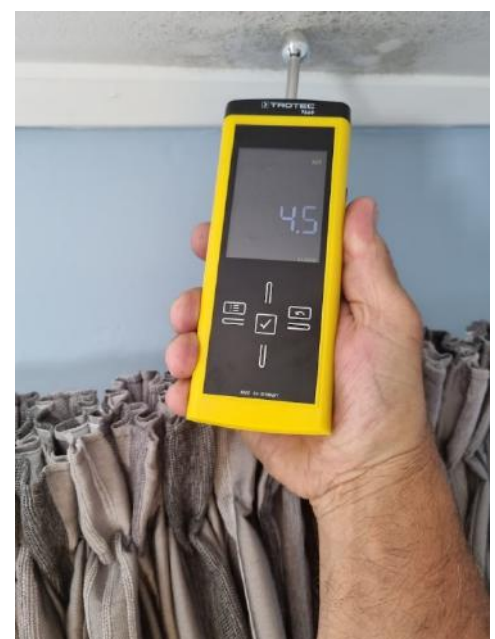
- Patch of mould present to right hand side of main window in bedroom 3 (Master). Moisture reading is 4.5 and is not showing any signs of damp.
- Walk in wardrobe off bedroom 3 is smelling damp and there is movement visible at the ceiling trim. Moisture reading shows no sign of dampness.

Patch of mould present to right hand side of main window in bedroom 3 (Master). Moisture reading is 4.5 and is not showing any signs of damp.

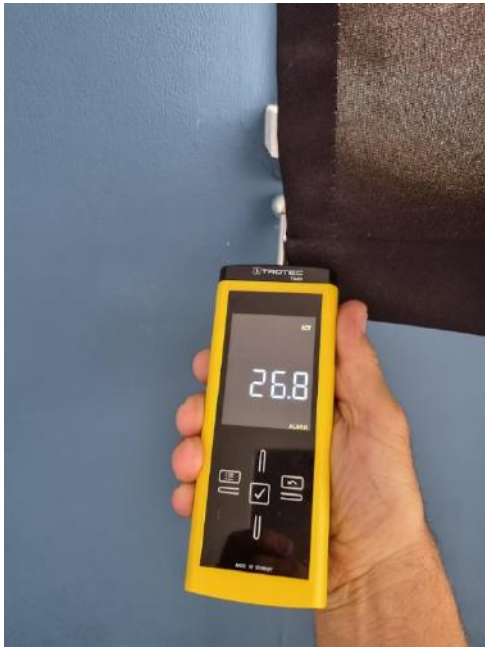
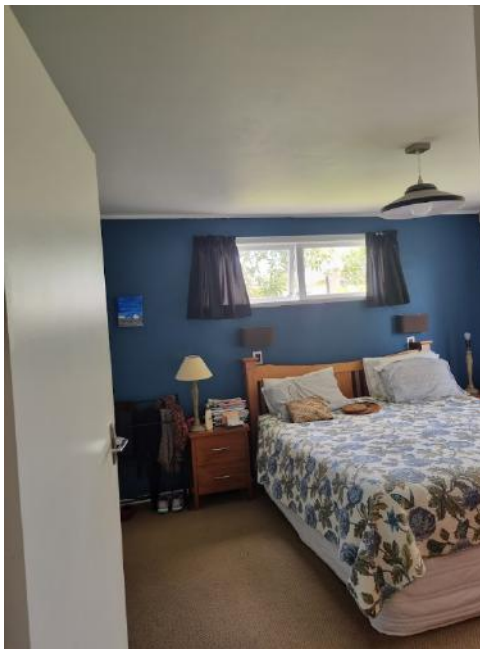
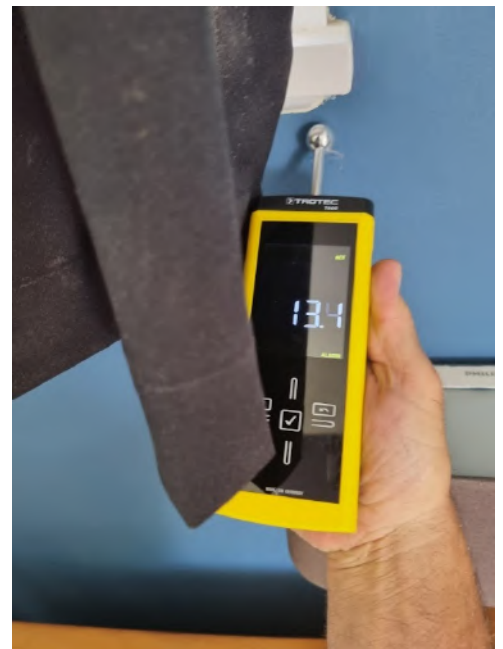
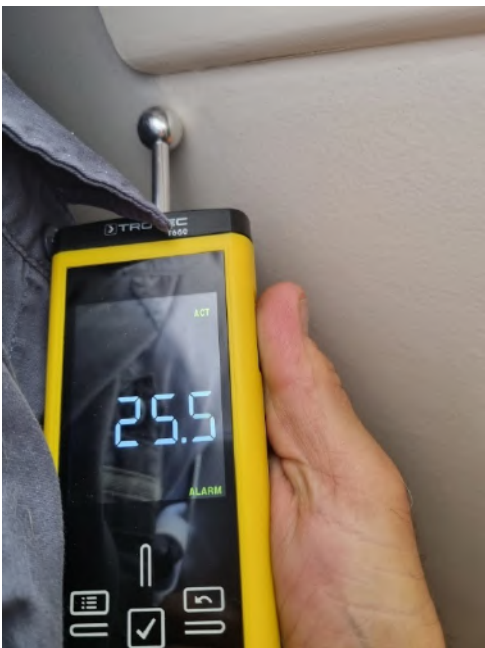
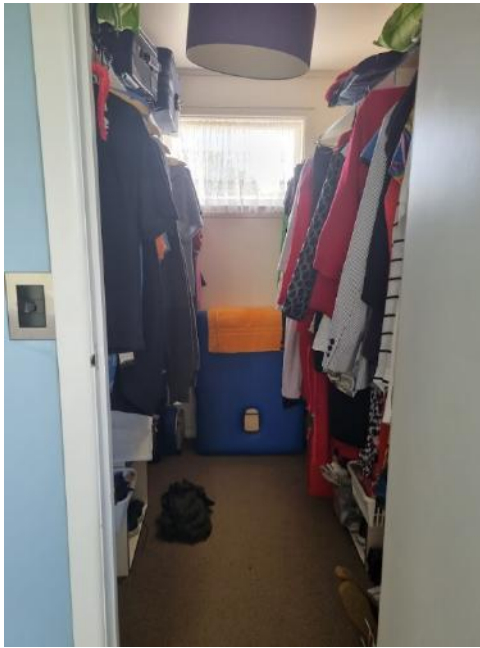
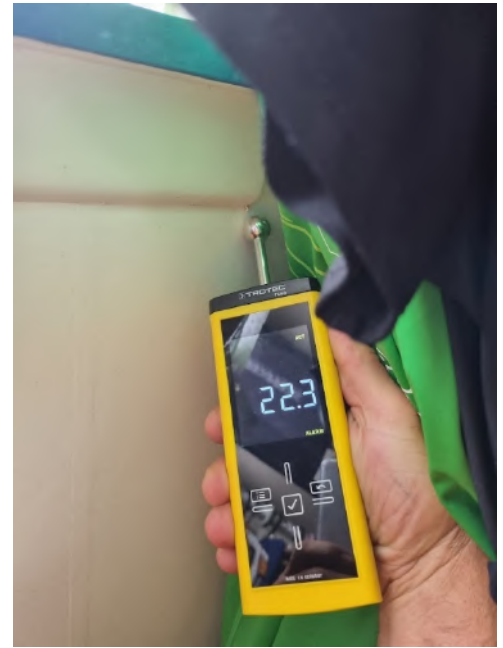
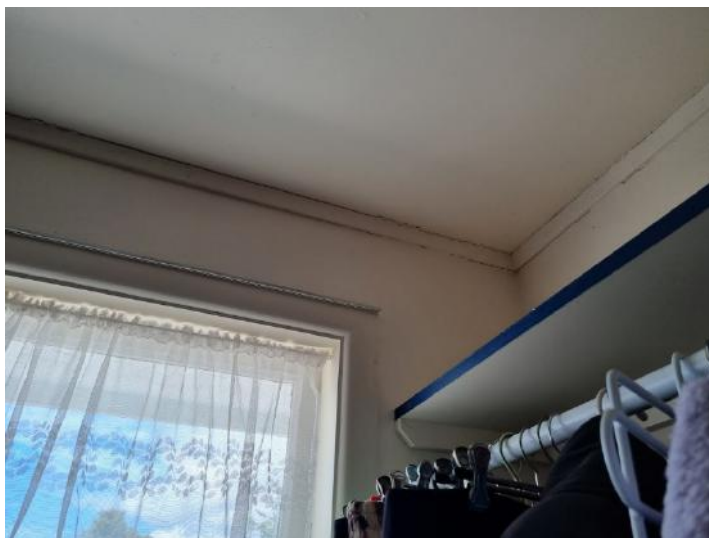
Walk in wardrobe off bedroom 3 is smelling damp and there is movement visible at the ceiling trim. Moisture reading shows no sign of dampness

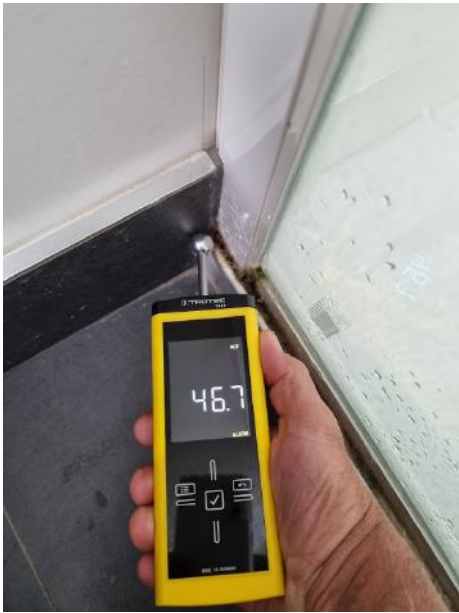
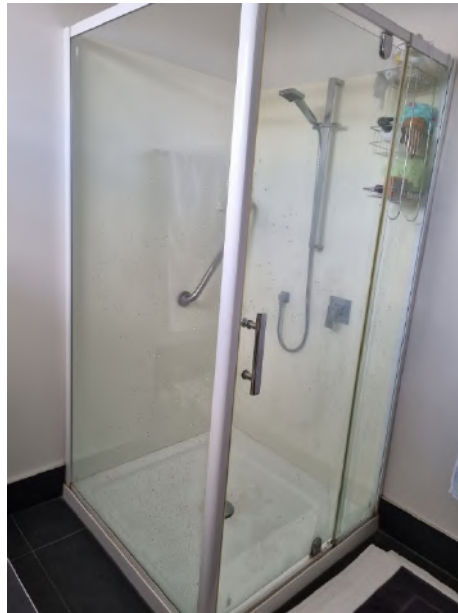
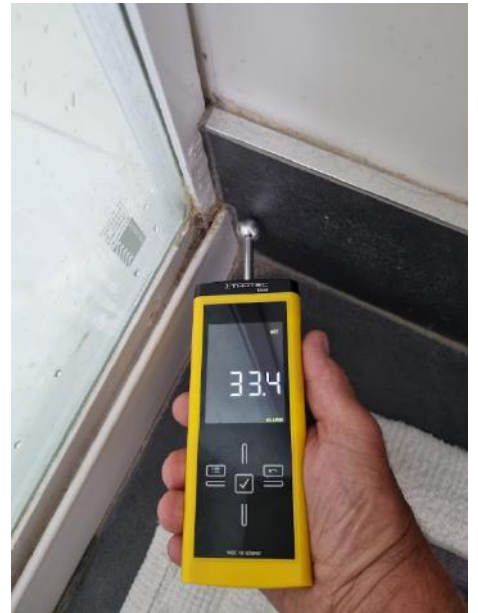
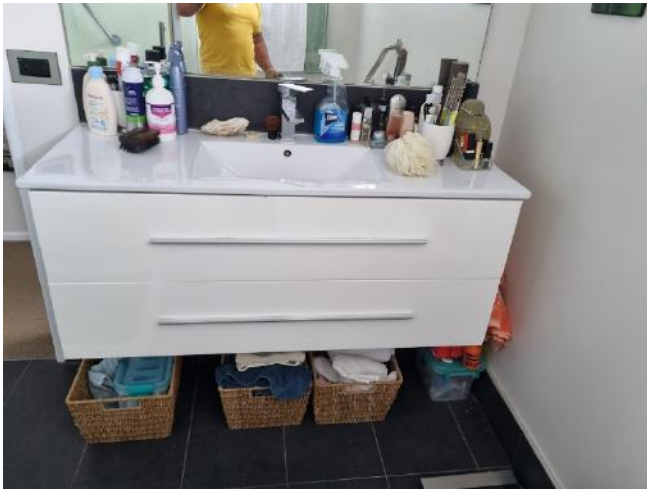
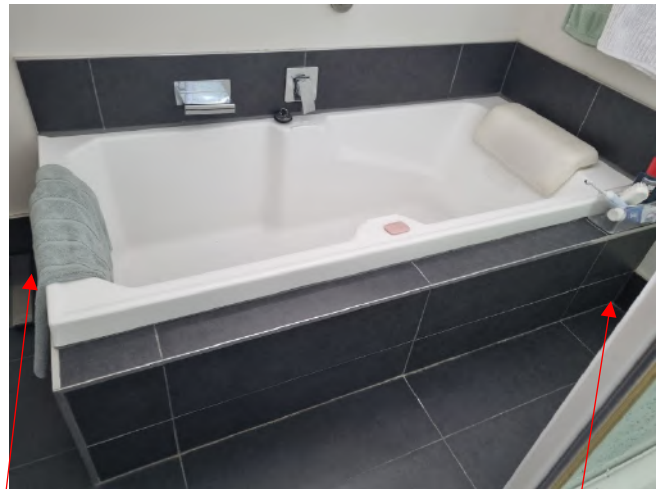
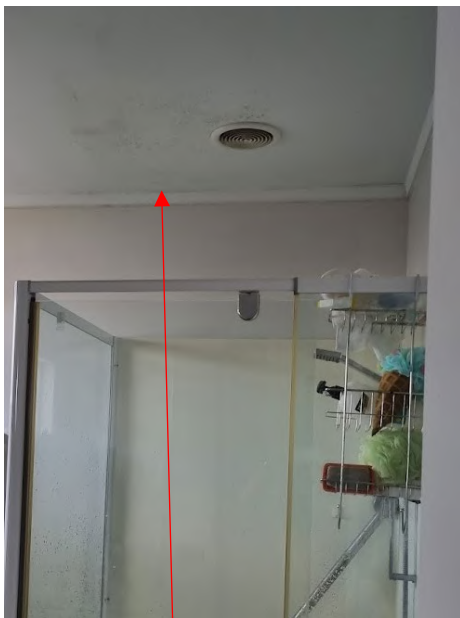
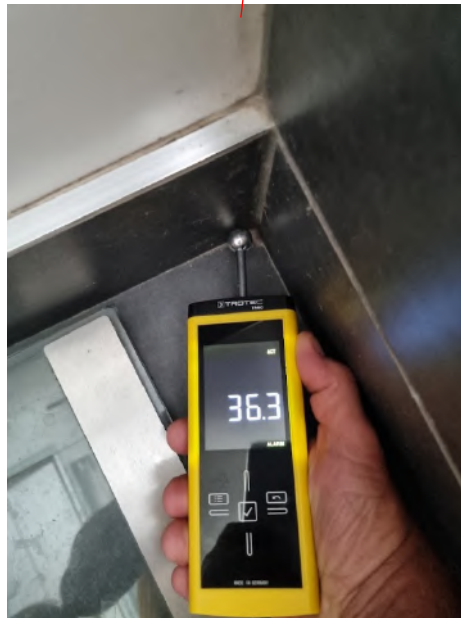
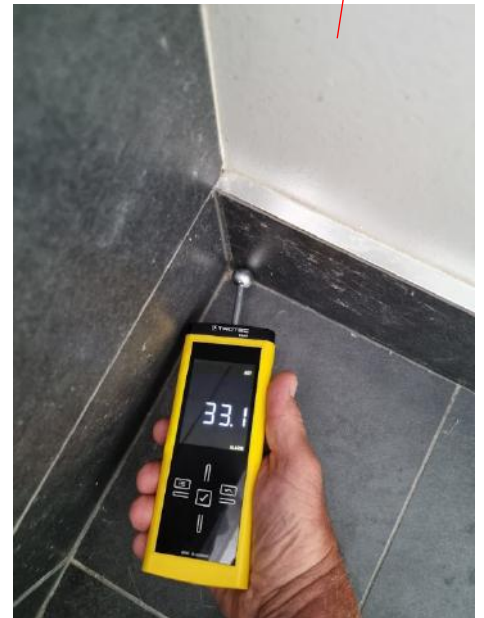
- Bathroom is showing signs of mould to the ceiling and upper wall area, ventilation system and a clean is recommended.
- Mould present to ceiling and on wall at the top in the separate toilet – ventilation system and a clean is recommended

Bathroom is showing signs of mould to the ceiling and upper wall area, ventilation and a clean is recommended

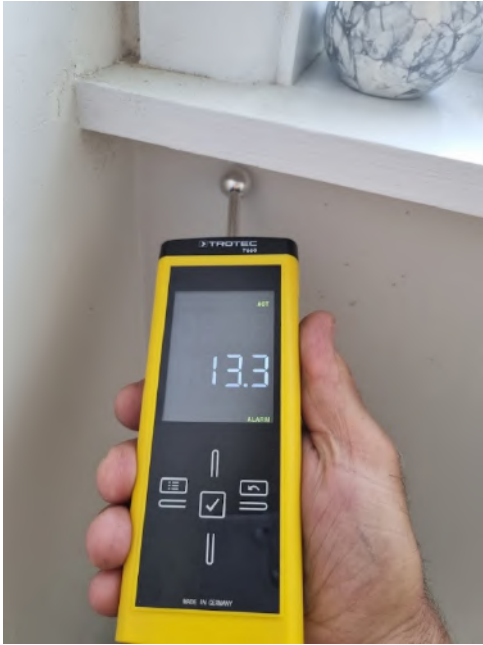
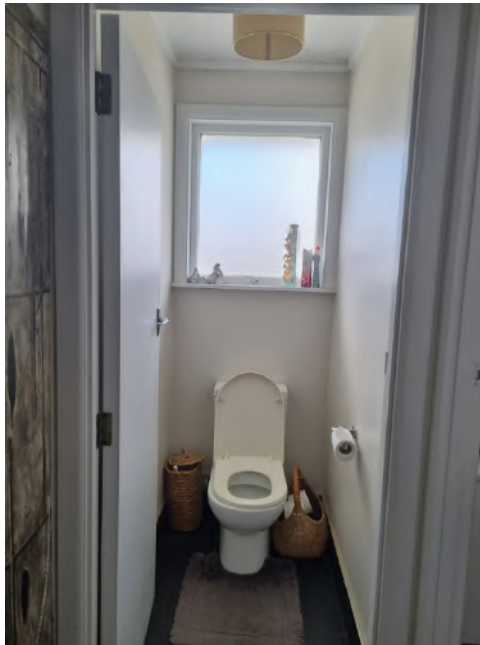
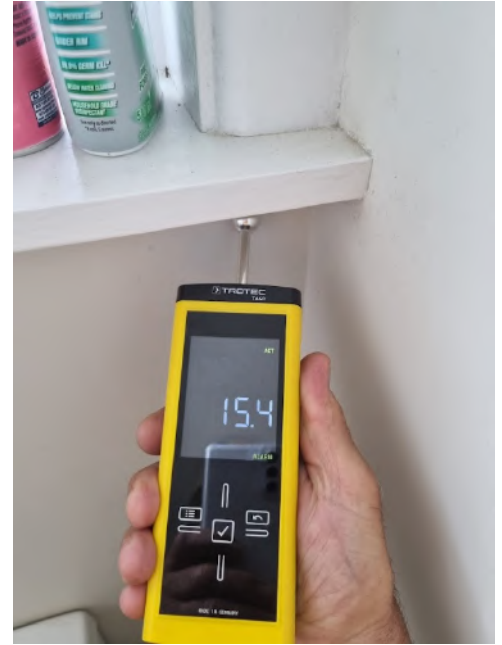
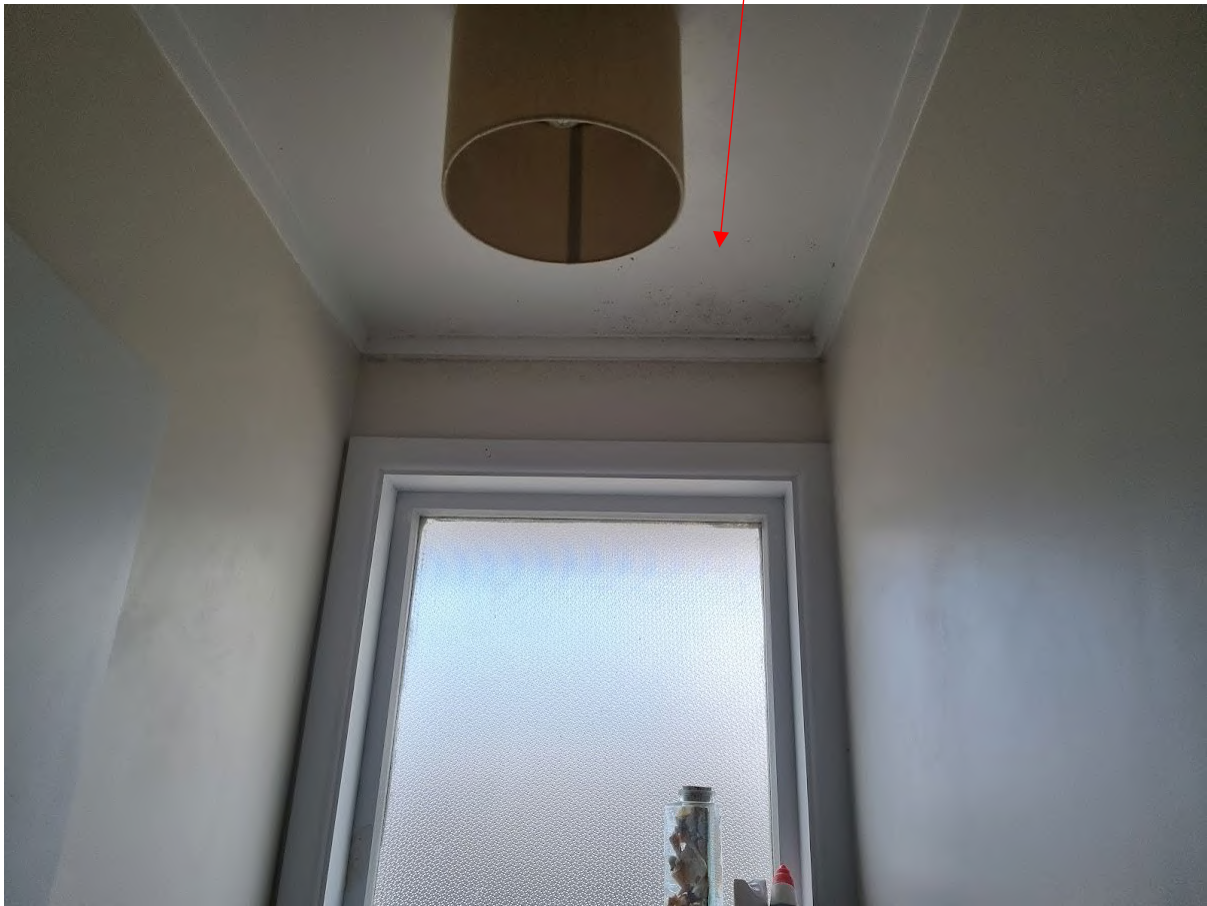
Separate toilet

Mould present to ceiling and on wall at the top in the separate toilet – ventilation and a clean is recommended

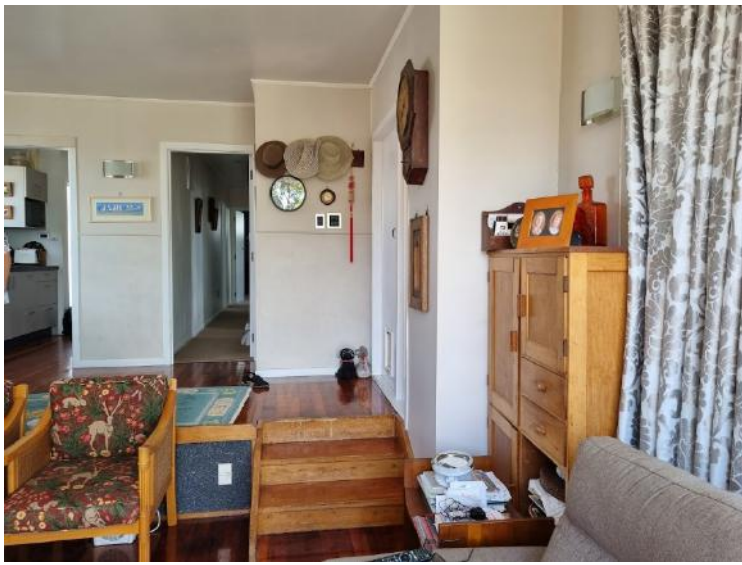
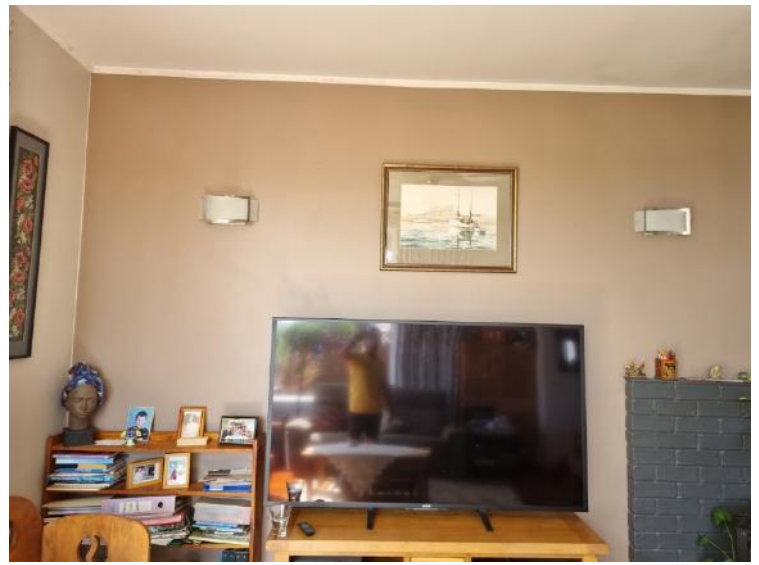
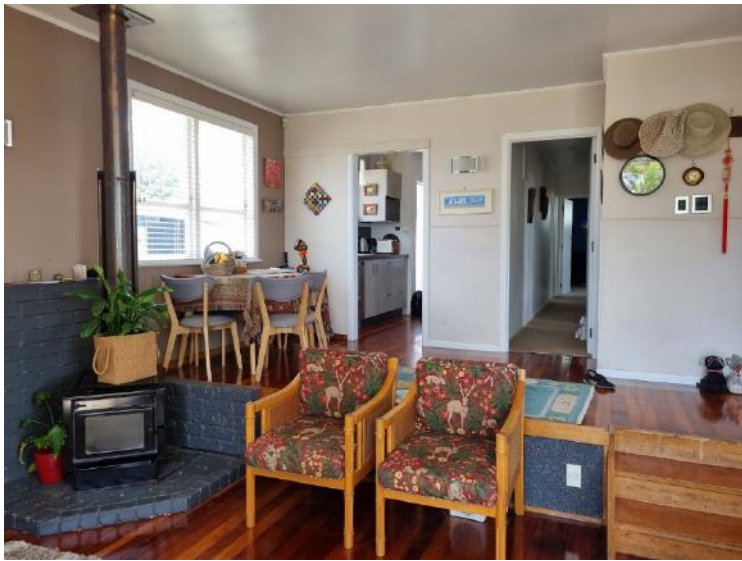
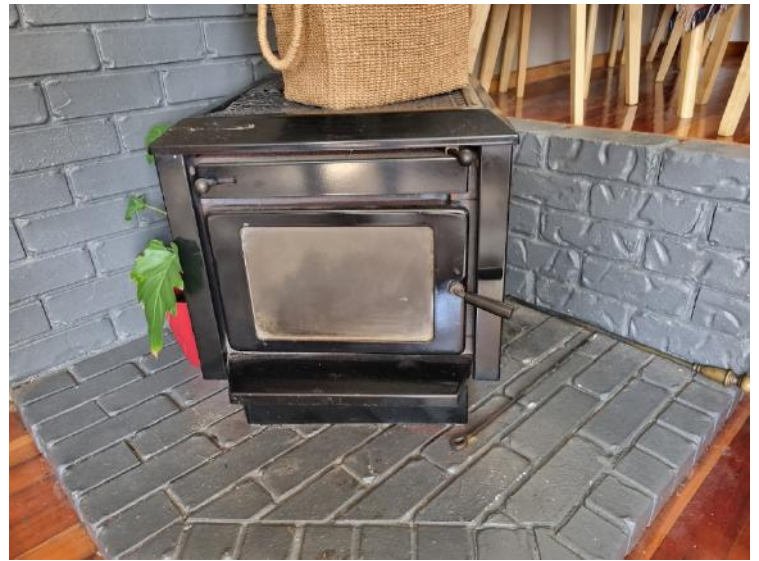
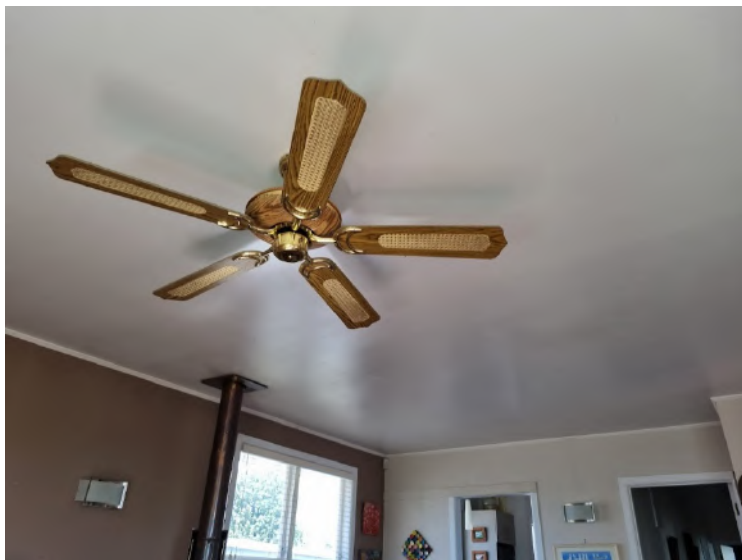
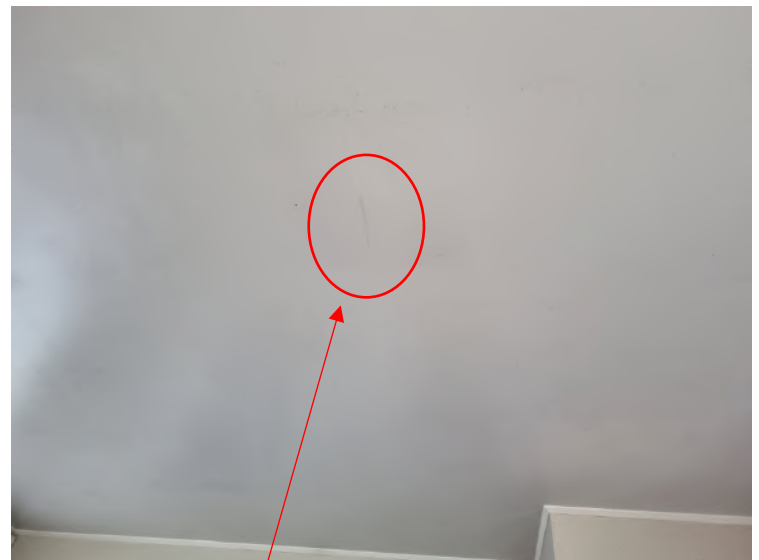
- Crack in the lounge ceiling where it shows slight sagging, unable to obtain a moisture reading. Could be a result for several reasons, it does appear dry at this point.

Crack in the lounge ceiling where it shows slight sagging, unable to obtain a moisture reading. Could be a result for several reasons, it does appear dry at this point.

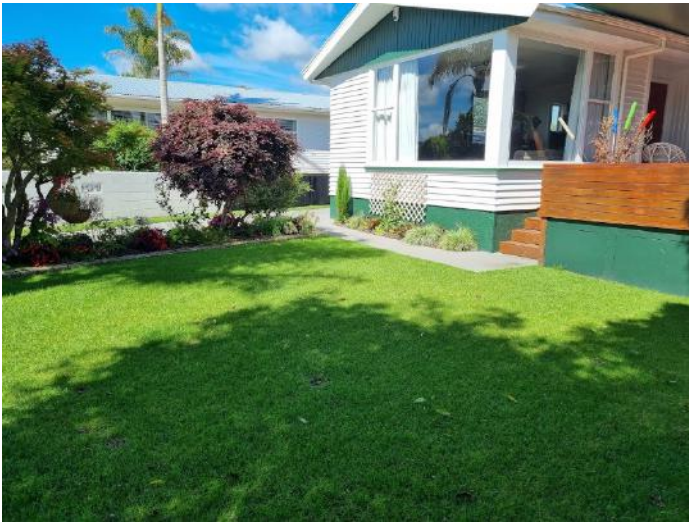
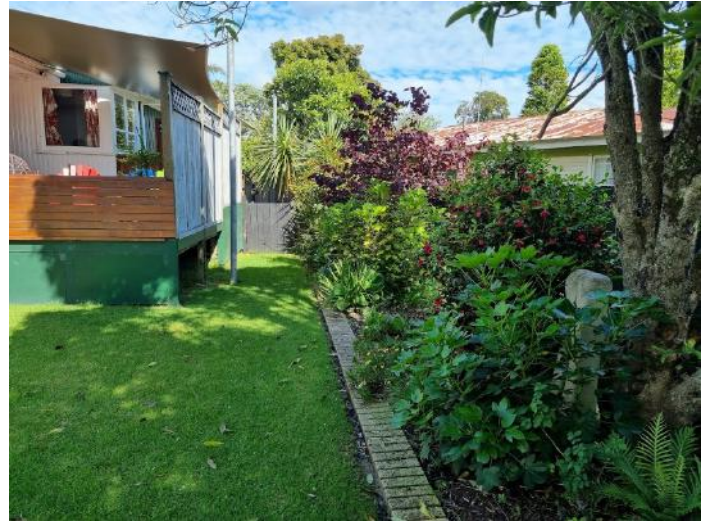
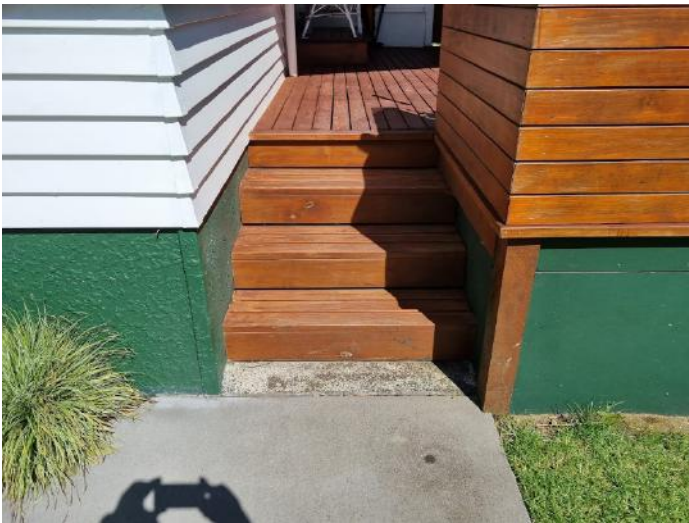
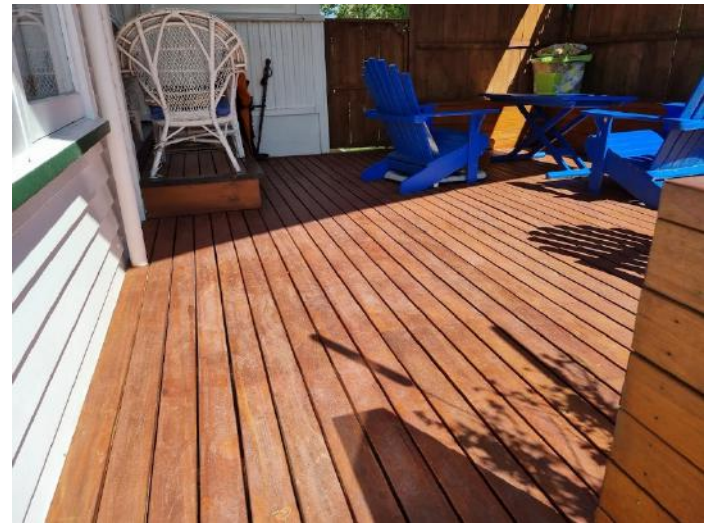
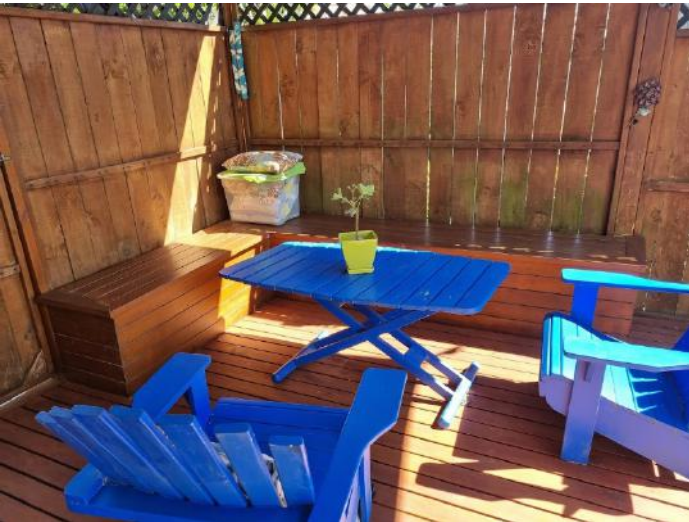
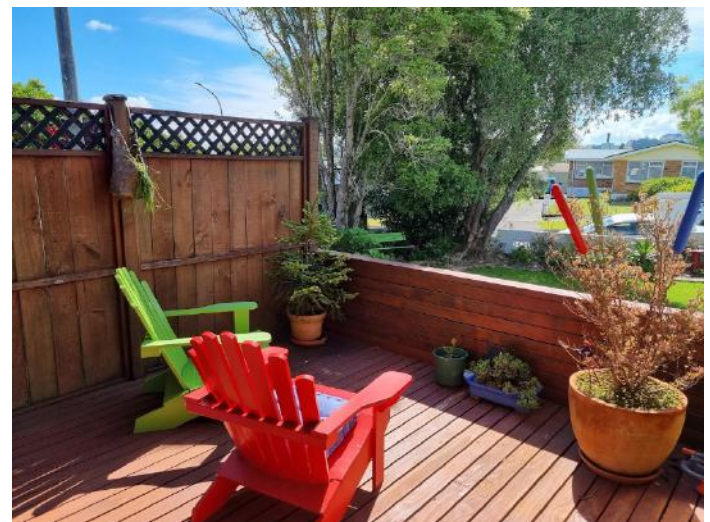
Timber decking appears in reasonable condition

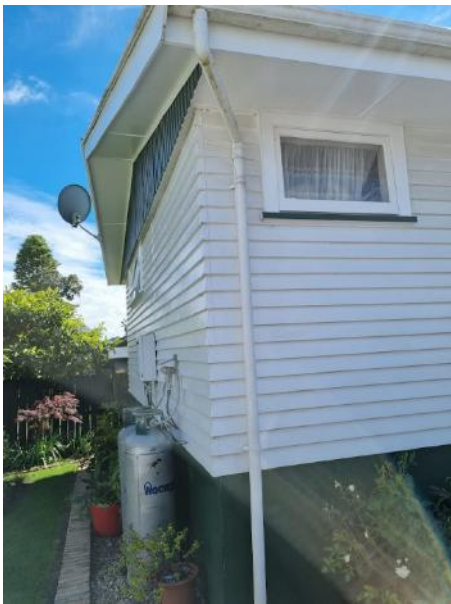
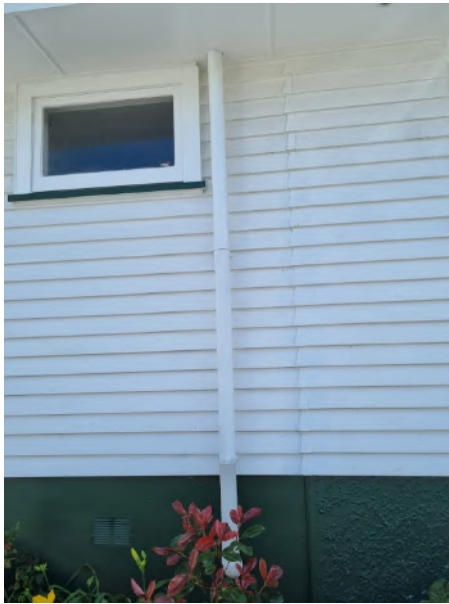
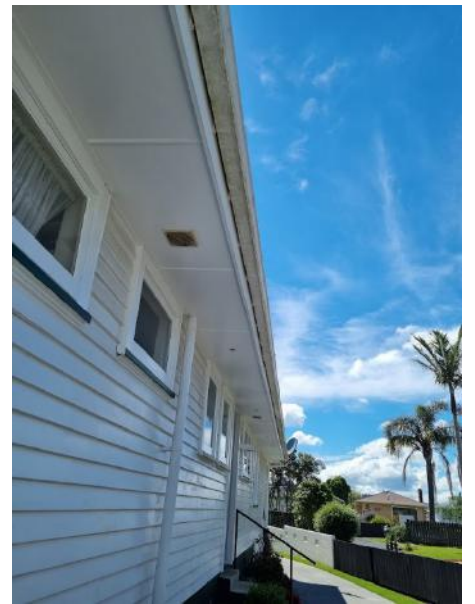
Fibrolite will most likely contain asbestos, present to the base, gable, and entryway

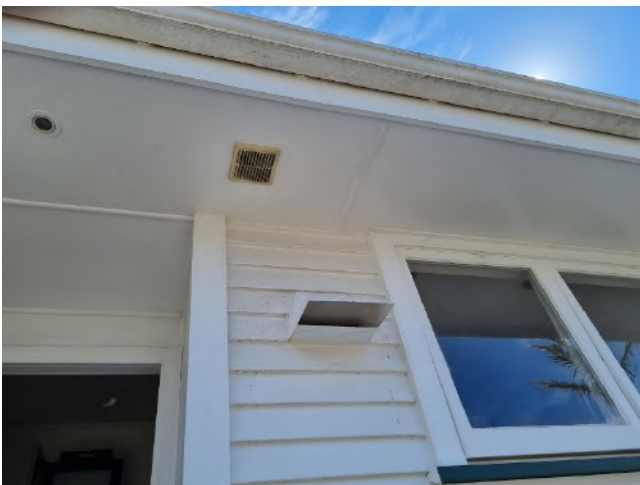
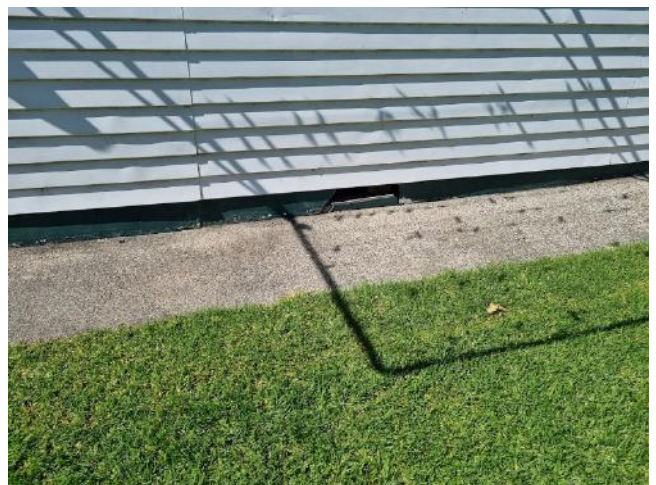
Window frames and sills facing exterior appear in reasonable condition

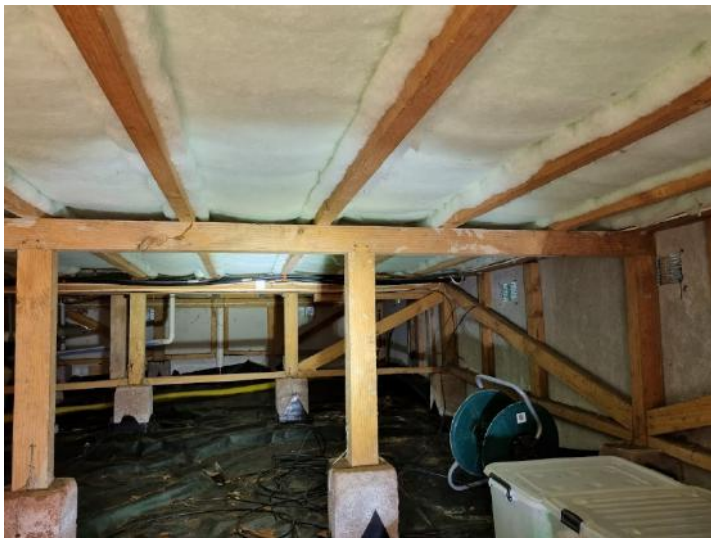
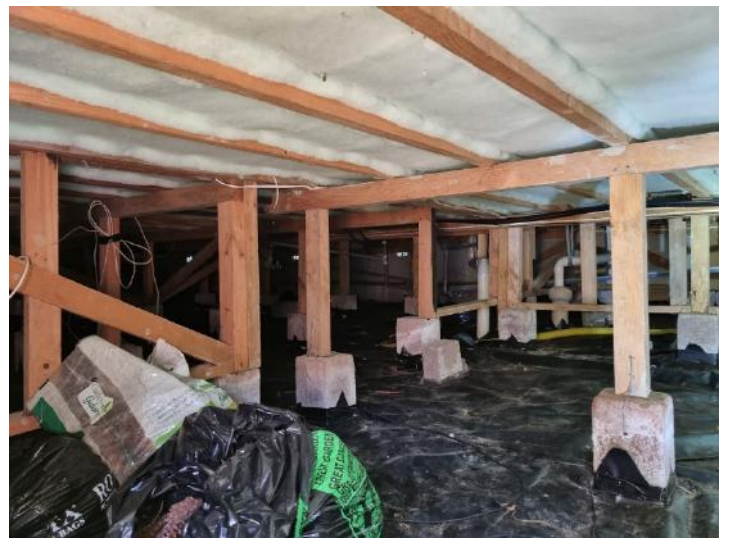
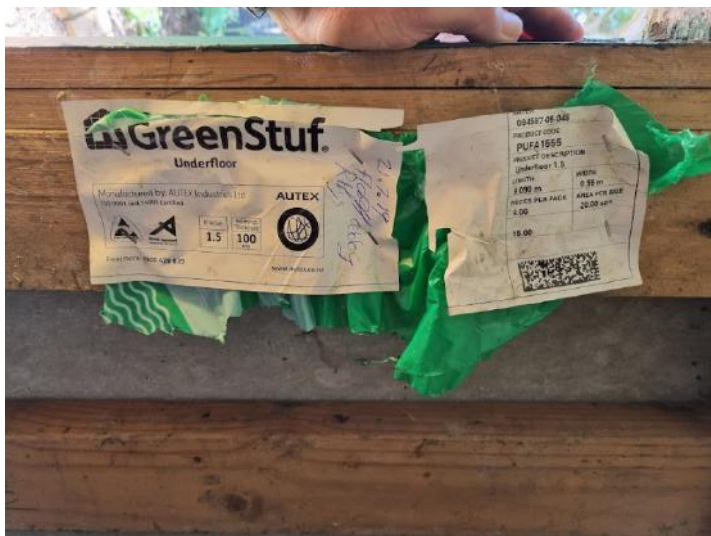
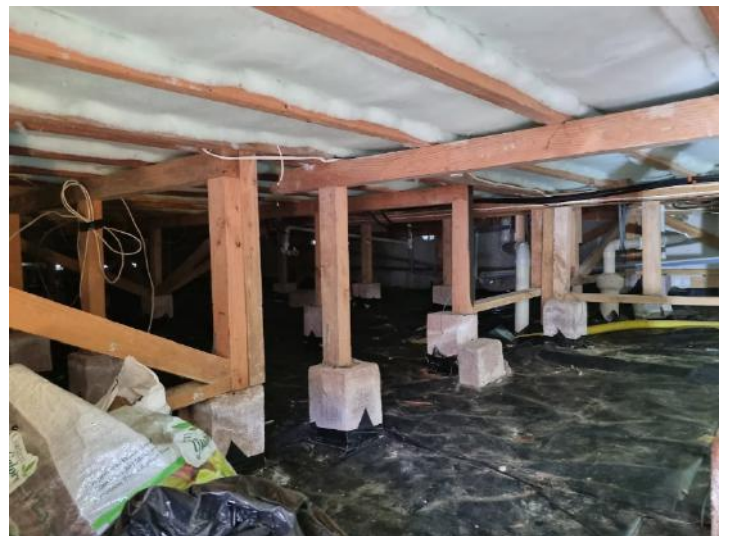
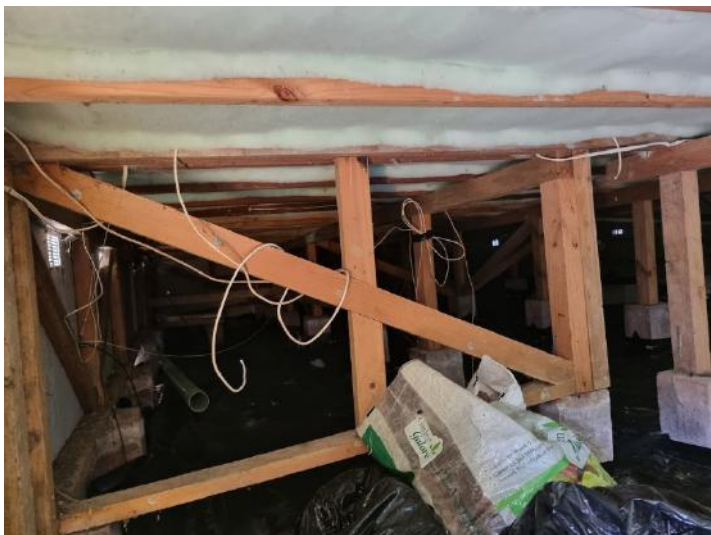
Substructure appears in sound condition

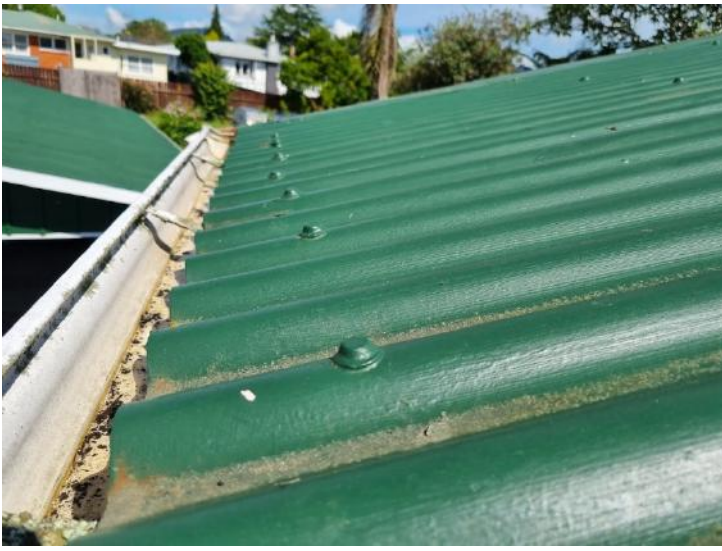
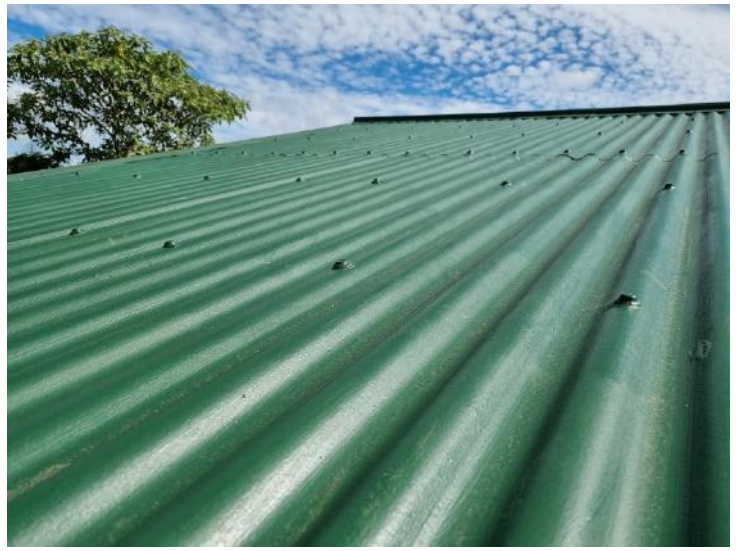
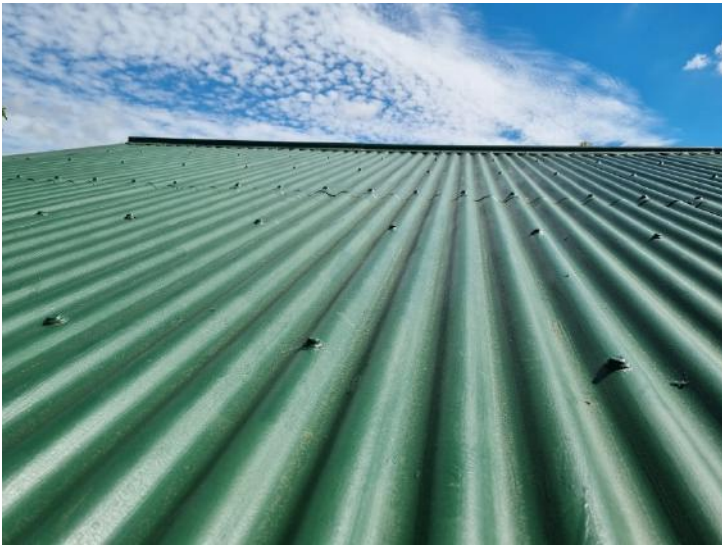
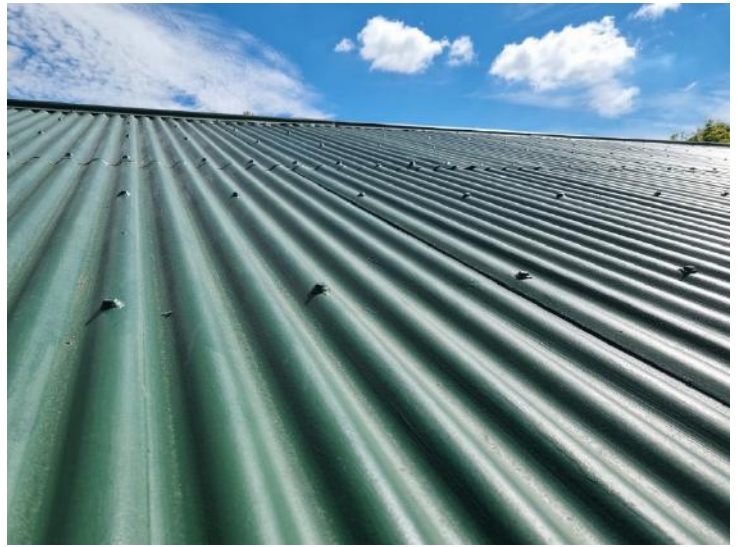
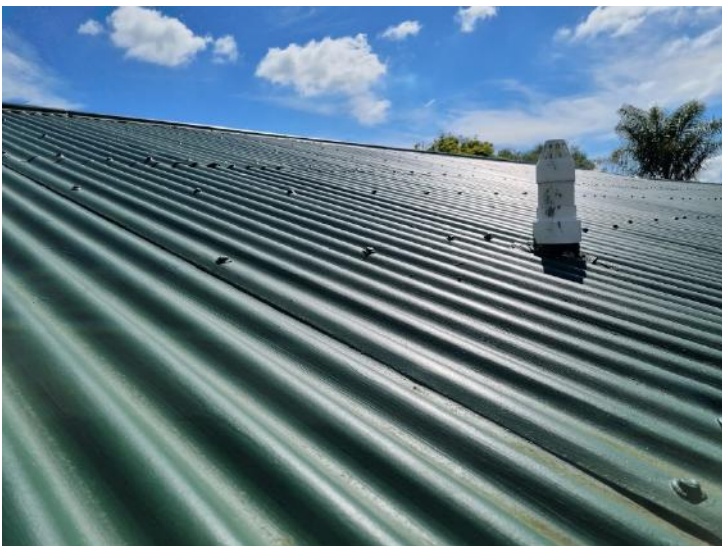
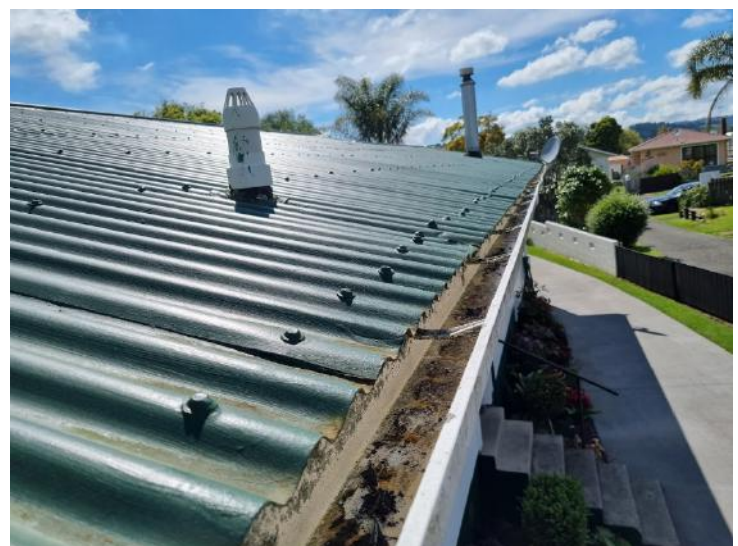
Roof appears in reasonable original condition for its age and appears to have been painted in the past 5 years or so. Recommend a re-roof at some stage due to being past its life span- monitor this.
