Building Inspection Report

Client: Jo Green and Paul Teahon
Location: 64 Crossett Road, Ruatangata
Whangarei

Inspection Date: 10/11/2021

RE: Building Inspection Report, 64 Crossett Road, Ruatangata, Whangarei.

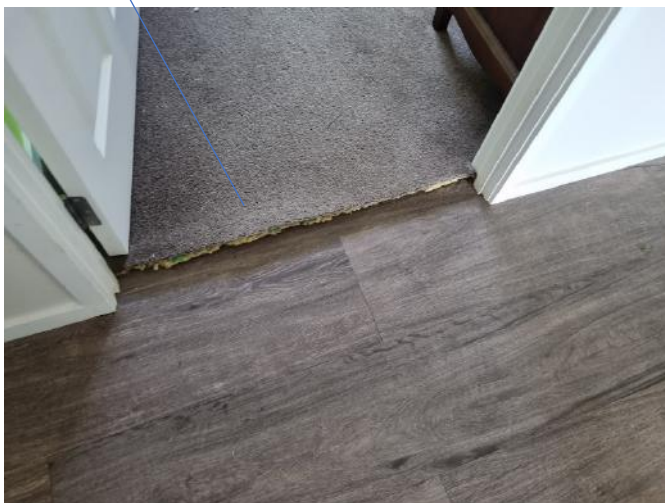
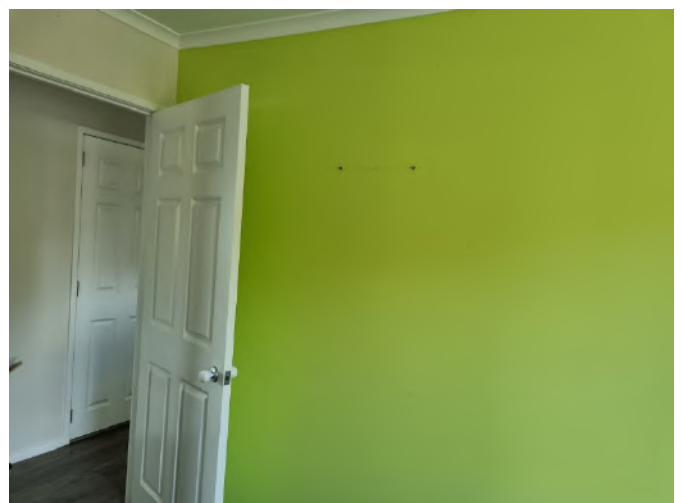
Missing Transition Bar

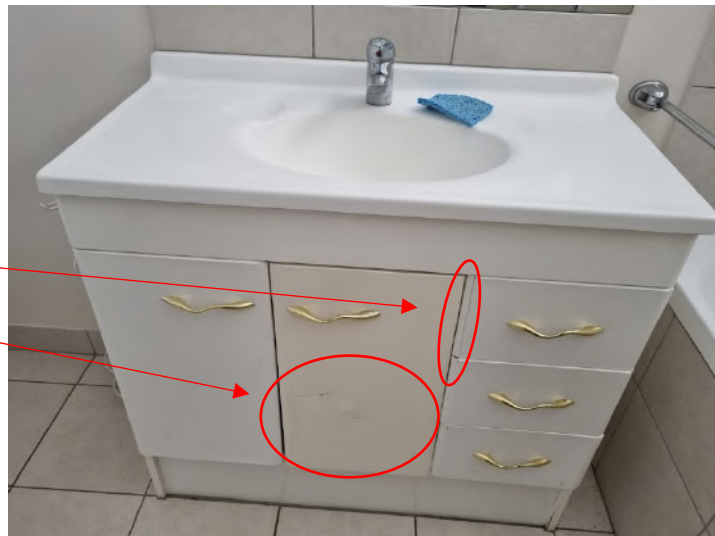
Vanity in main bathroom has damage to the cabinetry

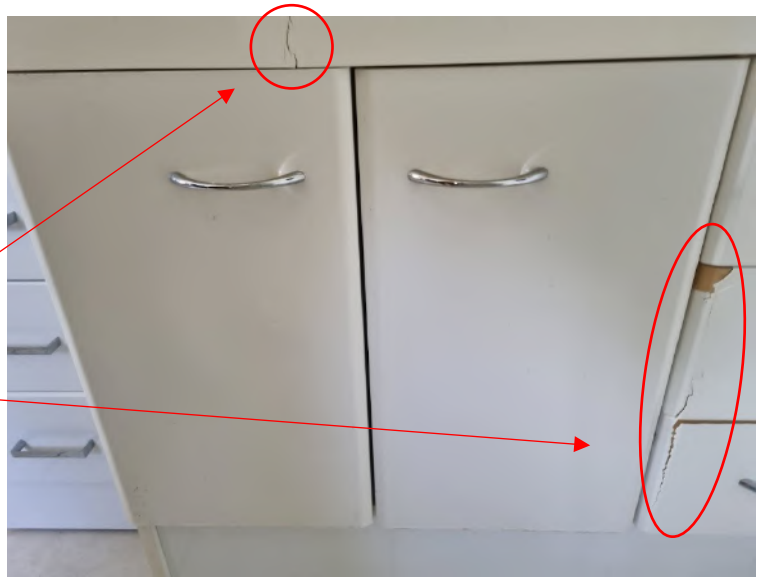
Vanity in the Ensuite has damage to the cabinetry

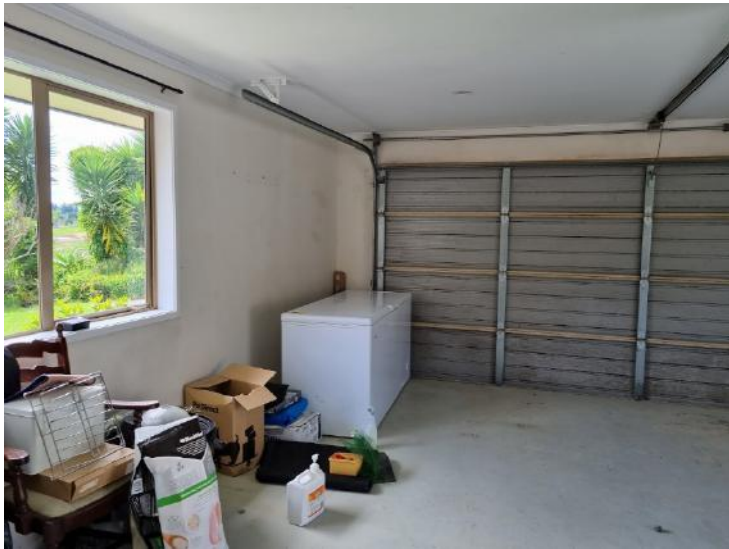
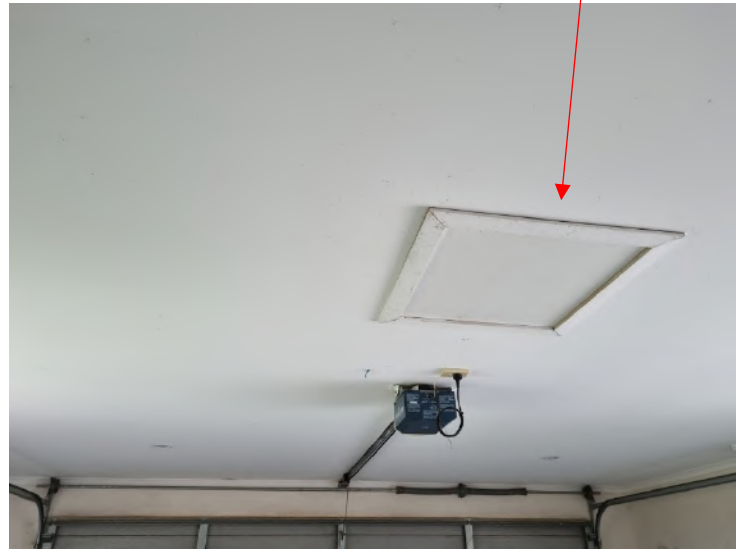
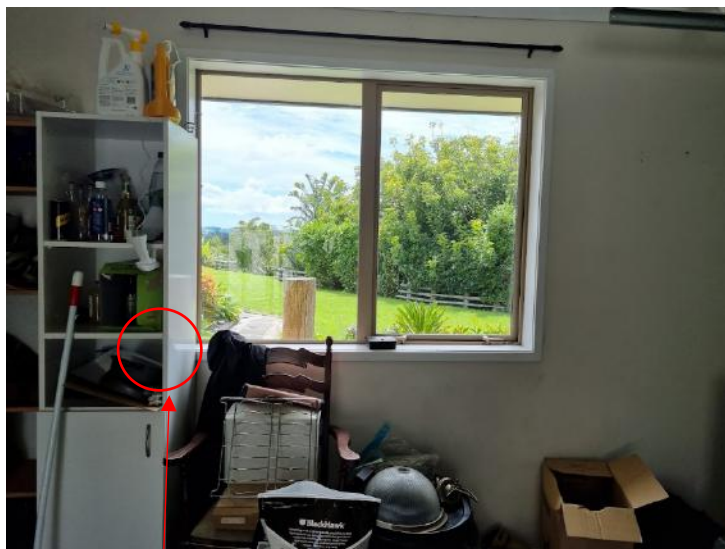
Roof hatch surround in garage requires re-fixing

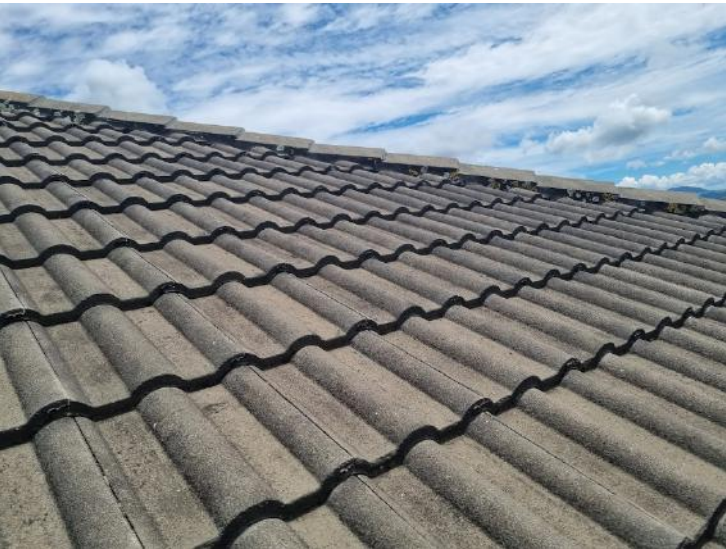
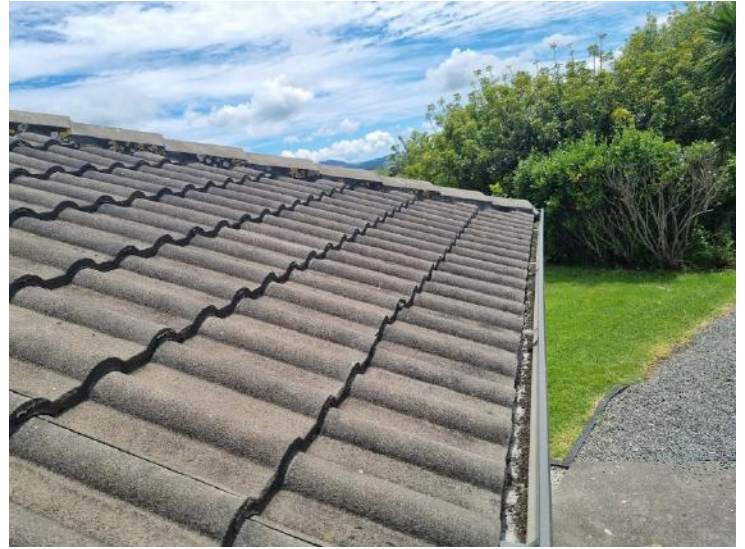
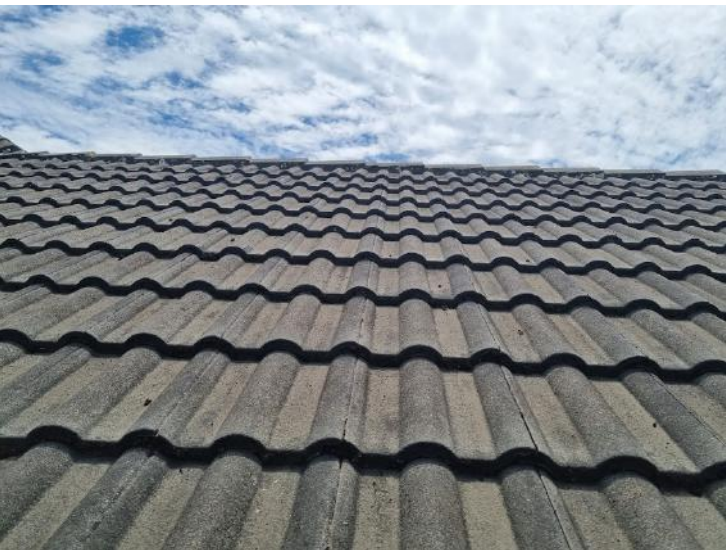
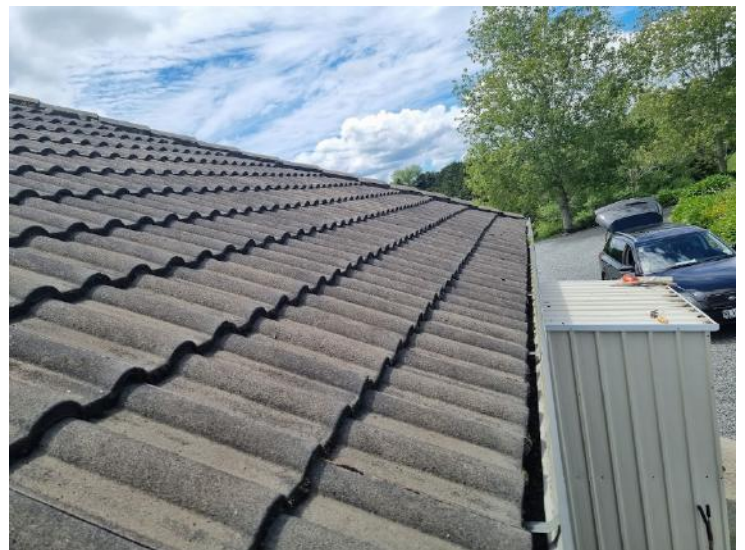
Concrete tile roof at ridges plaster work needs to be sealed to prevent water ingress. Appears in reasonable condition

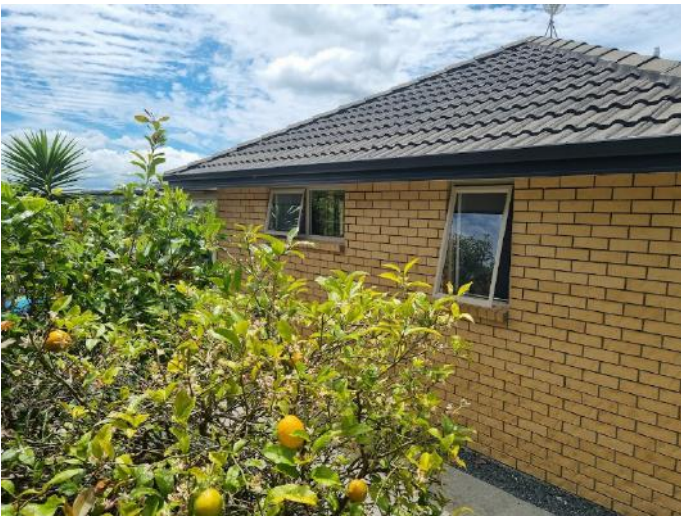
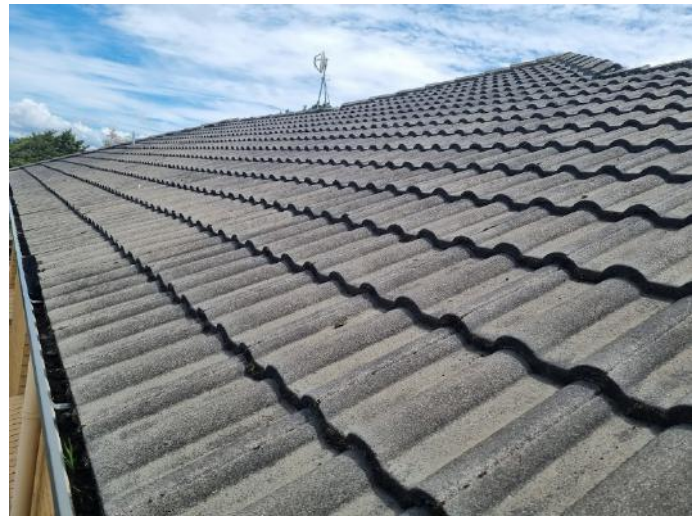
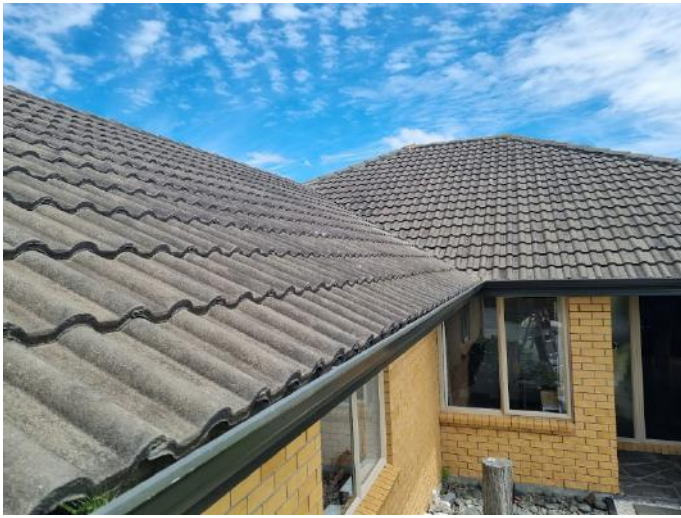
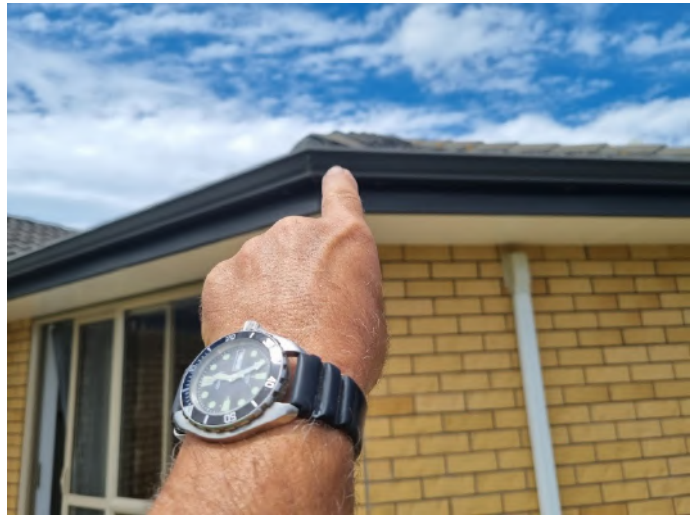
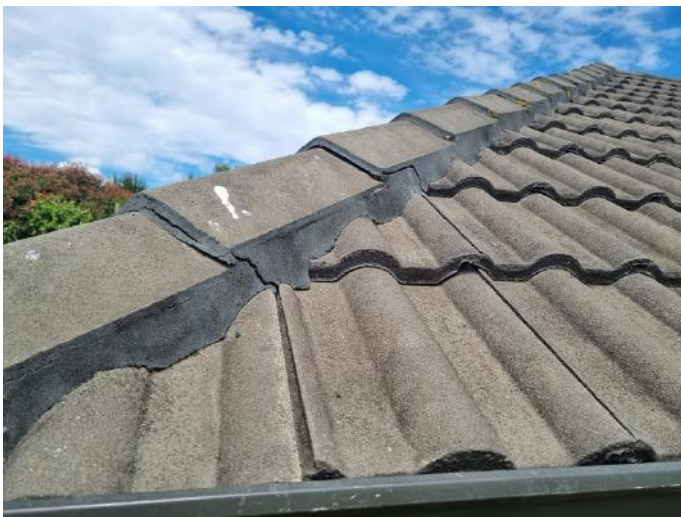
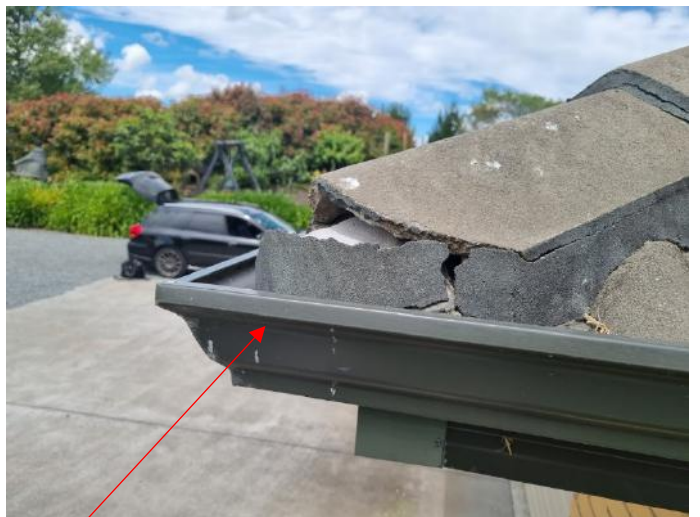
The plastered in ridge and hip capping require repair in place where they have cracked right hand side of garage and broken to prevent water ingress. Overall Appears in reasonable condition
