Pre-sale Building Inspection Report

PRE-PURCHASE BUILDING REPORT

Property Address	126 Kohinui Road, Parua Bay, Whareora, Northland, 0192, NZL		
Client	Ryan and Jessica Howard		
Date of Inspection	6th December 2023	Time	1:00 pm
Inspector	Jamie Mackintosh Licensed Building Practitioner Brick & Block		
LBP Number	116085		
Additional Information			
People Present	Inspector, Agent, Owner		
House Occupied	Yes

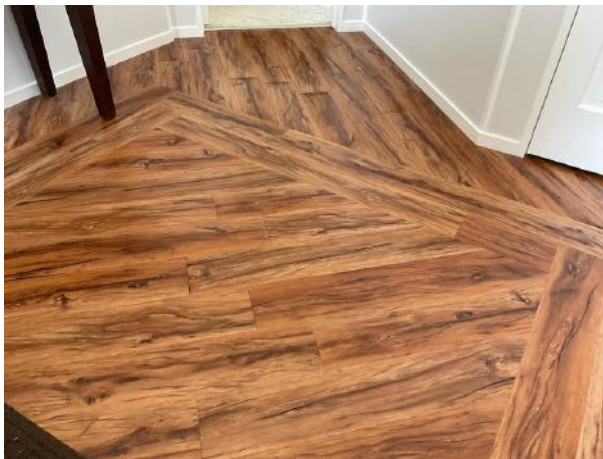
Photo 8

Vinyl flooring is loose/lifting in most areas. Recommend a flooring specialist report on the repairs/maintenance required.

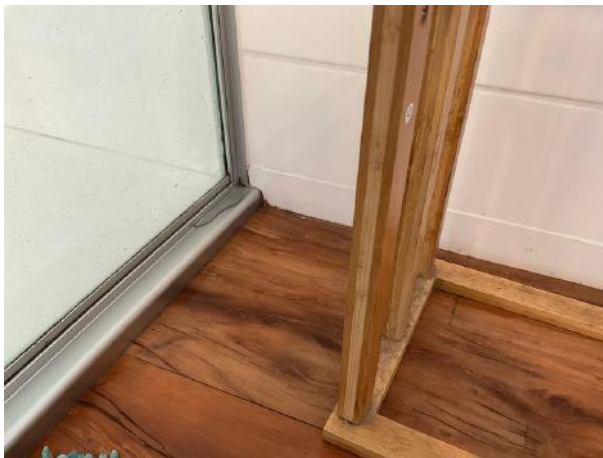
Photo 14

Shower - Enclosure. Corners of the shower are leaking.

Both shower corners are leaking.

There is visible water leaking from the corners of the shower enclosure with water directed to these areas. Have a professional remove and install the pieces correctly to repair this issue.

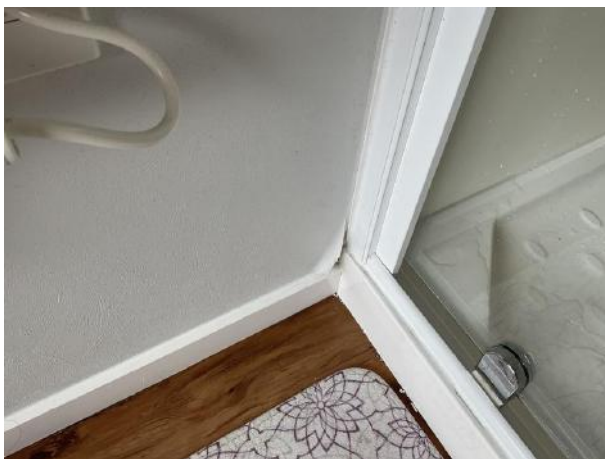
Photo 22

Wall defects - Damaged.

Damage to the corner by the shower.

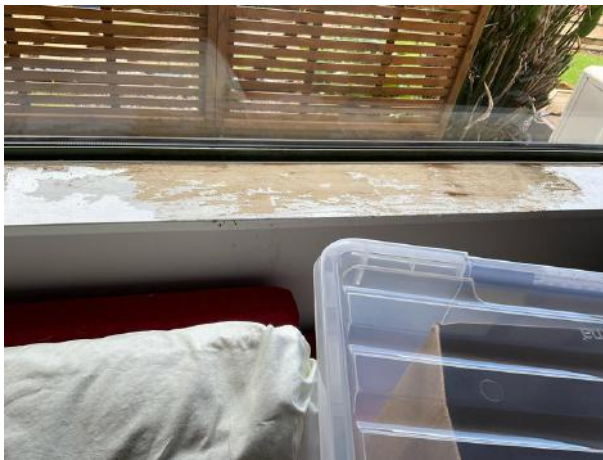
Photo 24

Damage to the garage window sill.

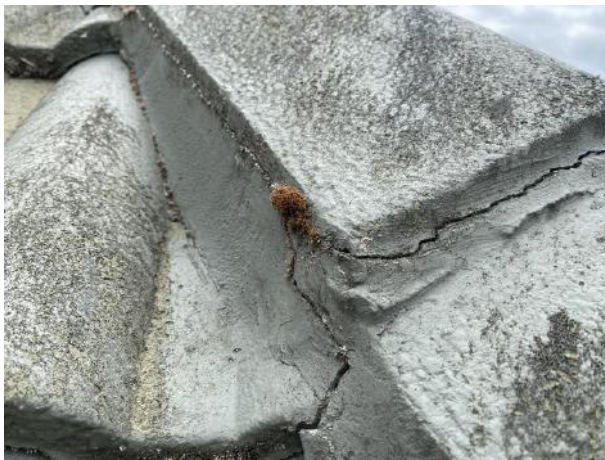
Photo 30

Ridges/Hips/Barges - Areas of cracking to the mortar are noted, refer to the photos below.

Example of minor cracking in some mortar on the hip flashings. No large cracking or movement visible.

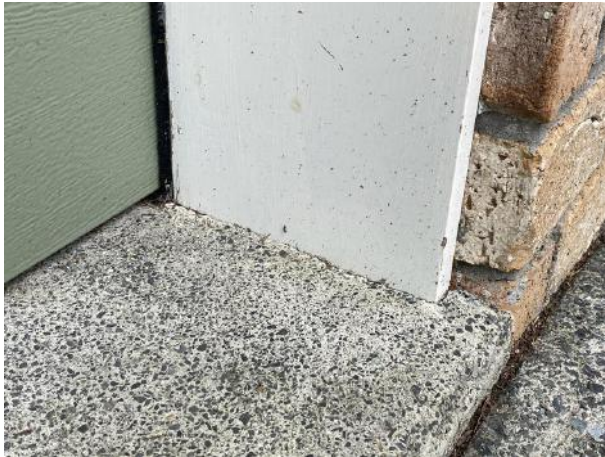
Photo 38

Recommend trimming the bottom of the garage door liners to allow a 10mm gap to the concrete.

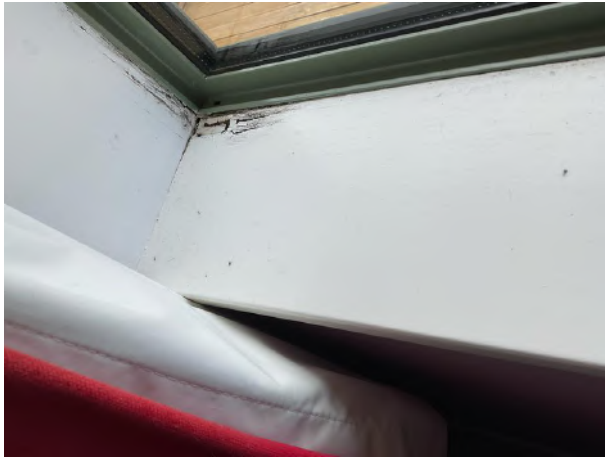
Photo 44

Visible rot in the corner of bedroom four window sill.

Recommend repairing the rotten window sill in bedroom four.

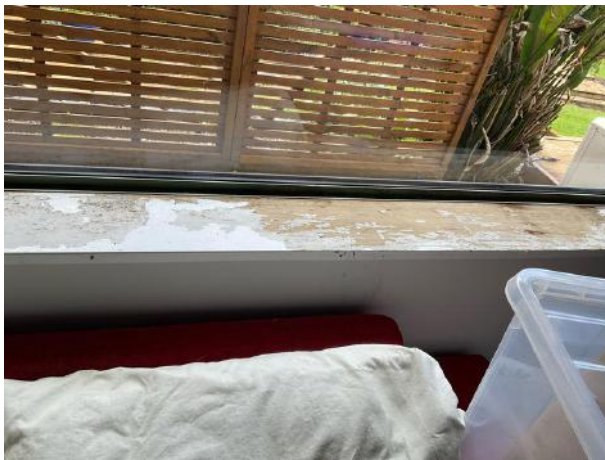
Photo 45

Damage - Moisture damage to the painted surface on the garage window sill.

Damage to the garage window sill. Recommend sanding back and re-decorating.

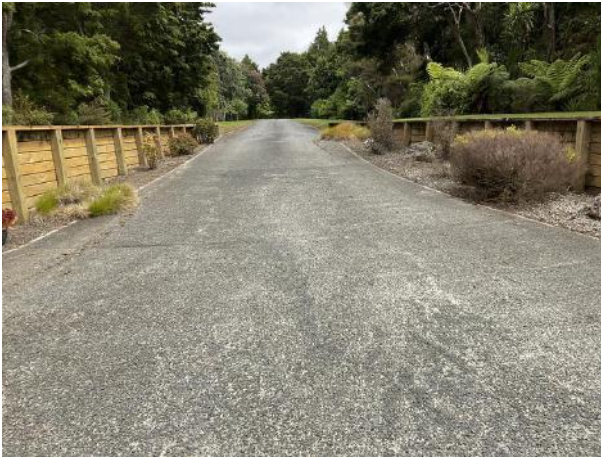
Photo 54

Cracking - Areas of cracking visible.

Concrete driveway with brick edging. Visible cracking.

General upkeep and maintenance of driveway by cleaning and keeping free of debris.

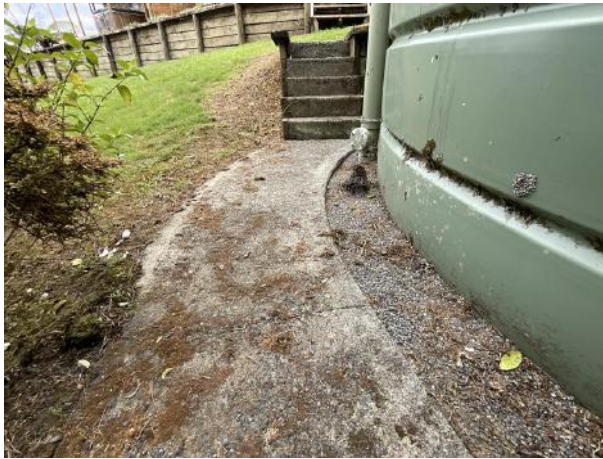
Photo 55

Concrete stairs with timber framing and concrete path with visible cracking, runs around the water tanks on the north side of the property.

General upkeep and maintenance.

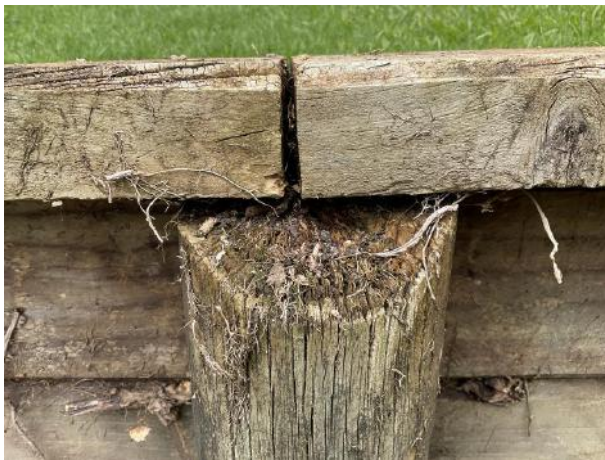
Photo 60

Visible rot in some of the timber post tops on the retaining wall.

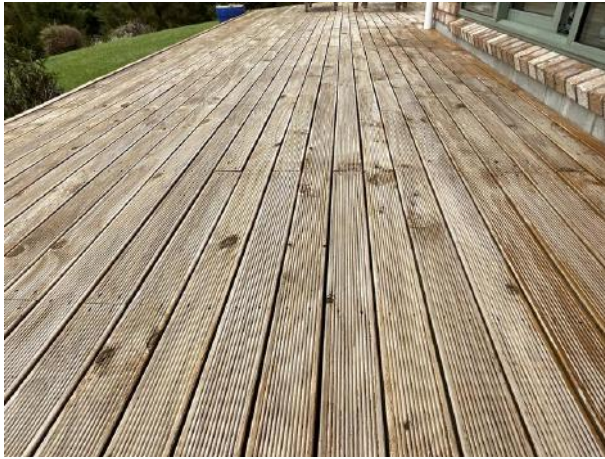
Photo 62

Stain coating has worn off in most areas. Recommend re-sealing.

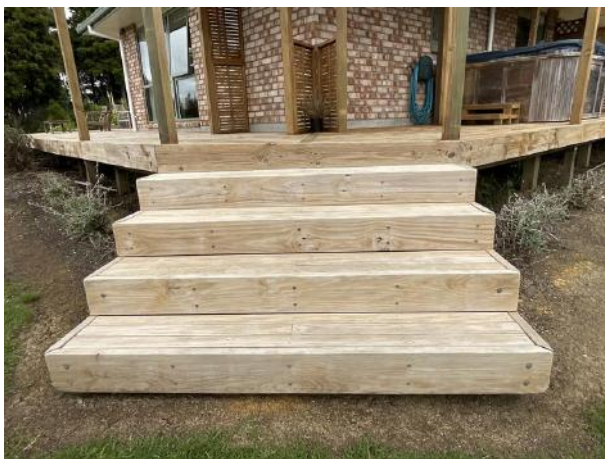
Photo 64

Timber stairs, leading to the northern deck. Recommend installing a handrail.

To ensure safety and compliance, it is recommended to install handrails on any access steps in the home that have three or more steps.

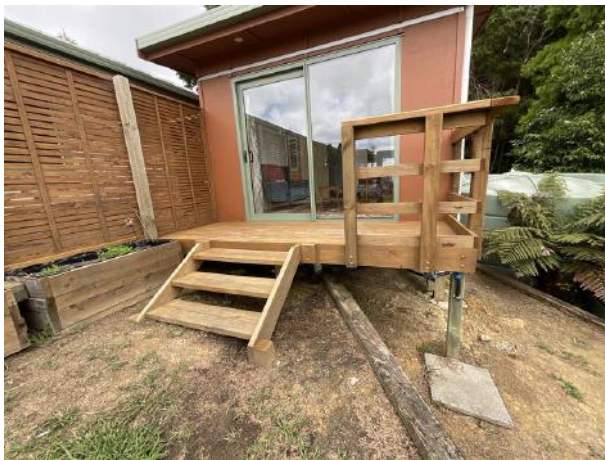
Photo 69

Timber deck, stairs and balustrade off the studio living room on the north side of the property. Recommend installing a handrail on the stairs.

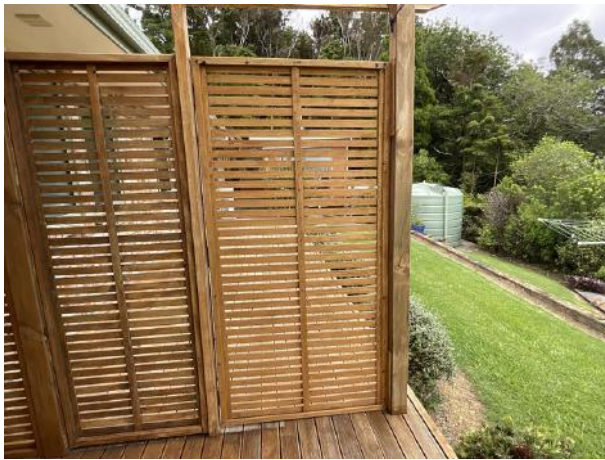
Photo 71

Timber trellis gate located on the northern deck privacy screen. Needs adjusting, bottom is scraping on the deck.

Recommend regular lubrication of the hinges and latch to maintain full function.
