RED LBP PRE-PURCHASE REPORT

PRE-PURCHASE BUILDING REPORT

Property Address	7 Highfield Way, Maunu, Whangarei, Northland, 0110, NZL		
Client	Lucy Evans		
Date of Inspection	19th April 2024	Time	9:30 am
Inspector	Jamie Mackintosh Licensed Building Practitioner Brick & Block		
LBP Number	116085		
Additional Information			
People Present	Inspector, Agent		
House Occupied	Staged

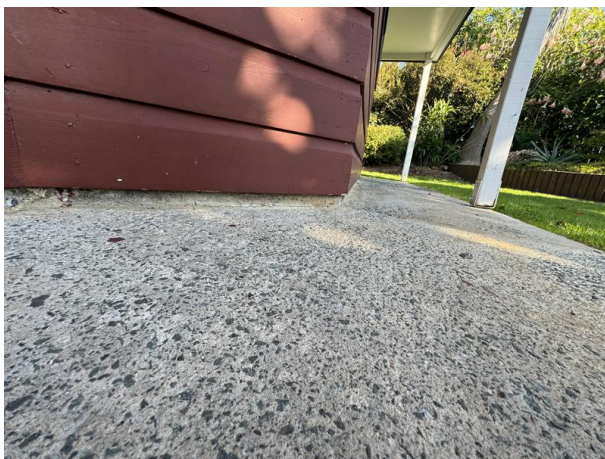
Photo 5

Minimal ground clearances on the patio to cladding junctions.

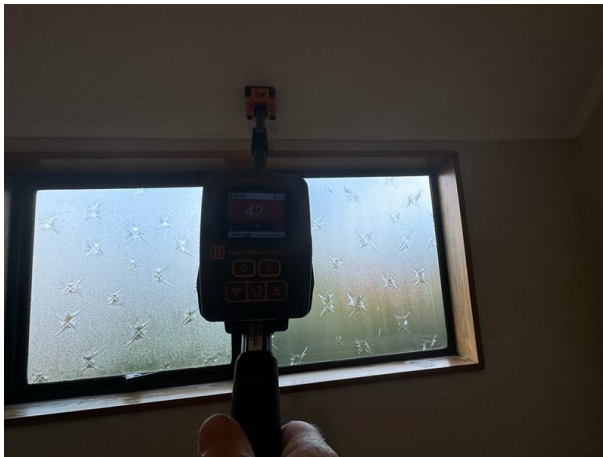
Photo 6

Recommend further investigation into the elevated moisture reading above the bathroom window. The internal guttering is showing signs of overflowing in this area. Refer to the fascia/guttering section for further detail.

Elevated moisture readings above the first floor bathroom window (420). Visible moisture damage to the timbers around this area. Further investigation is recommended.

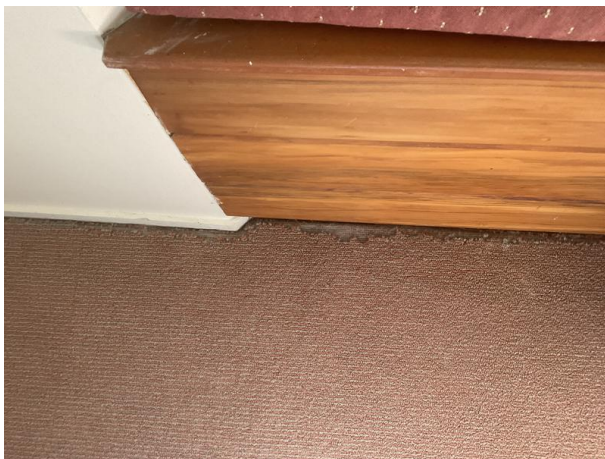
Photo 15

Example of damaged carpet to several areas of the dwelling.

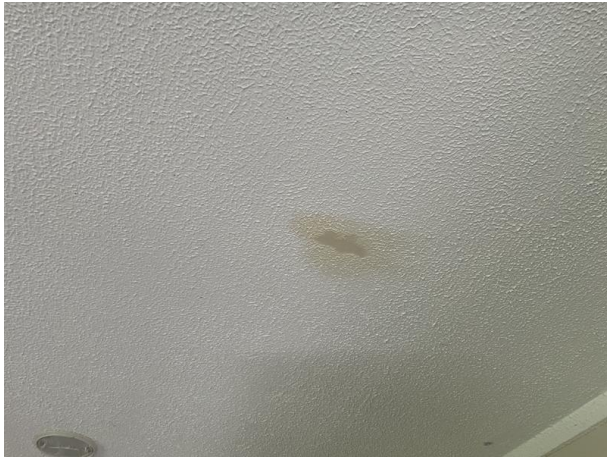
Photo 16

Example of cosmetic damages to several areas of the ceiling.

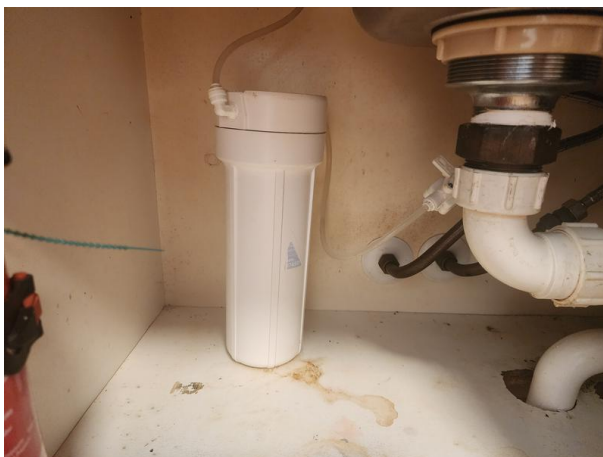
Photo 19

Water leaking from the pipe connection on the filter cartridge. Recommend trimming the pipe and re-seating in the fitting.

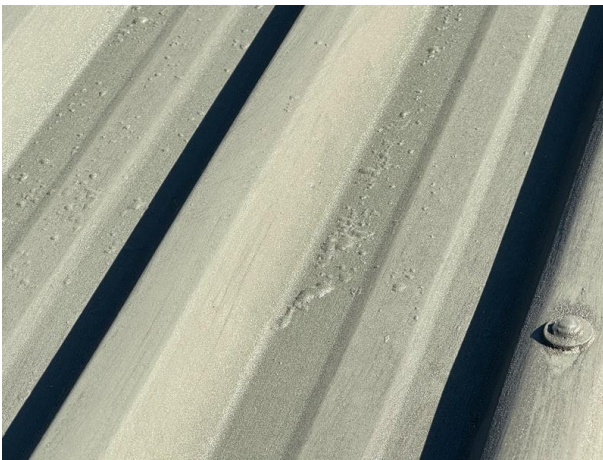
Photo 35

Example of rusting under the paint coating. This is in several areas of the roof system.

It is recommended to obtain a thorough assessment of the roof's condition by engaging a Licensed Building Practitioner (LBP) specialising in roofing to conduct a comprehensive inspection and prepare a detailed report.

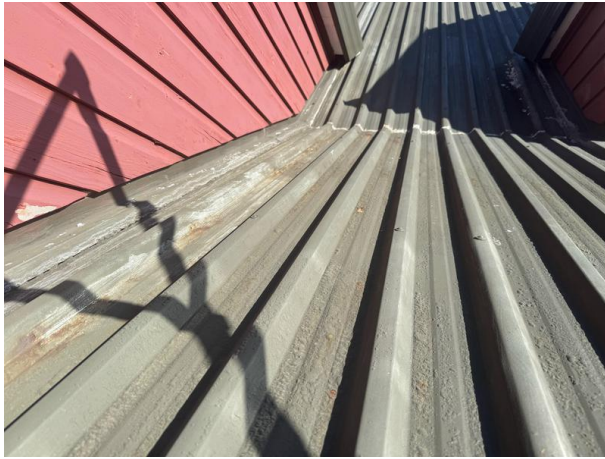
Photo 37

Visible rusting to the iron above the front door.

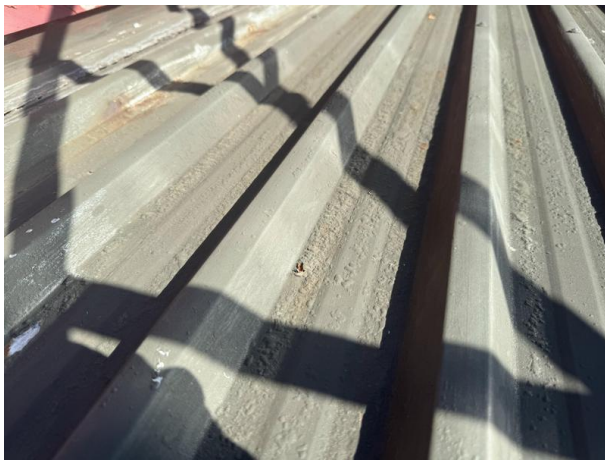
Photo 38

Example of rusting. Some areas have almost rusted through.

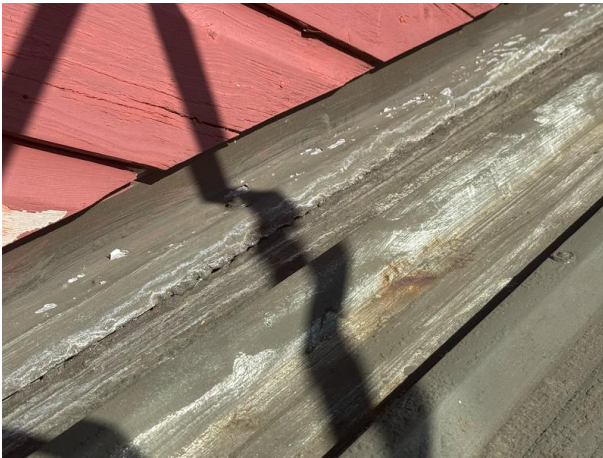
Photo 40

Visible rusting to the apron flashing above the front door.

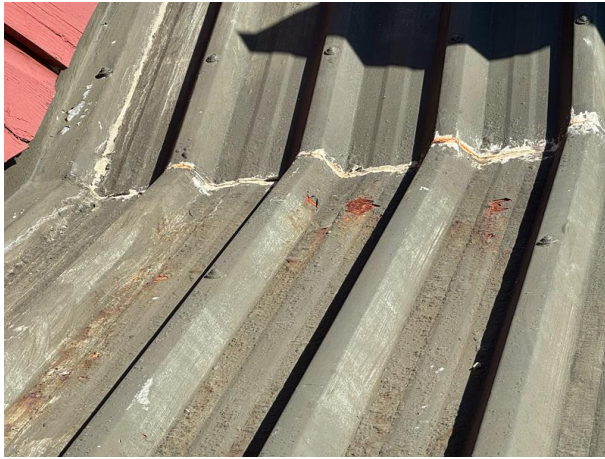
Photo 41

Historic repairs around the change of pitch flashing on the east elevation.

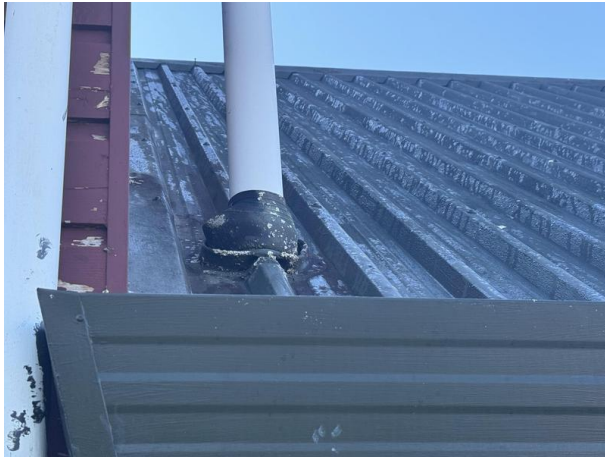
Photo 44

Vent penetration with rubber boot flashing. Boot is bunched with water pooling in the folds. Recommend replacing with the correct boot.

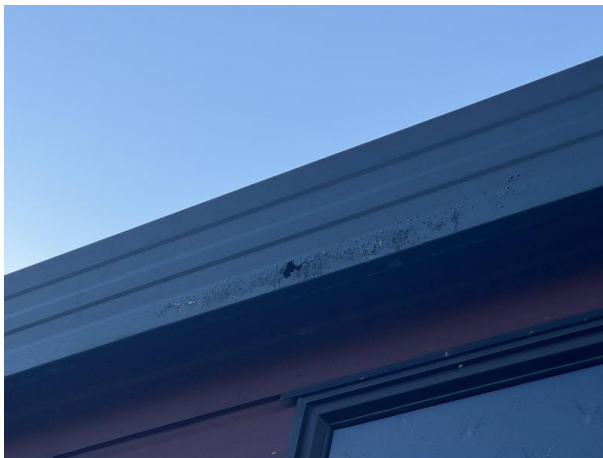
Photo 46

Visible rusting in the west facing internal gutters.

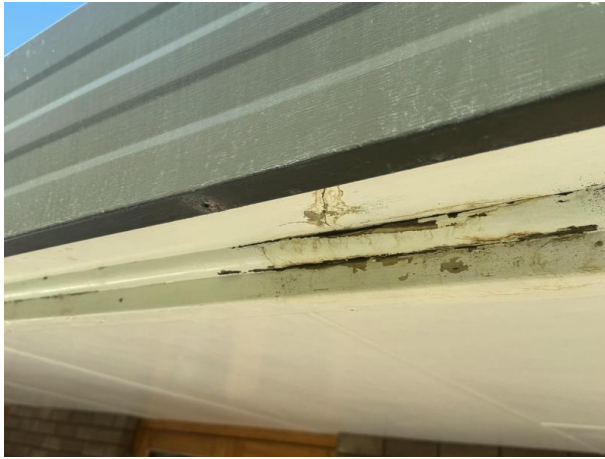
Photo 47

Internal guttering has been leaking on the east side. Broken soffit and rotten timber trim.

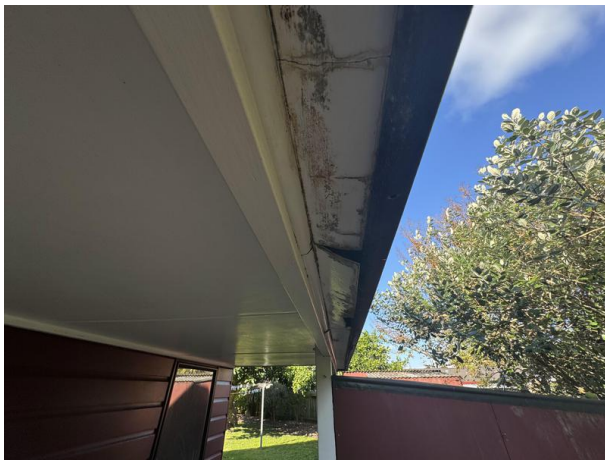
Photo 48

Broken soffits and rotten trim on the west side. Gutters appear to have been leaking.

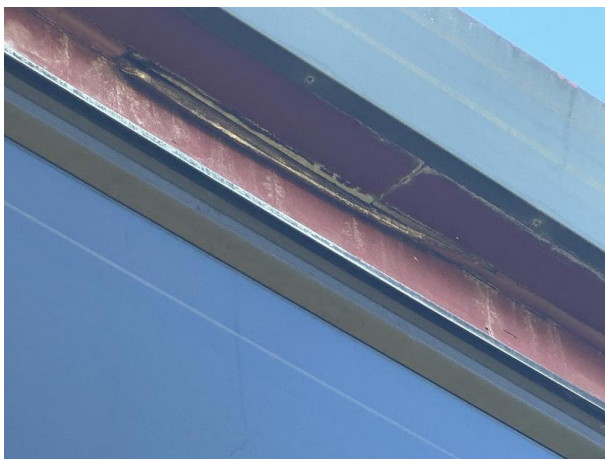
Photo 49

West side above the first floor bathroom. Moisture damage to the soffit and rotten trim.

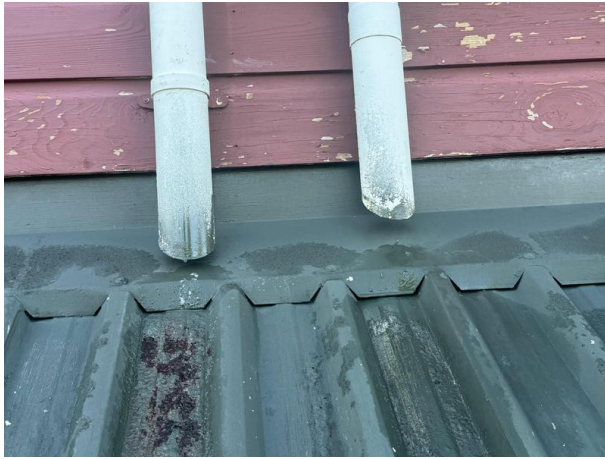
Photo 50

Recommend installing spreaders to the first floor downpipes. Visible rusting to the roof under most of these areas.

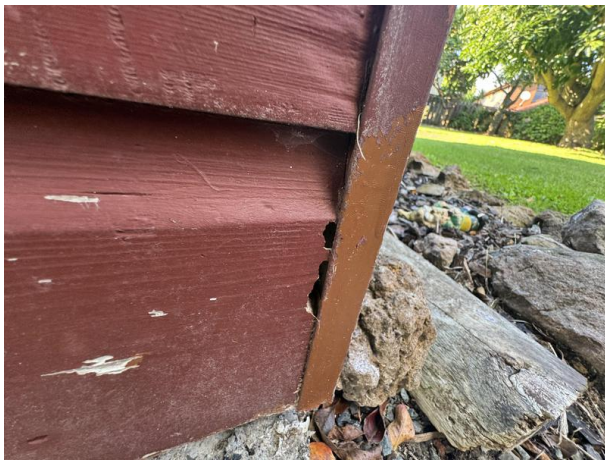
Photo 54

Example of rot to the exterior corners.

There is significant rot to most areas of the timber weatherboards, it is recommended to have an LBP in carpentry investigate and report on the repairs/maintenance required.

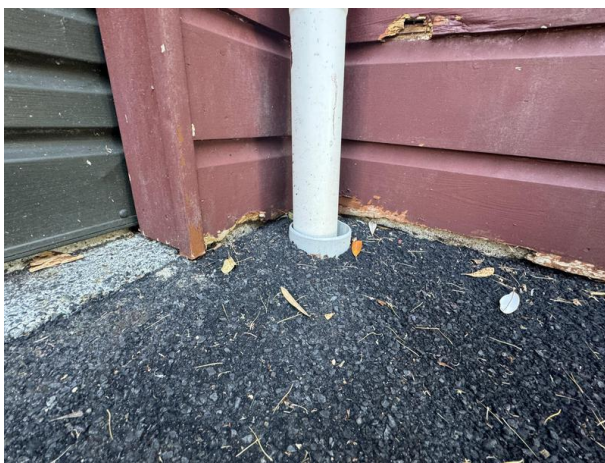
Photo 57

Visible rot along the bottom edges where they have ground contact. Rotten areas throughout the cladding.

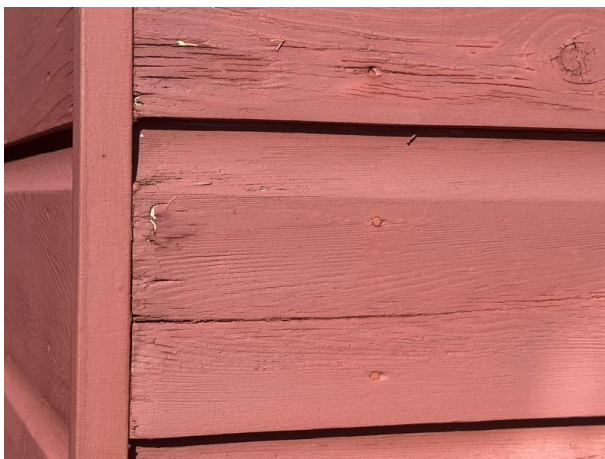
Photo 58

Example of rot on the first floor above the front door.

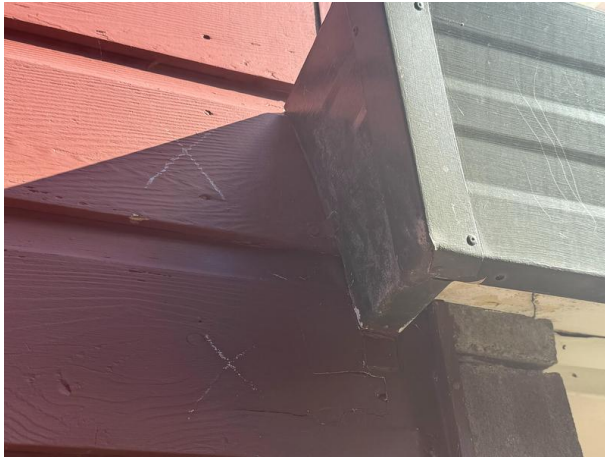
Photo 59

Several areas have been marked with chalk in the past to show some of the rotten boards.

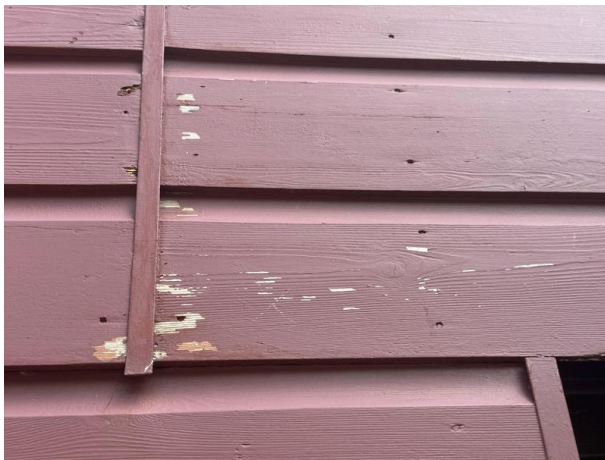
Photo 60

Example of rot to the joins.

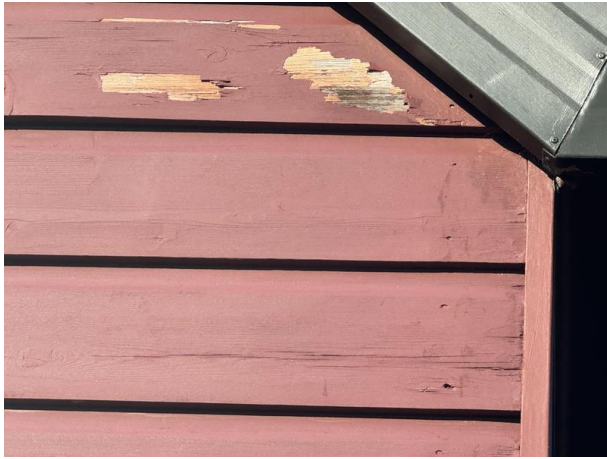
Photo 62

Paint flaking in most areas. Rot up the ends.

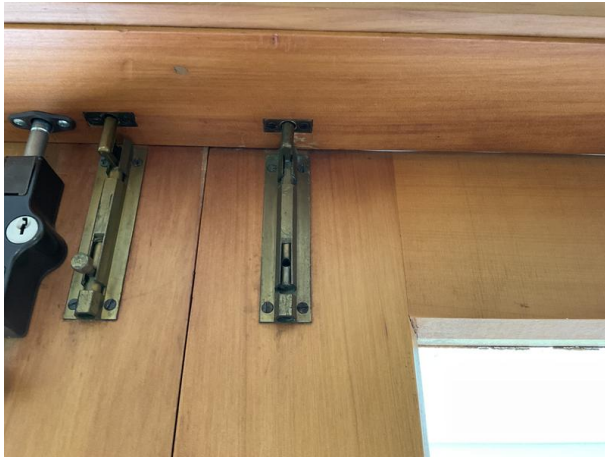
Photo 63

Missing bolt/handle on patio doors in the living room.

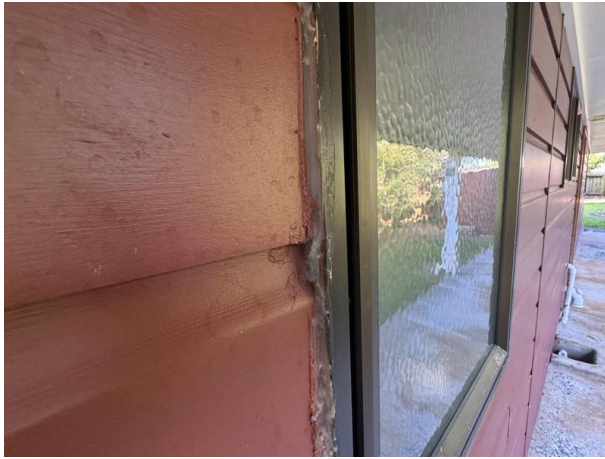
Photo 66

Large amount of silicone on the bathroom window.
Recommend having an LBP in carpentry flash this correctly.

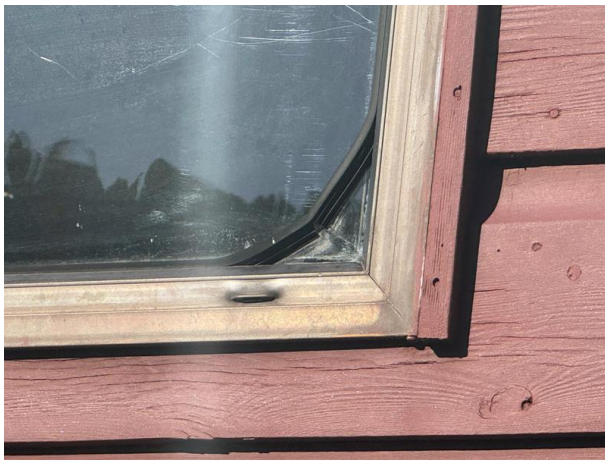
Photo 67

Broken rubber on the north facing bedroom window.

To prevent water & draughts from entering, it is recommended to replace or properly re-seat the rubber seals on the exterior of the joinery. By doing so, you can ensure a tight seal that effectively safeguards against water & draught ingress.

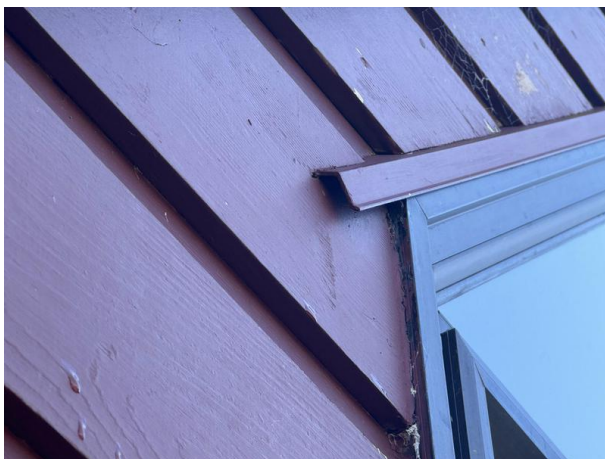
Photo 68

Gable angled windows.
Cladding to head flashing junction does not have the required 5mm gap. No return on the end to direct water away from the framing.

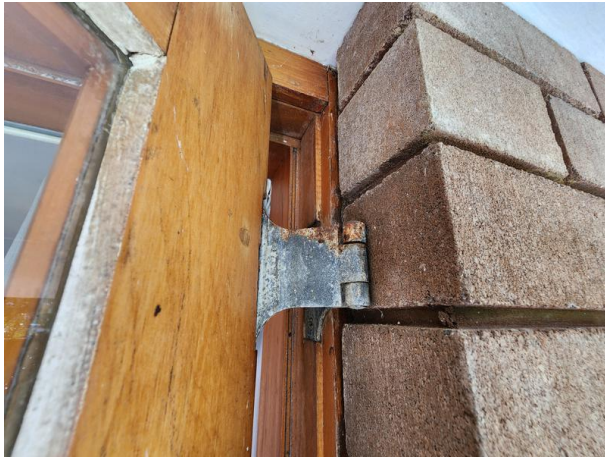
Photo 69

Patio door hinges have visible rust.

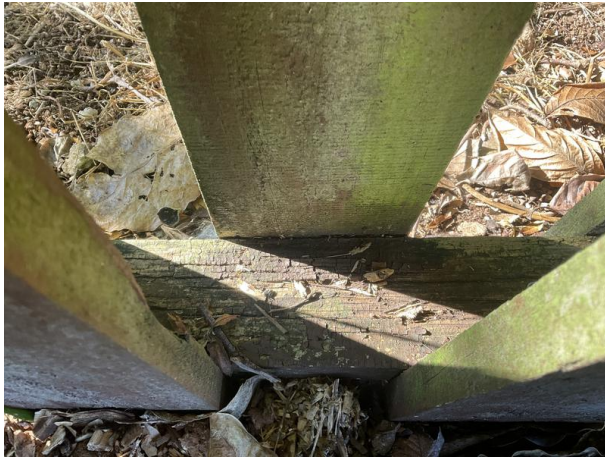
Photo 73

Visible rot along the bottom rail.

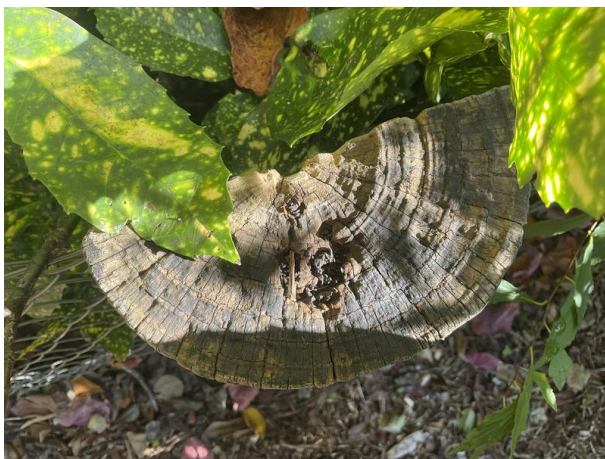
Photo 75

Visible rot in some of the tops of the timber posts.

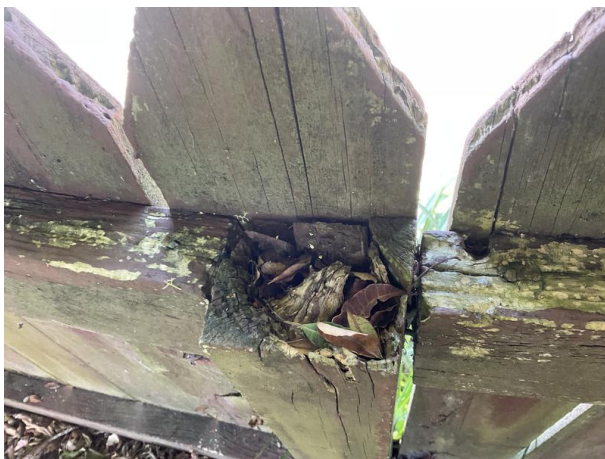
Photo 78

Visible rot in most of the timber posts and along the top rail.

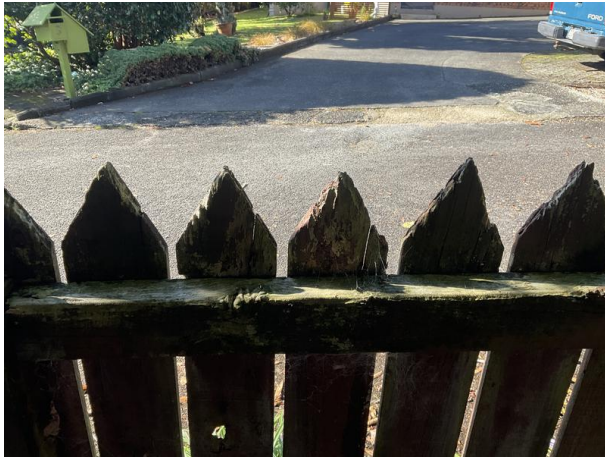
Photo 79

Visible rot on both the top and bottom of the palings. Broken palings in some areas.

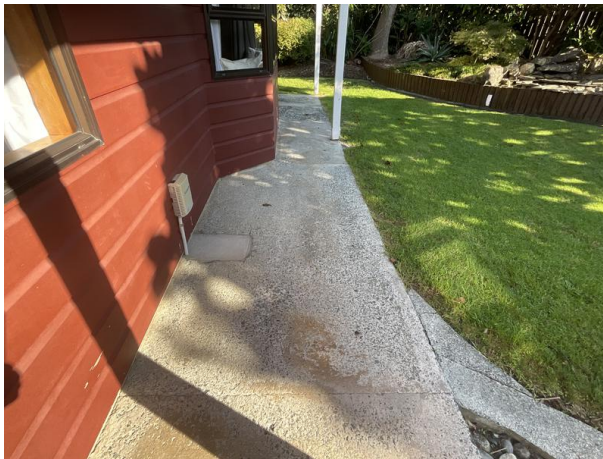
Photo 81

Concrete path with visible cracking and pitting located off the northern patio.

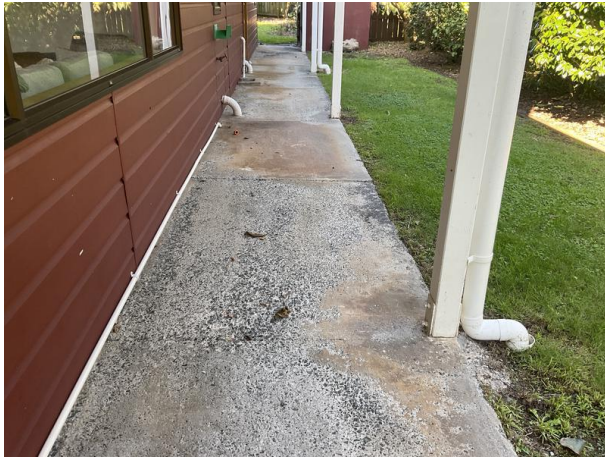
Photo 82

Concrete path with visible pitting located on the west side of the house.

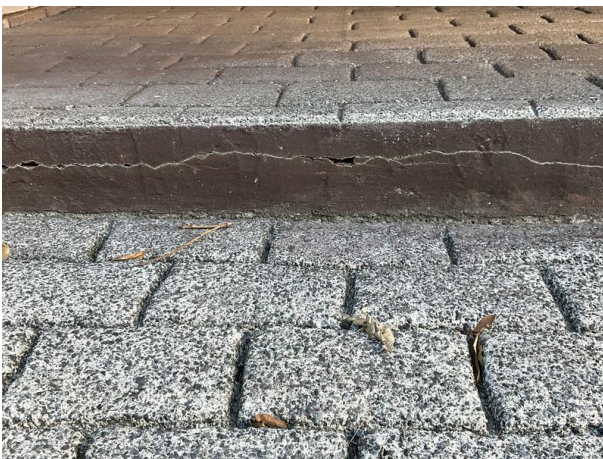
Photo 85

Large crack in the plaster along the front edge of the patio.

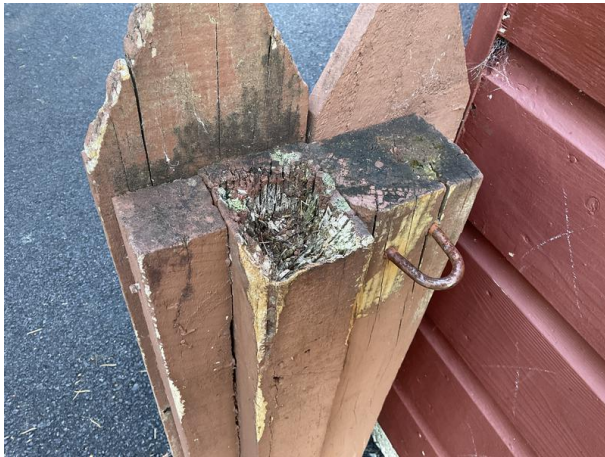
Photo 87

Visible rot in the timber post beside the gate latch.

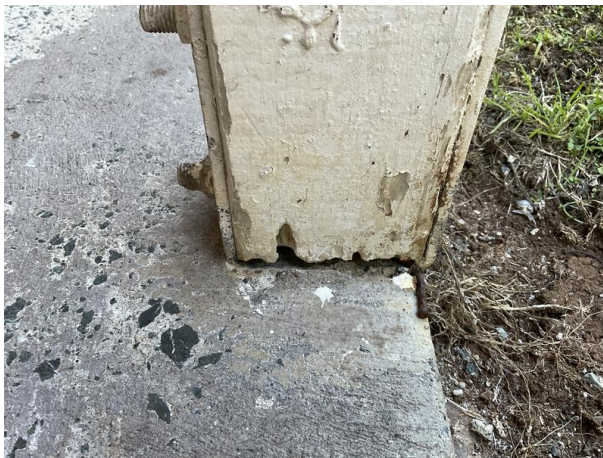
Photo 90

Visible rot along the bottom of some of the timber posts where they have ground contact.
