Property Condition Report

**12 Cross Street
Regent
Whangarei District**

Inspection Date: 31/07/2020

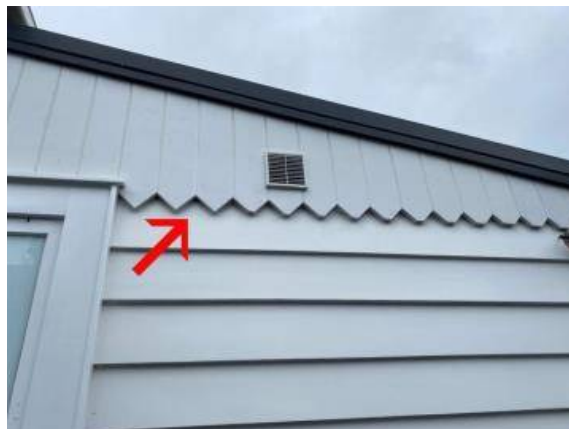
Visible cladding void to exterior kitchen wall. We recommend sealing this junction to reduce the risk of moisture ingress. There were no elevated moisture readings in this area at the time of inspection.

Visible cladding void to exterior kitchen wall. We recommend sealing this junction to reduce the risk of moisture ingress. There were no elevated moisture readings in this area at the tie of inspection.

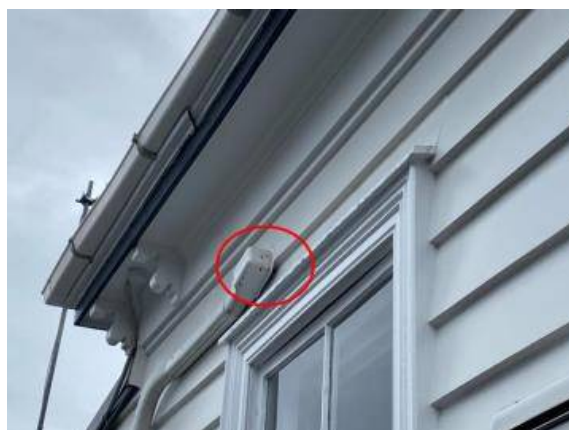
Poor seal to heat pump penetration. We recommend sealing this junction to ensure penetration remains weathertight.

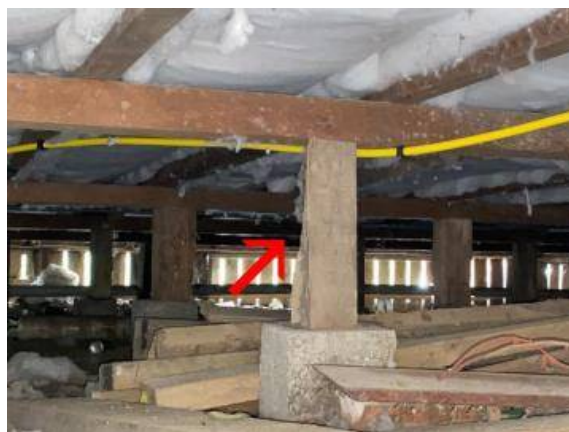
Timber pile visible from access appears to be damaged. We recommend engaging the services of a LBP to replace this pile as required.

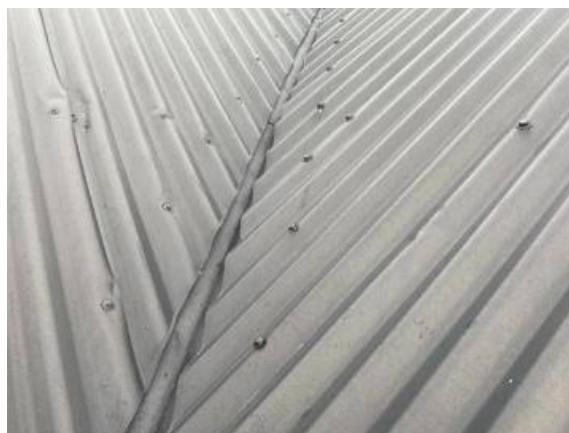
Visible corrosion around lead head fixings. Lead heads should be removed and replaced with new fixings. Roof covering should be inspected for signs of corrosion and treated with a suitable rust inhibitor where required.

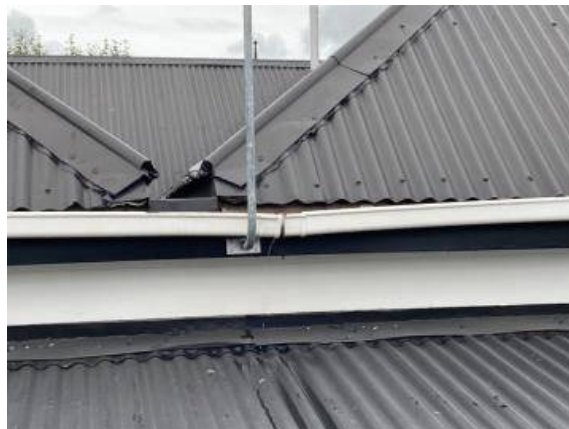
Gutter system separated on slip joint, will require repair. No down pipes installed to veranda. These should be installed to ensure rain water is diverted away from the building.

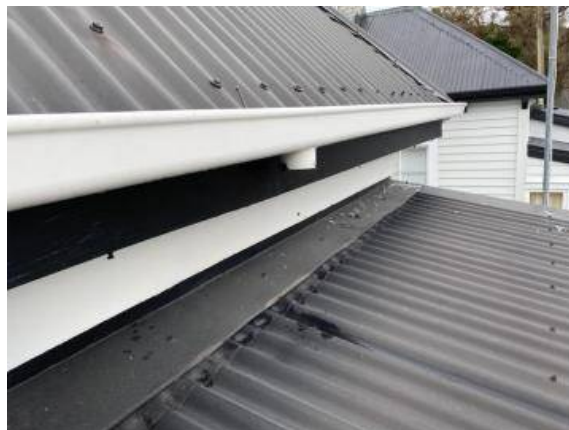
No spreader pipe installed. We recommend the installation of a spreader pipe to ensure rain water is diverted evenly on to roof covering.
