# Building Inspection Report

Client: Paul Sumich  
C/- Harcourts  
Location: 23 Tapper Crescent, Tikipunga  
Whangarei  
Inspection Date: 12/10/2021

RE: Building Inspection Report, 23 Tapper Crescent, Tikipunga, Whangarei.

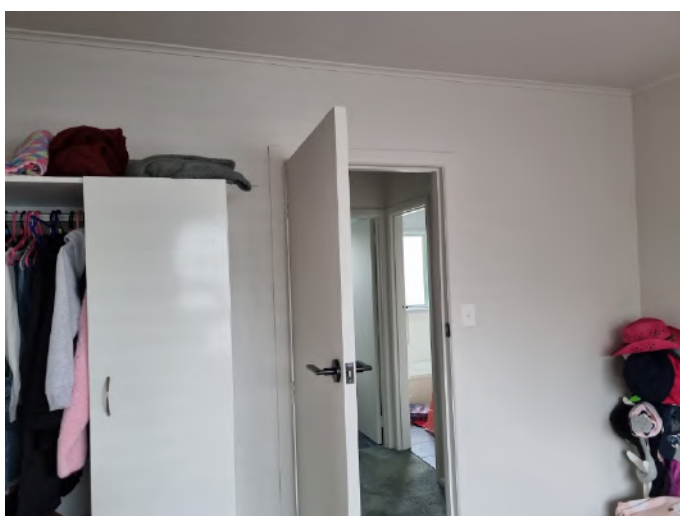
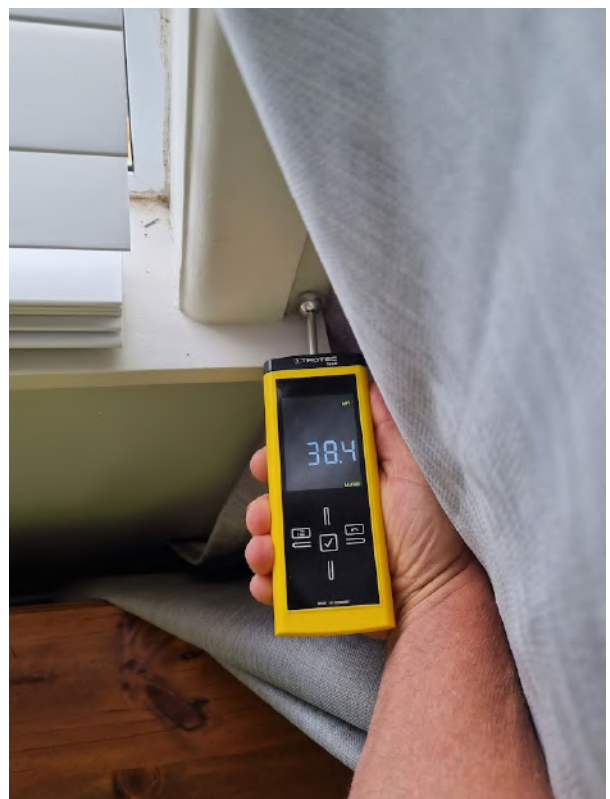
## Bedroom 1

Could not access left hand side of window in bedroom 1 due to furniture blocking the moisture meter access point

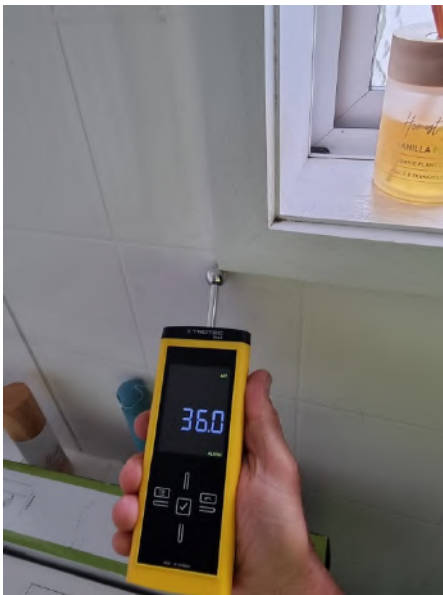
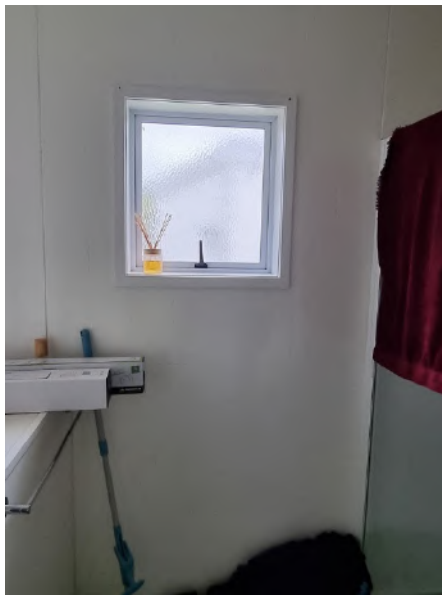
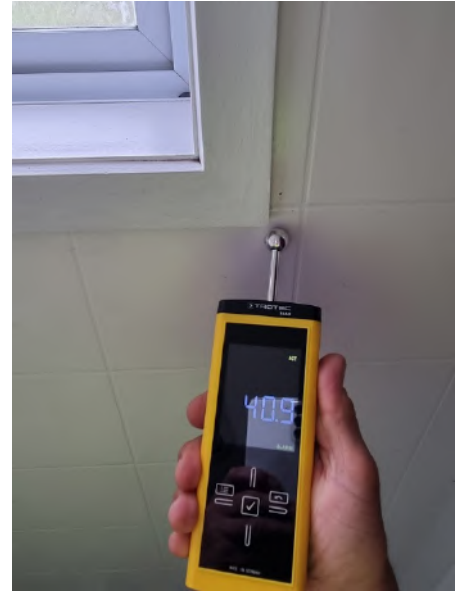
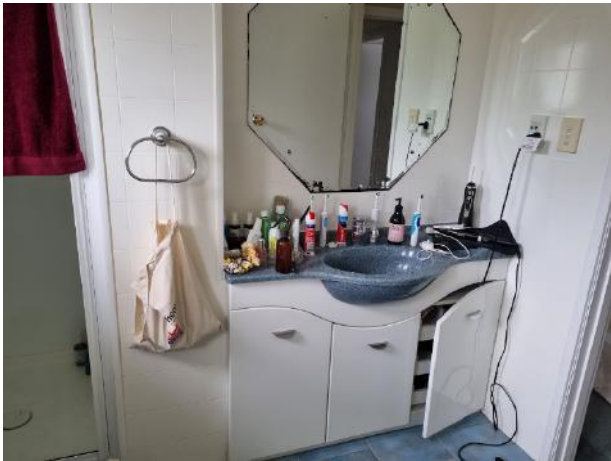
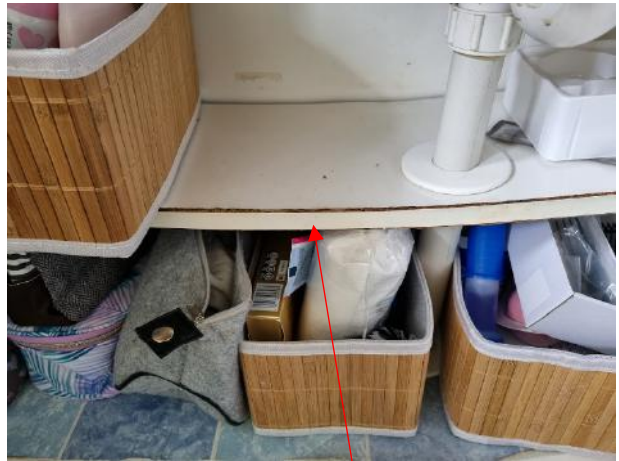
## Bathroom 2

Vanity shelving in bathroom 2 is in poor condition

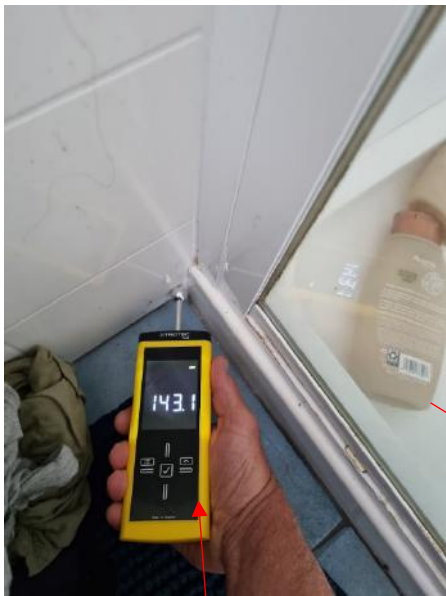
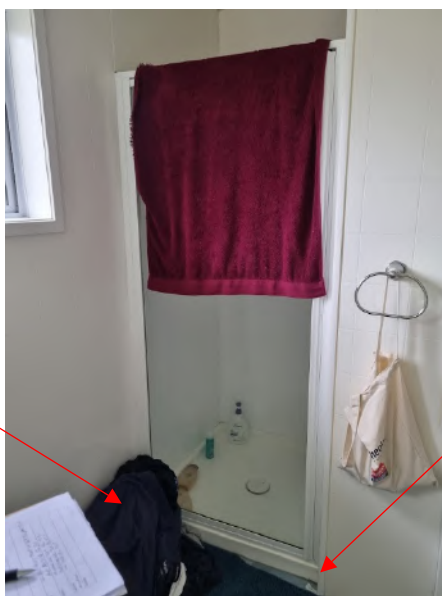
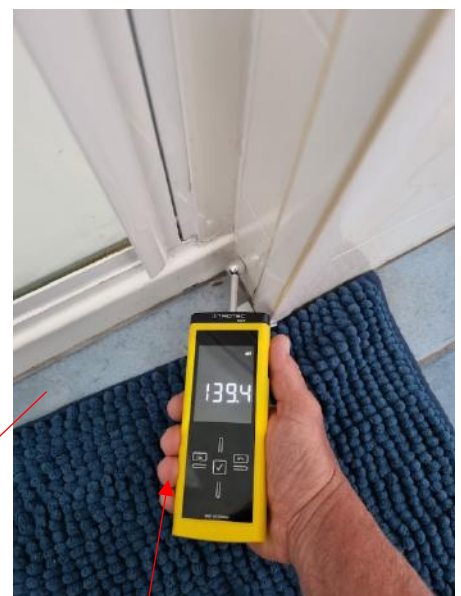
Moisture meter readings are higher than 80, this indicates there is wet materials and is at risk. Further investigation is required

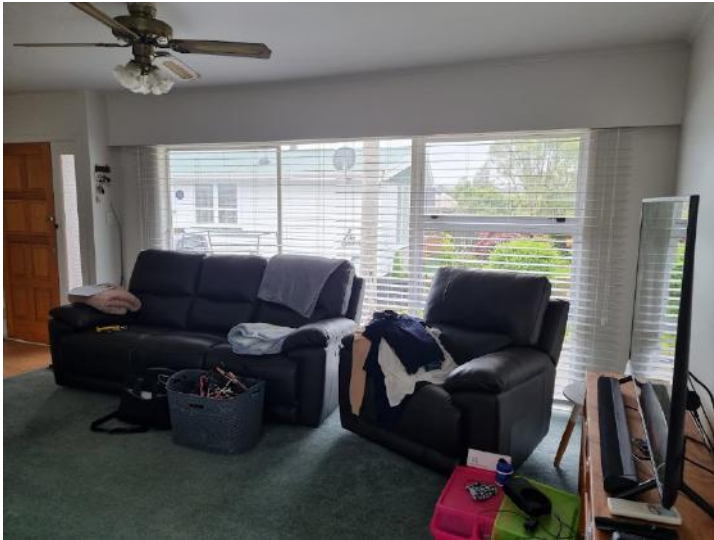
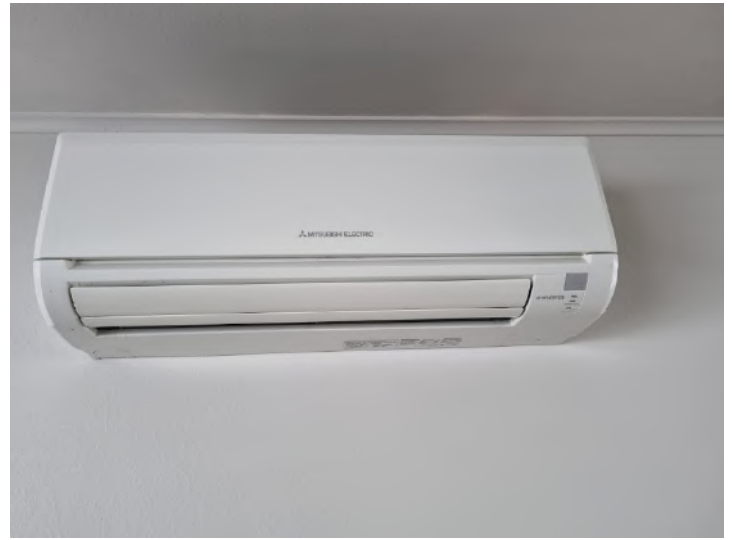
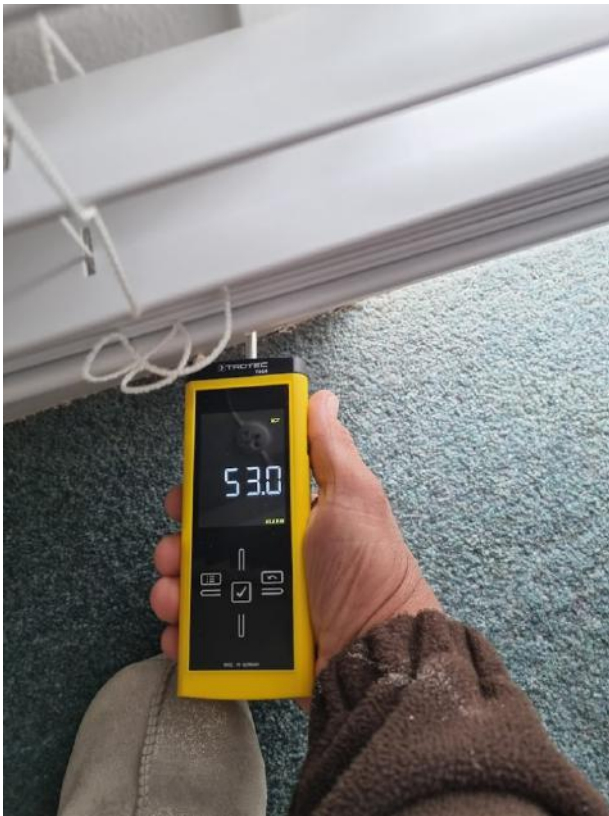
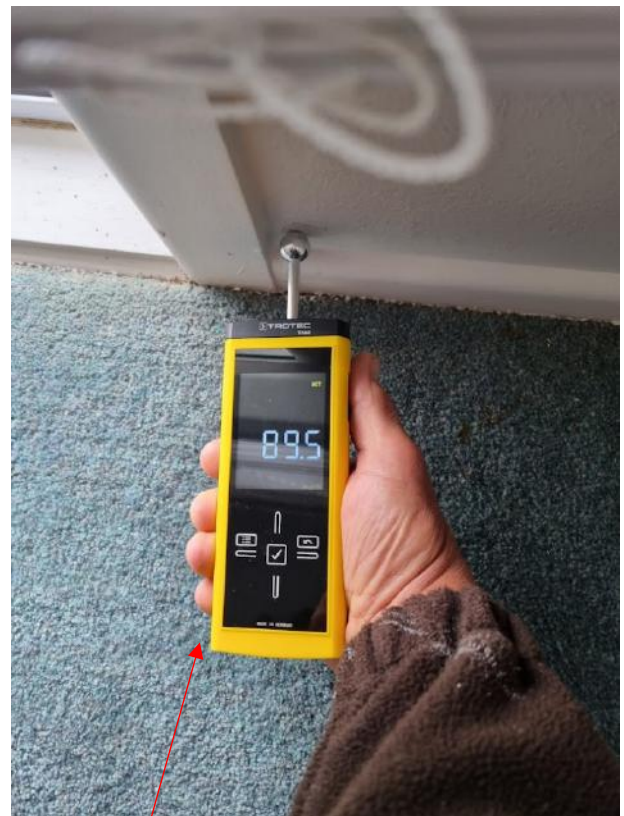
# Lounge

Moisture meter readings are higher than 80, this indicates there is wet materials and is at risk – further investigation is required

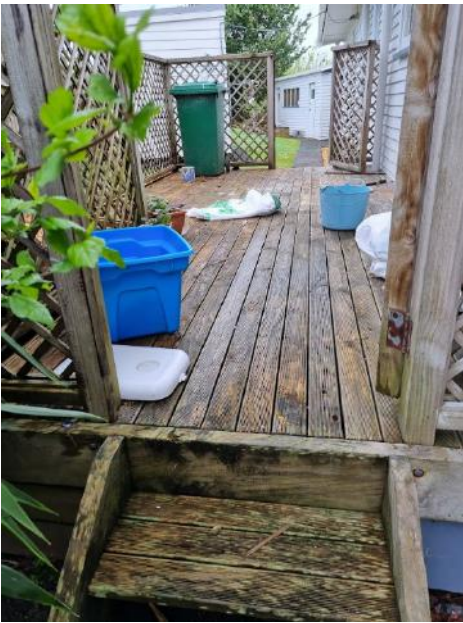
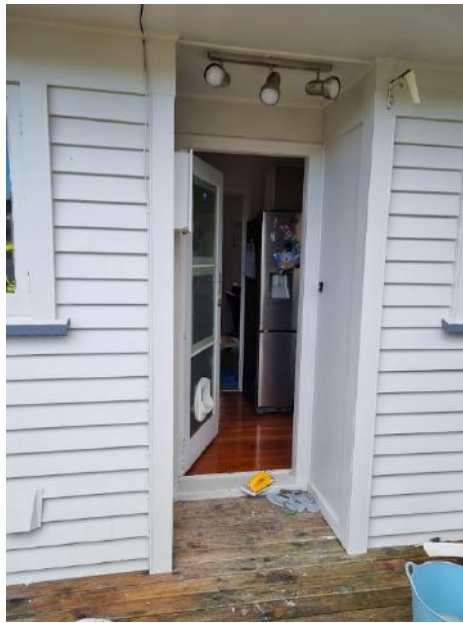
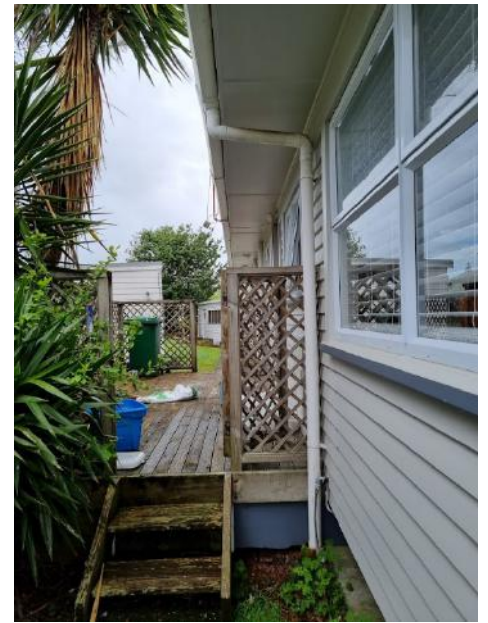
Timber decking to the back of the property is in poor condition – could do with replacing as rotting in places
