Property Condition Report

**26 Zealandia Street
Kensington
Whangarei District**

Inspection Date: 7/10/2020

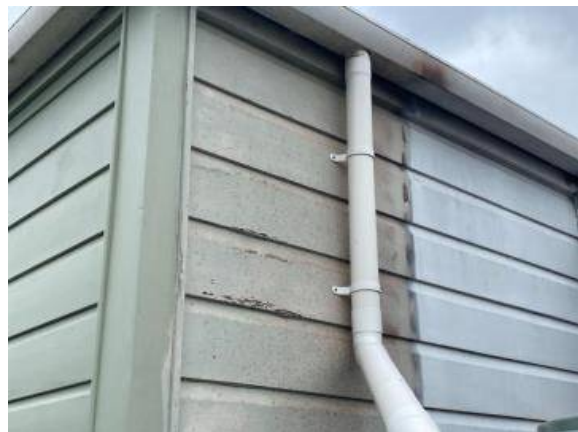
Paint lifting from timber weatherboards. Weatherboards will require appropriate preparation and paint to ensure cladding remains well sealed. Failure to maintain paint coating increases the risk of exposure

Paint lifting from timber weatherboards. Weatherboards will require appropriate preparation and paint to ensure cladding remains well sealed. Failure to maintain paint coating increases the risk of exposure

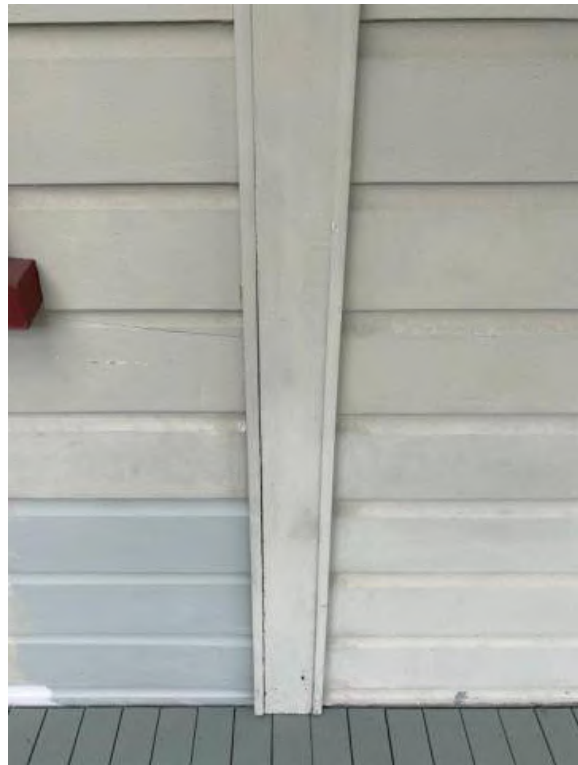
Separation between scribe and facing. This is a possible ingress point. We recommend sealing scribed details to ensure cladding junctions remain weathertight. Unable to condition of internal framing.

Separation between scribe and facing. This is a possible ingress point. We recommend sealing scribed details to ensure cladding junctions remain weathertight. Unable to condition of internal framing.

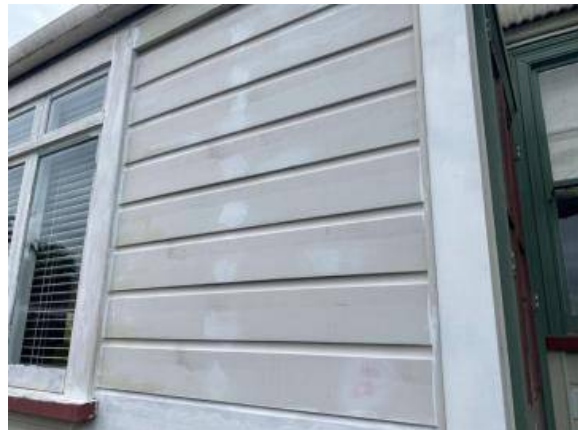
Weatherboard have been primed but require top coat, paint lift to original weatherboards. Weatherboards will require appropriate preparation and paint to ensure cladding remains well sealed. Failure to maintain paint coating increases the risk of exposure

Weatherboard have been primed but require top coat, paint lift to original weatherboards. Weatherboards will require appropriate preparation and paint to ensure cladding remains well sealed. Failure to maintain paint coating increases the risk of exposure

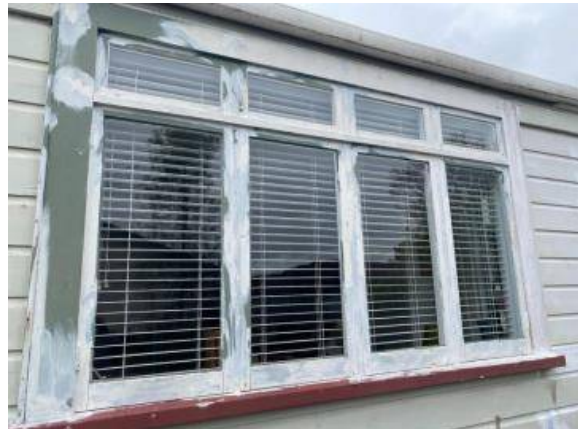
Visible paint lift from timber window joinery. Paint lift increases the risk of exposure to timber. We recommend engaging the services of a painter to prep and paint joinery as required. Failure to maintain may result in joinery failure.

Visible paint lift from timber window joinery. Paint lift increases the risk of exposure to timber. We recommend engaging the services of a painter to prep and paint joinery as required. Failure to maintain may result in joinery failure.

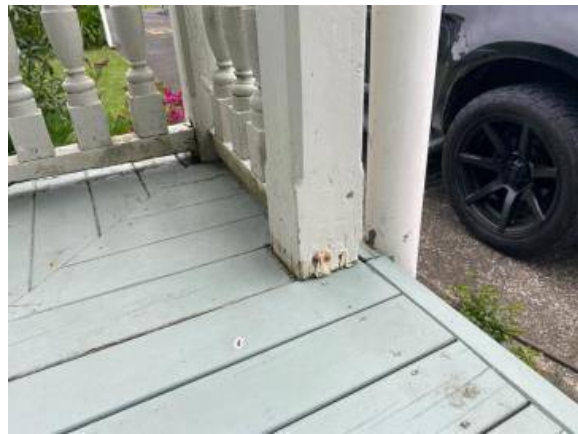
Visible decay to base of veranda posts. We recommend engaging the services of a LBP to inspect further. If posts have been compromised we recommend replacement.

Visible decay to base of veranda posts. We recommend engaging the services if a LBP to inspect further. If posts have been compromised we recommend replacement.

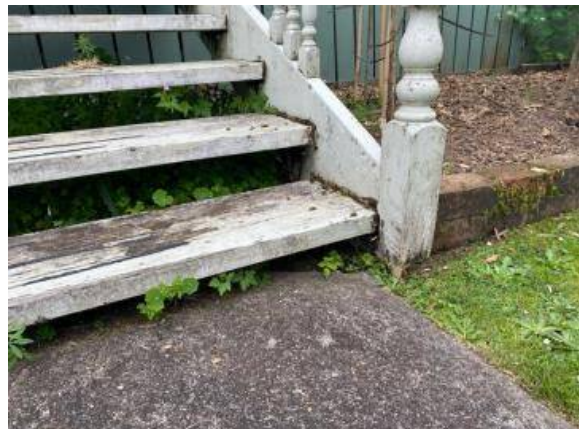
Evidence of decay to timber stringer and treads. This is a potential safety hazard. We recommend engaging a Builder to inspect further and replace decayed treads as required to ensure safe access via staircase.

Evidence of decay to timber stringer and treads. This is a potential safety hazard. We recommend engaging a Builder to inspect further and replace decayed treads as required to ensure safe access via staircase.

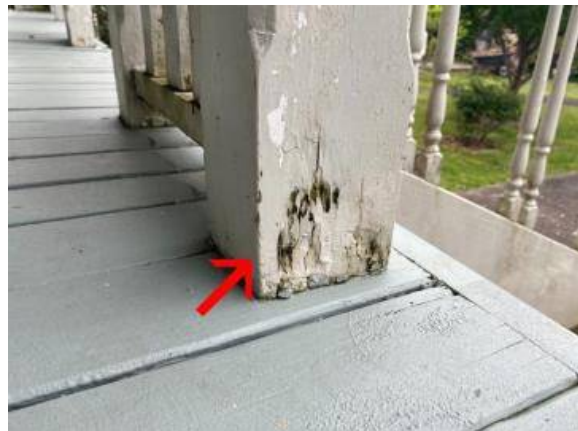
Visible decay to base of veranda posts. We recommend engaging the services of a LBP to inspect further. If posts have been compromised we recommend replacement.

Visible decay to base of veranda posts. We recommend engaging the services if a LBP to inspect further. If posts have been compromised we recommend replacement.

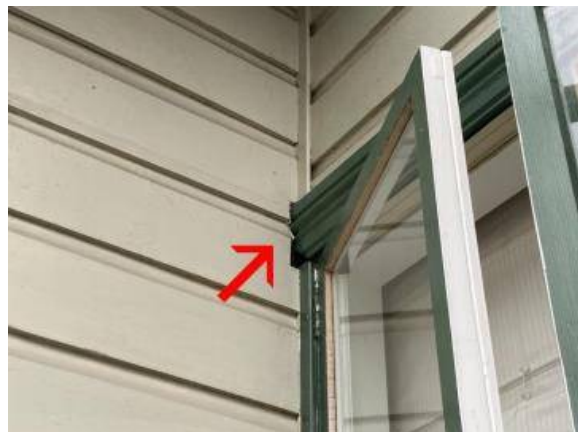
Poor seal to window joinery/cladding junction. We recommend engaging the services of a LBP builder to modify this detail to ensure a weathertight seal.

Poor seal to window joinery/cladding junction. We recommend engaging the services of a LBP builder to modify this detail to ensure a weathertight seal.

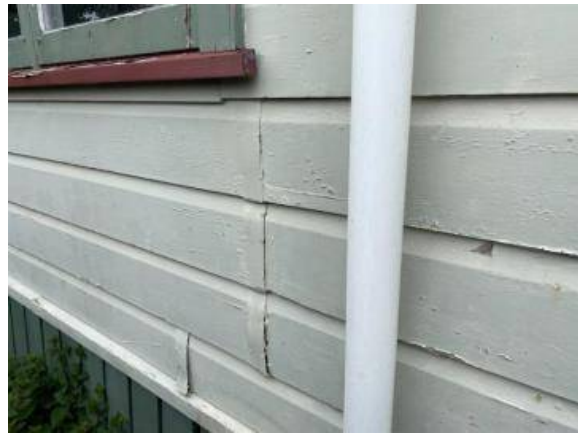
Paint lifting from timber weatherboards. Weatherboards will require appropriate preparation and paint to ensure cladding remains well sealed. Failure to maintain paint coating increases the risk of exposure

Paint lifting from timber weatherboards. Weatherboards will require appropriate preparation and paint to ensure cladding remains well sealed. Failure to maintain paint coating increases the risk of exposure

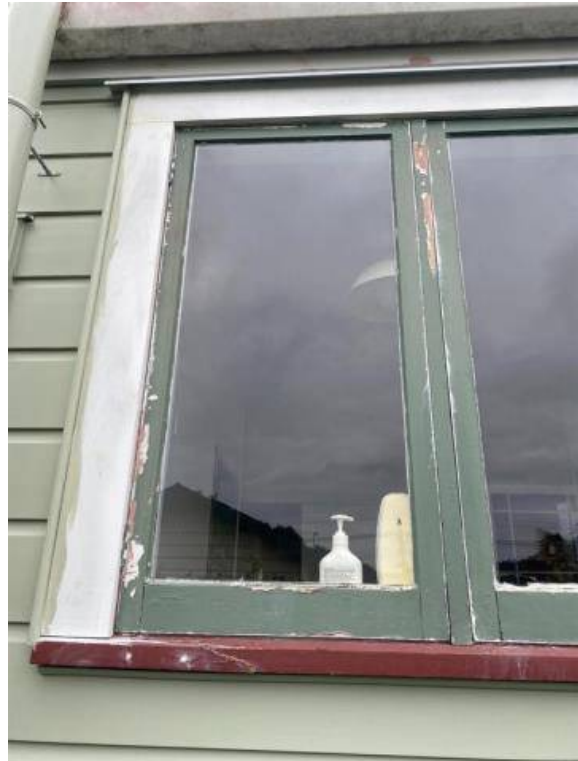
Visible paint lift from timber window joinery. Paint lift increases the risk of exposure to timber. We recommend engaging the services of a painter to prep and paint joinery as required. Failure to maintain may result in joinery failure.

Visible paint lift from timber window joinery. Paint lift increases the risk of exposure to timber. We recommend engaging the services of a painter to prep and paint joinery as required. Failure to maintain may result in joinery failure.

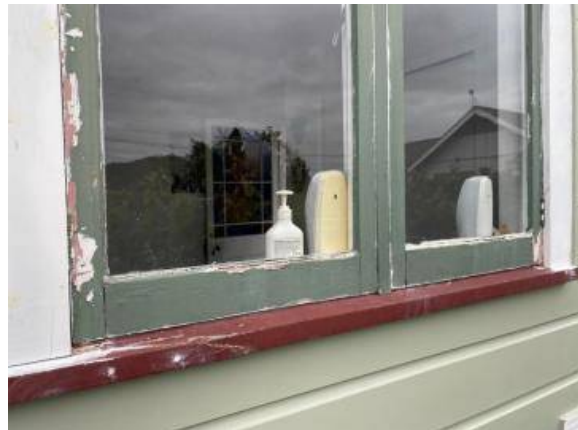
Loose glazing putty to window joinery. We recommend replacing compromised putty to ensure window panes remain glazing remains secure and weathertight.

Loose glazing putty to window joinery. We recommend replacing compromised putty to ensure window panes remain glazing remains secure and weathertight.

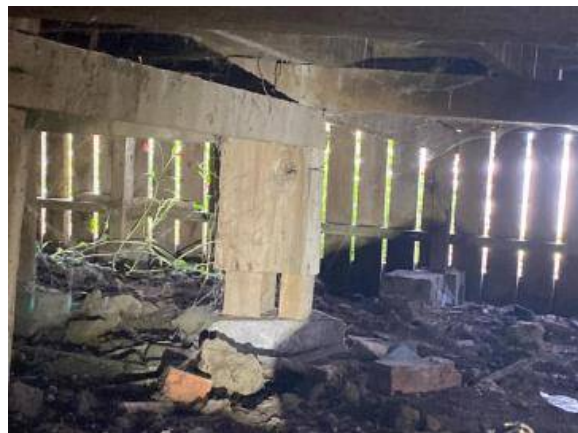
A number of piles have been packed over the years. We recommend engaging a LBP to inspect these piles further, replacing packed piles will likely be the most viable option.

A number of piles have been packed over the years. We recommend engaging a LBP to inspect these piles further, replacing packed piles will likely be the most viable option.

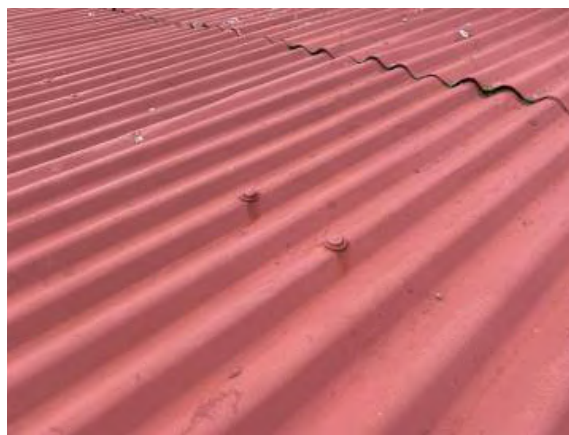
Visible corrosion around lead head fixings. Lead heads should be removed and replaced with new fixings. Roof covering should be inspected for signs of corrosion and treated with a suitable rust inhibitor where required.

Visible corrosion around lead head fixings. Lead heads should be removed and replaced with new fixings. Roof covering should be inspected for signs of corrosion and treated with a suitable rust inhibitor where required.

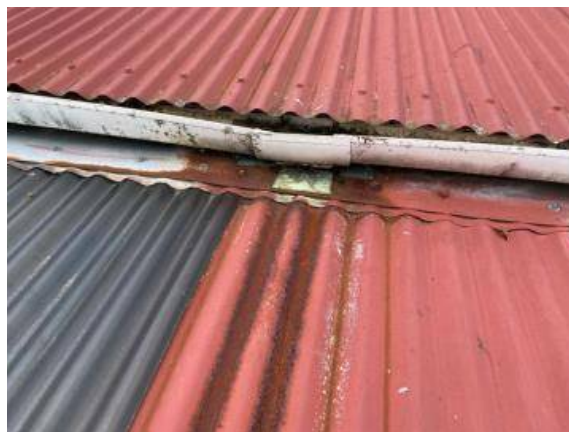
Evidence of corrosion to roof covering. We recommend engaging the services of a roofer to inspect covering further. Corrosion should be treated with a suitable rust inhibitor and painted to reduce the risk of damage to covering.

Evidence of corrosion to roof covering. We recommend engaging the services of a roofer to inspect covering further. Corrosion should be treated with a suitable rust inhibitor and painted to reduce the risk of damage to covering.

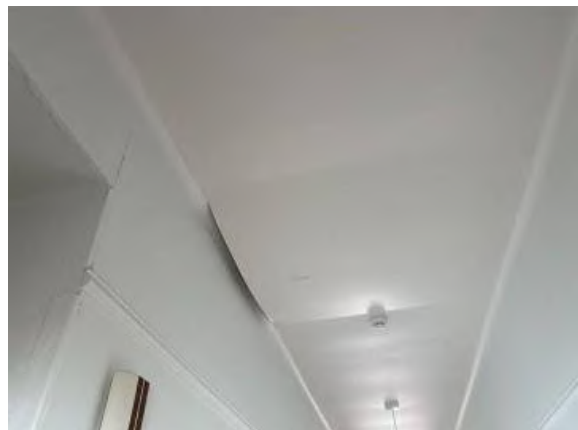
Ceiling lining paper loose. This area corresponds with internal gutter system. No elevated moisture readings in this area at the tie of inspection.

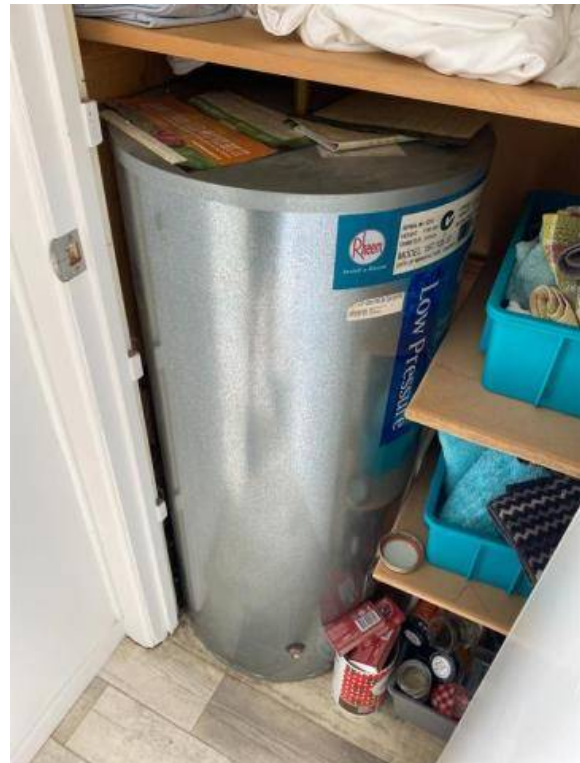
No seismic restraint installed. A seismic restraint should be installed to ensure cylinder is secured. We recommend engaging the services of a builder to install suitable restraints.
