## **Property Condition Report**

**66a King Street  
Kensington  
Whangarei District**

**Client:** Paul Sumich C/- Bayleys Whangarei

**Inspection Date:** 9/03/2022

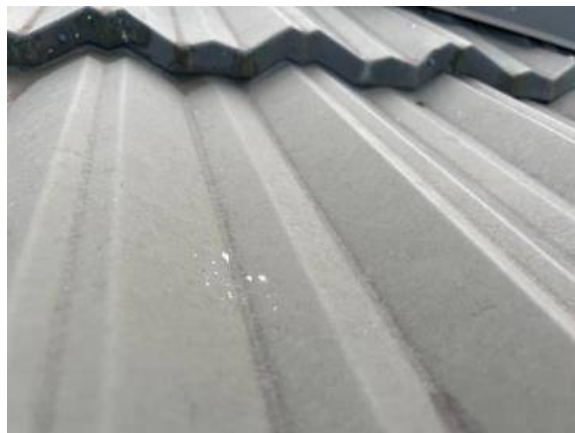
Contaminant build up to roof covering. We recommend cleaning roof covering annually or as required during periodic maintenance to ensure the finished coating is not compromised by growth and airborne contaminants.

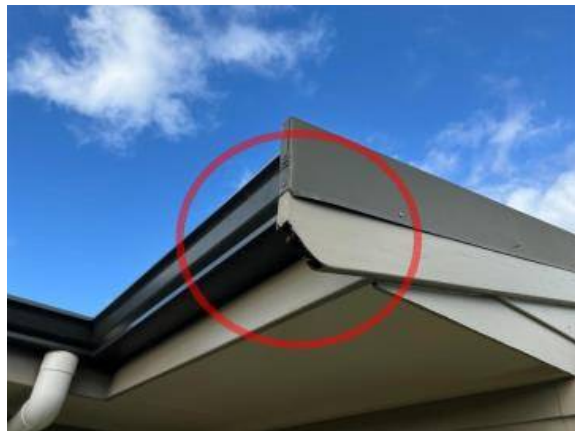
Evidence of decay to timber fascia board above kitchen. Decayed fascia may increase the risk of moisture ingress to roof space. We recommend engaging the services of a Builder to replace damaged Fascia as required.
