Building Report

Building Inspection Report

Client: Paul Sumich - C/o Bayleys
Location: 1 Kentia Lane, Whau Valley
Whangarei
Inspection Date: 01/02/2022

RE: Building Inspection Report, 1 Kentia Lane, Whau Valley, Whangarei.

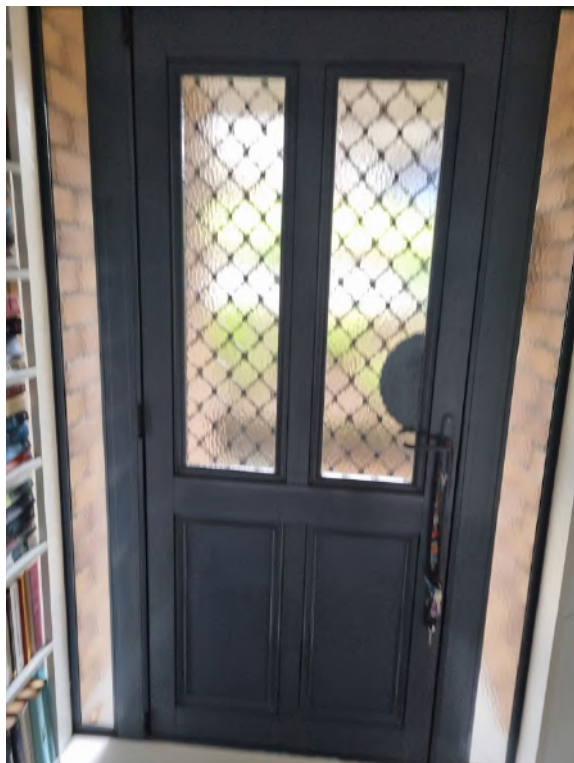
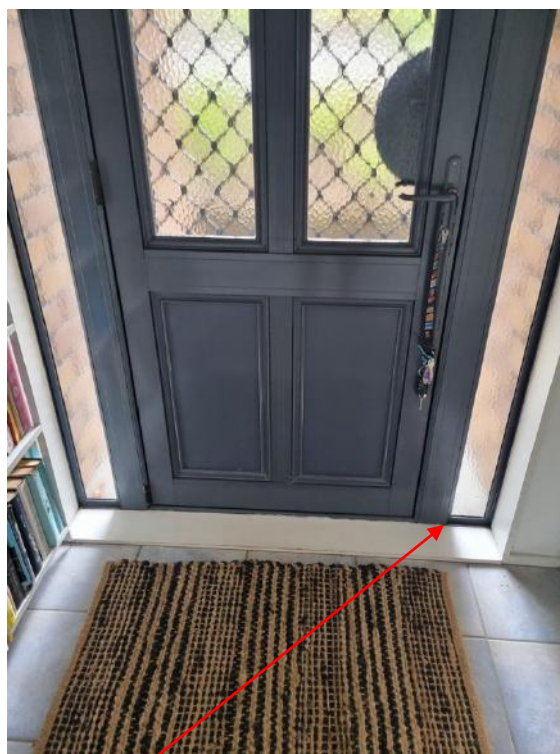
Front Entry

No access to check reading on left side

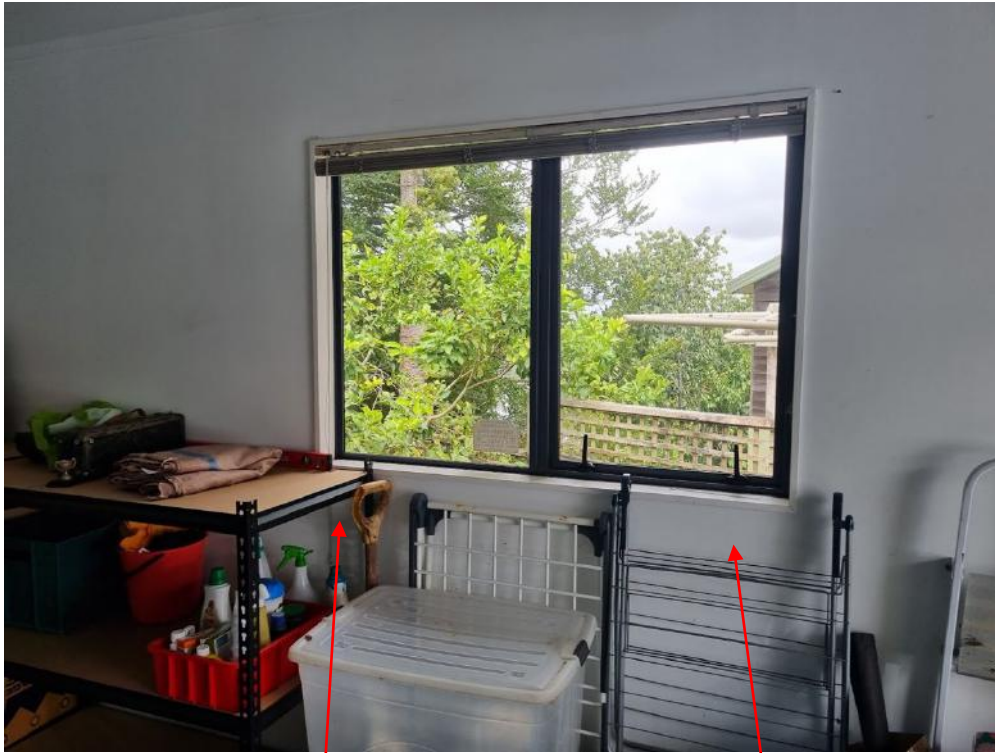
Garage

Plywood to garage floor

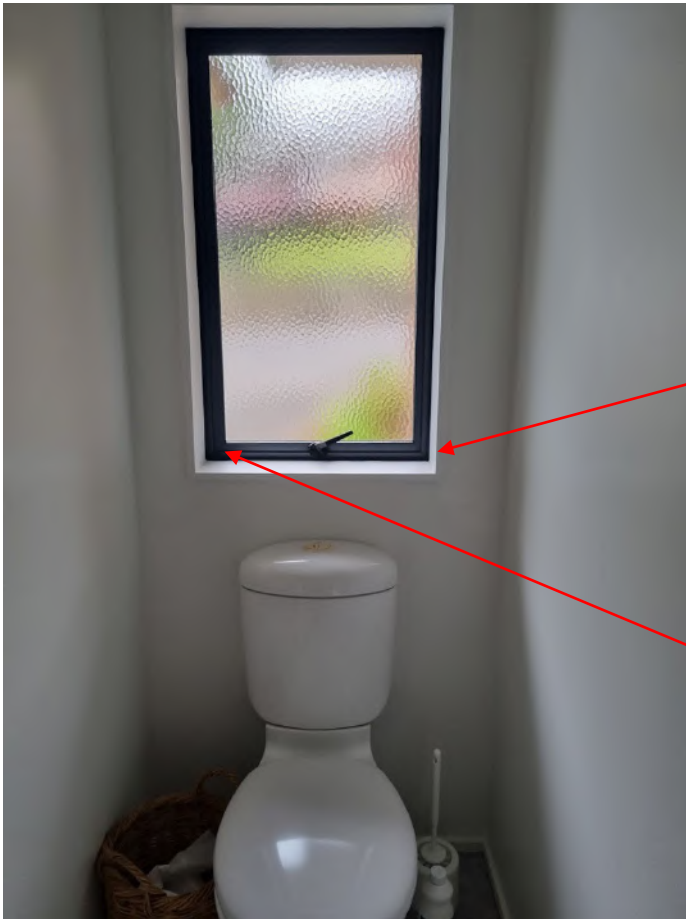
Toilet- separate

Separate toilet has no vent

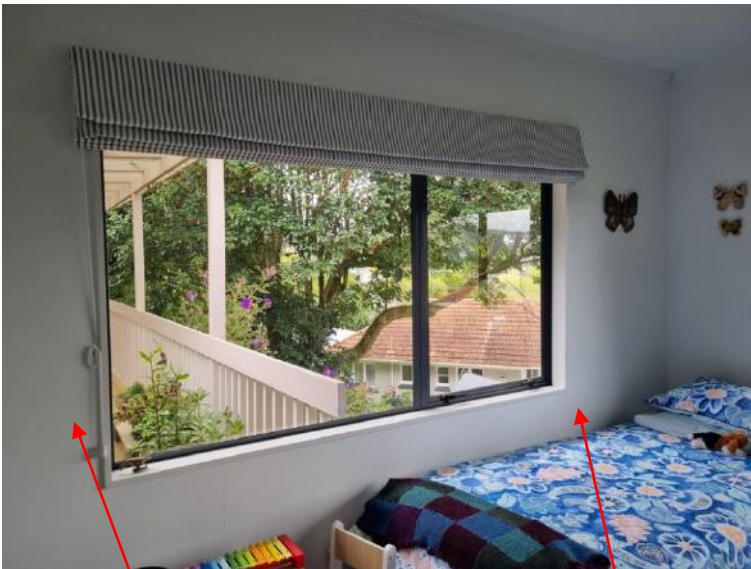
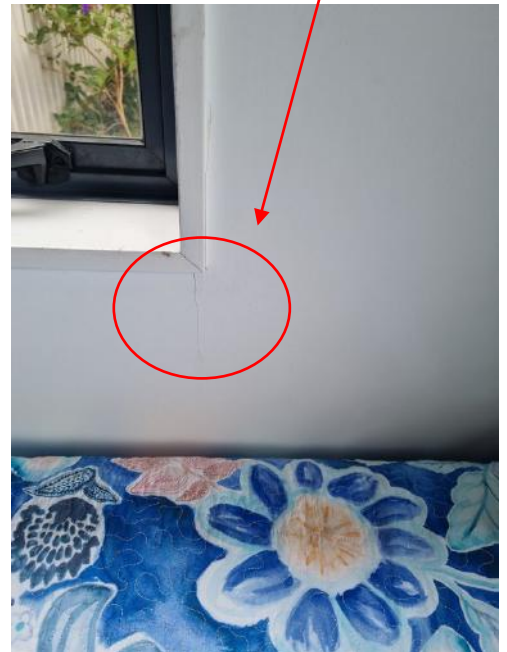
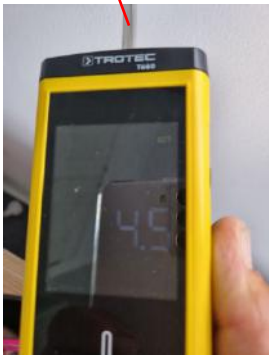
Bedroom2 has surface crack under window

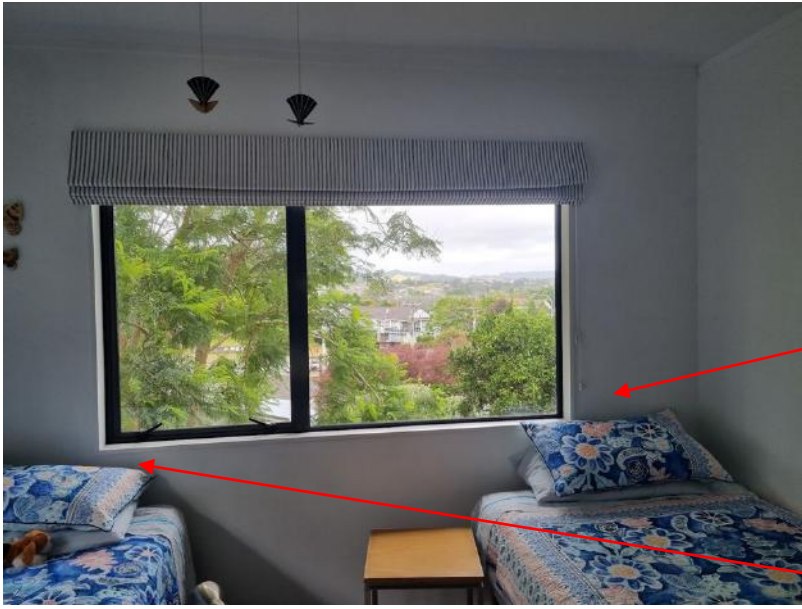
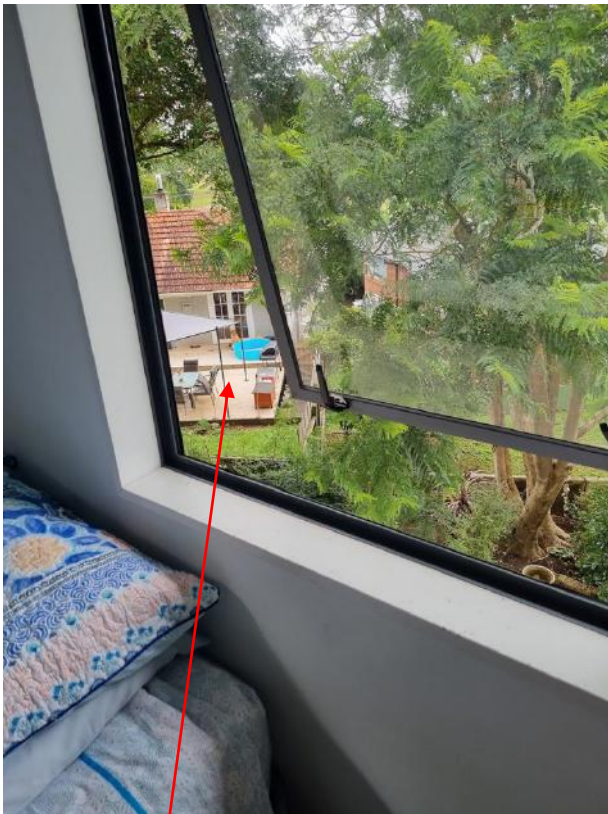
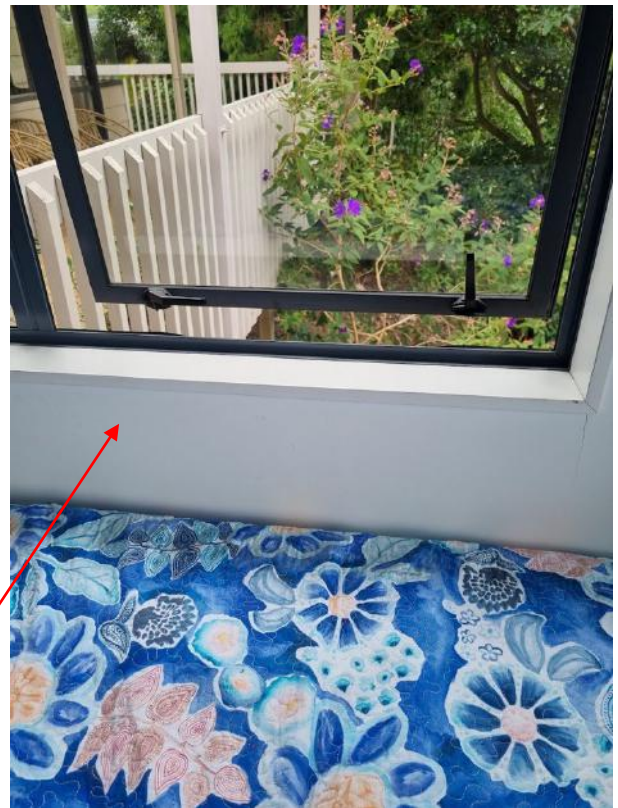
Bedroom 2 must have security stays to both windows due to its height of ground.

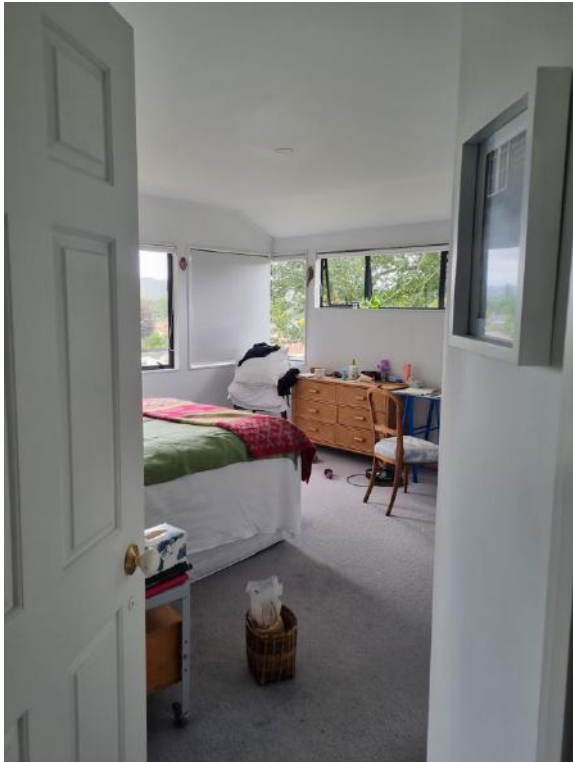
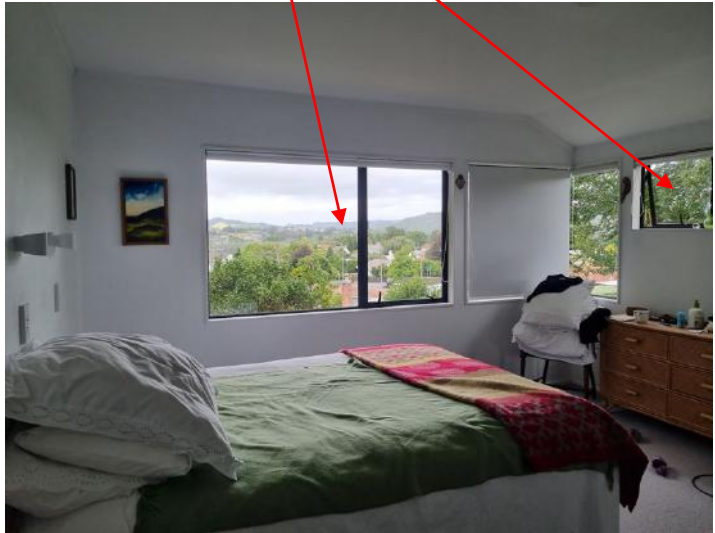
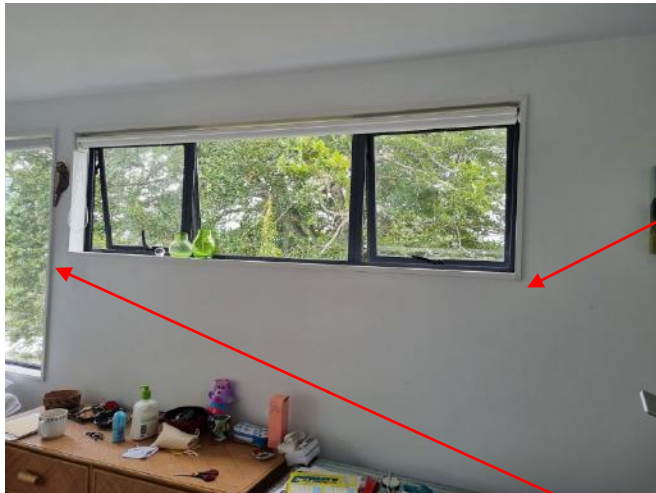
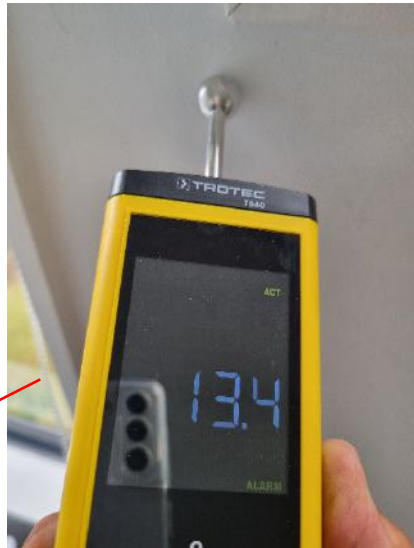
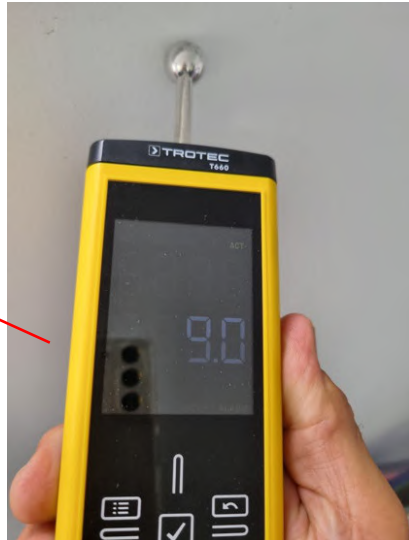
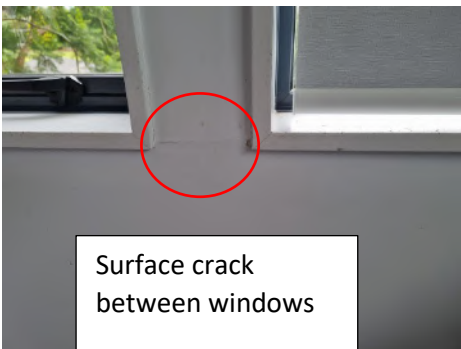
Bedroom3- Master

Master bedroom must have a security stay to both windows due to its height off ground.

Surface crack between windows

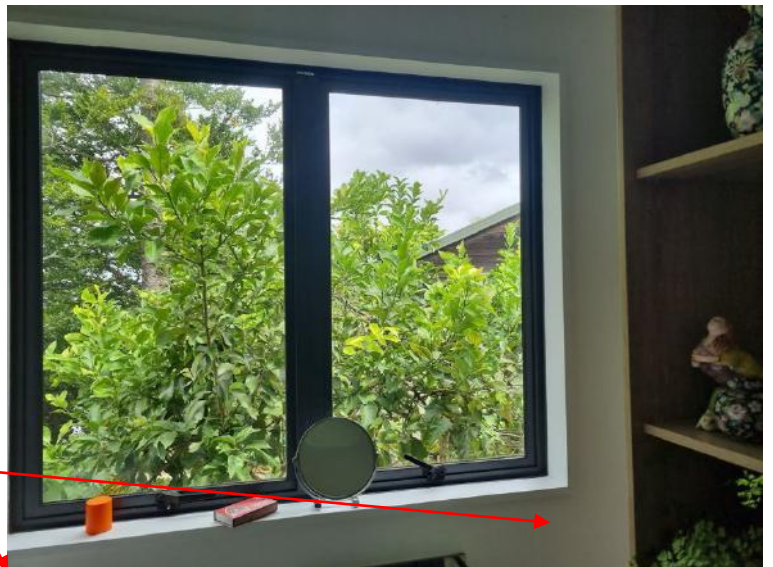
Ensuite must have a security stay to both windows due to its height off ground.

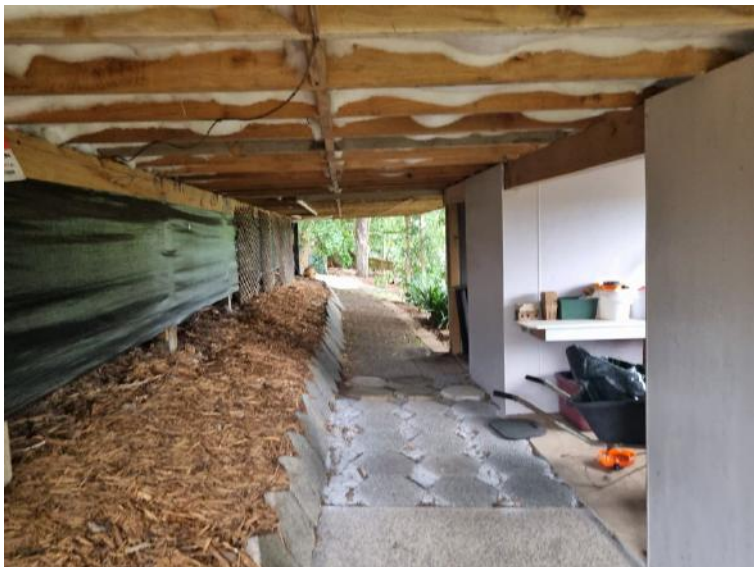
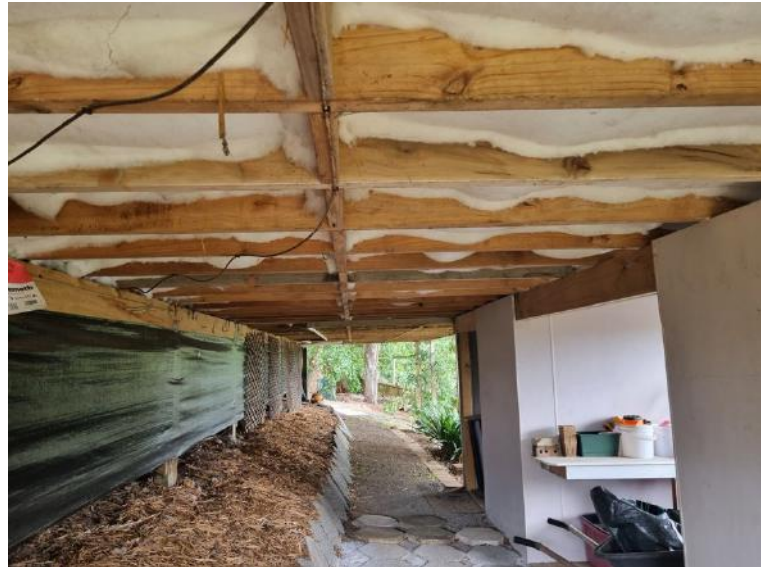
2x sheds under house were dry. Both are part board flooring and lined with fibrolite cladding.

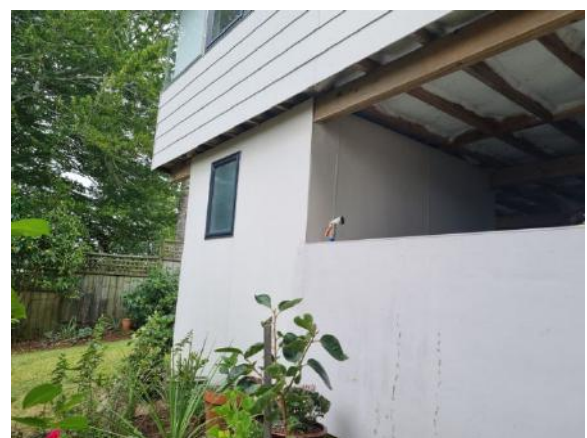
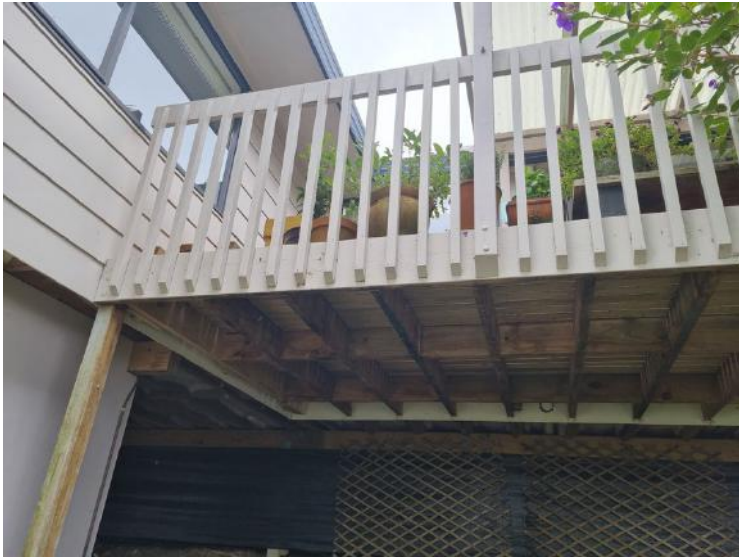
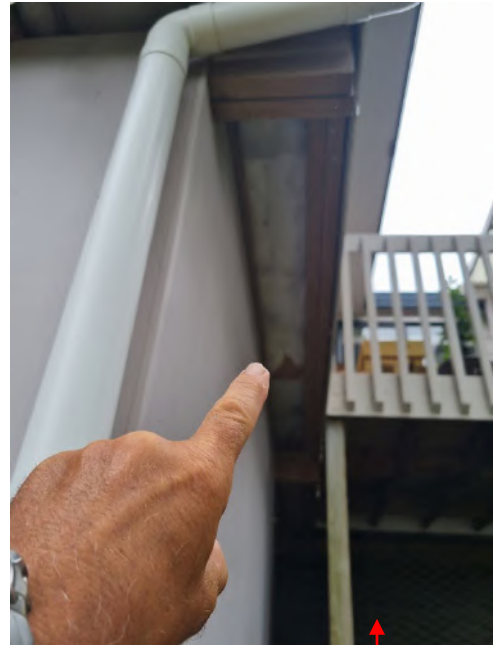
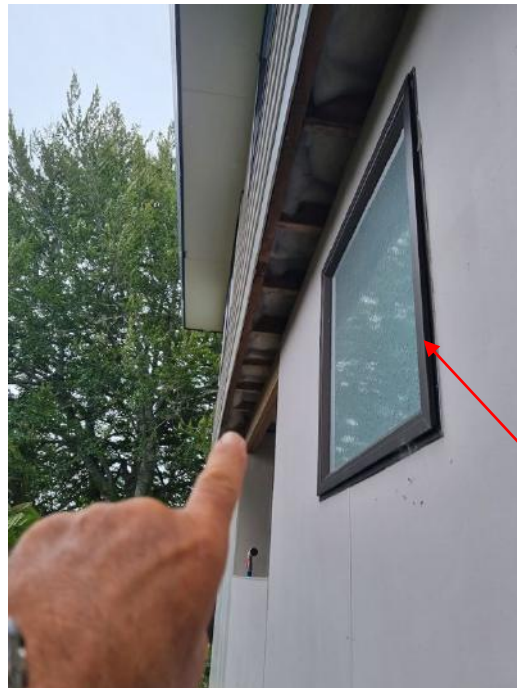
Under house where sheds are the joists are exposed to the outside elements. Recommend cladding of fibrolite to these areas for protection against the outside conditions. Treatment H1.2 not H 3.2

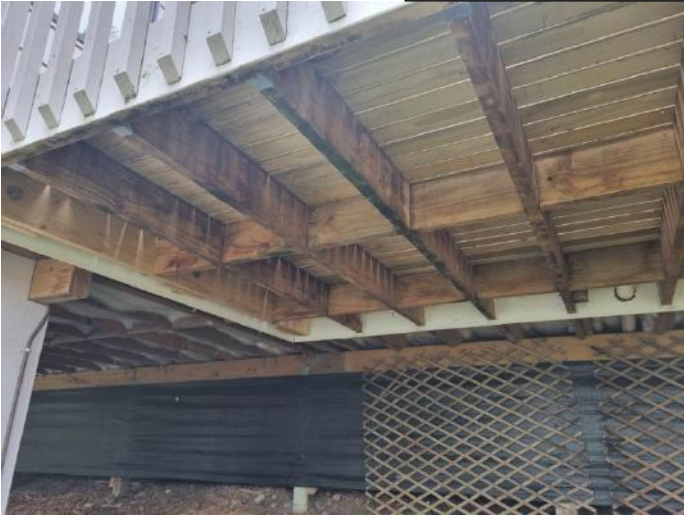
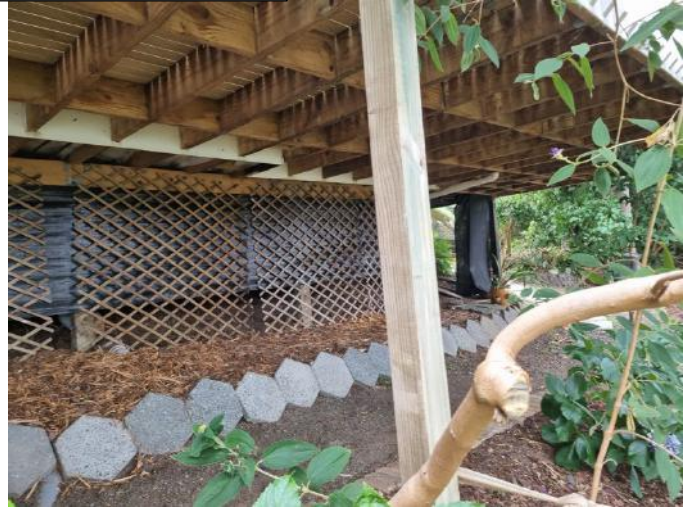
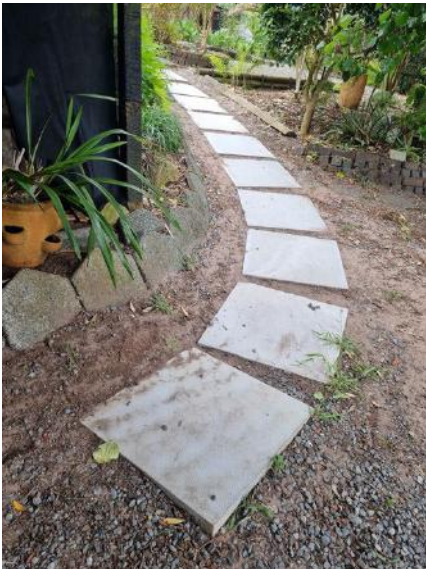
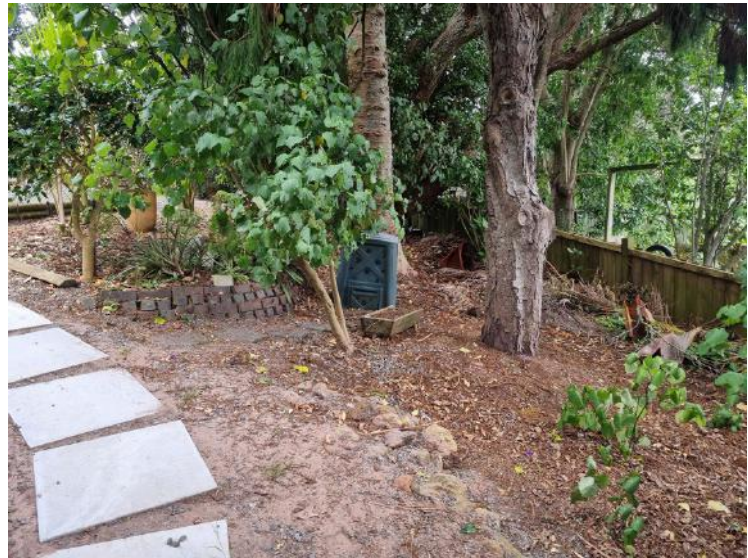
Substructure appears in sound condition

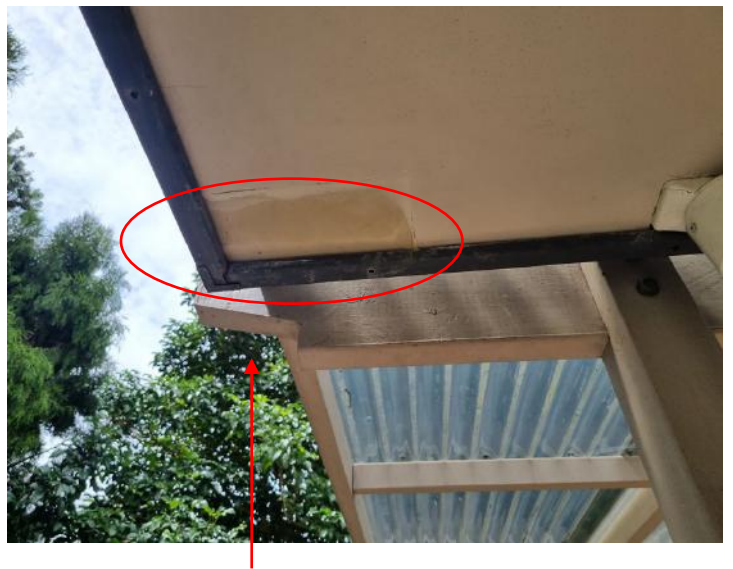
Small patch job has been done in corner of roof.

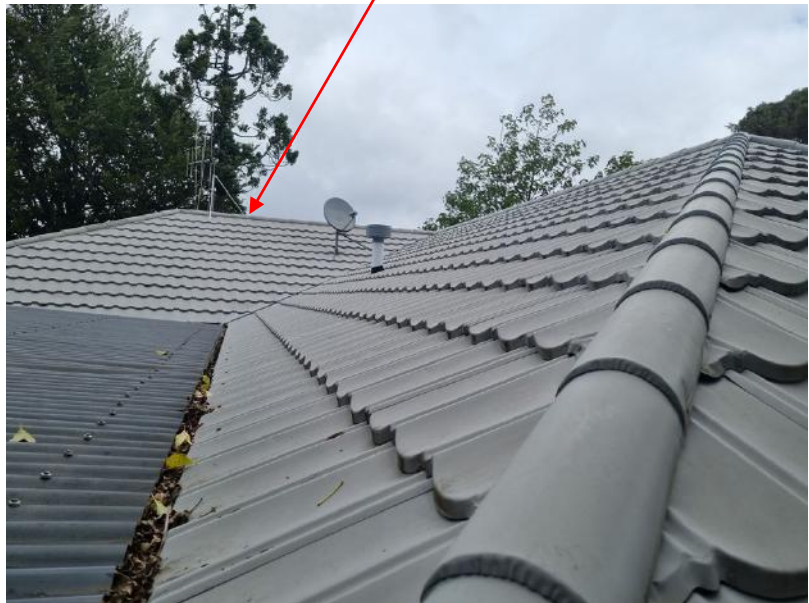
All guttering needs to be cleaned to avoid water backing up and going inside.
