# Building Inspection Report

Client: Paul Sumich  
Location: 103 Maunu Road, Woodhill  
Whangarei

Inspection Date: 20/10/2021

RE: Building Inspection Report, 103 Maunu Road, Woodhill, Whangarei.

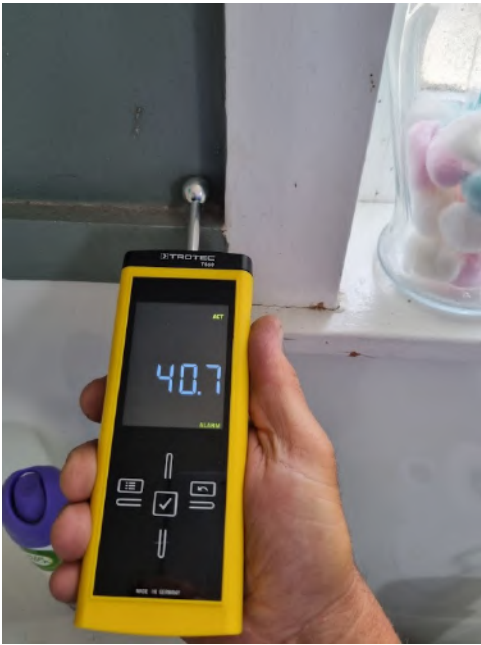
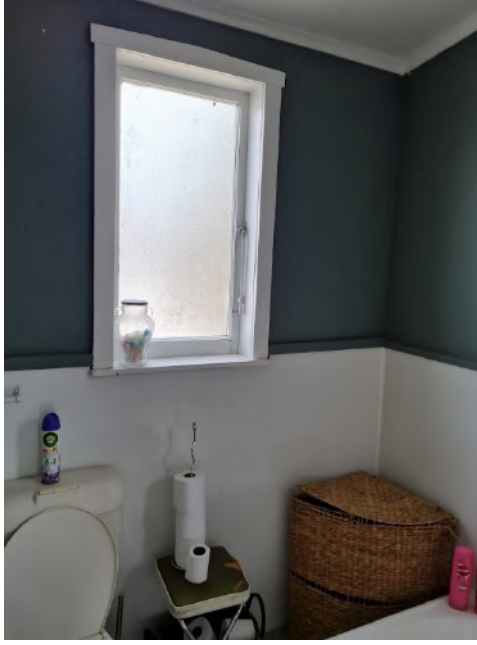
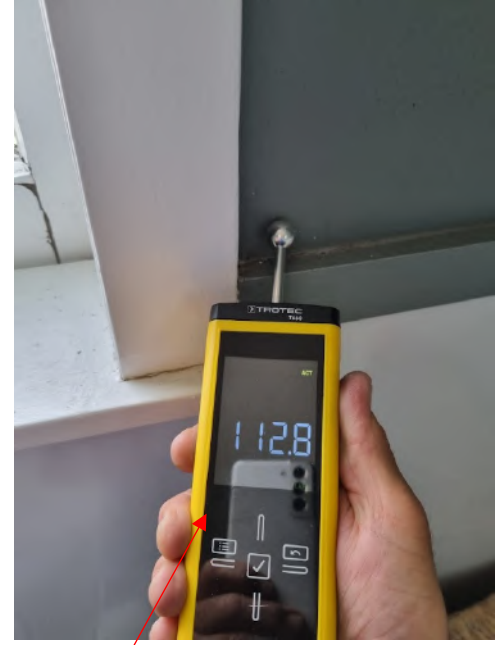
Moisture meter reading is higher than 80, this indicates great risk for wet material and further investigation is required

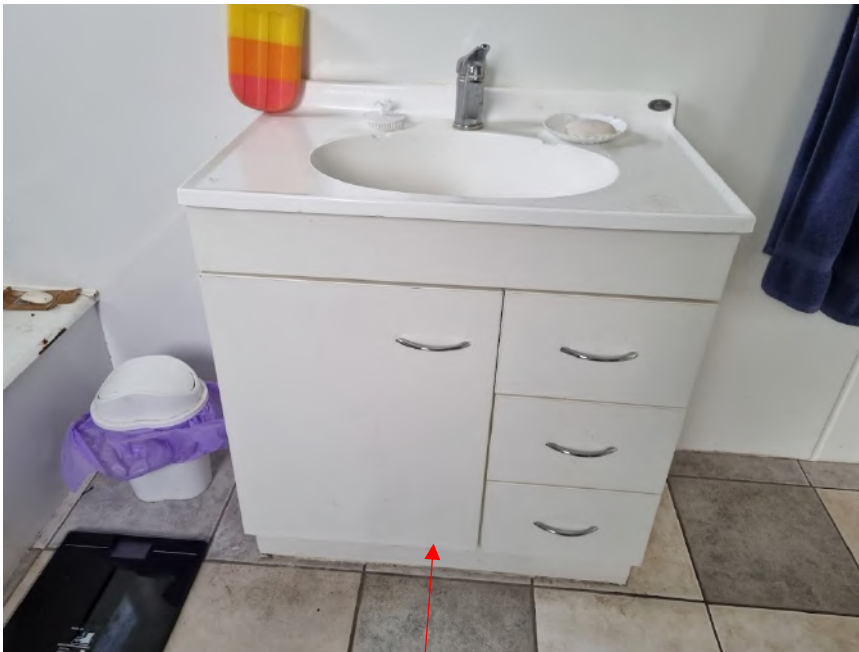
Vanity door in bathroom needs repair

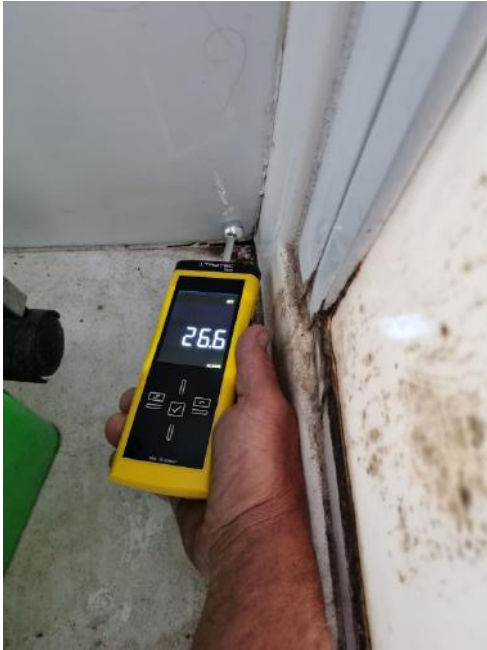
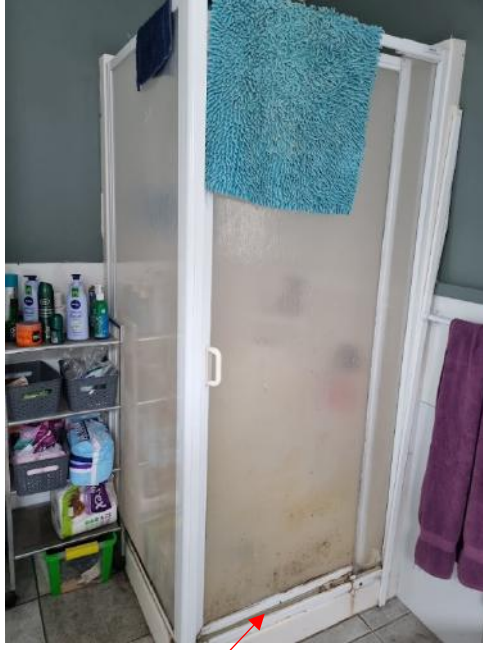
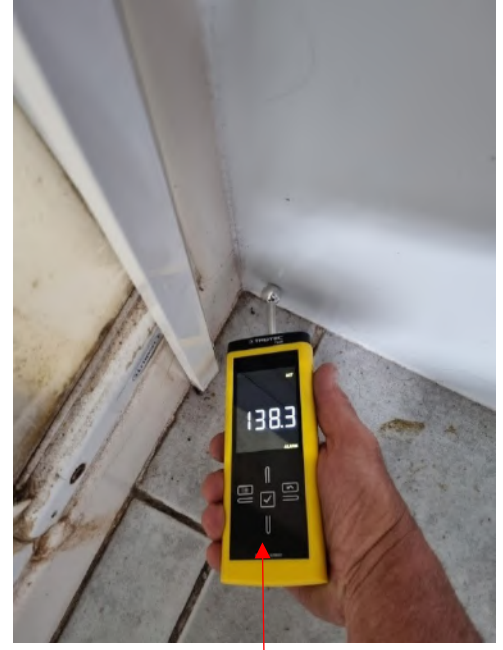
Shower door requires adjustment

Moisture meter reading is higher than 80, this indicates great risk for wet material and further investigation is required

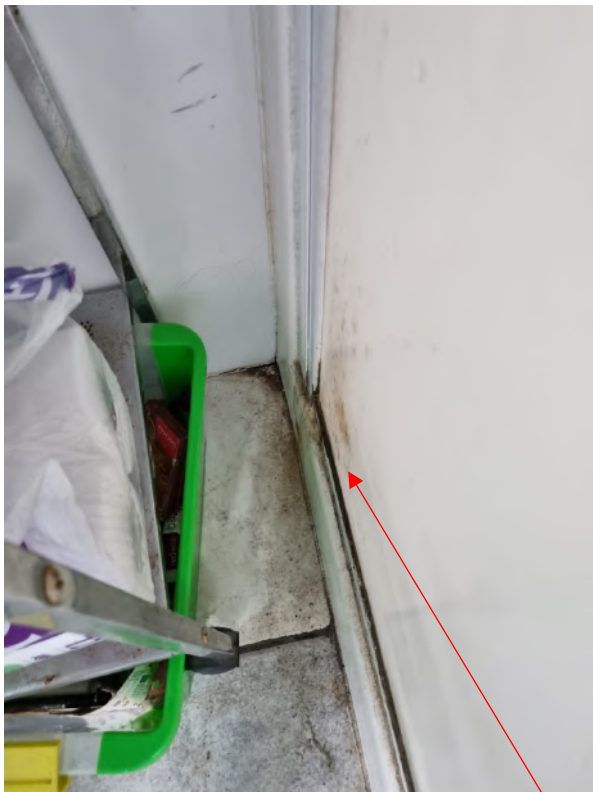
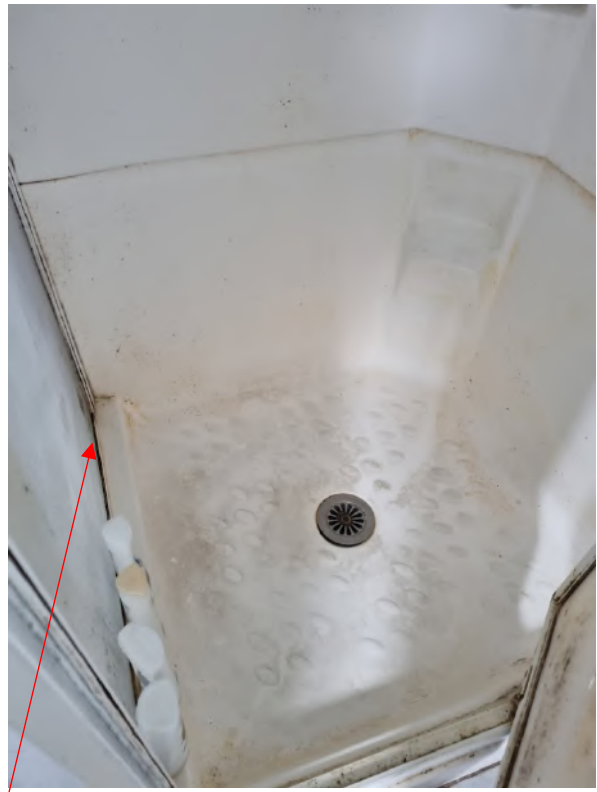
Left corner of shower lining needs repair

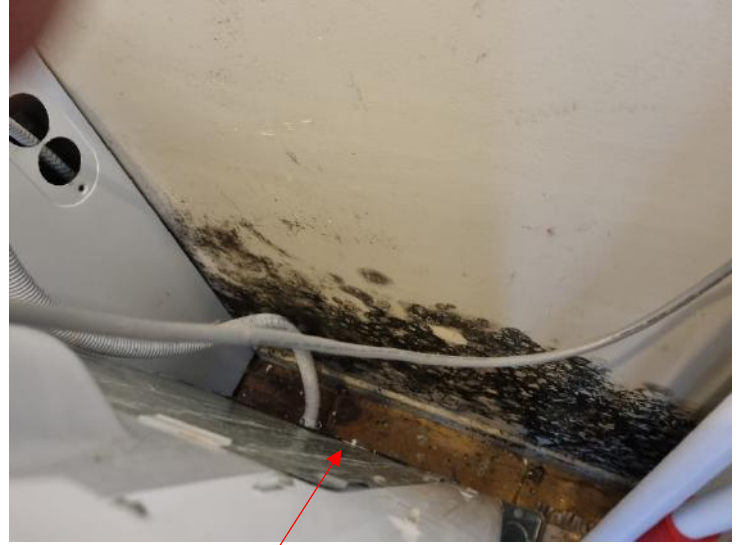
Mould is present behind washing machine – further investigation is required

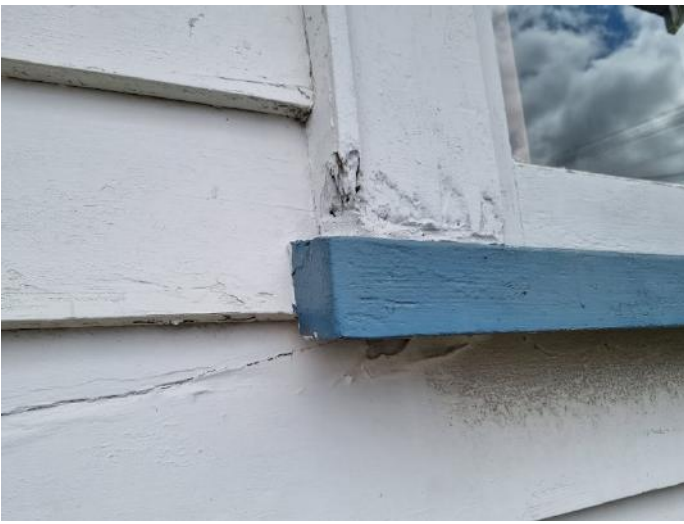
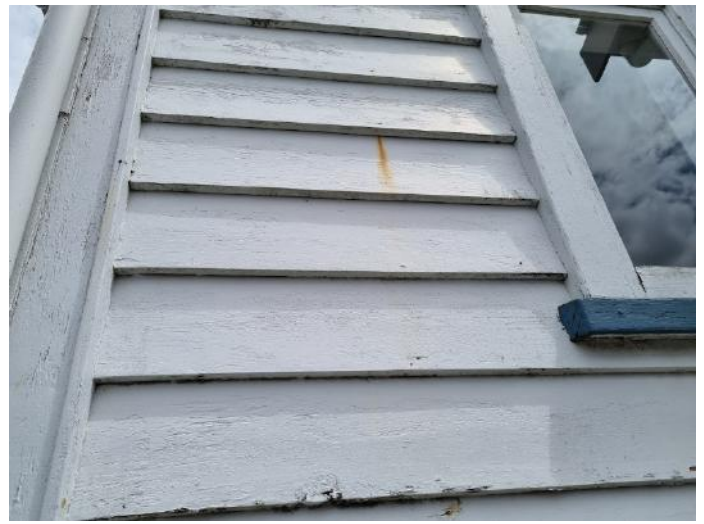
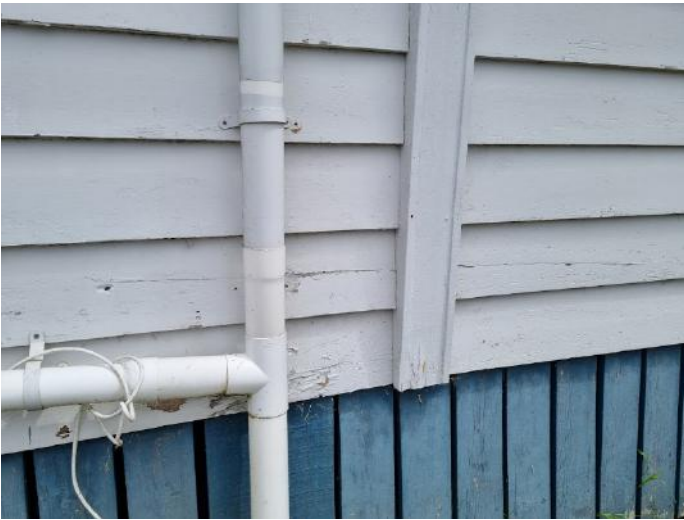
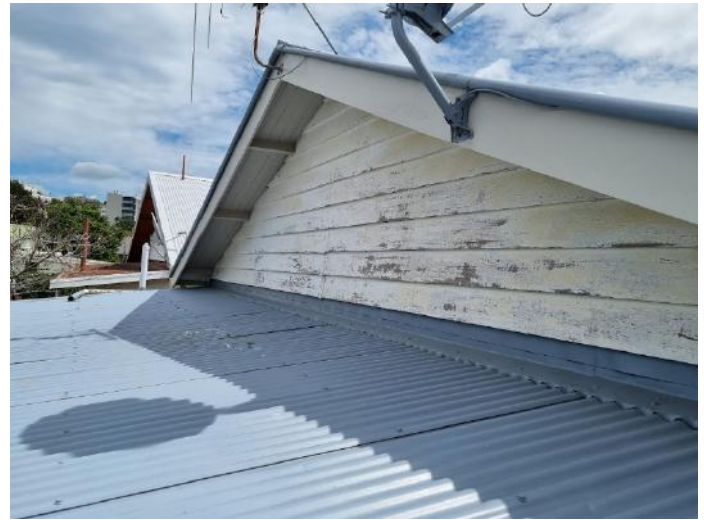
Signs of deterioration to the tongue and groove soffit boards, the timber cladding, the window facings, and corner facings

Exterior cladding would benefit with a complete paint

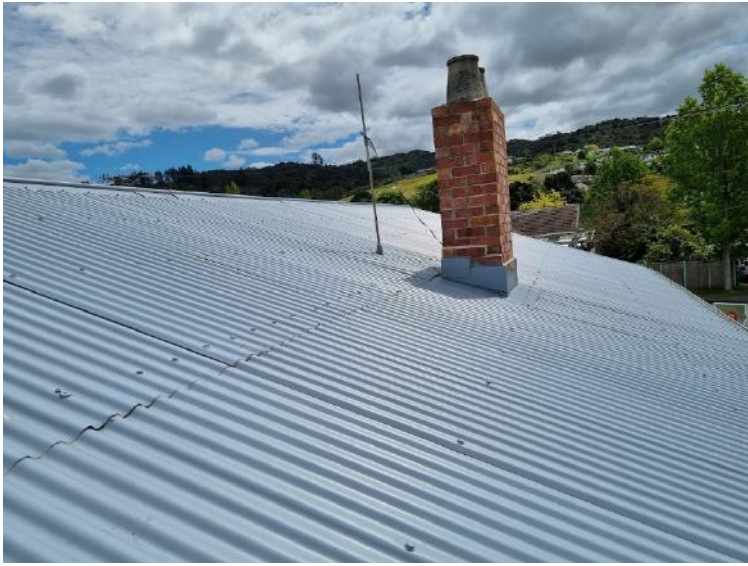
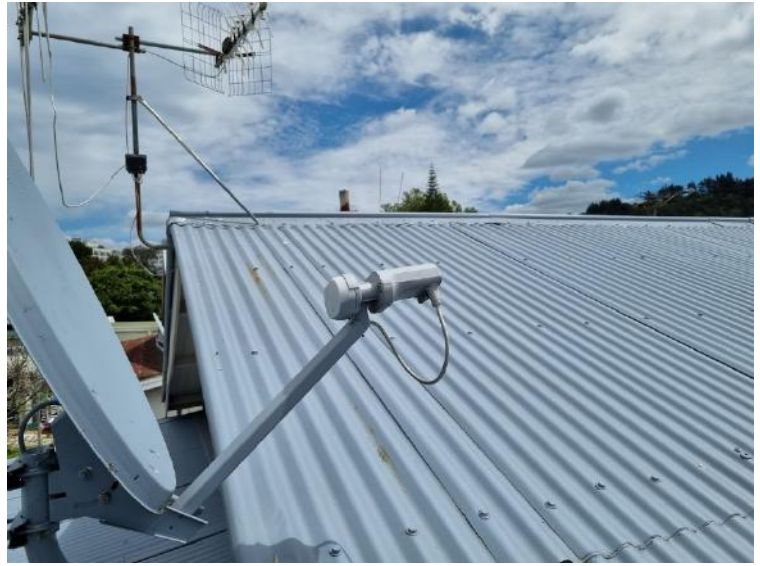
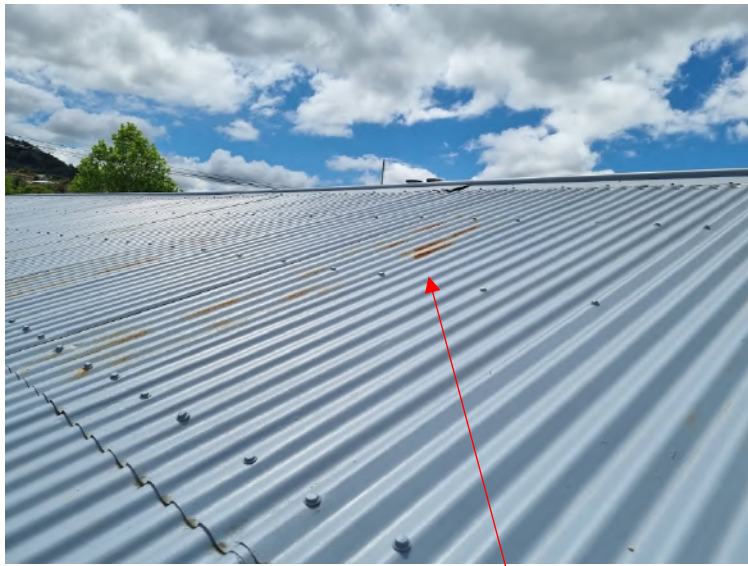
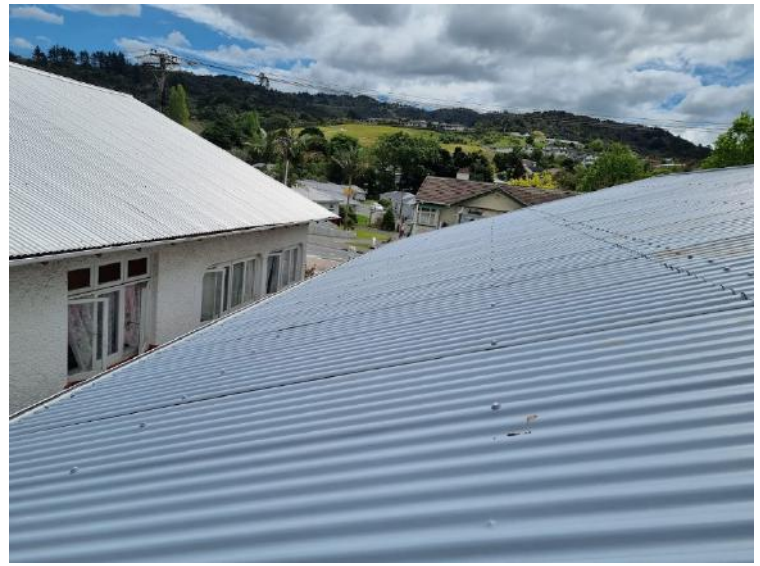
Roof is due for a replacement as it is showing signs of rust and deterioration

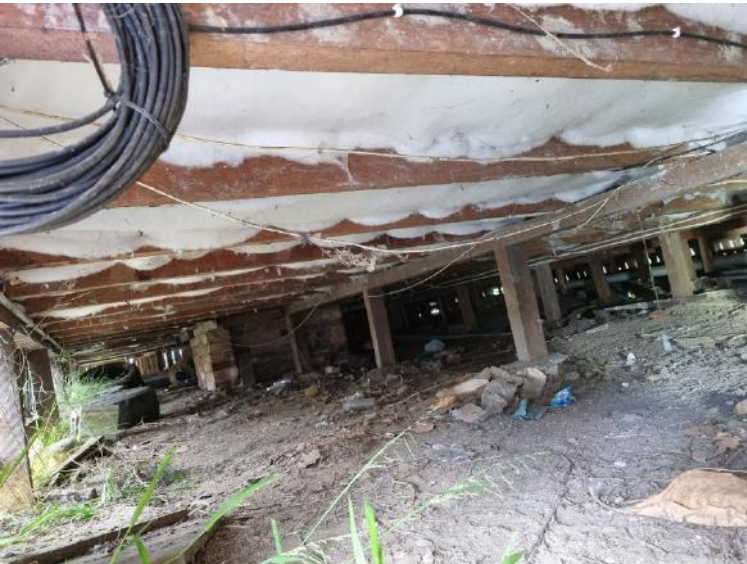
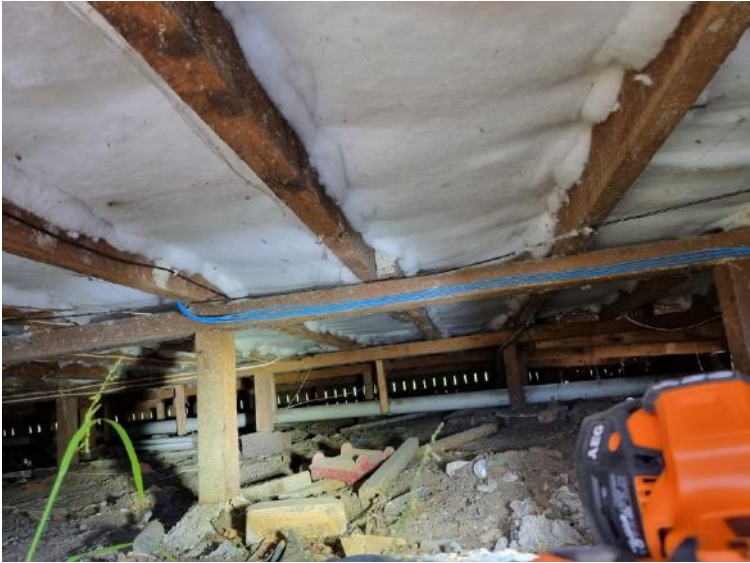
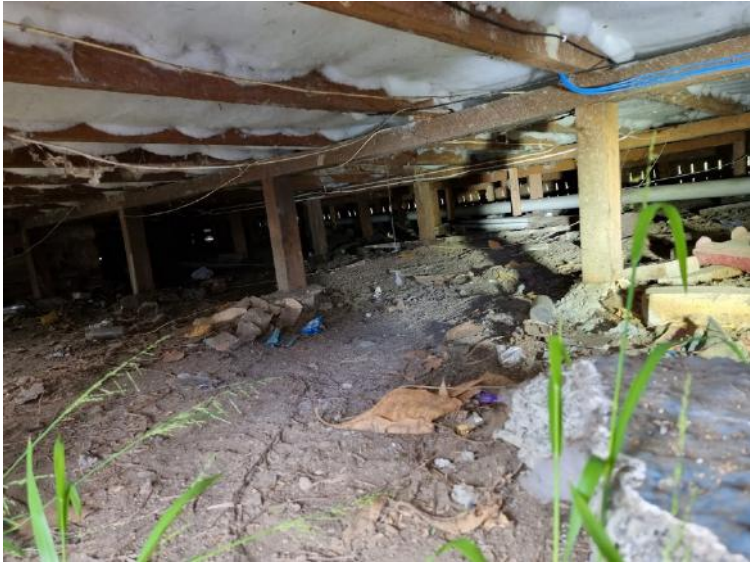
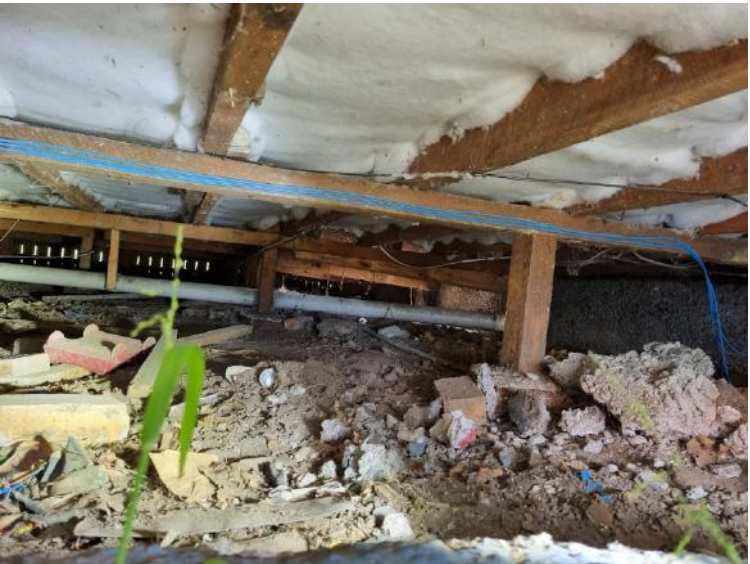
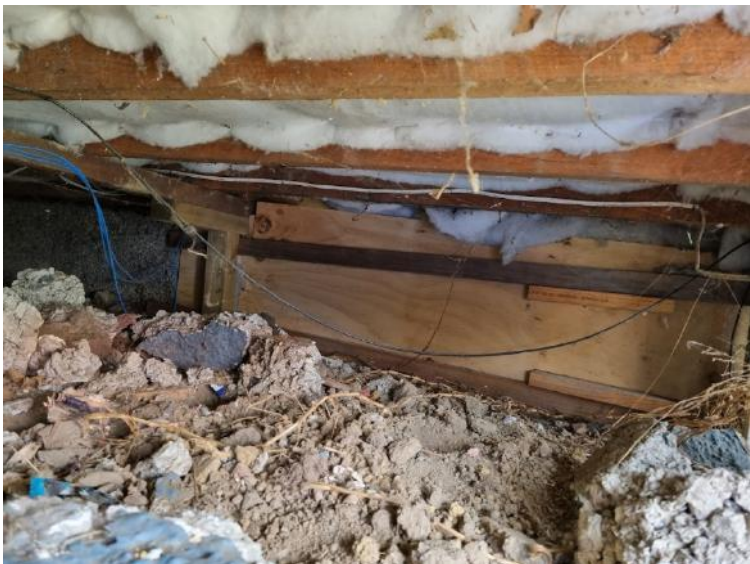
Sub structure appears sound and in reasonable original condition
