# Building Inspection Report

Client: Paul Sumich  
Location: 105 Maunu Road, Woodhill  
Whangarei

Inspection Date: 19/10/2021

RE: Building Inspection Report, 105 Maunu Road, Woodhill, Whangarei.

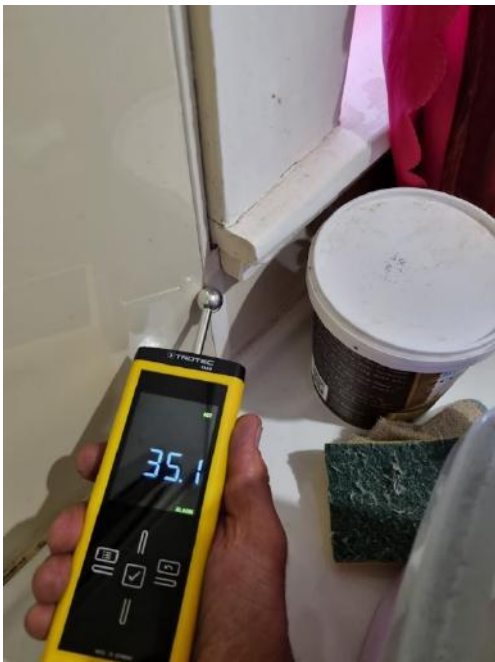
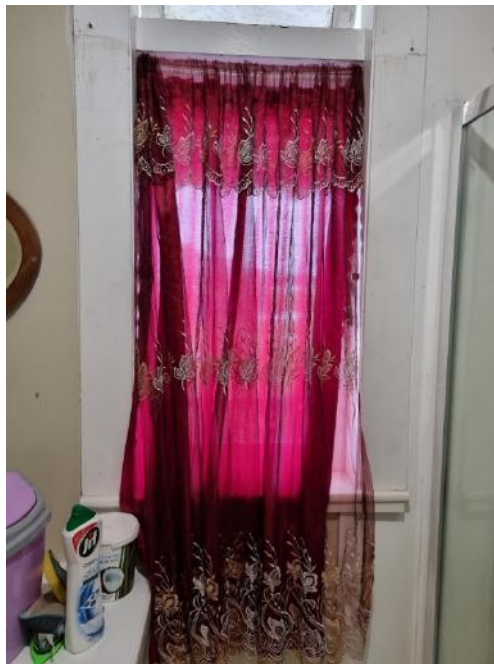
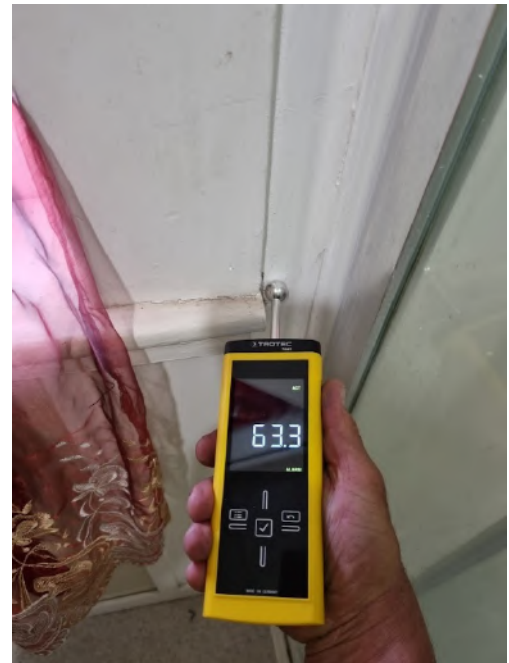
Bathroom has heavy signs of mould, most likely due to no extractor fan

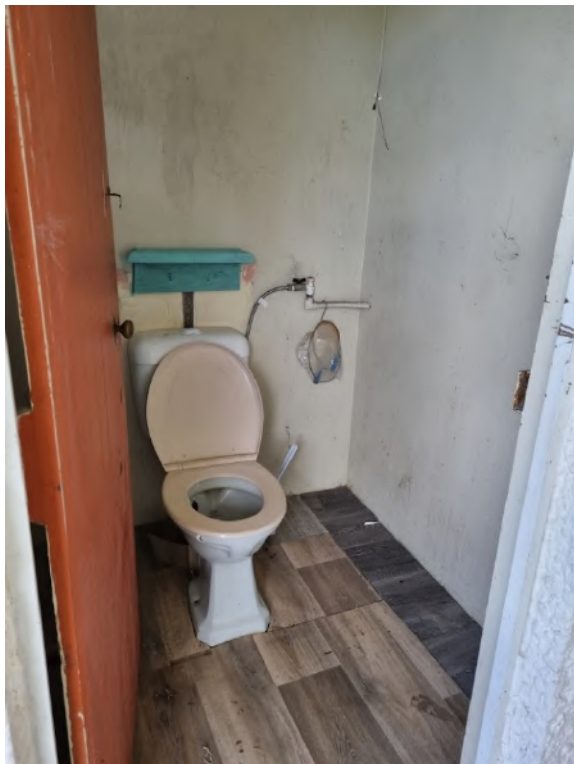
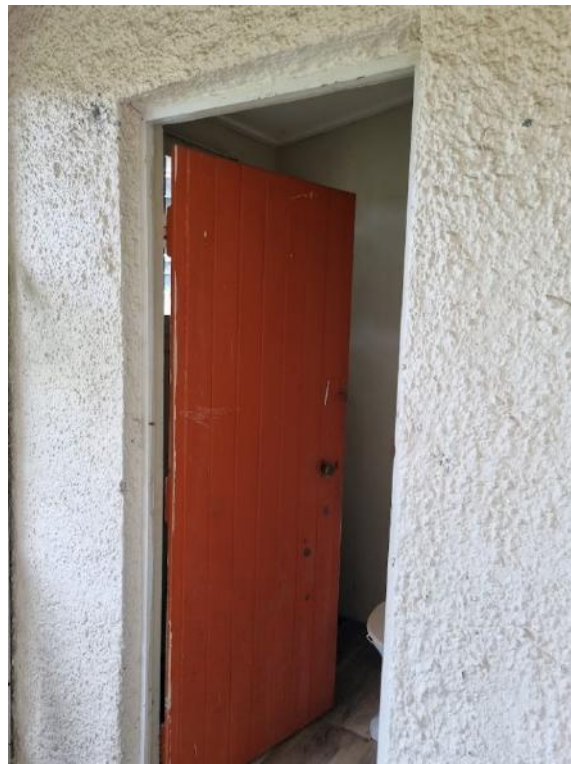
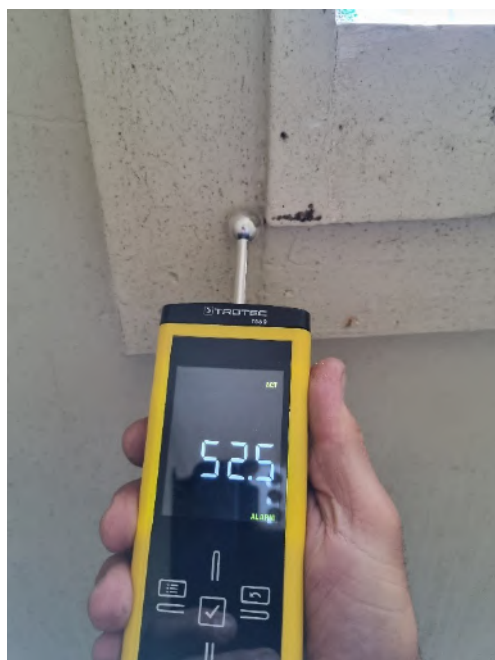
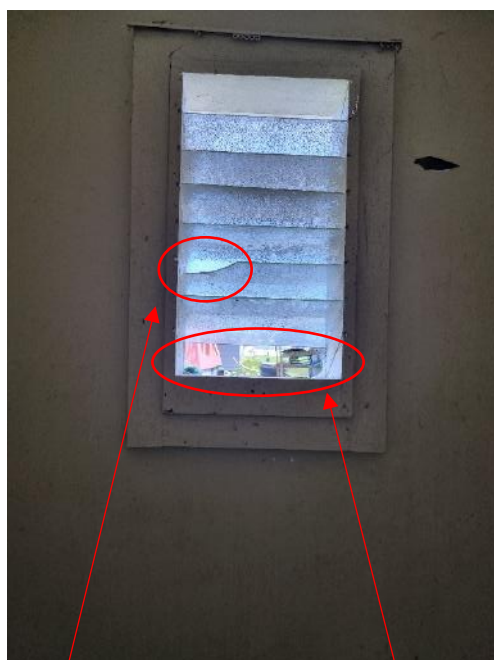
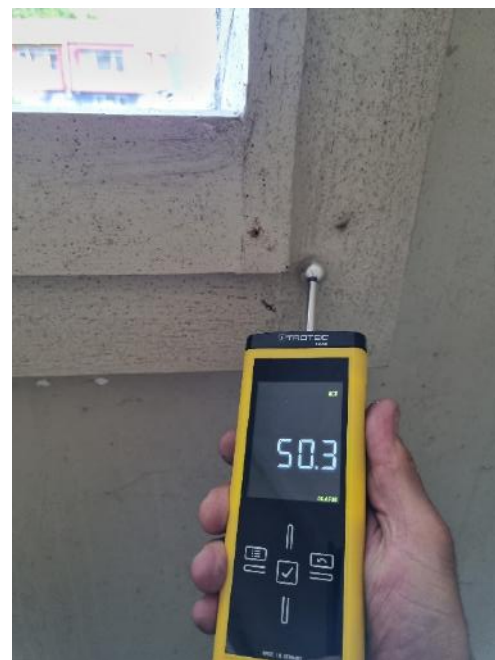
## Exterior toilet

Exterior toilet louvre is missing a window slat, and another is broken

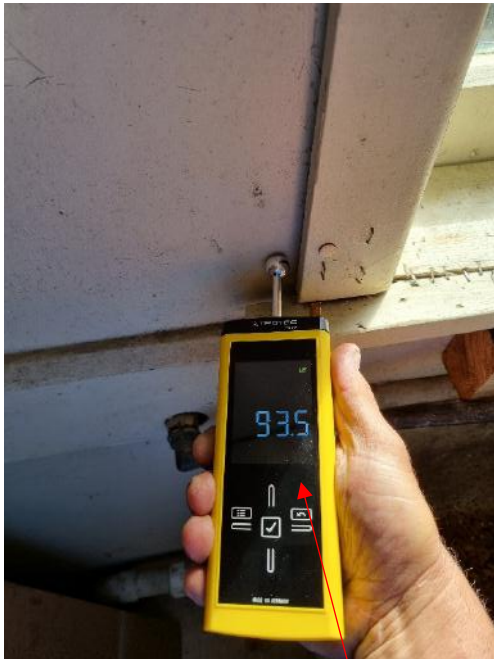
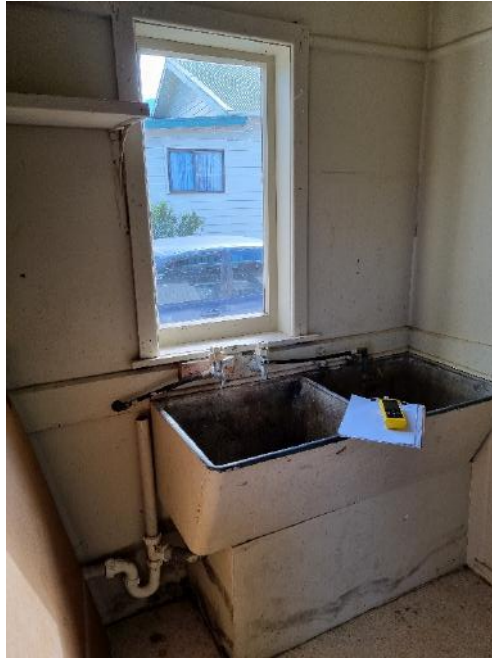
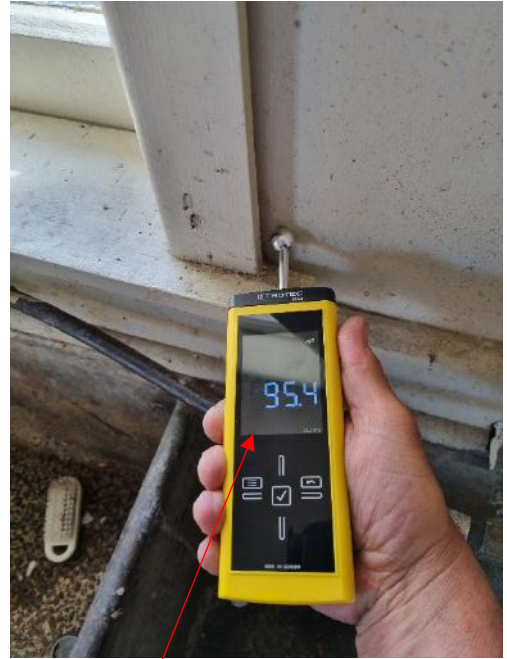
Moisture meter reading is greater than 80, this means material is at risk for wetness – further investigation is required

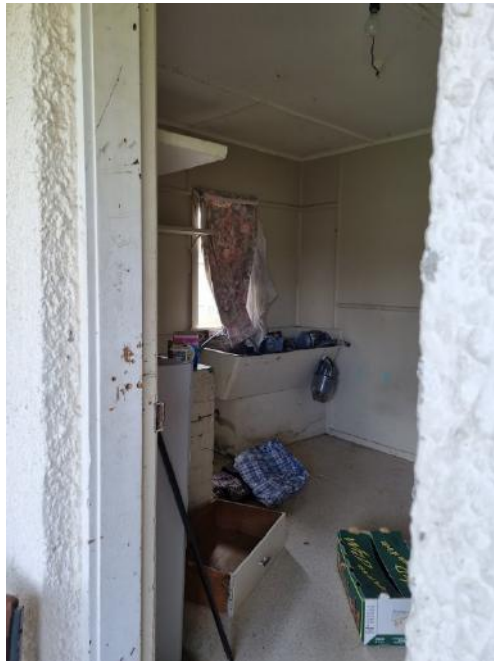
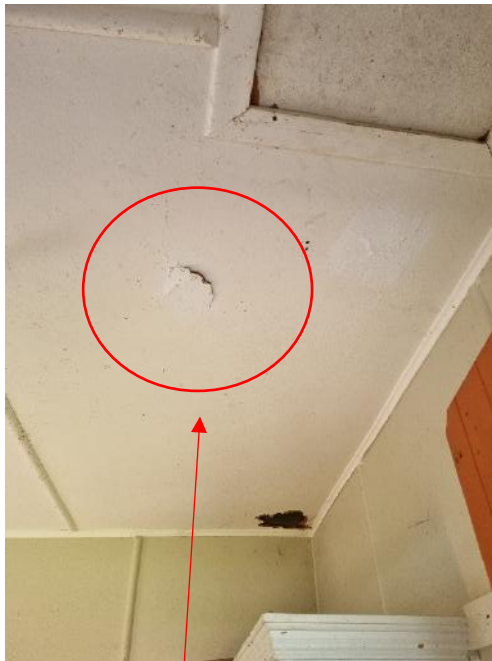
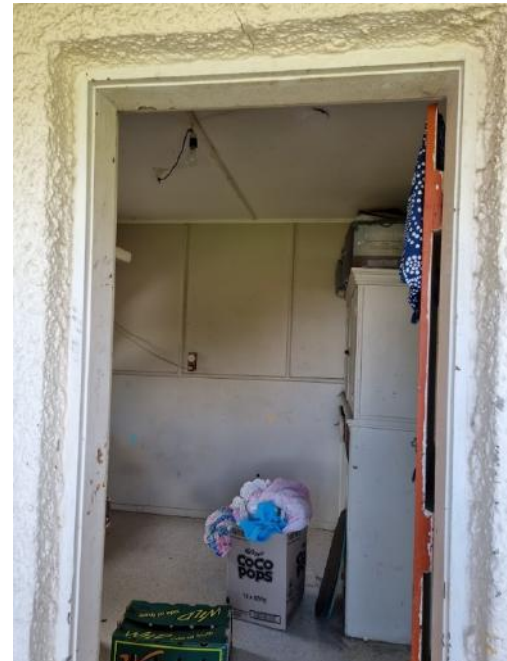
Damage to laundry ceiling - possible as a result from a past leak

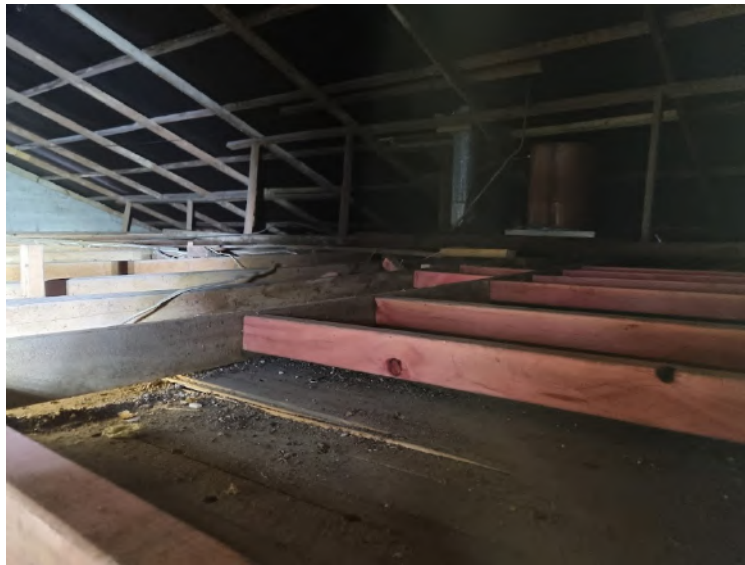
Ceiling is missing insulation

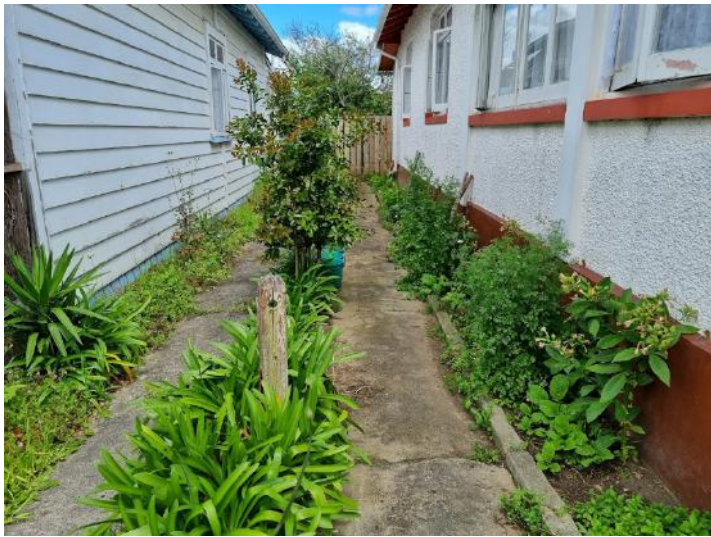
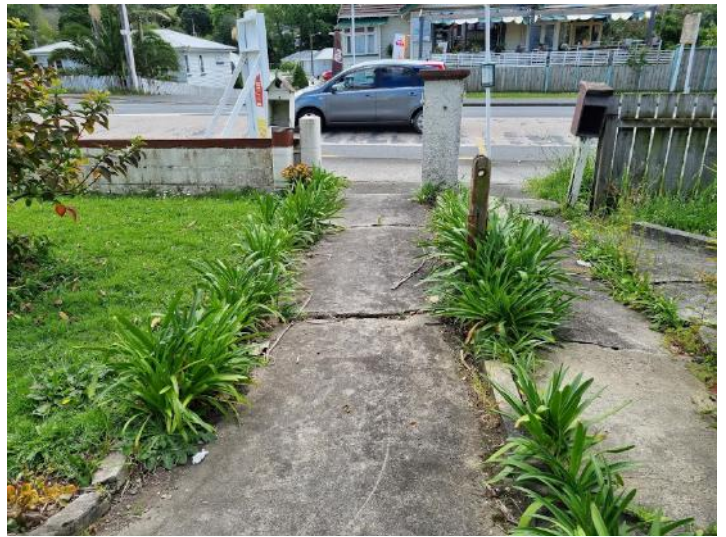
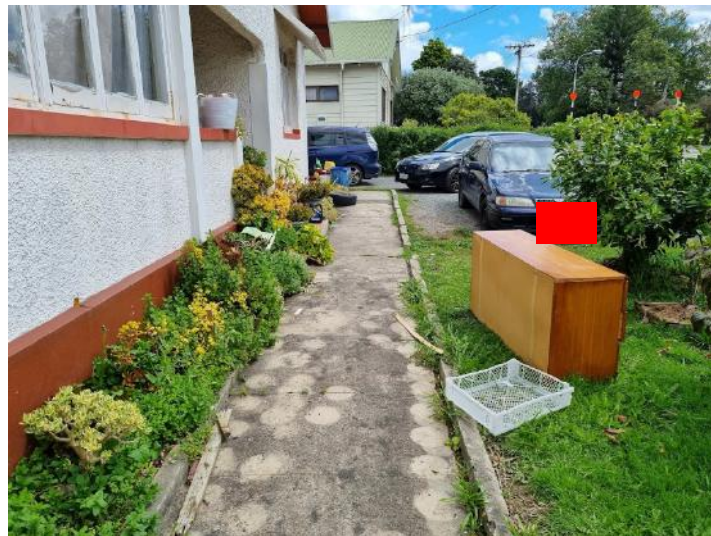
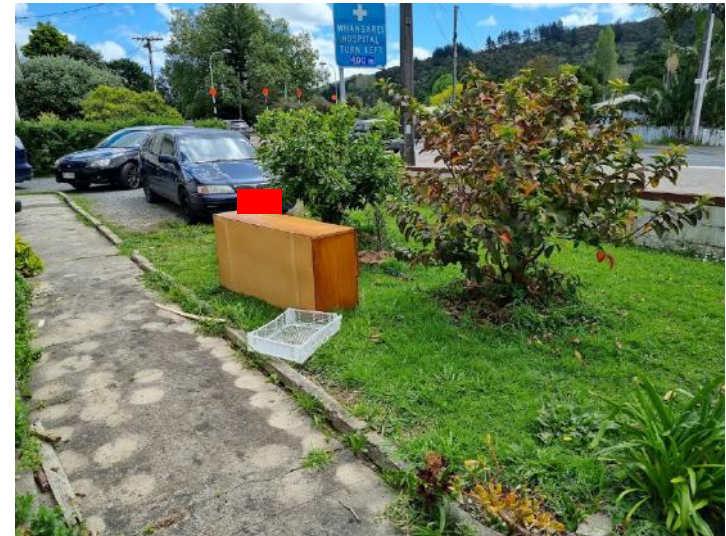
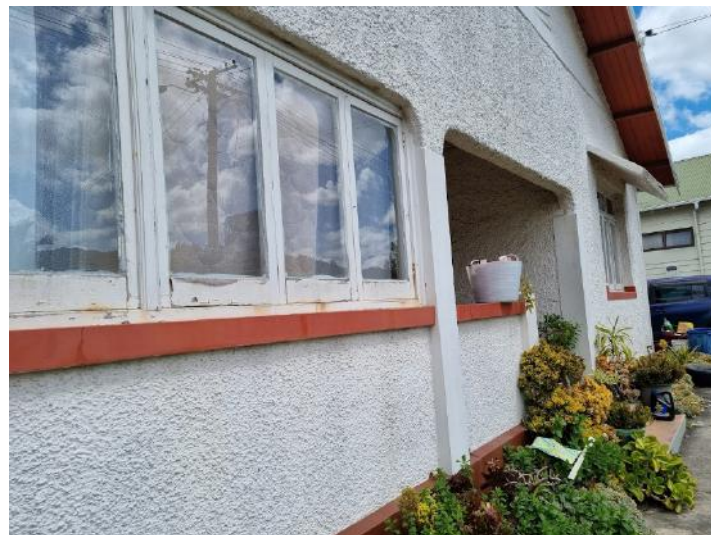
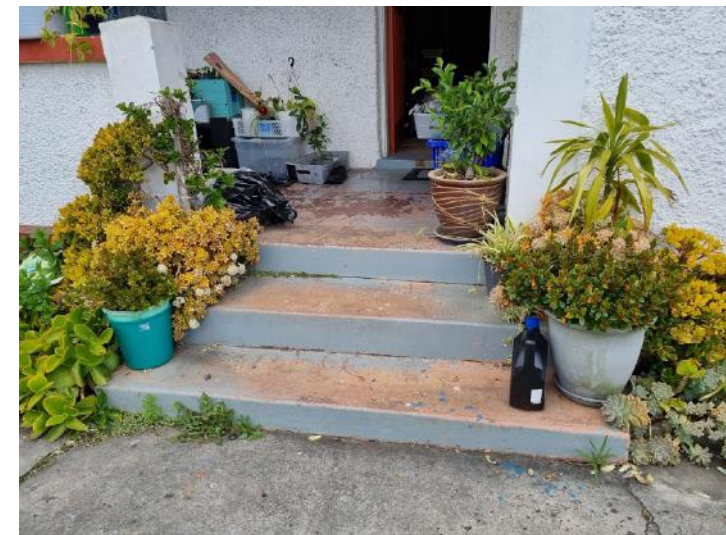
No access at the time to examine underfloor.

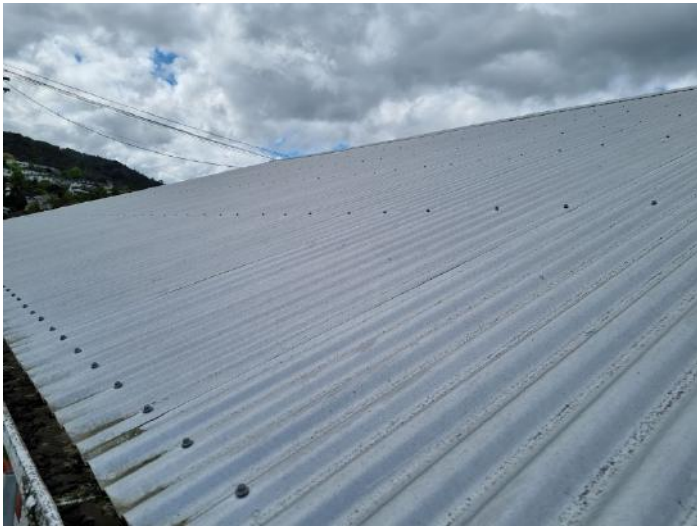
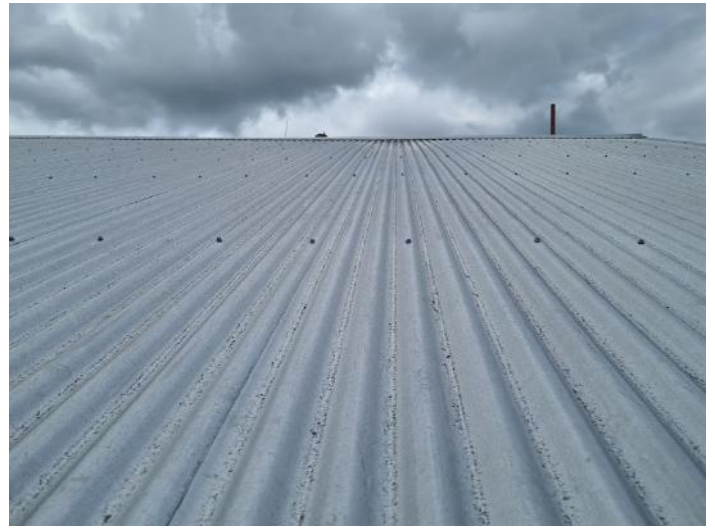
Could only examine the west and south side of the roof

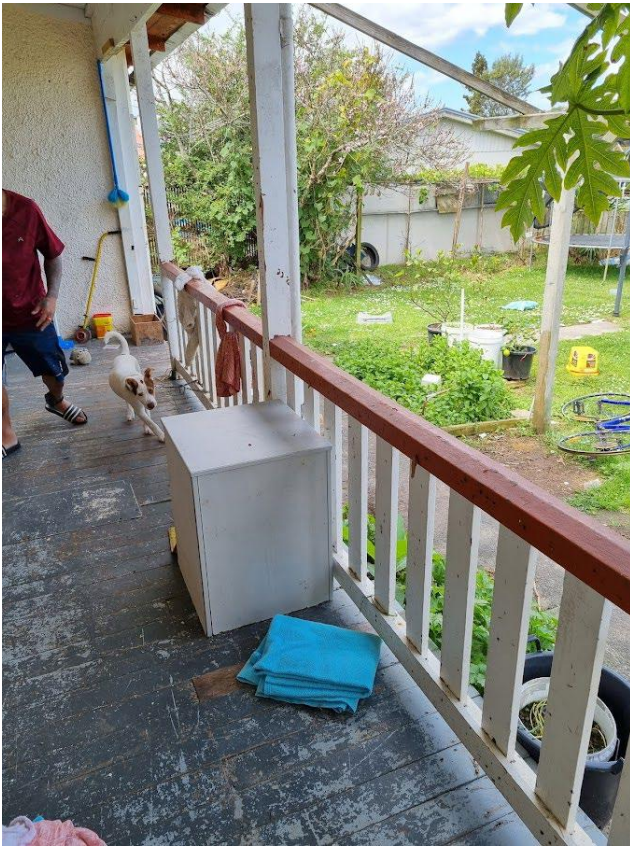
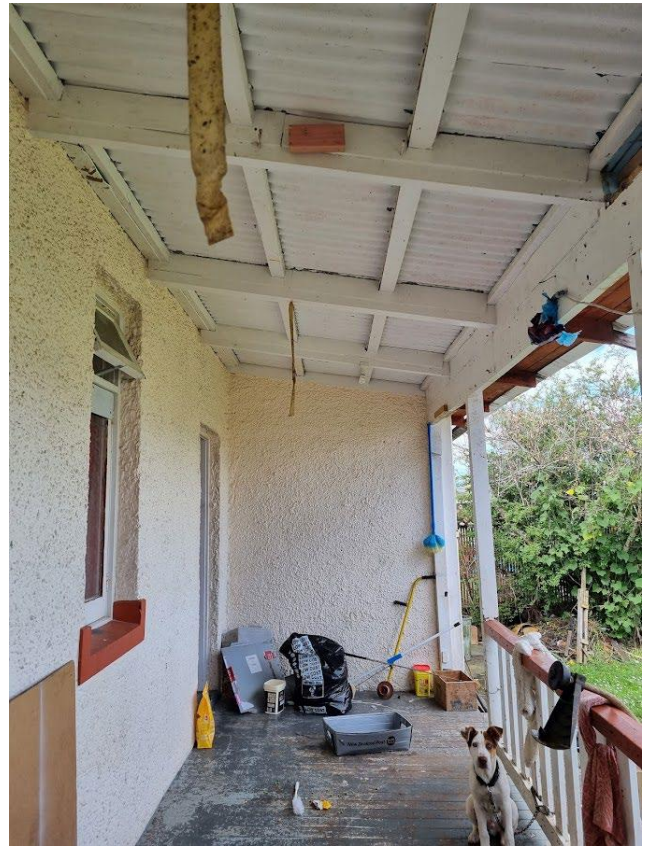
Wooden exterior joinery requires maintenance such as painting etc.  
The rear porch could also do with some maintenance, painting etc.
