Building Inspection Report

Client: Paul Sumich
Location: 11 Paranui Valley Road, Tikipunga
Whangarei

Inspection Date: 19/10/21

RE: Building Inspection Report, 11 Paranui Valley Road, Kamo, Whangarei.

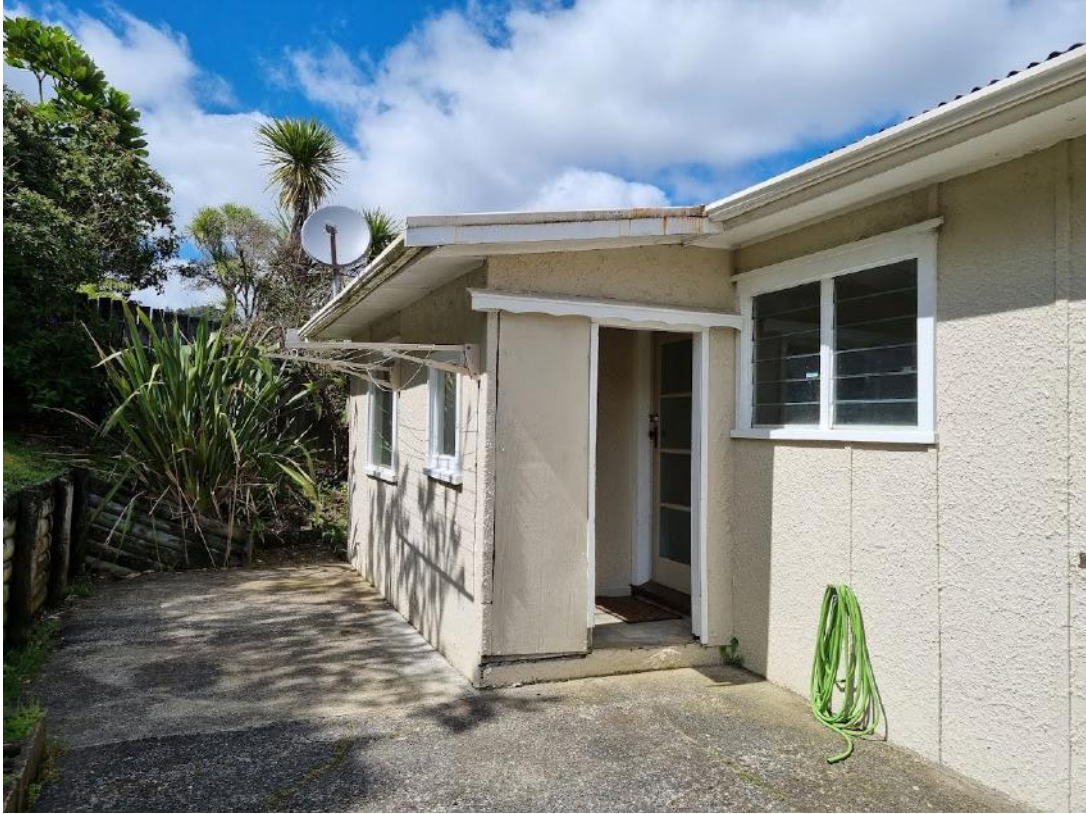
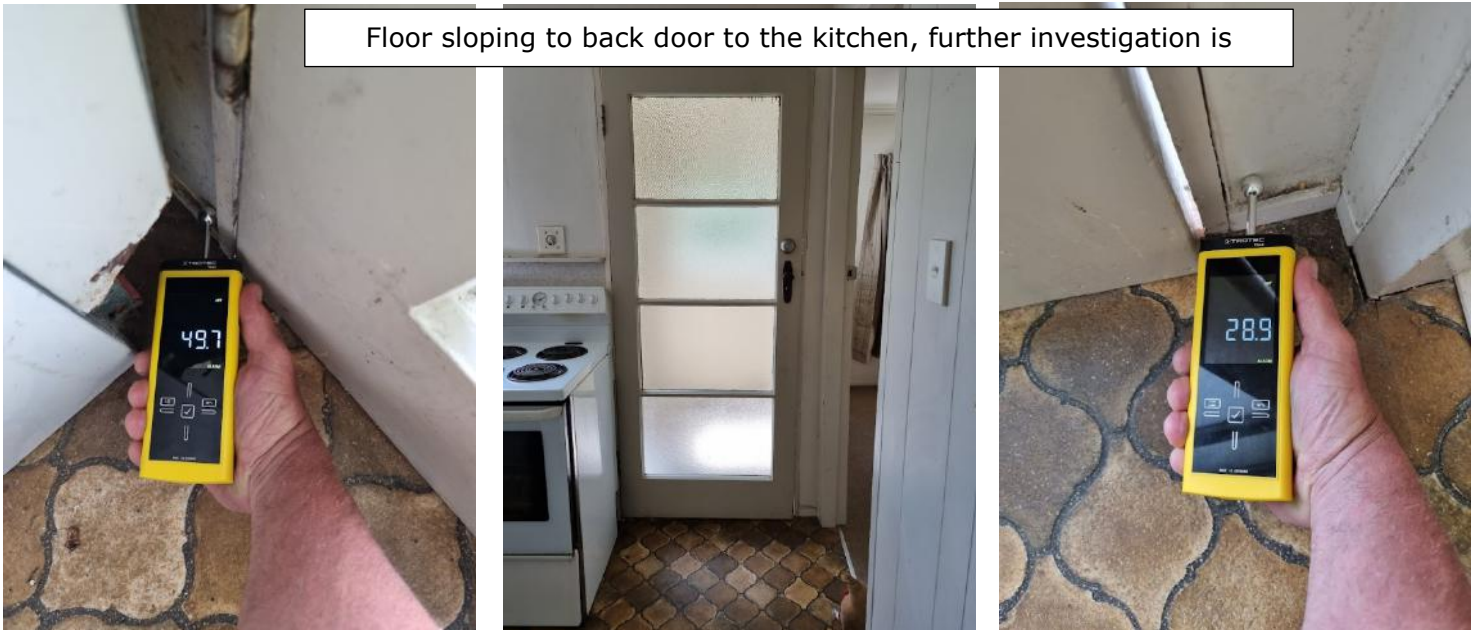
Front Entry – Rear porch entry

Floor sloping to back door to the kitchen, further investigation is

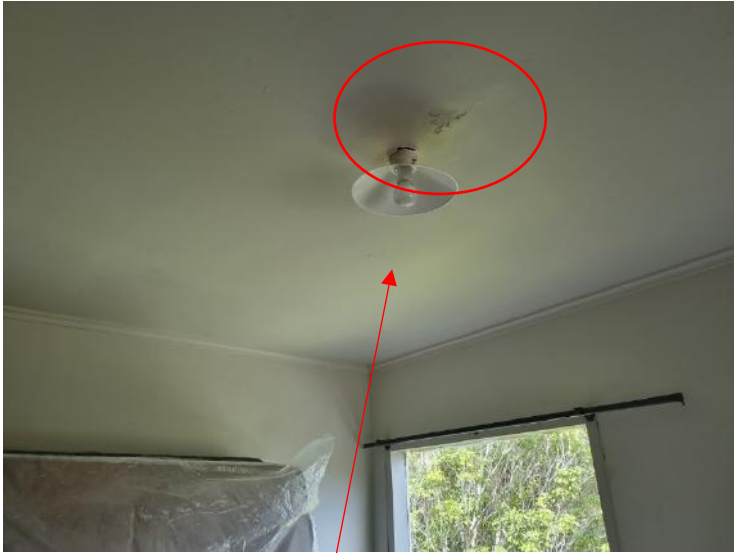
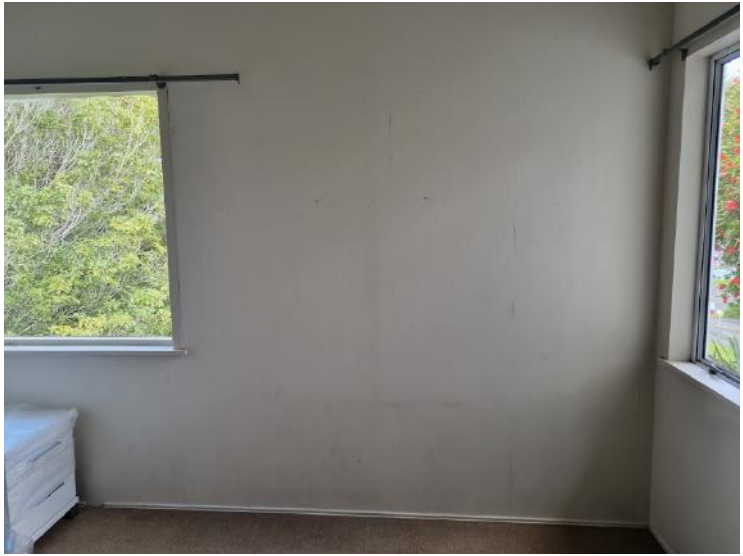
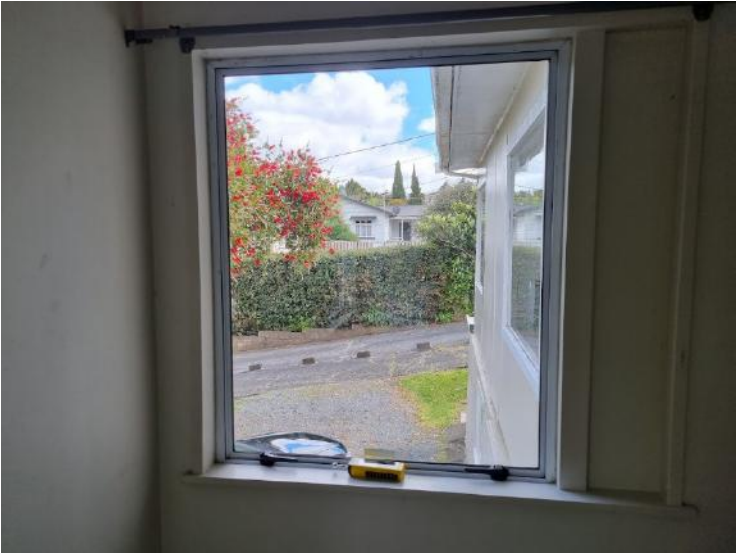
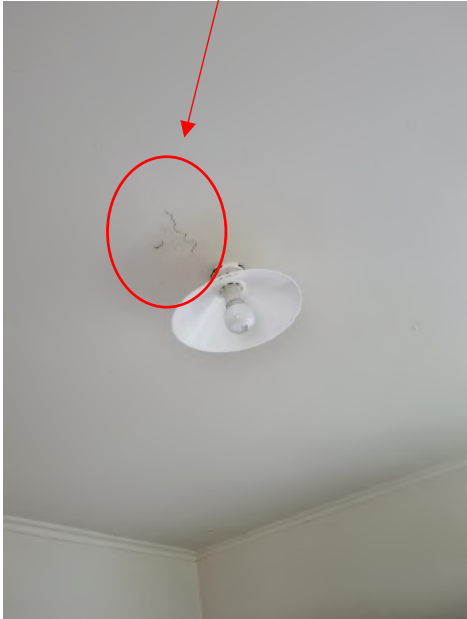
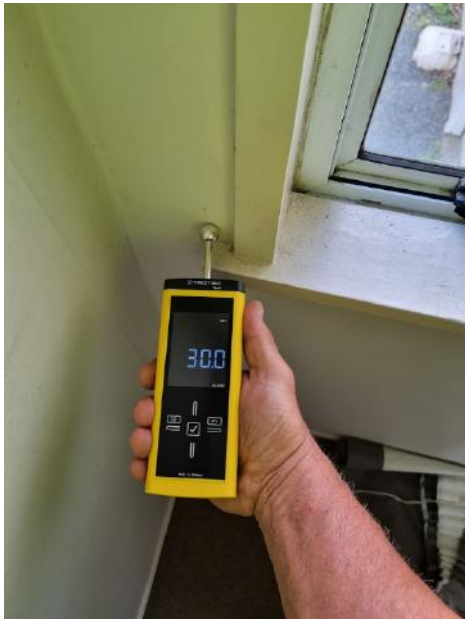
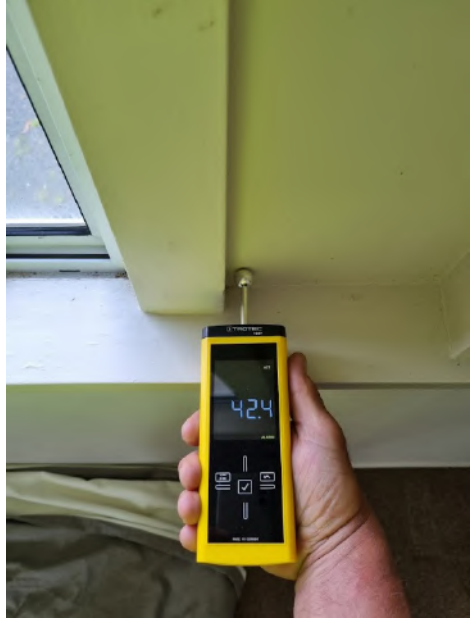
Bedroom 3

Ceiling water damage observed to bedroom 3

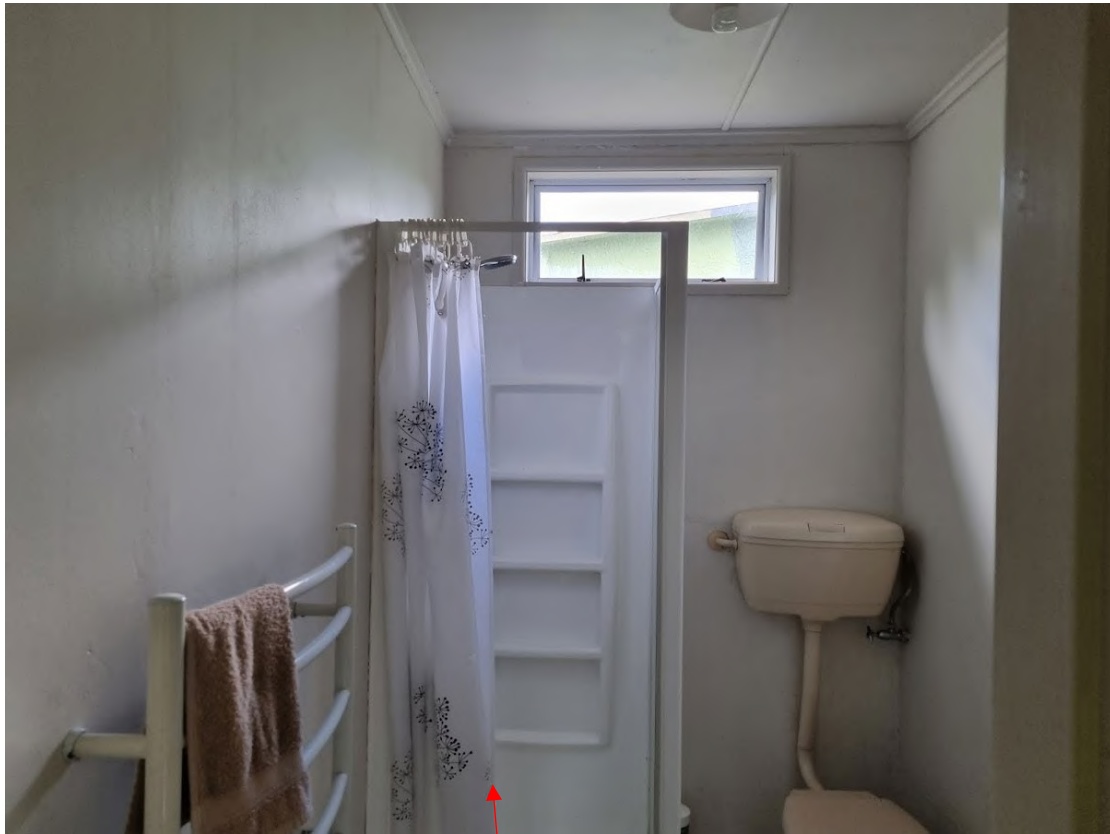
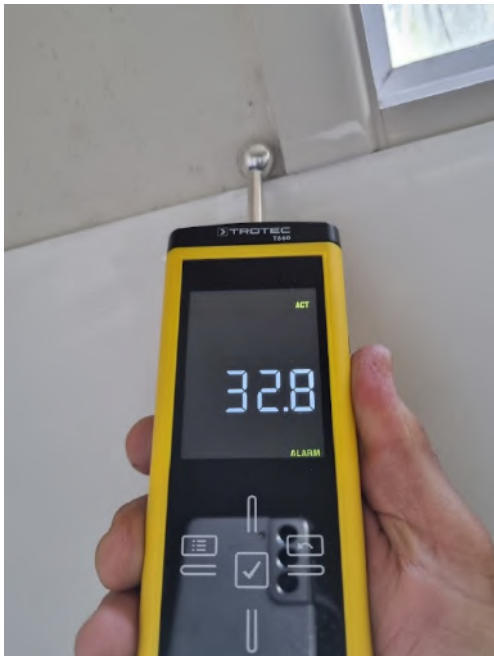
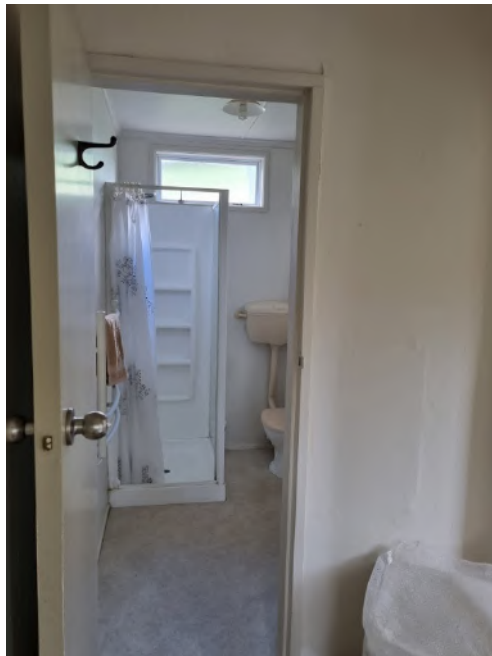
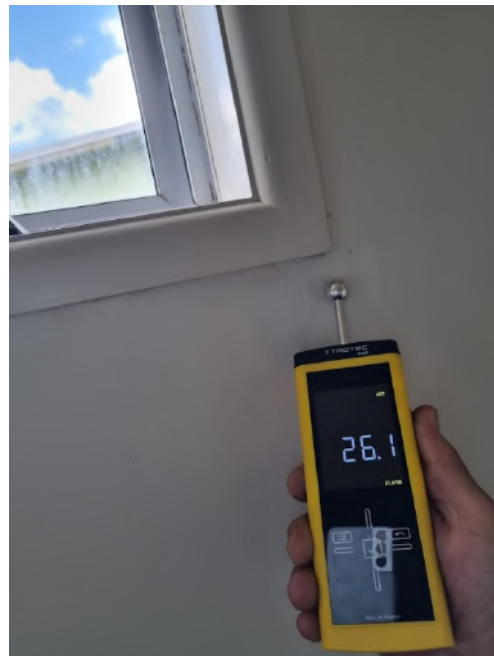
Bathroom

Shower door is missing

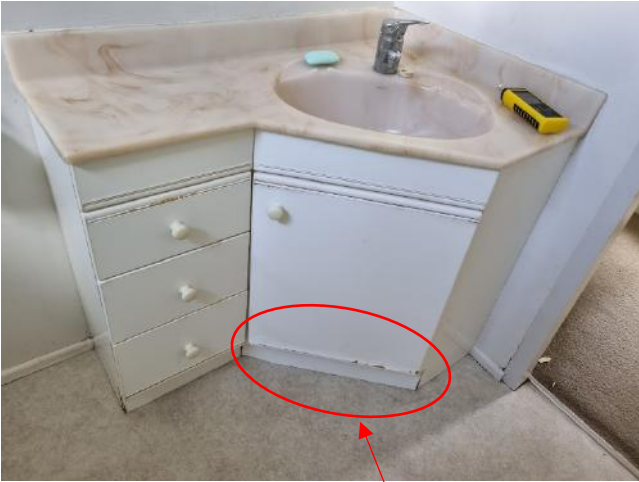
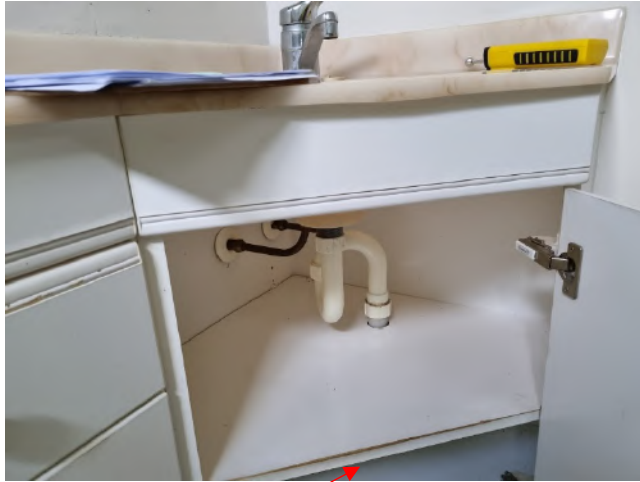
Signs of dampness to ceiling in bathroom

Water damage to vanity cabinetry

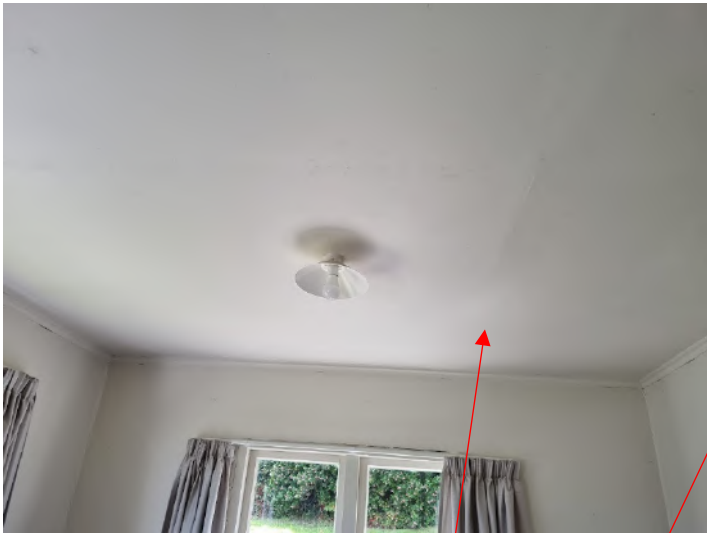
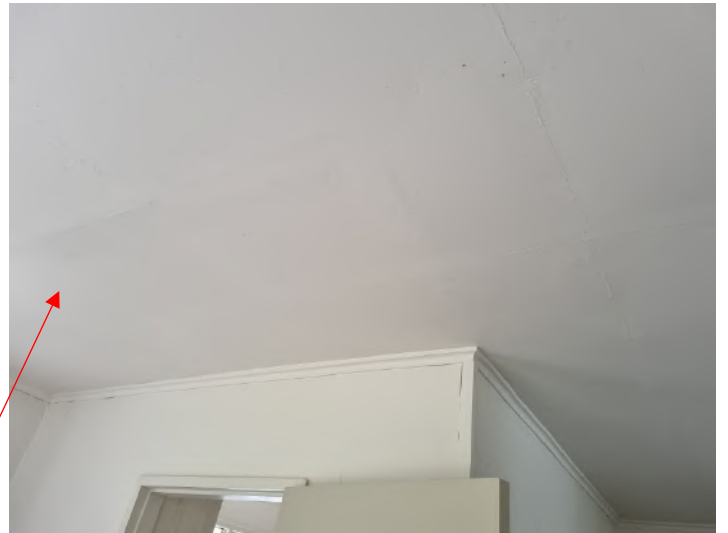
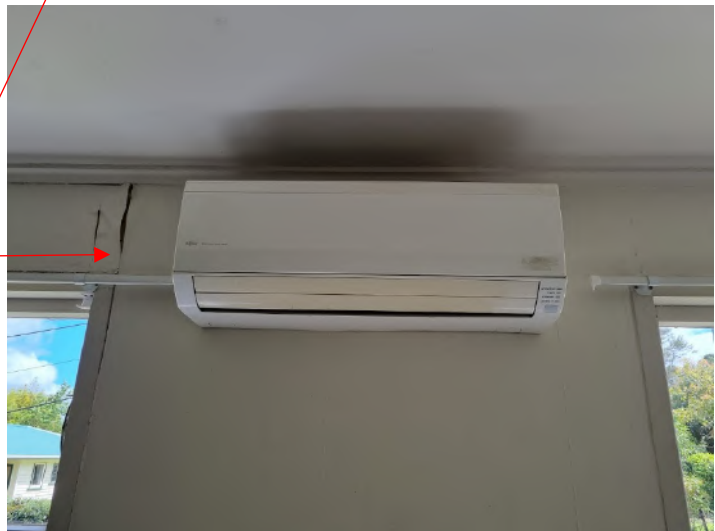
Possible signs of past water ingress in the lounge

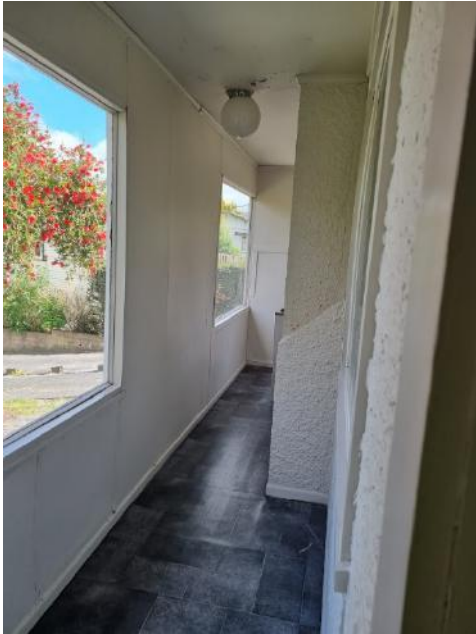
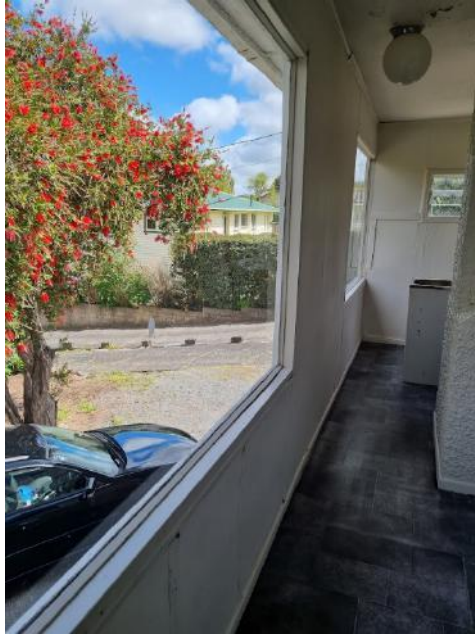
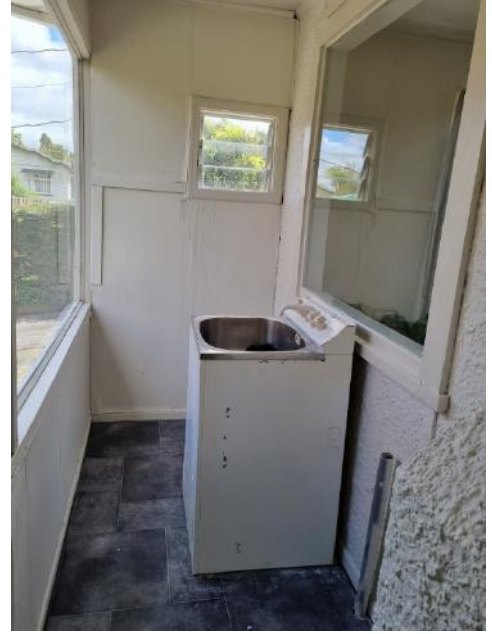
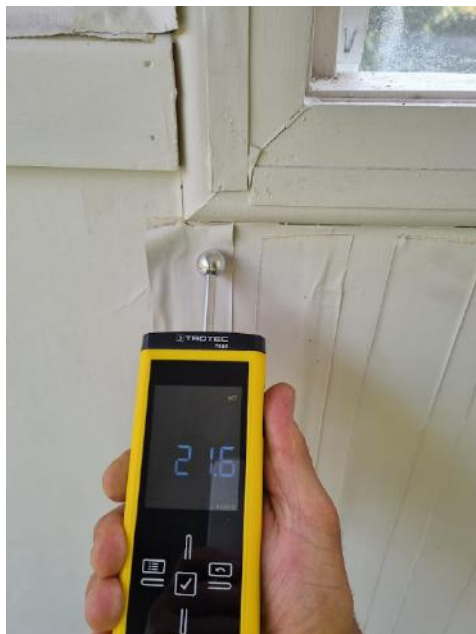
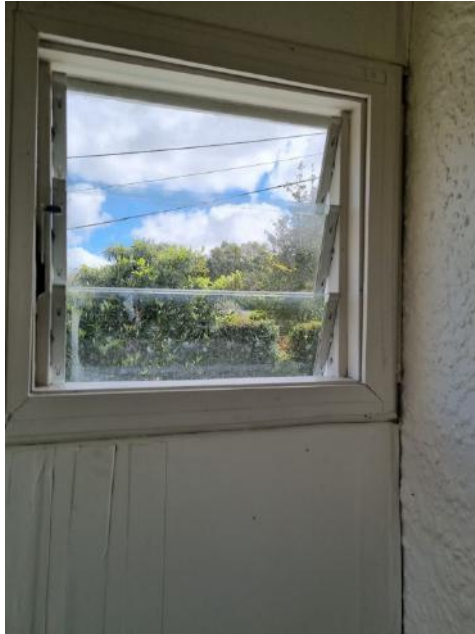
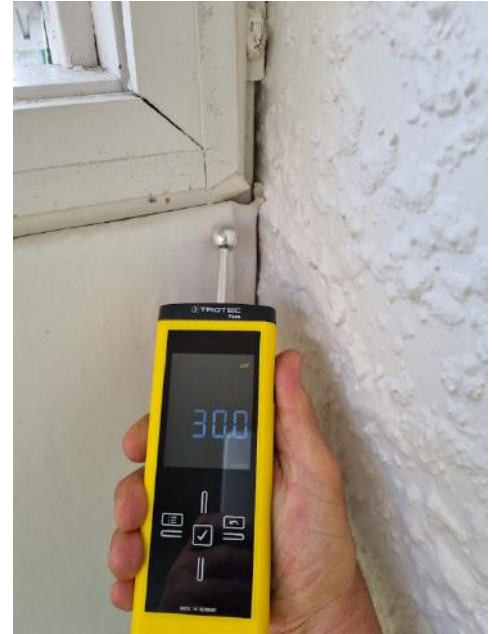
Laundry

Obvious signs of some DIY repair work – further investigation

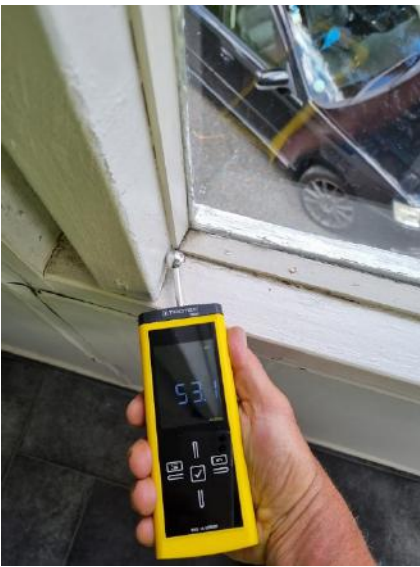
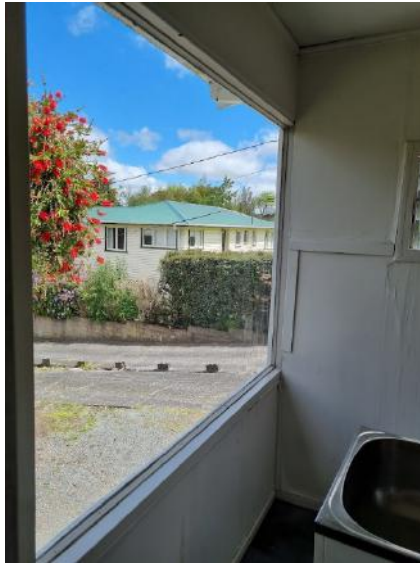
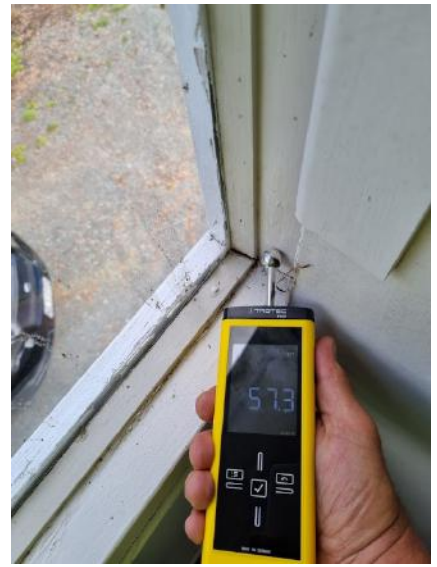
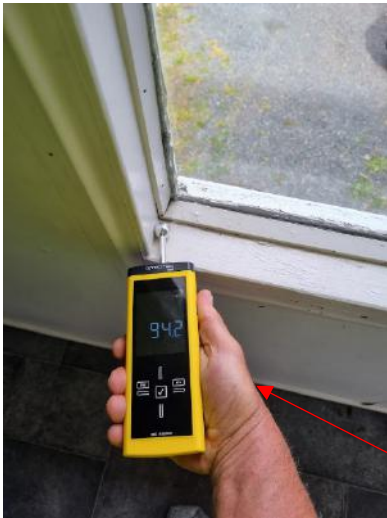
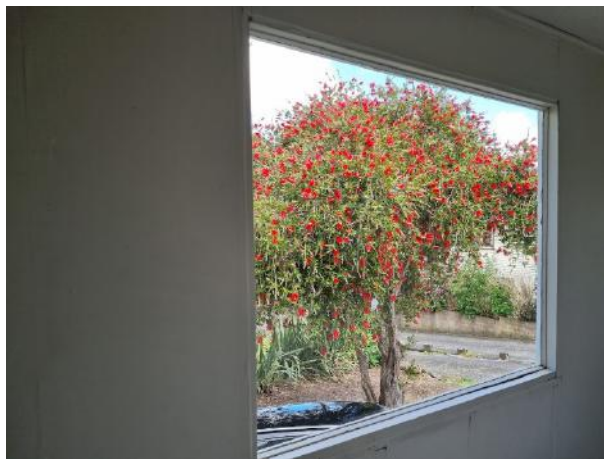
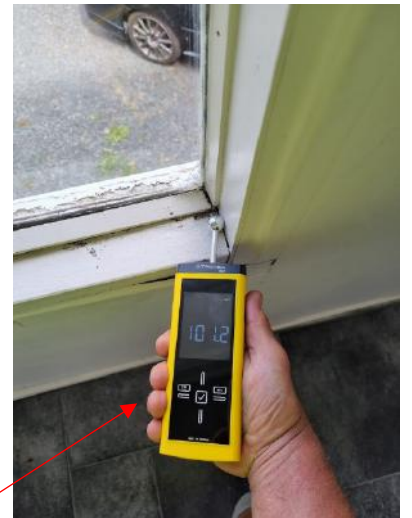
Moisture meter reading higher than 80 shows at risk for wet material, further investigation is required

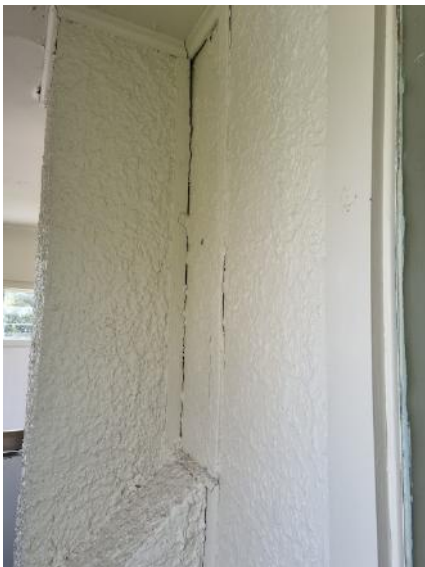
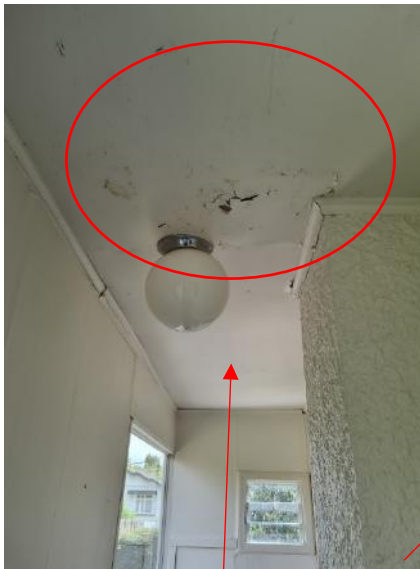
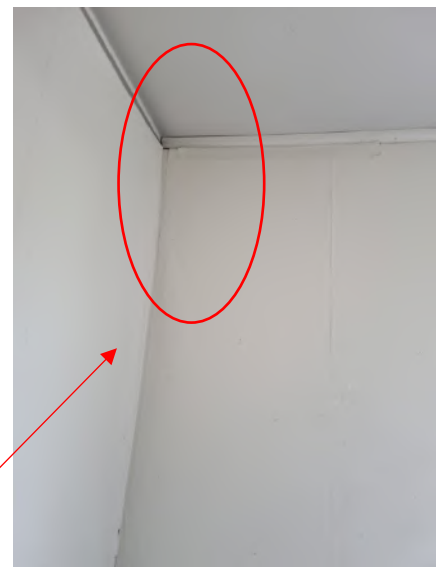
Ceiling water damage to laundry

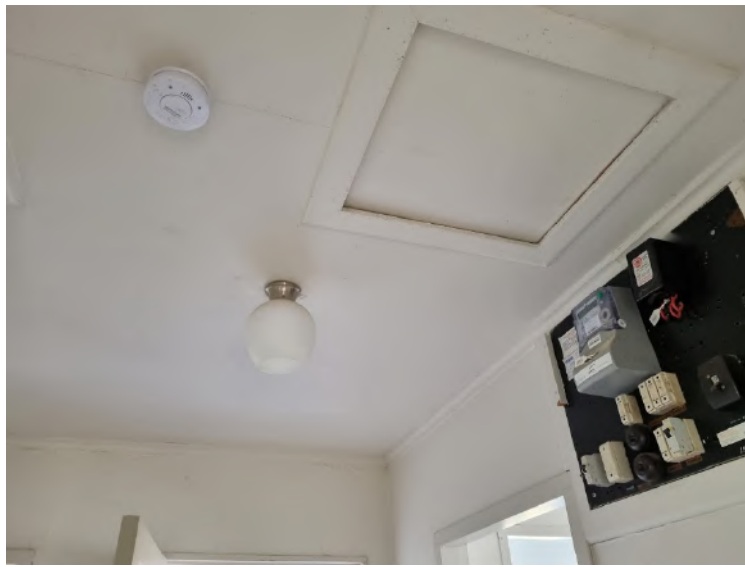
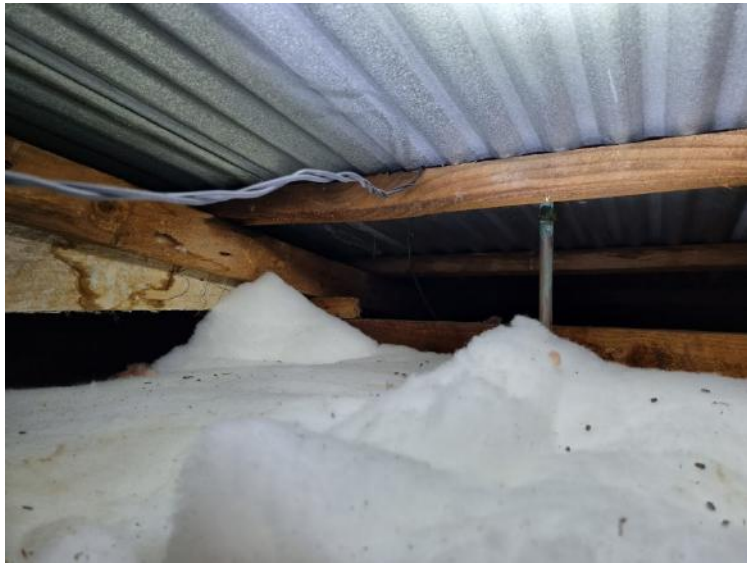
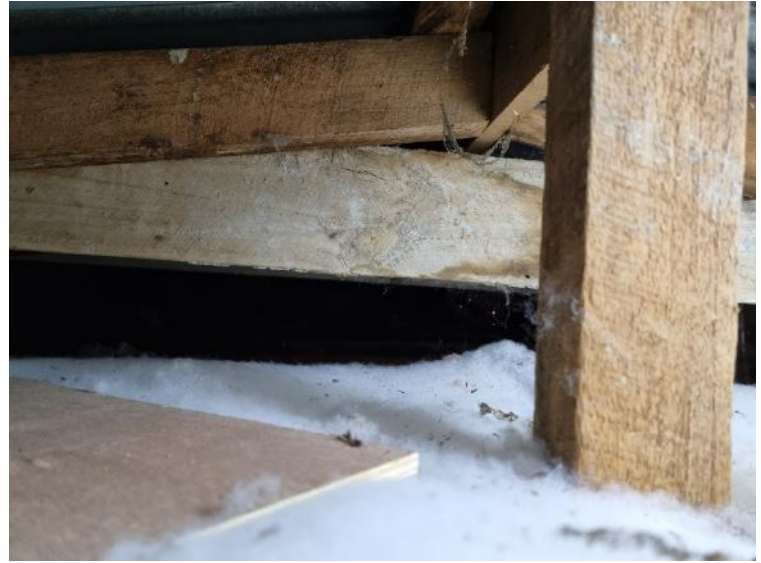
Ceiling

New insulation to only part of the ceiling as very narrow and they possible couldn't get the rest so the original insulation is still installed in places

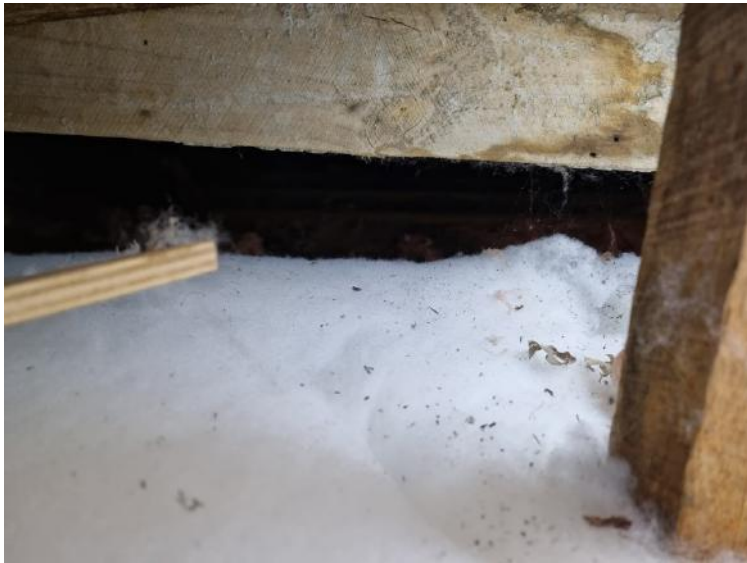
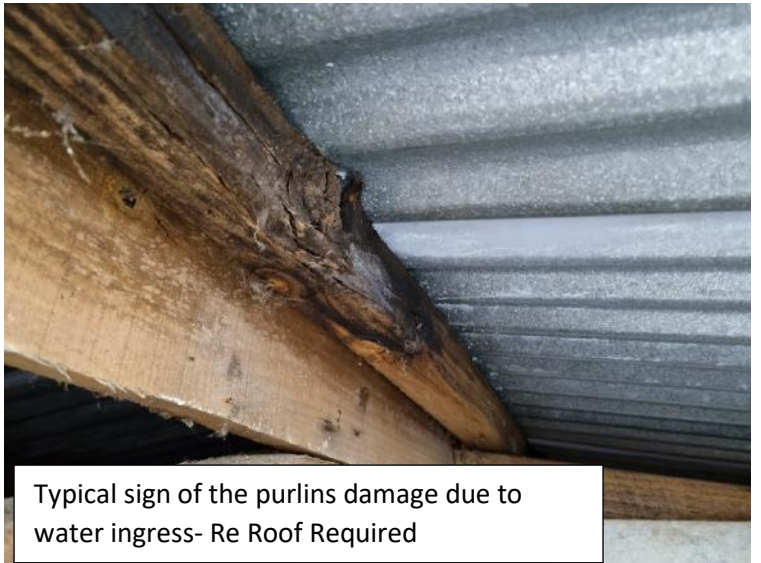
Typical sign of the purlins damage due to water ingress- Re Roof Required

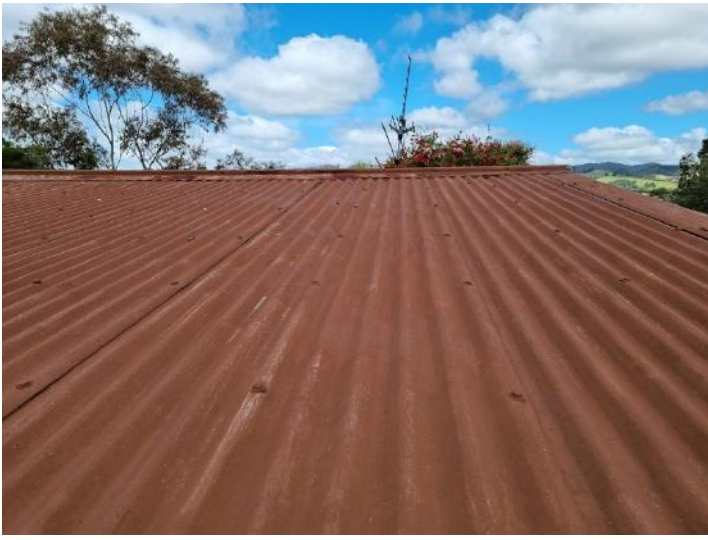
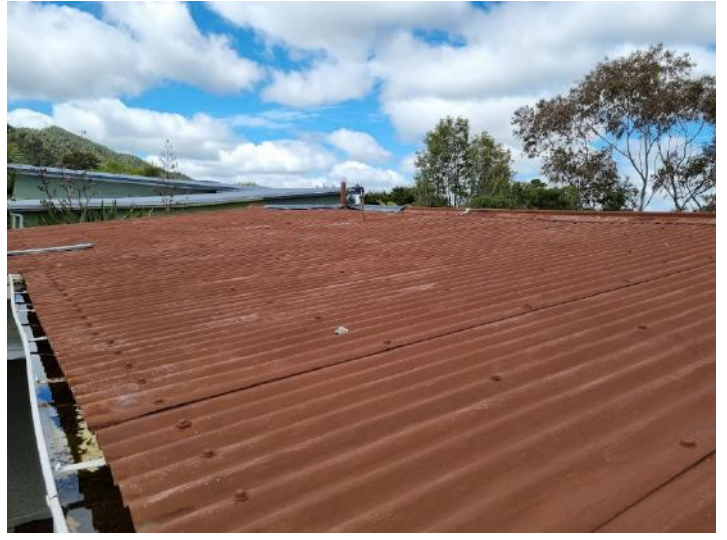
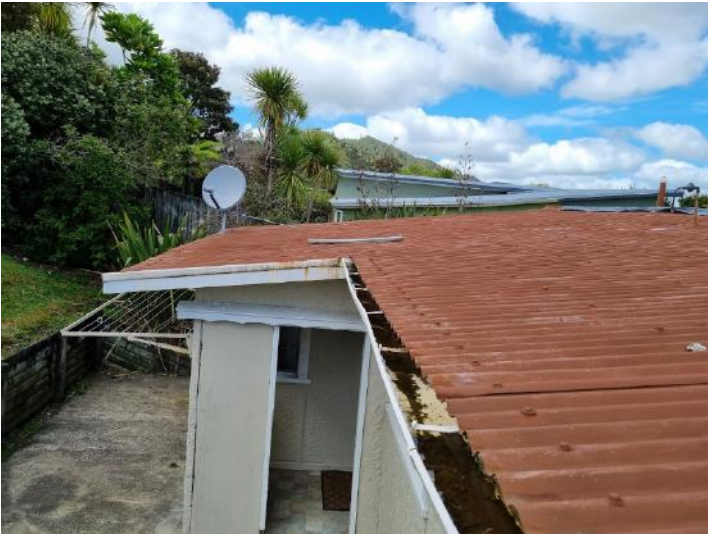
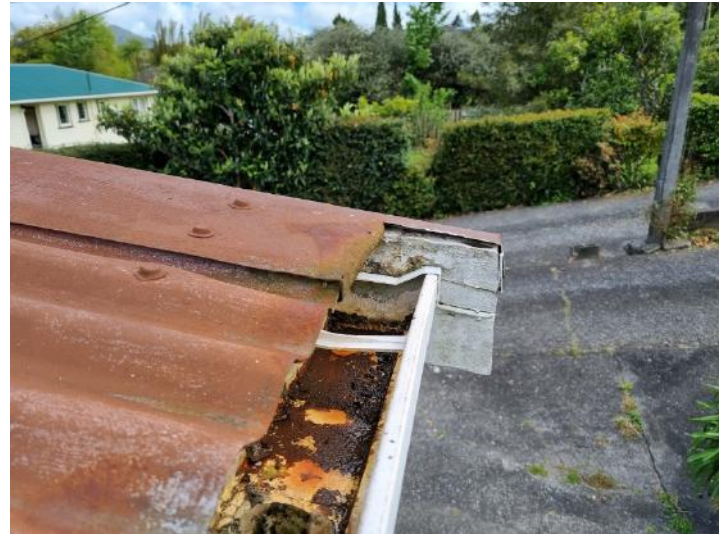
Requires new roofing iron and ridge capping is rotten

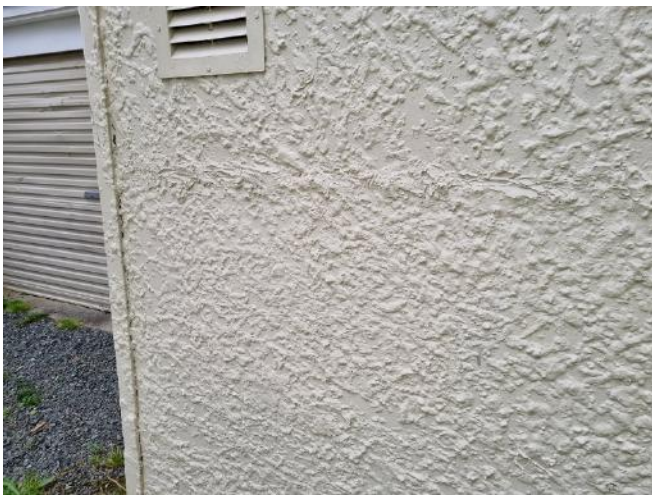
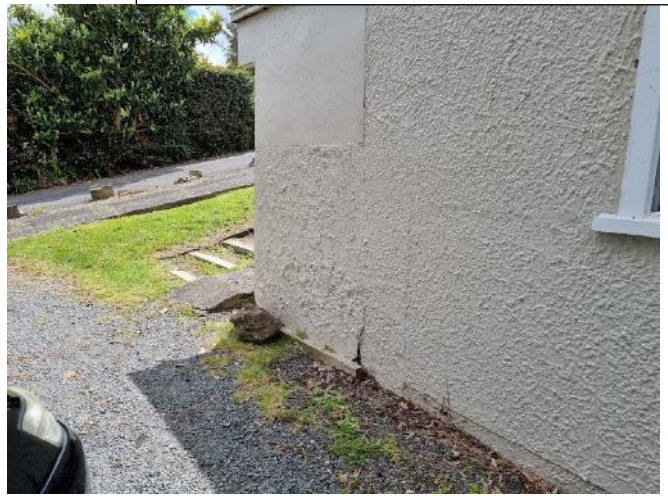
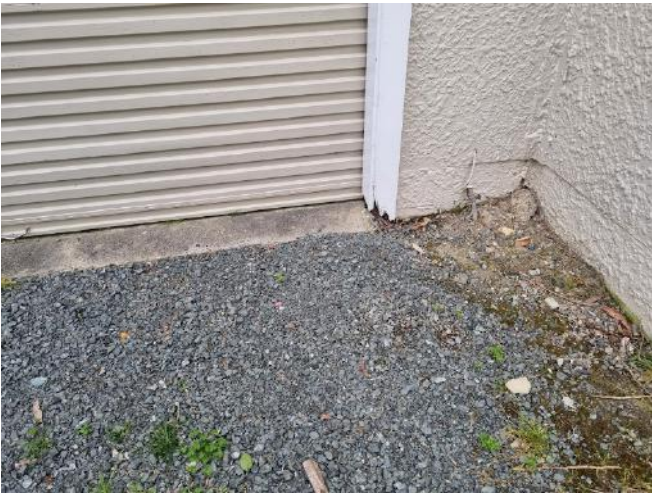
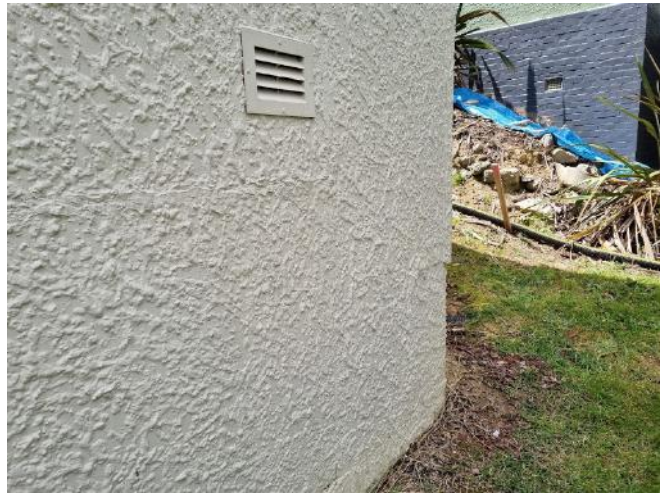
Hole on cladding vulnerable to water ingress

Requires a cladding plasterer specialist to check over the cladding – requires/recommend a reclad as there are holes allowing water ingress, Asbestos warning with cladding as there is fibrolite present, take precaution and use PPE.
