Building Inspection Report

Client: Paul Sumich
Location: 11 Pukemiro Road, Kamo
Whangarei

Inspection Date: 21/10/2021

RE: Building Inspection Report, 11 Pukemiro Road, Kamo, Whangarei.

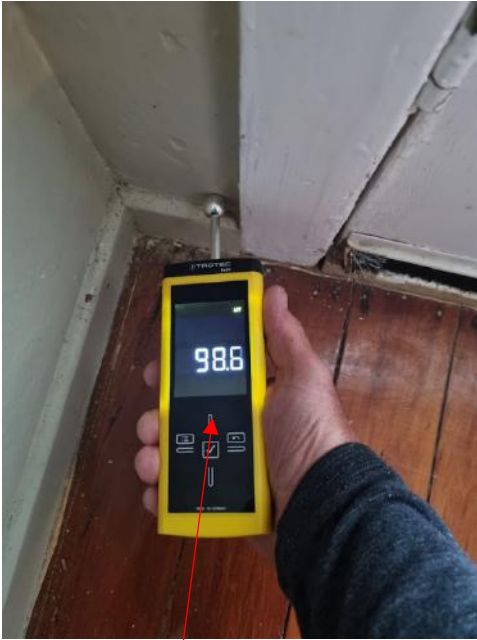
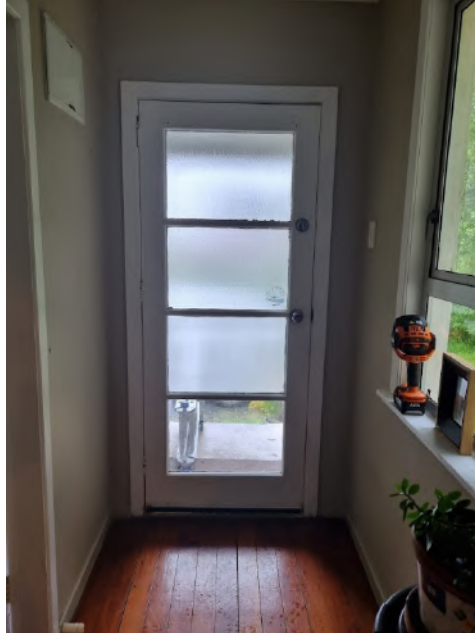
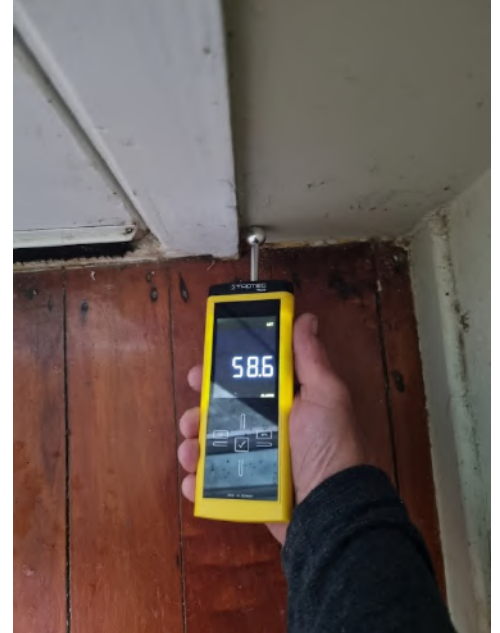
Front Entry

General wear and tear to interior throughout dwelling

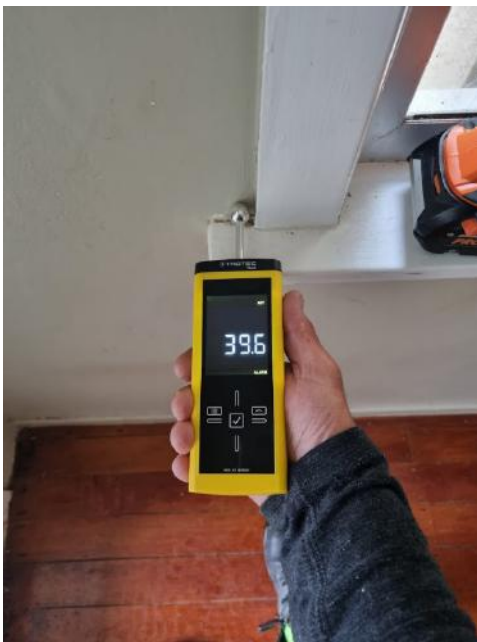
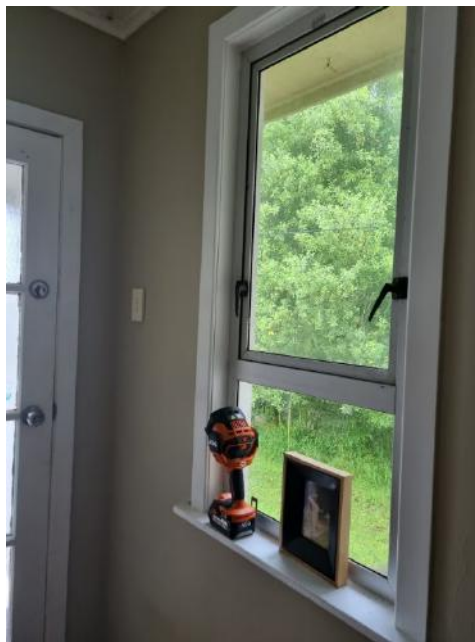
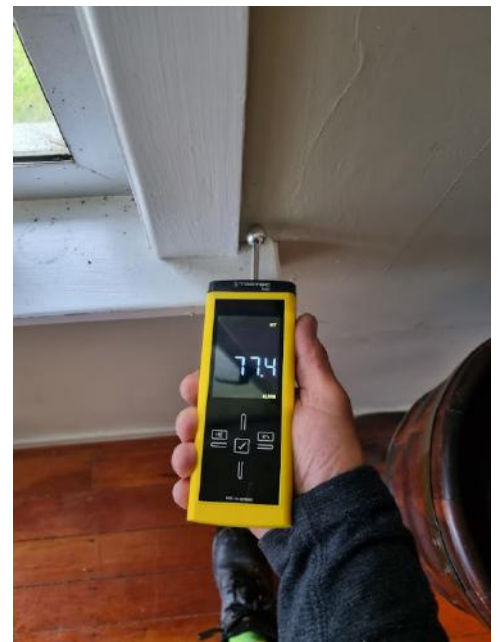
- General wear and tear to interior throughout dwelling
- Front entry - Moisture meter reading is higher than 80, this indicates there is wet materials at risk – further investigation is required

Moisture meter reading is higher than 80, this indicates there is wet materials at risk – further investigation is required

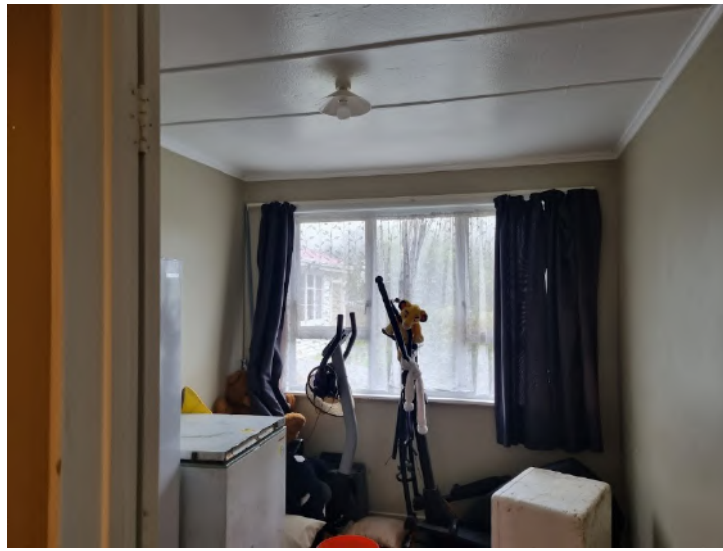
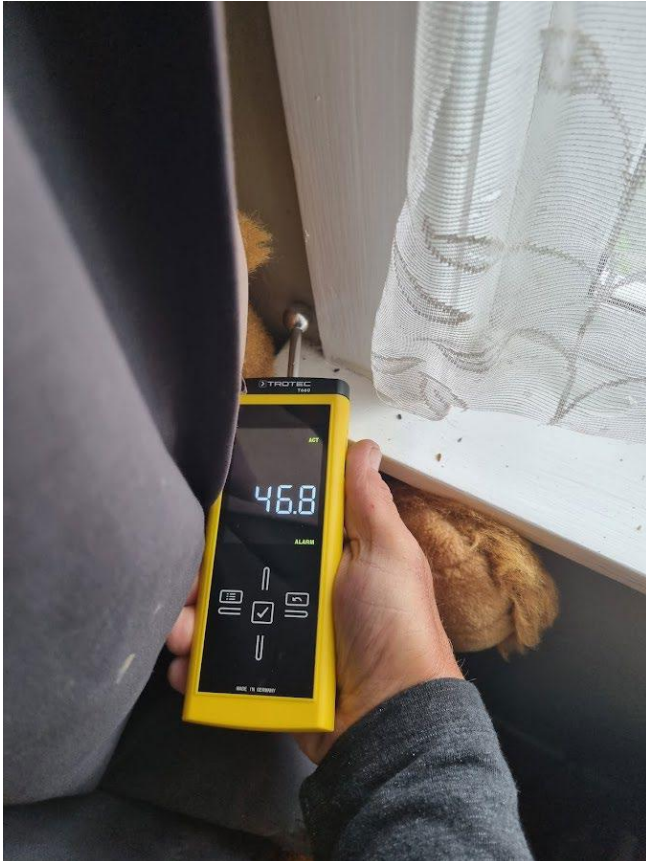
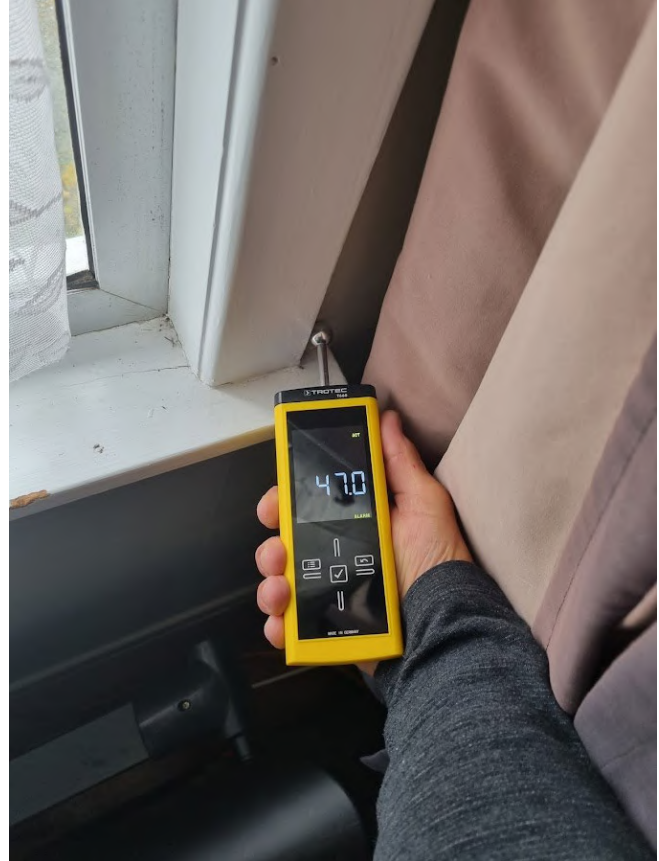
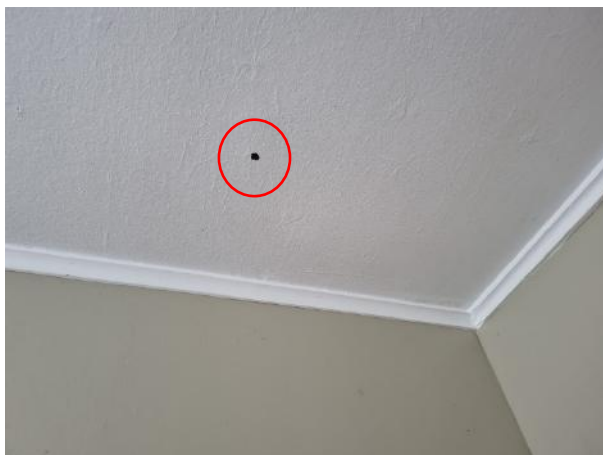
Bedroom 2

- Small hole in the ceiling of bedroom 2, this could possibly be the result of previous water ingress
- Laundry - Moisture meter reading is higher than 80, this indicates there is wet materials at risk – further investigation is required

Small hole in the ceiling of bedroom 2, this could possibly be caused as a result of water ingress

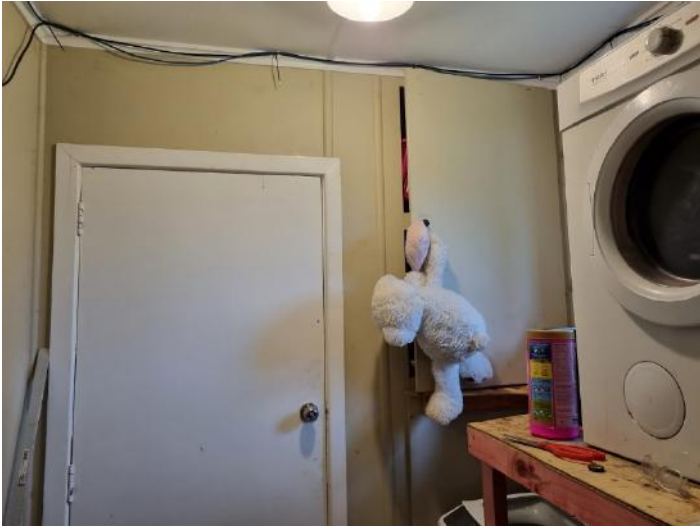
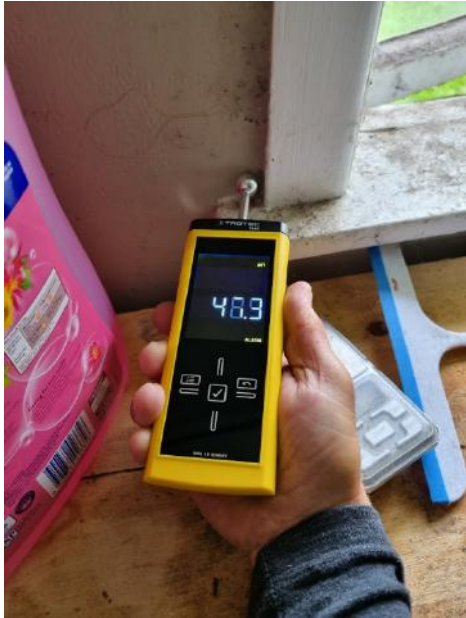
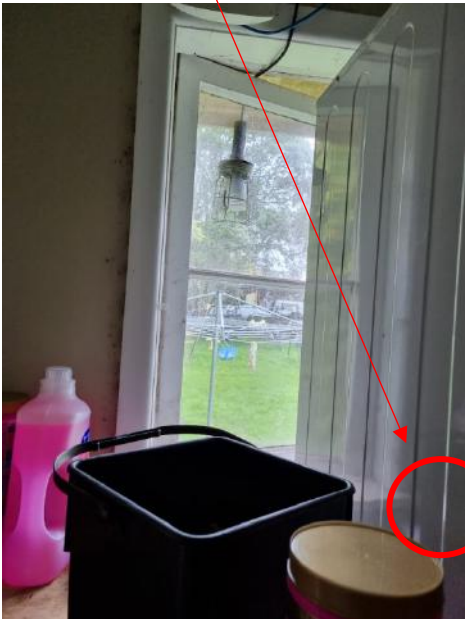
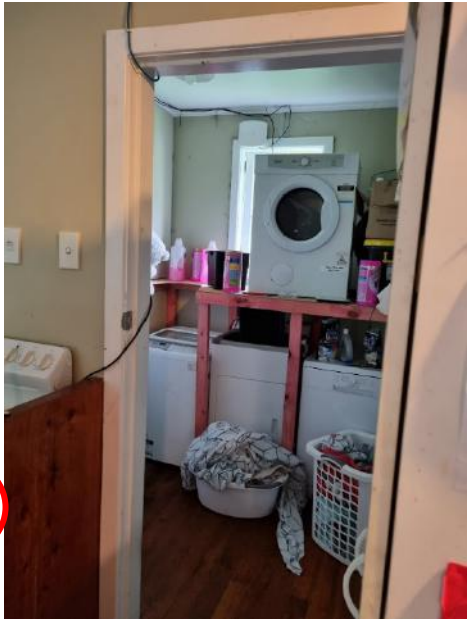
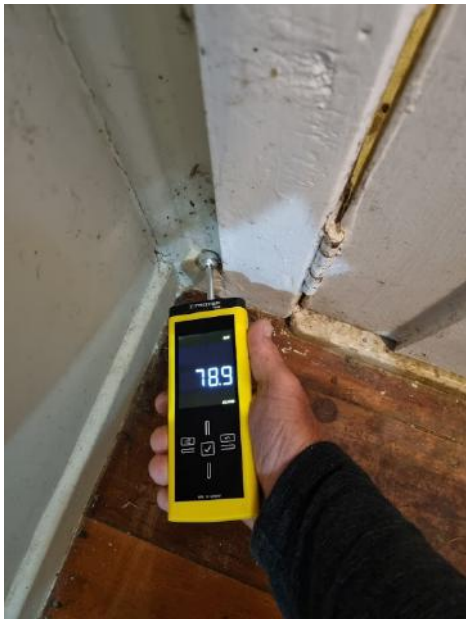
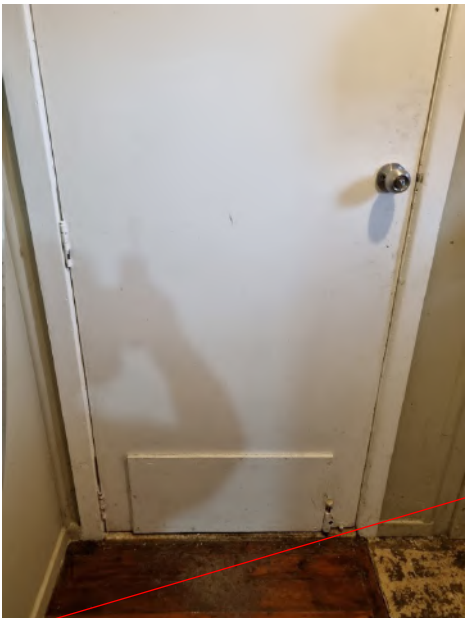
Laundry

Moisture meter reading is higher than 80, this indicates there is wet materials at risk – further investigation is required

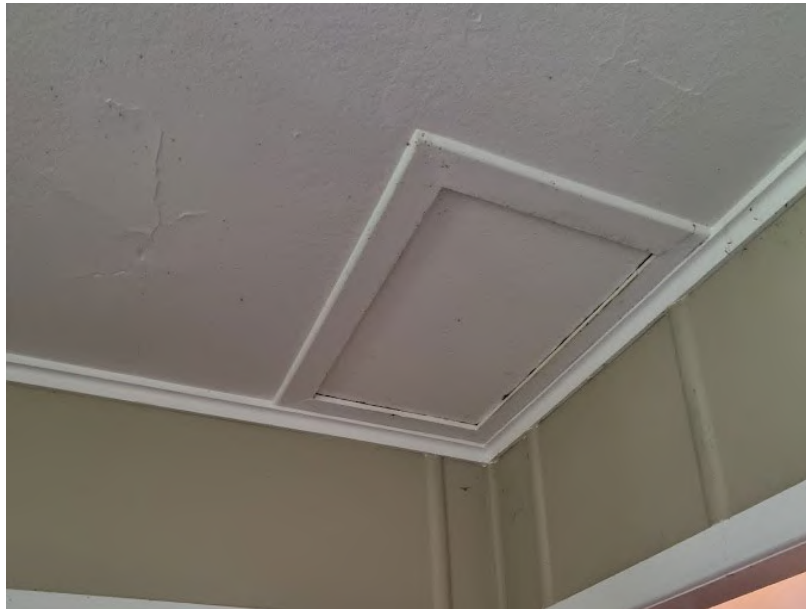
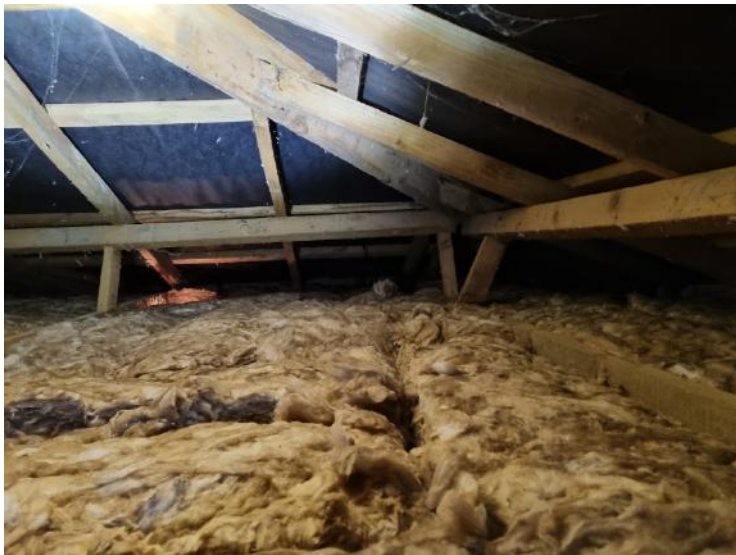
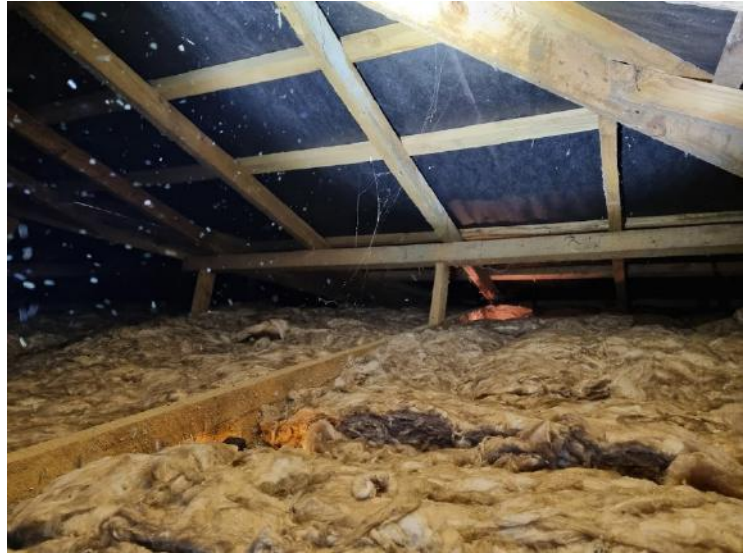
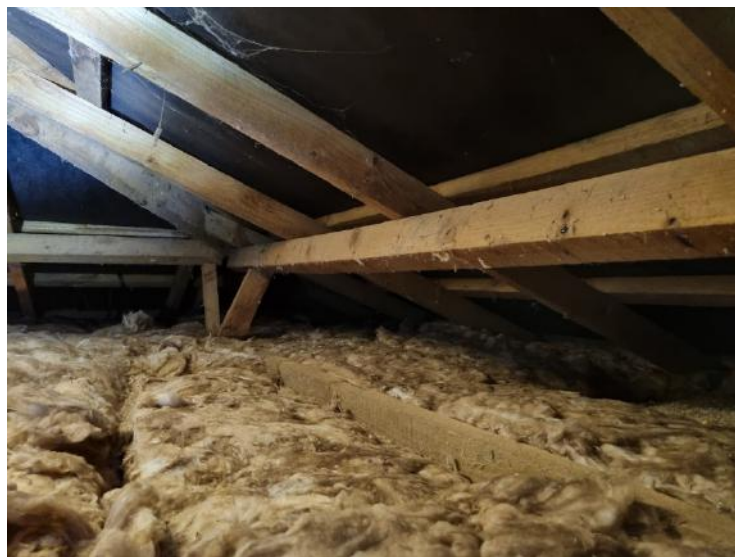
Ceiling

Roof framing appears sound and in reasonable condition

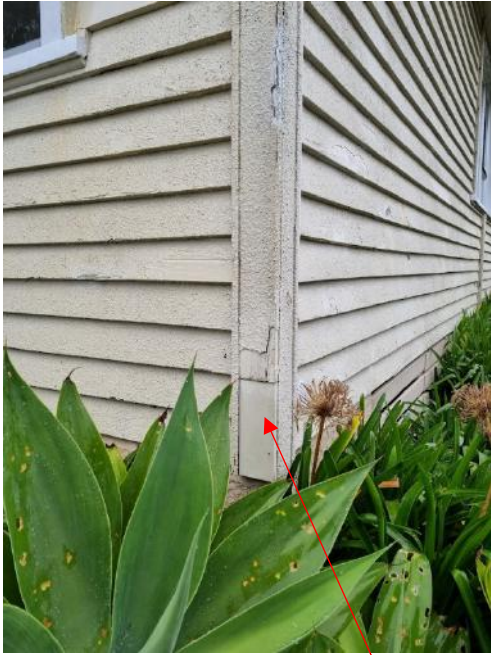
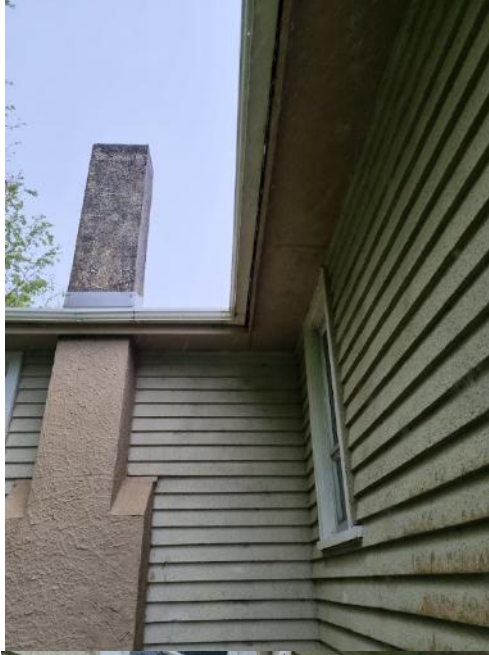
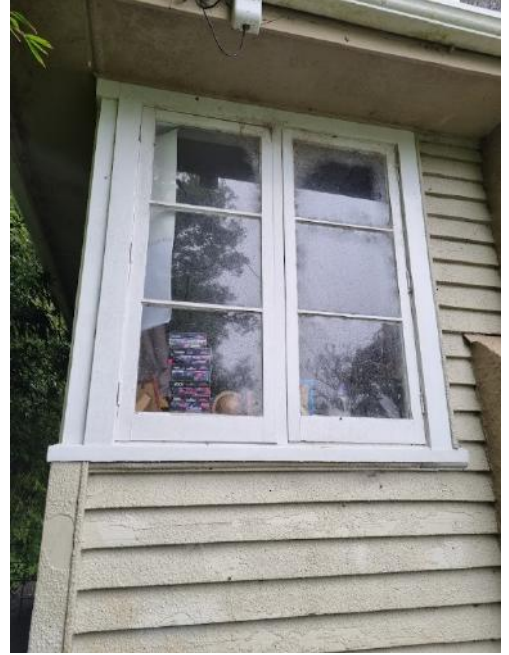
Insufficient clearance along this boundary. Bush needs cutting back.

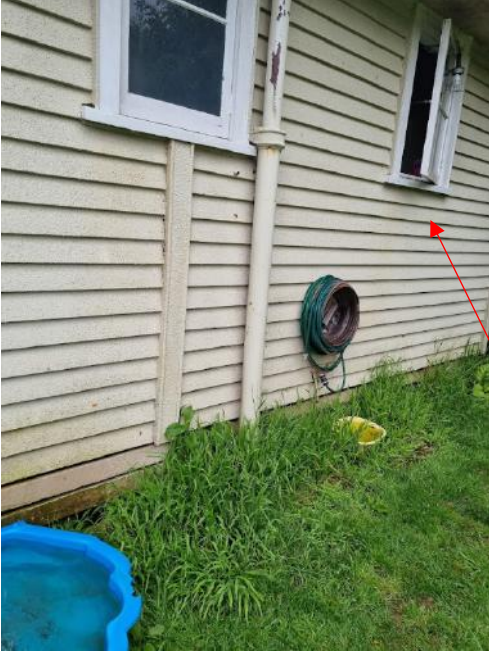
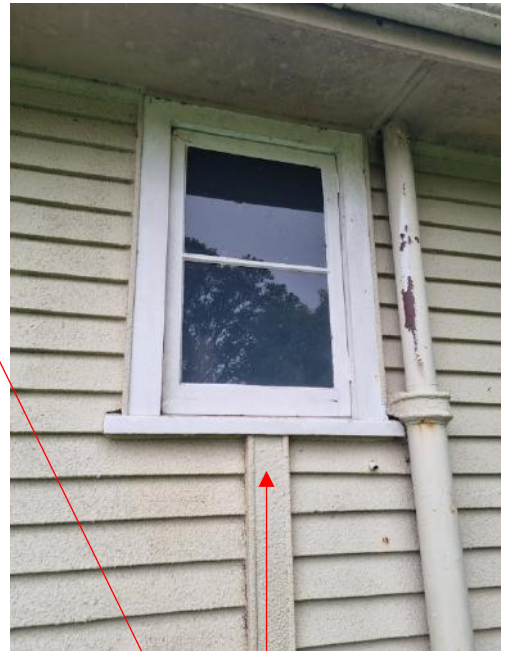
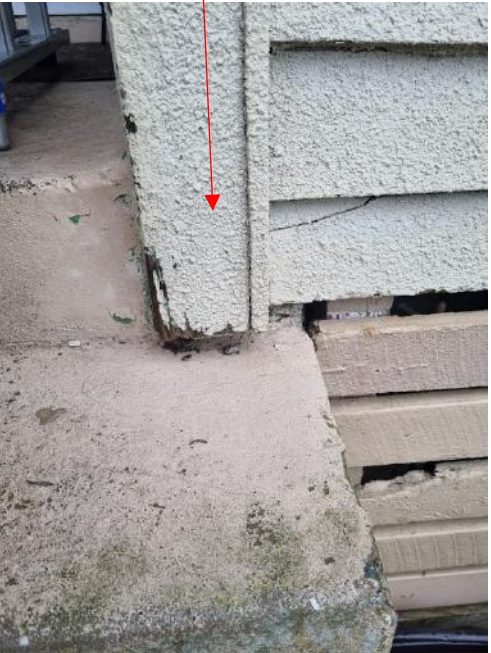
Exterior cladding and facings are showing serious deterioration – recommend some maintenance here or recladding. Paint to weatherboards has completely deteriorated.

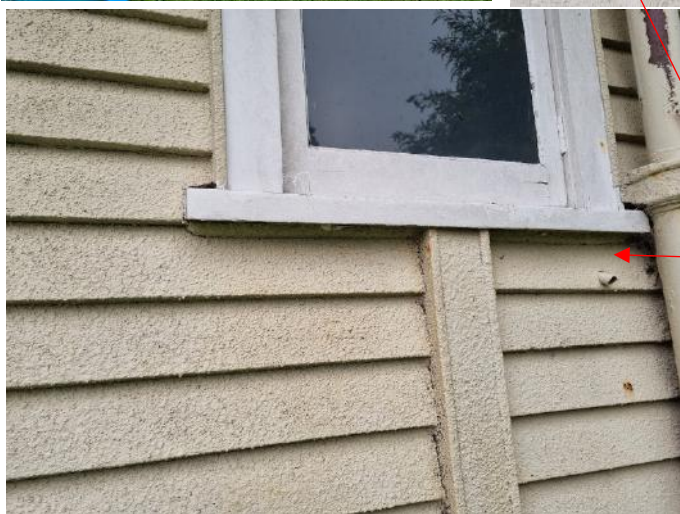
Exterior windowsills to the northwest need maintenance and to check all windows

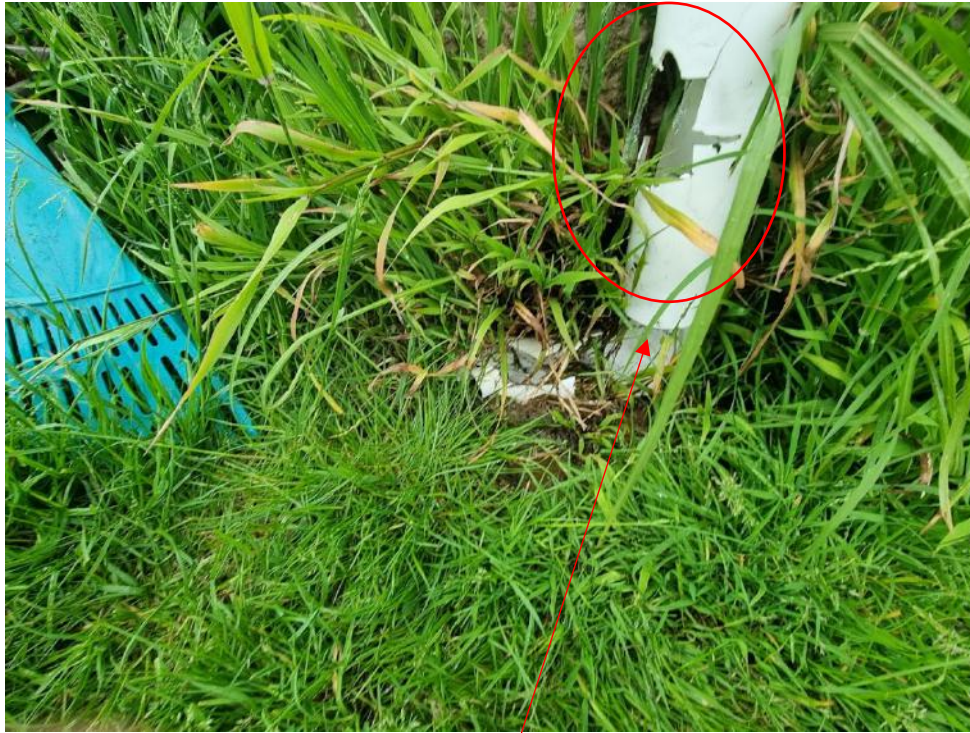
PVC has a hole/tear to rear downpipe, these needs repairing.

Stormwater is not connected to a public line and the roof water drains to the surface of the property which does not comply with current standards.

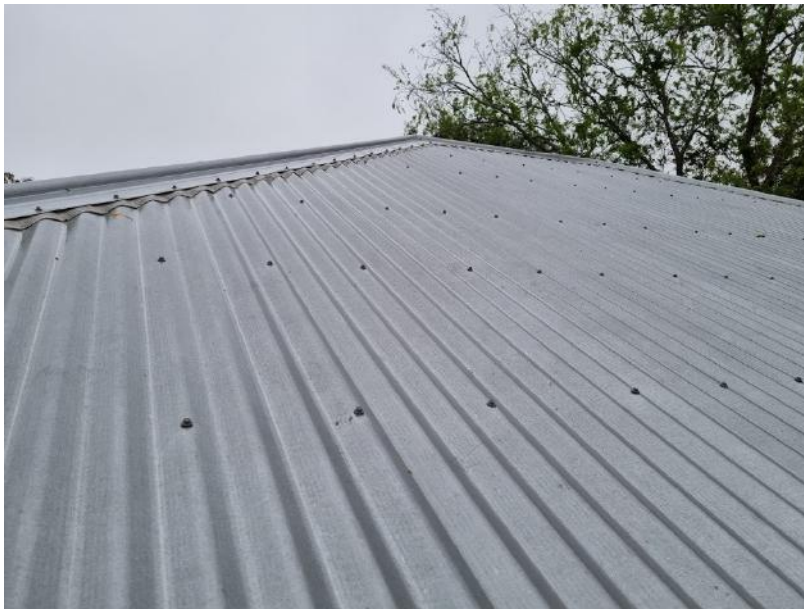
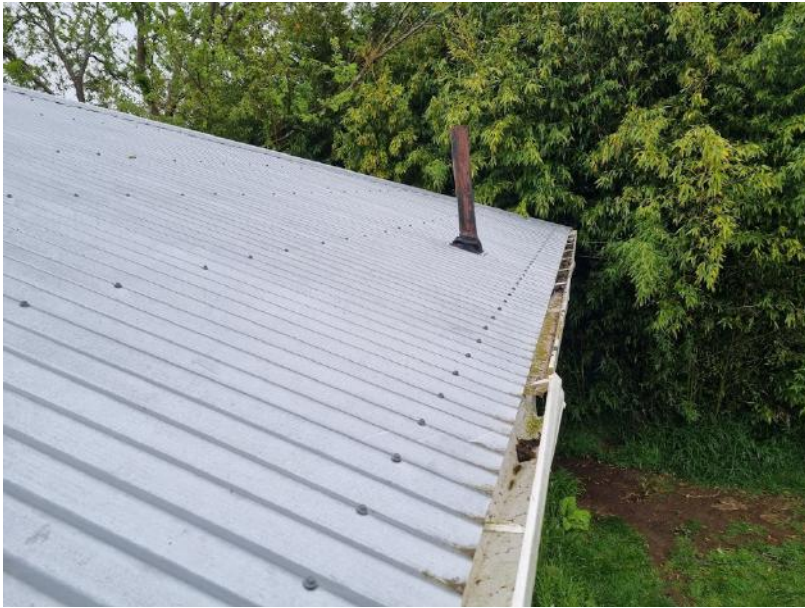
Copper vent pipe has steel at base which requires painting

Roofing Iron is in good condition.

Guttering requires repair/general maintenance

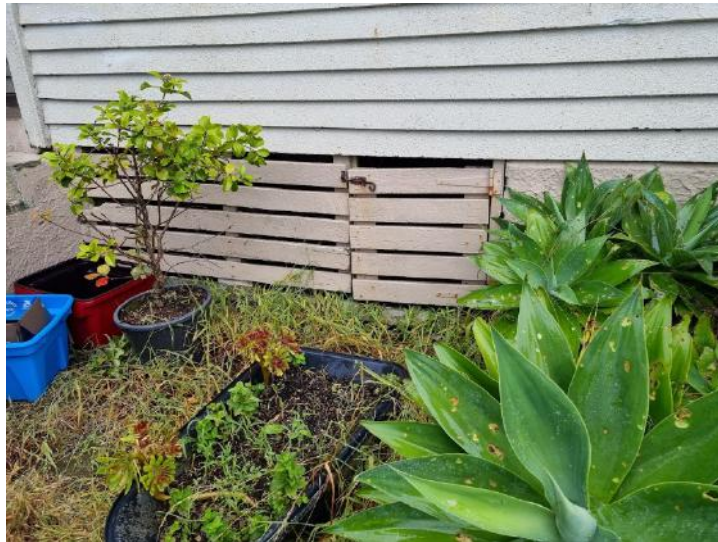
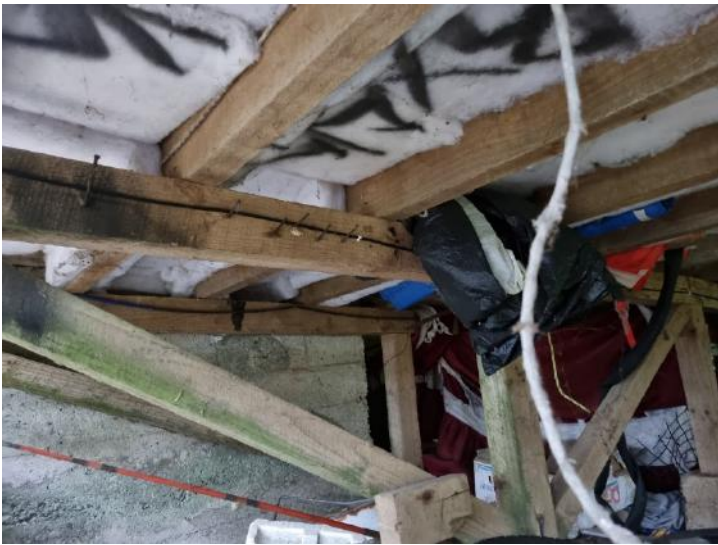
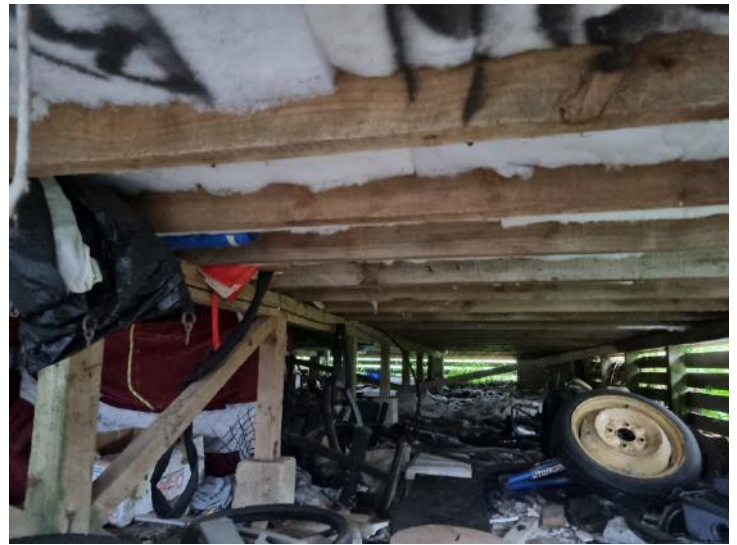
Good ground clearances from sub floor

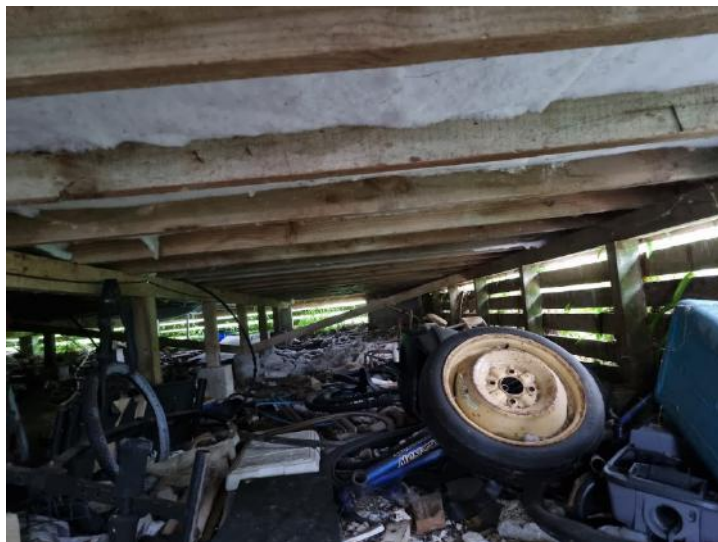
Sub structure framing appears in good original condition for its age
