# Building Inspection Report

Client: Paul Sumich  
Location: 7 Pukemiro Road, Kamo  
Whangarei

Inspection Date: 21/10/2021

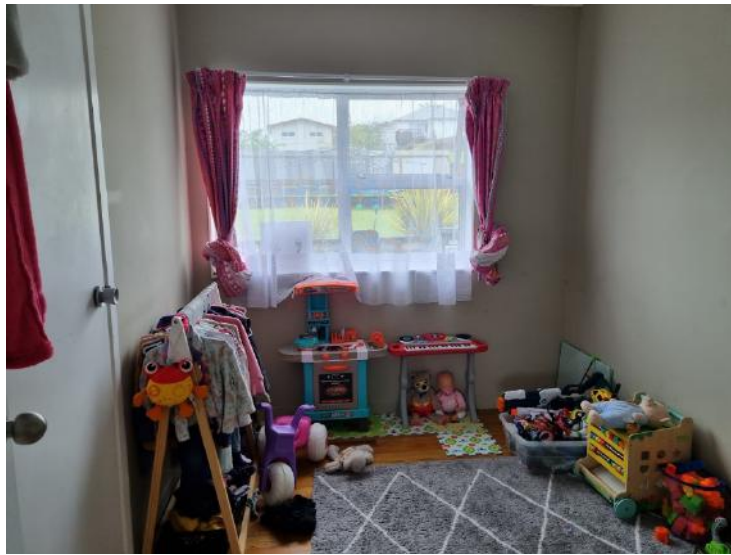
Bedroom 1

Hardware in bedroom 1 needs maintenance

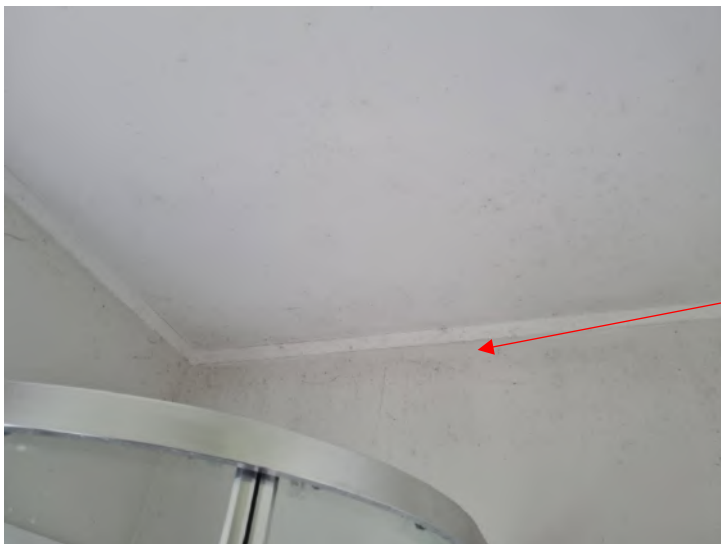
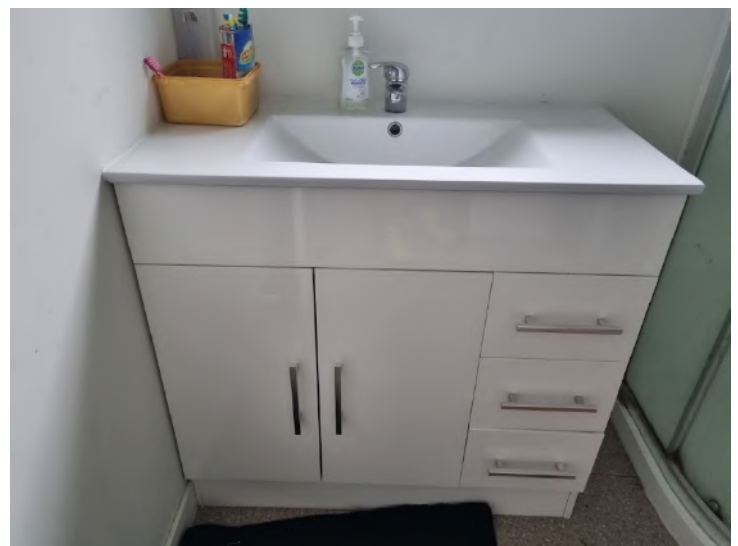
Mould to ceiling above shower

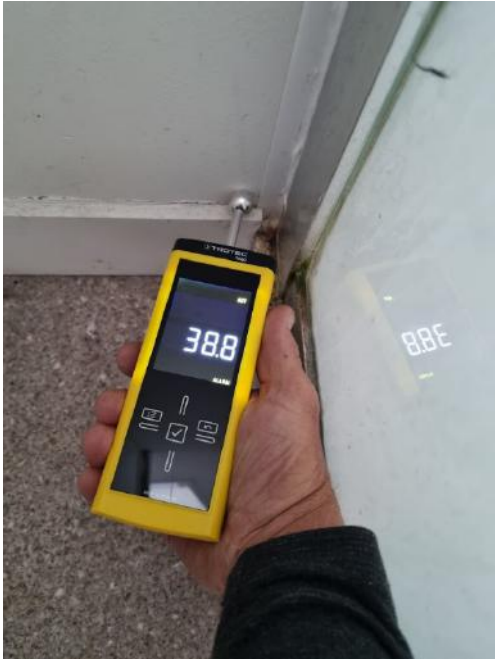
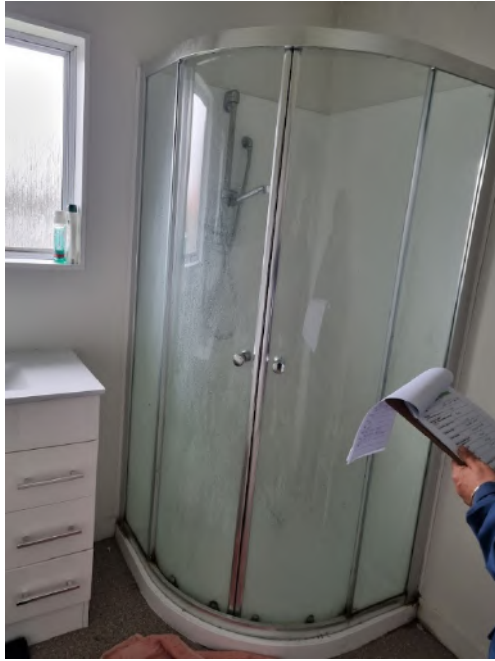
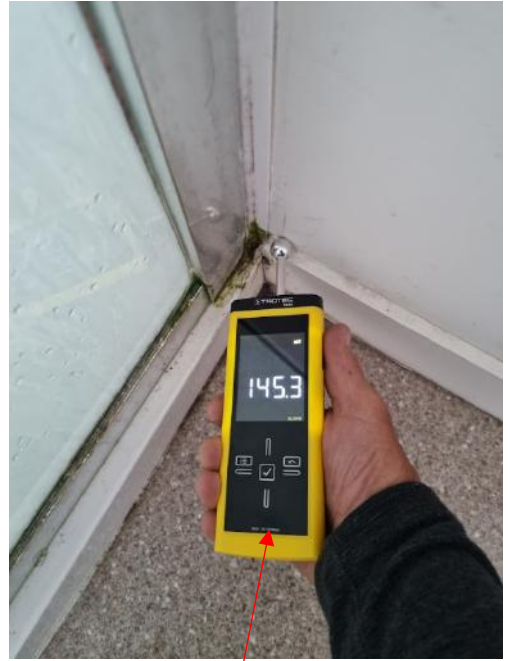
Moisture meter reading is higher than 80, this shows it is at risk for wet material and further investigation is required

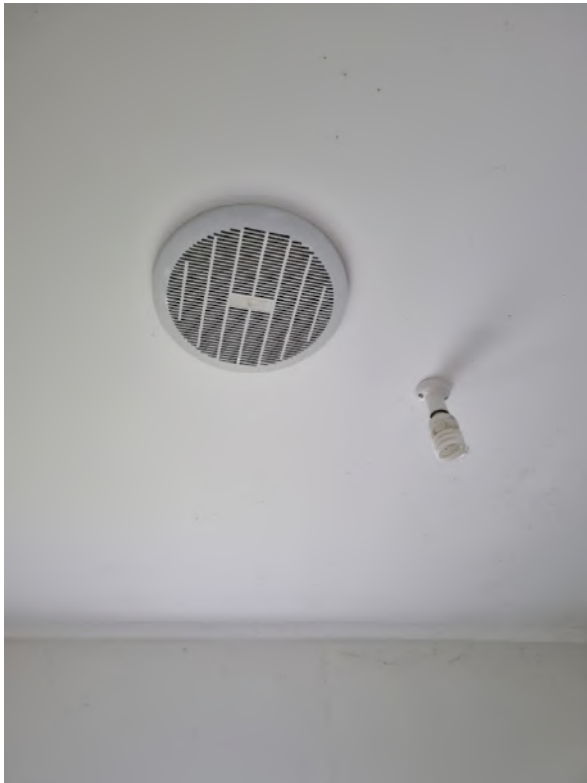
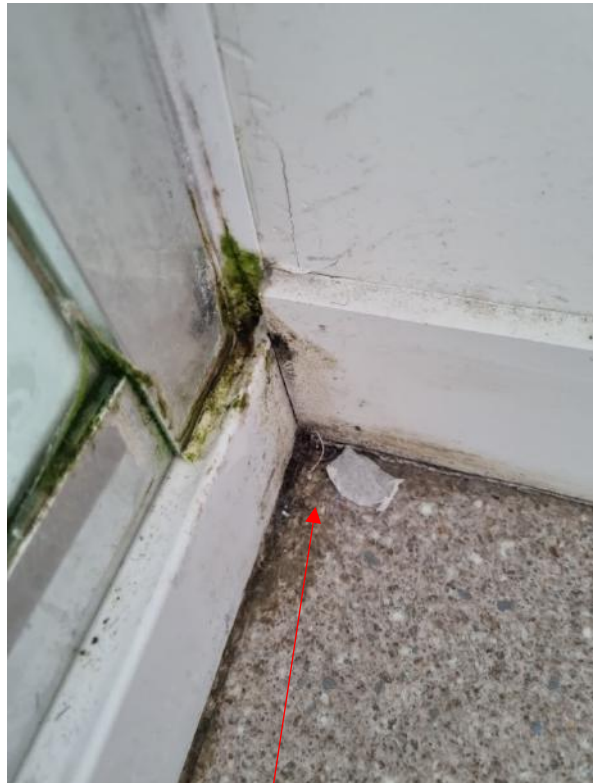
Shower showing excessive moisture – requires sealing

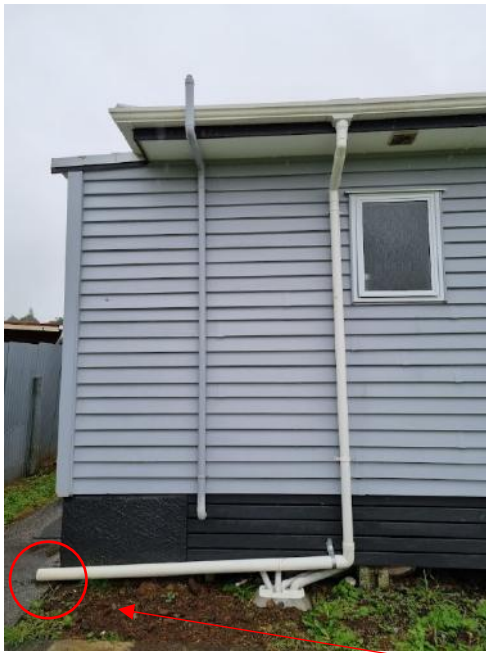
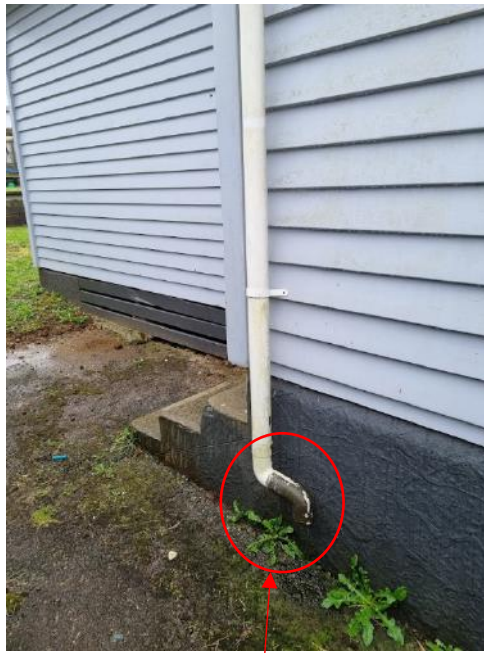
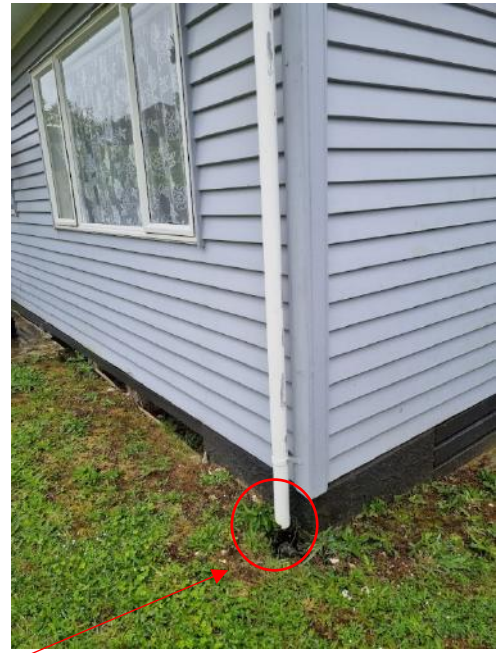
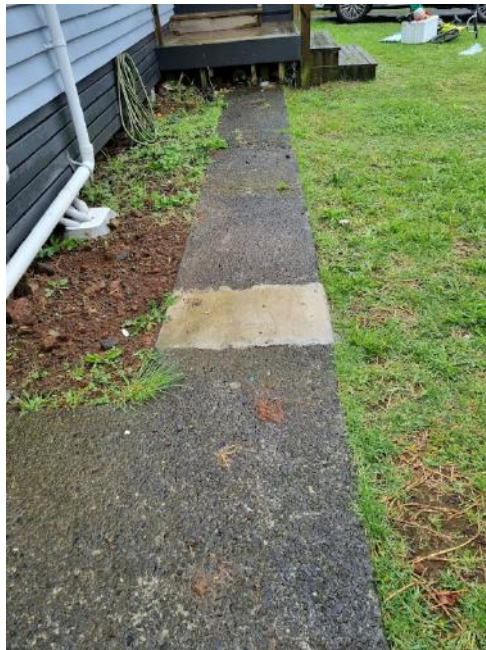
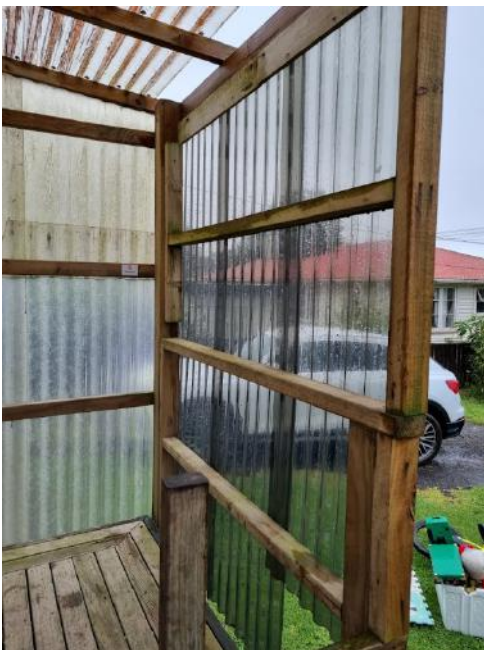
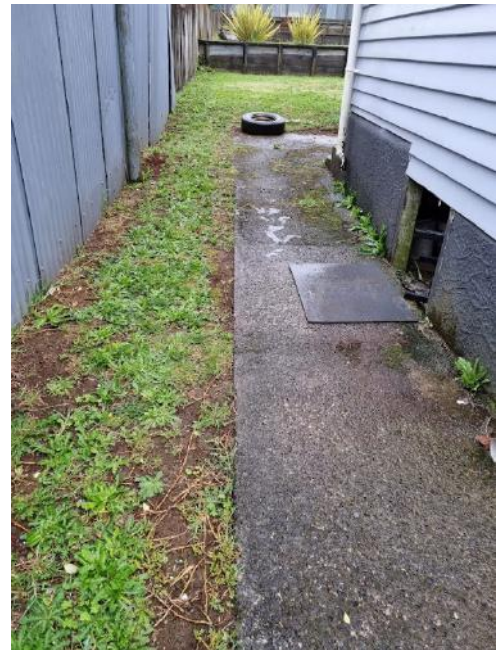
PVC downpipes pipe are not connected to any underground drainage – free flow over surface which does not comply with current NZ standards

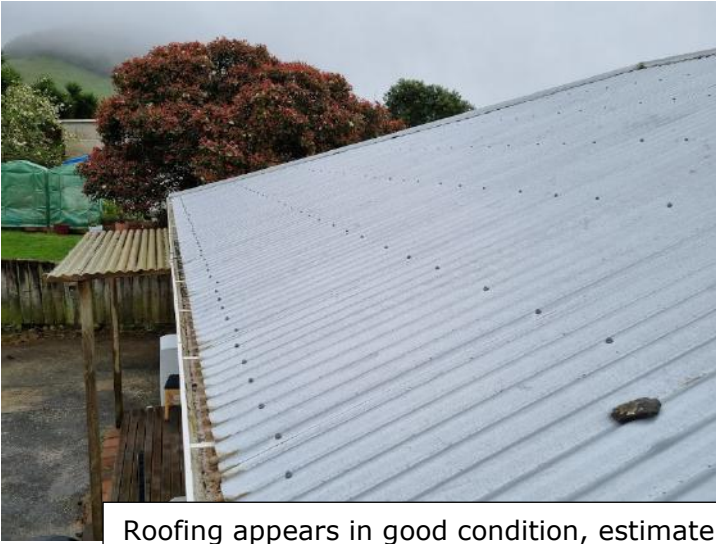
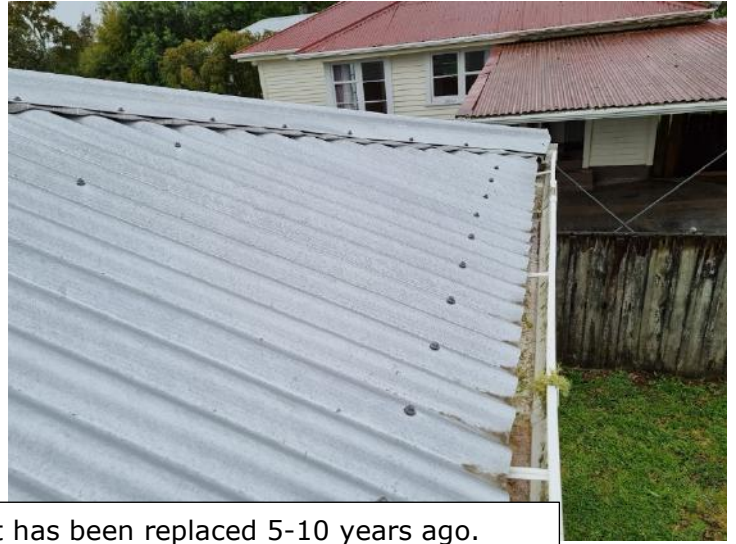
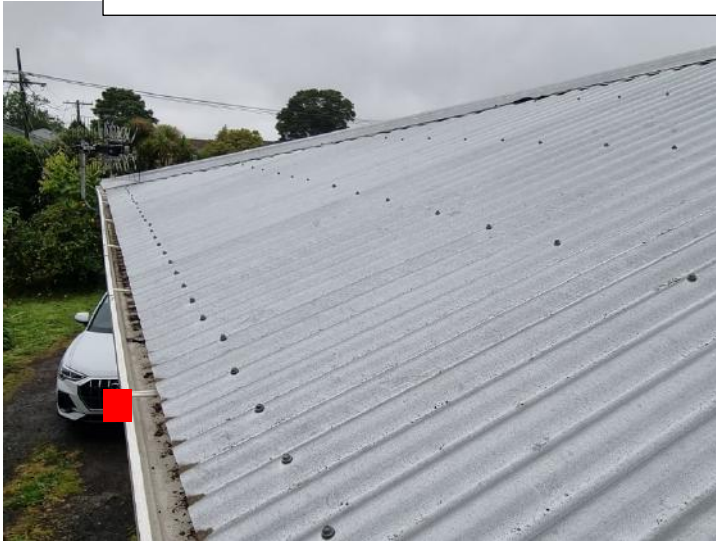
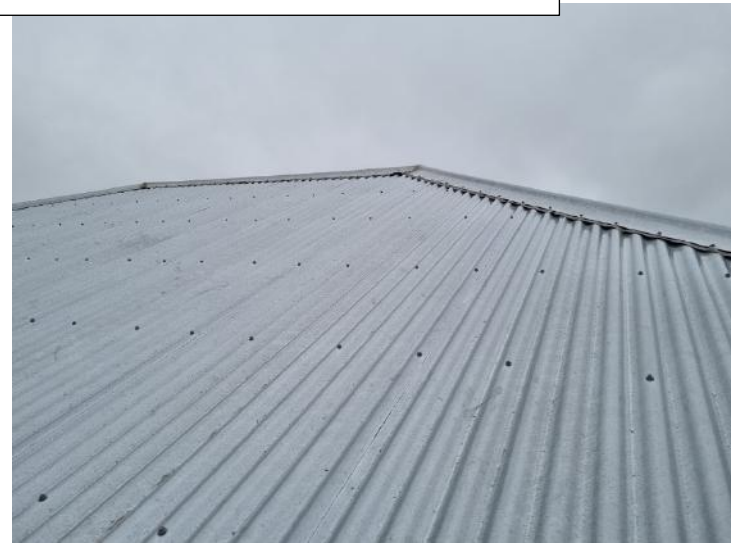
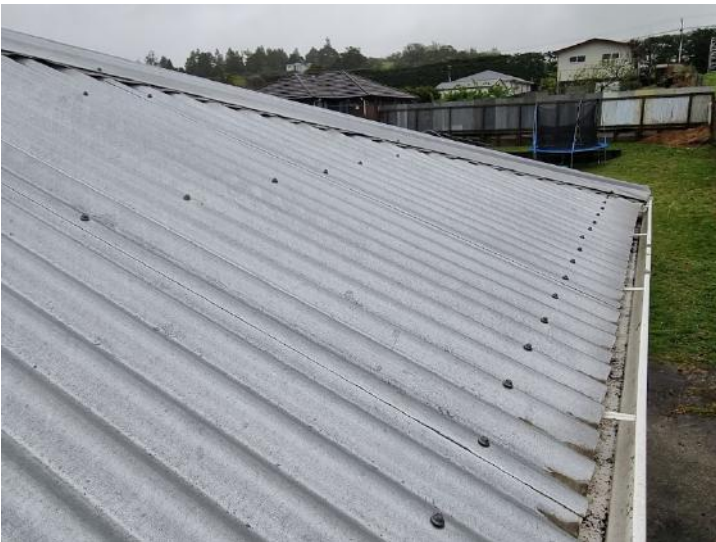
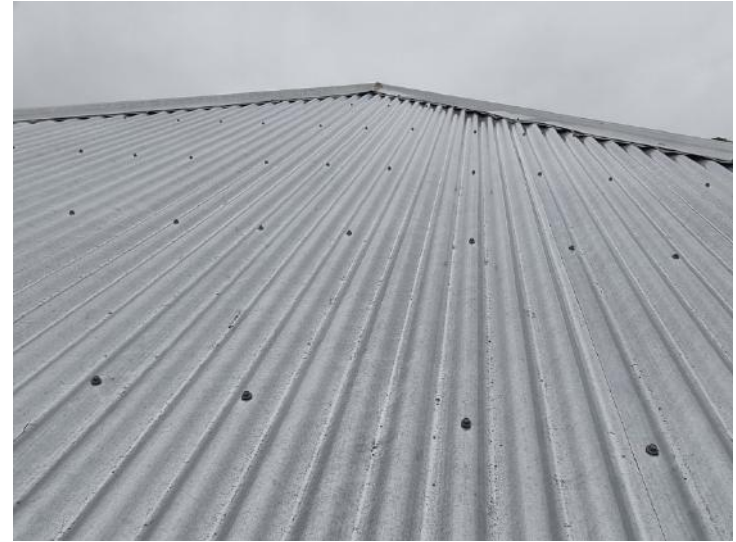
Roofing appears in good condition, estimate it has been replaced 5-10 years ago.

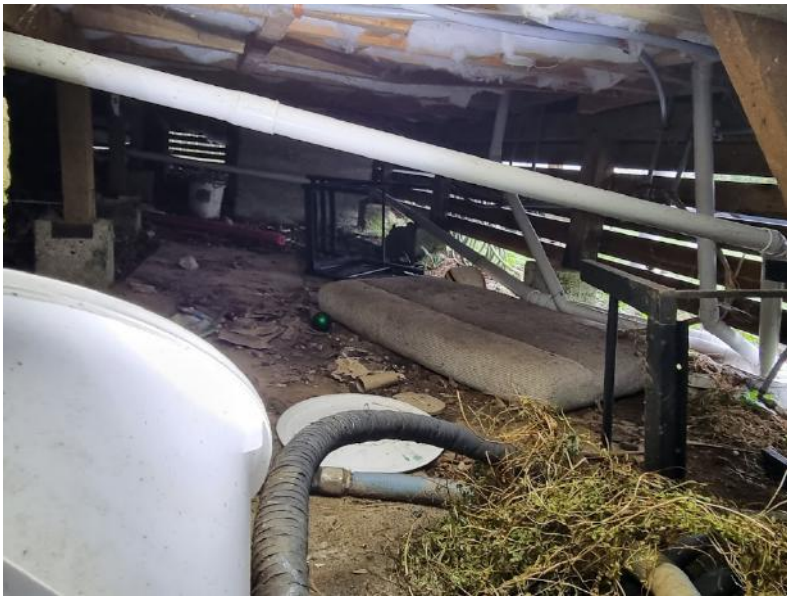
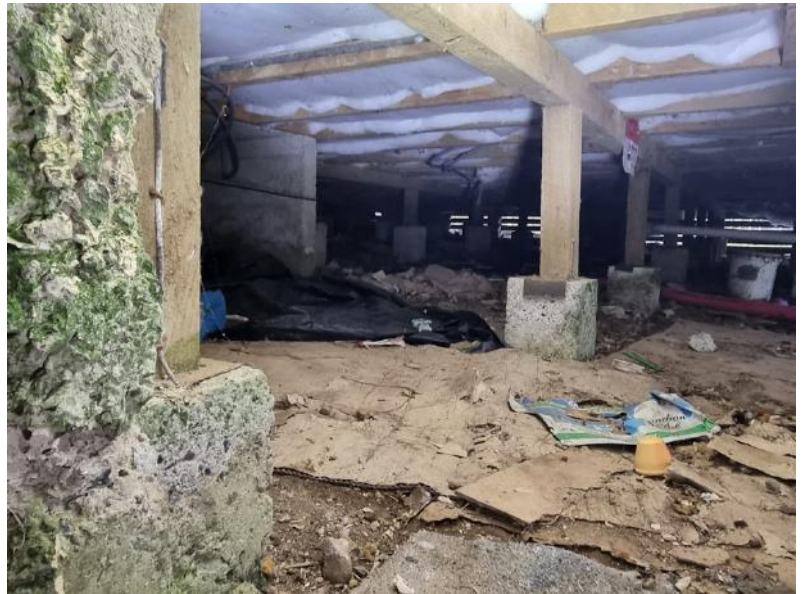
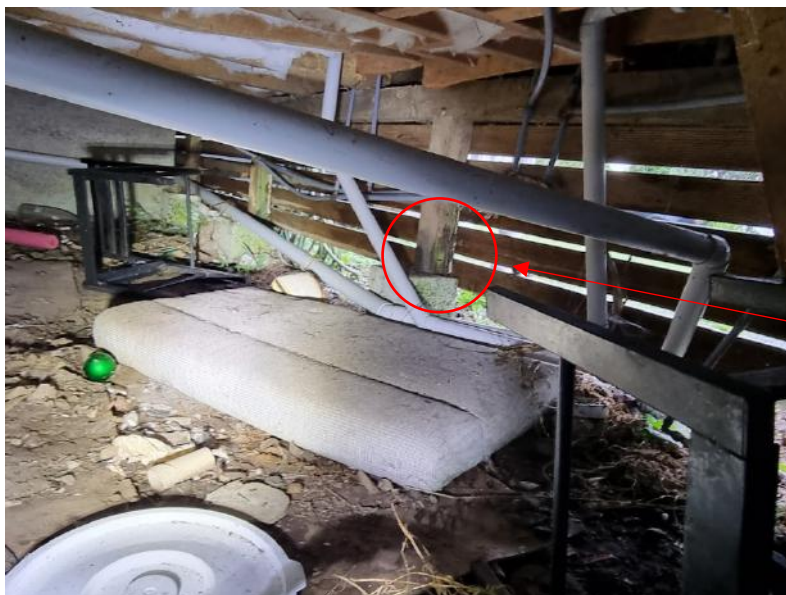
Pile framing to front showing signs of rot where base cladding is fixed. Check the rest as only limited this view.
