Building Inspection Report

Client: Paul Sumich
Location: 9 Pukemiro Road, Kamo
Whangarei

Inspection Date: 21/10/2021

RE: Building Inspection Report, 9 Pukemiro Road, Kamo, Whangarei.

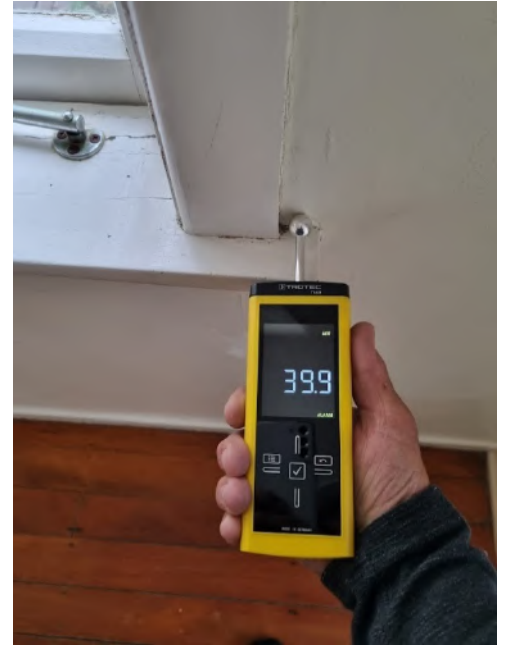
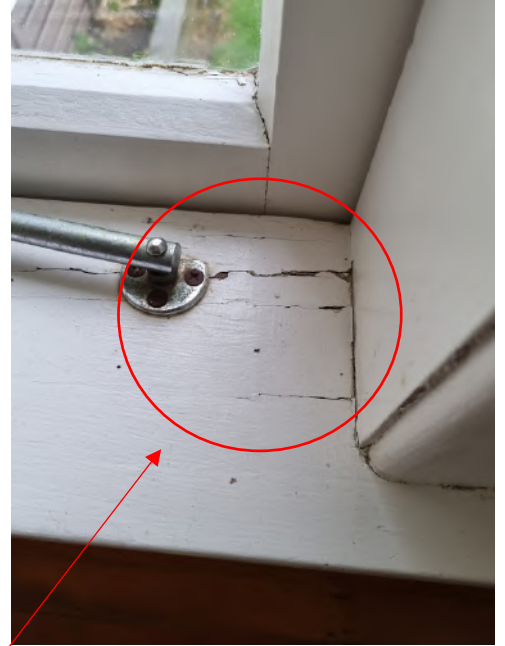
Front Entry

Paint required to front entry door and porch

All windowsills throughout dwelling require maintenance and paint – splitting to the sills

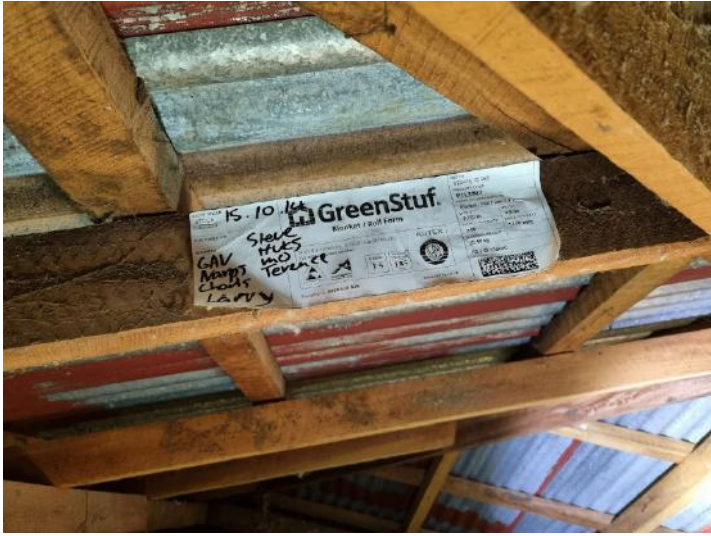
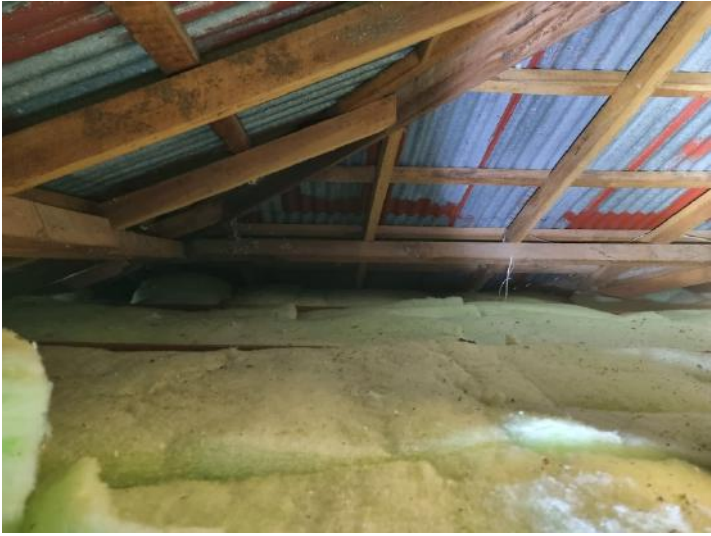
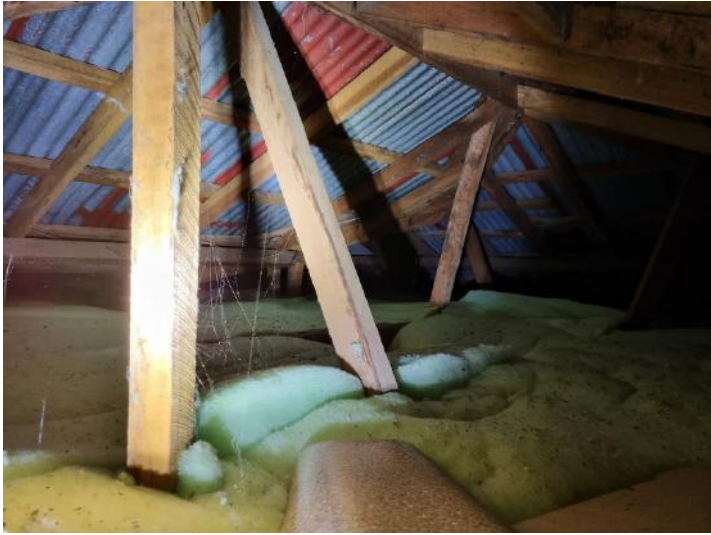
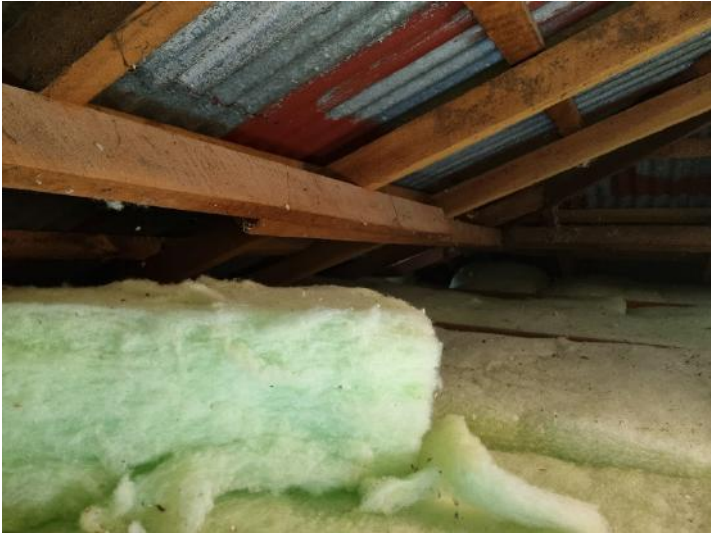
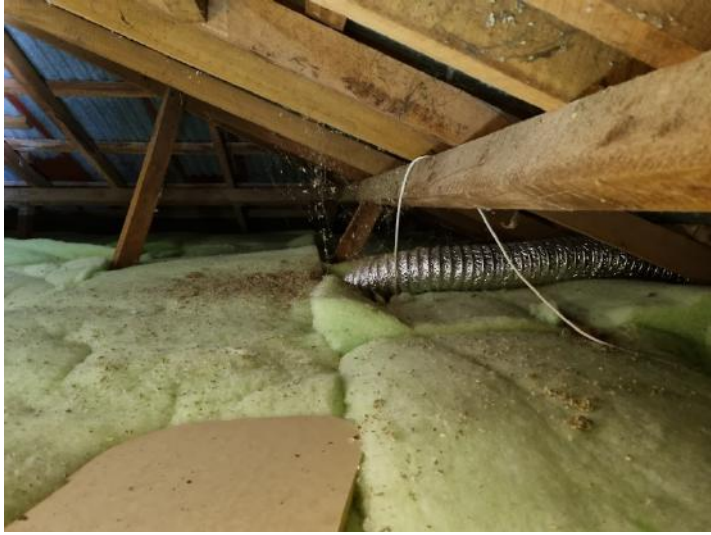
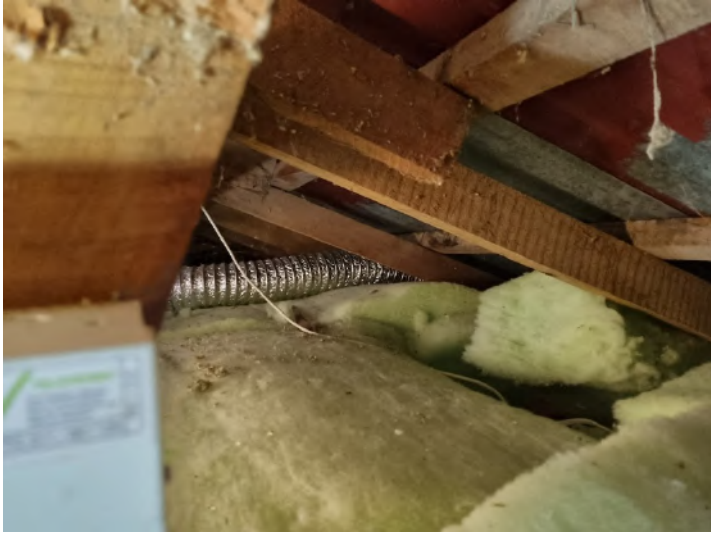
Ceiling

No building paper to roof space

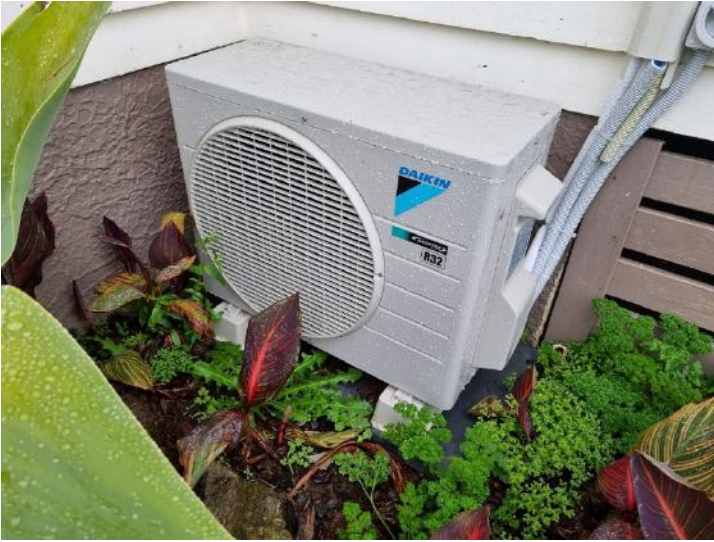
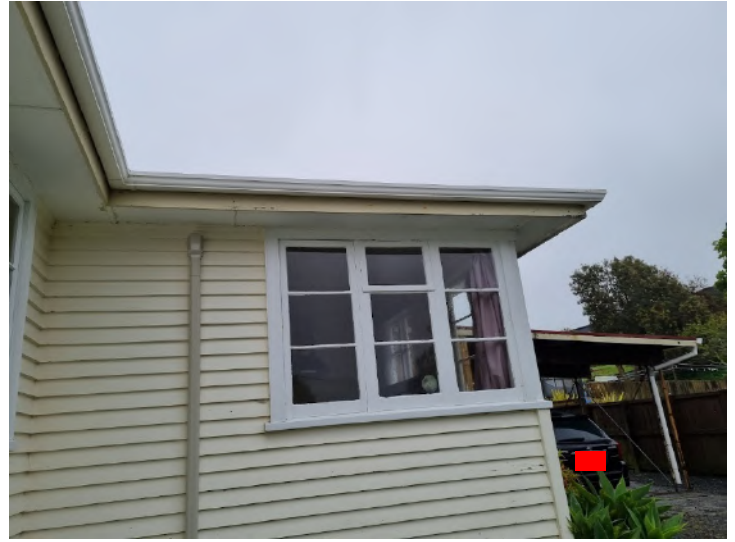
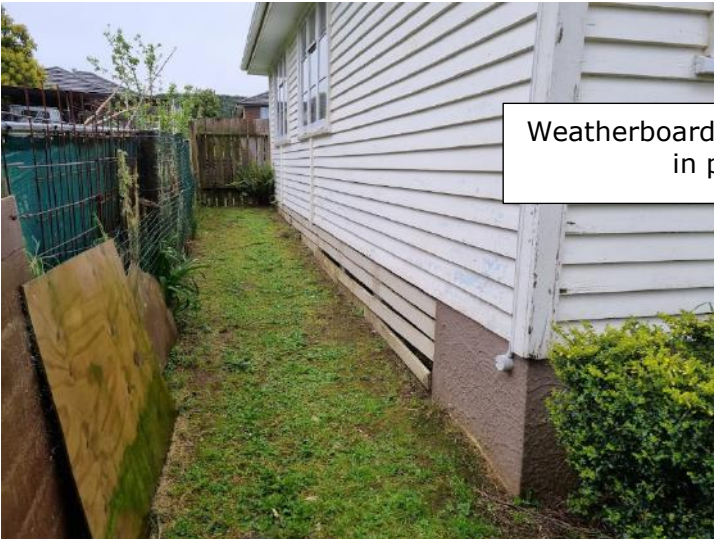
Dwelling front outside and driveway

Weatherboards need replacing in places

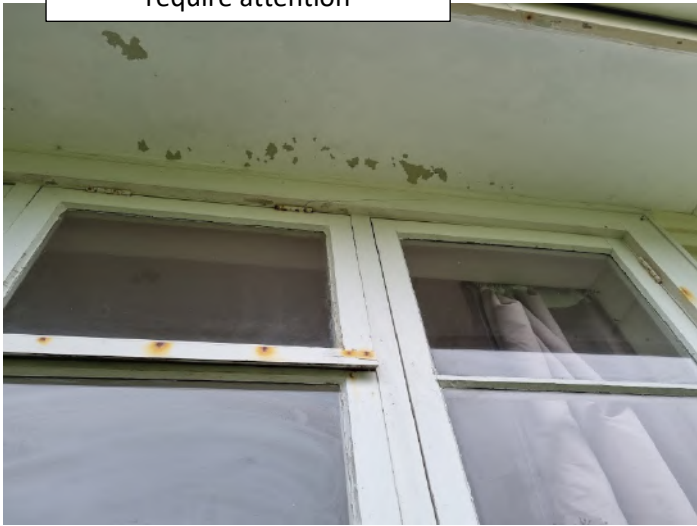
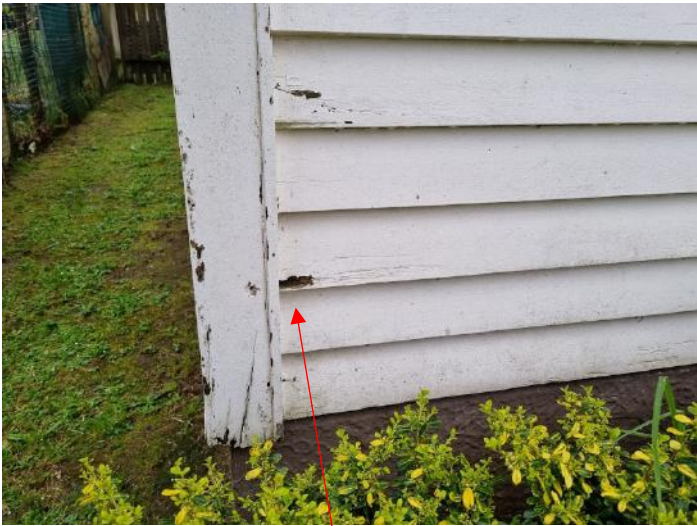
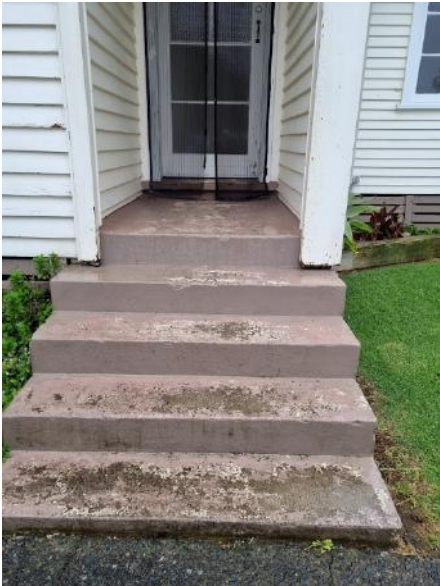
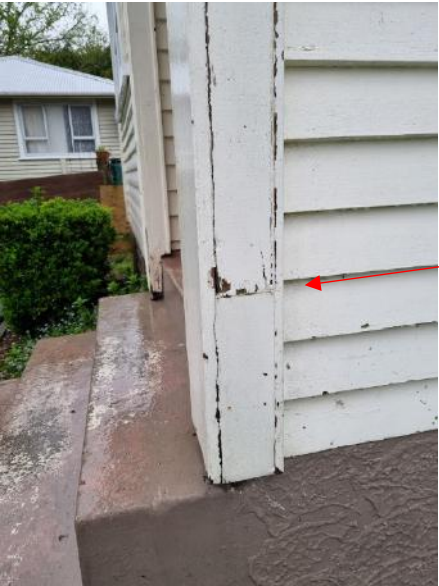
Window facings and frames, soffits, and weatherboards need painting

Window facings throughout require attention

Weatherboards need repair/replacing in places

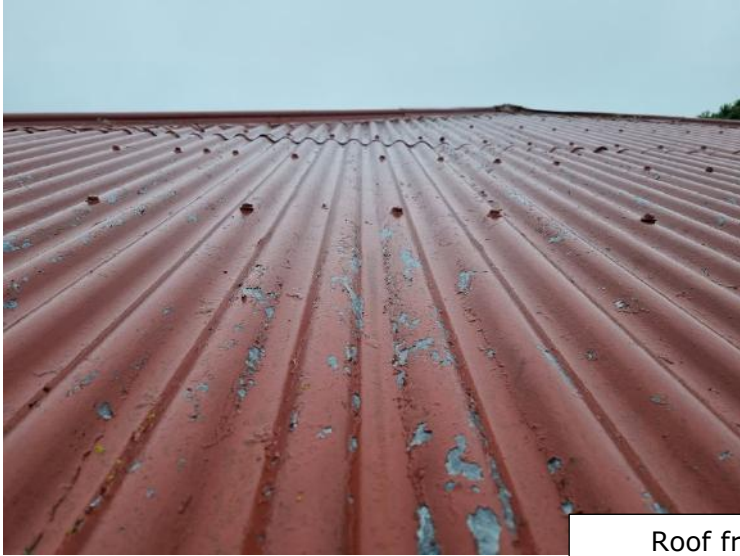
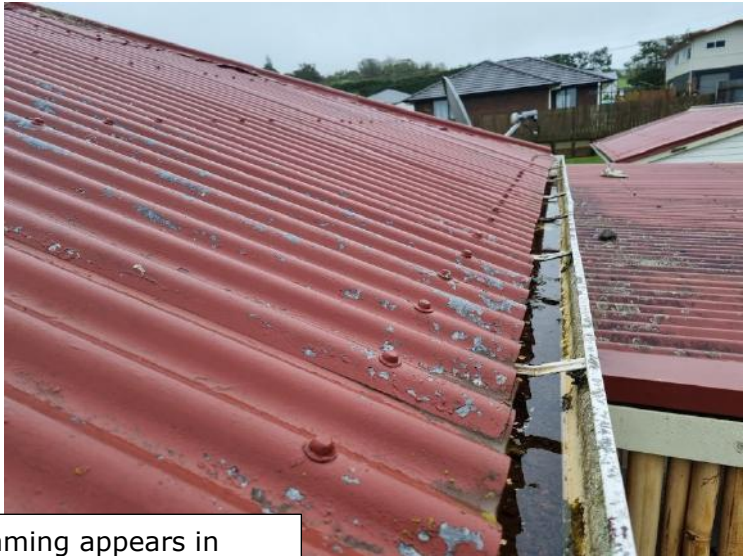
Roof needs replacing or heavy maintenance – sheeting, fixings, and paint to increase longevity

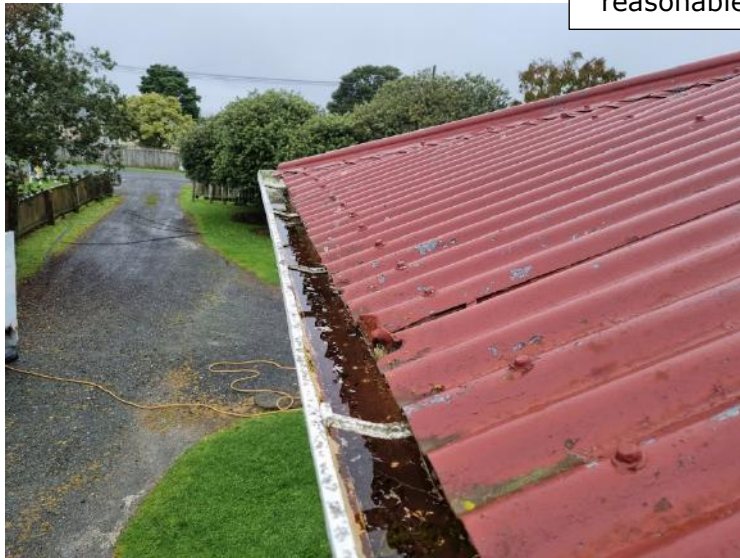
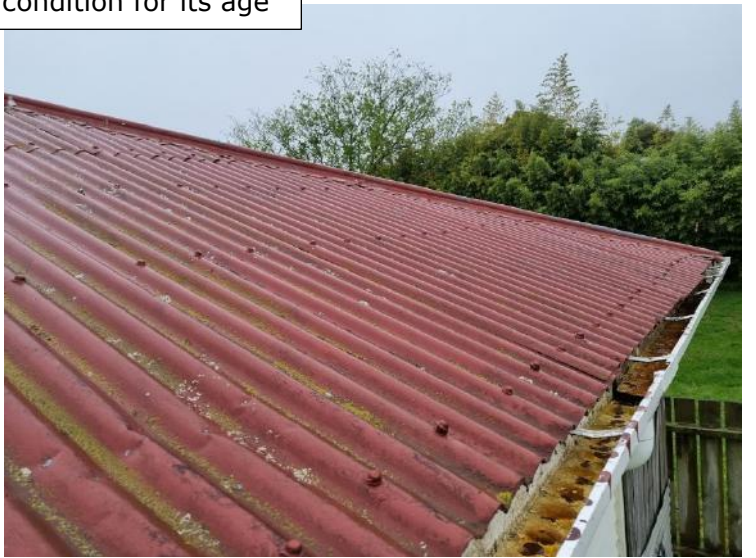
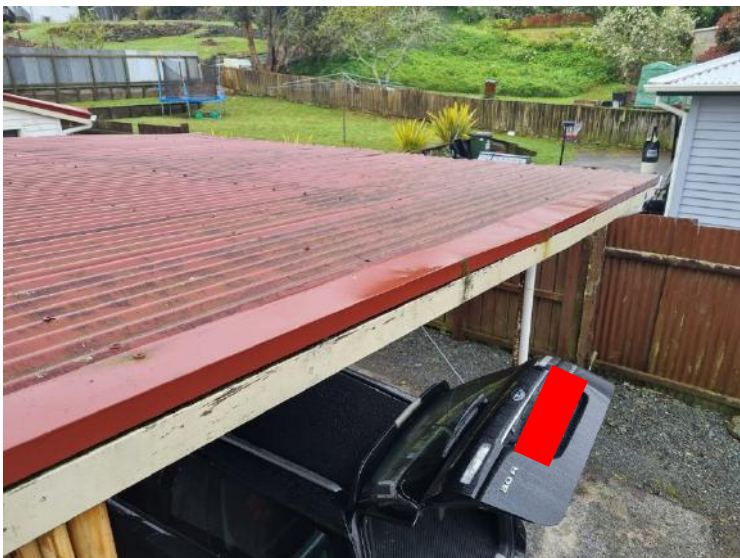
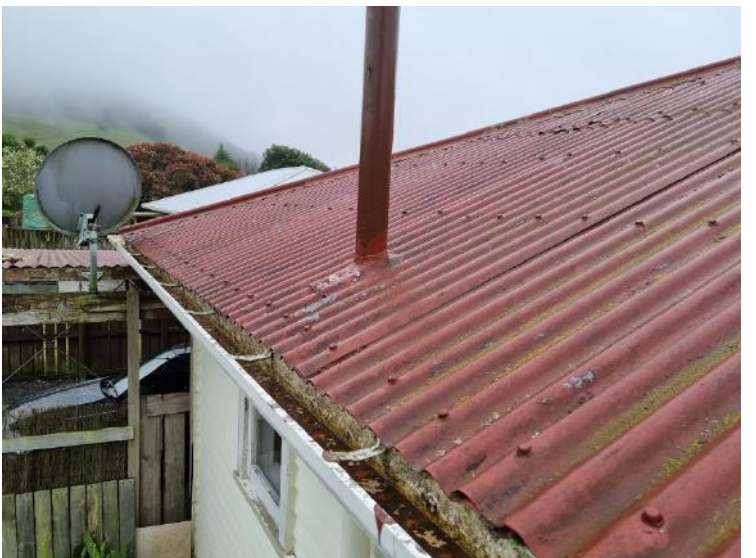
Roof framing appears in reasonable condition for its age

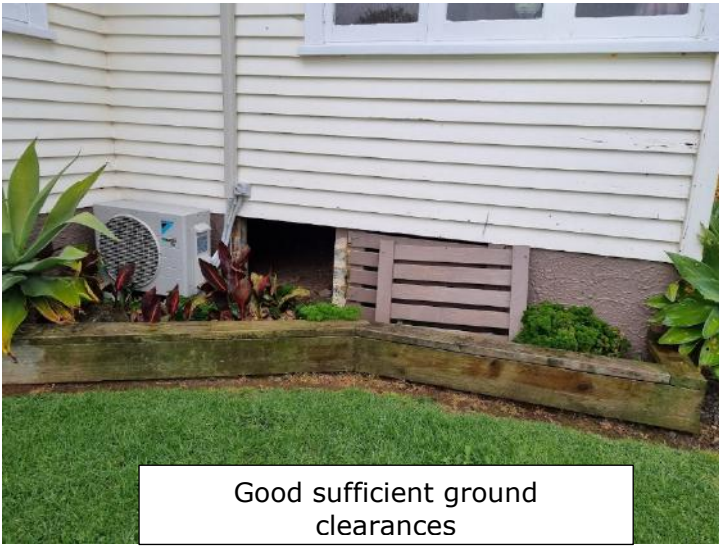
Good sufficient ground clearances

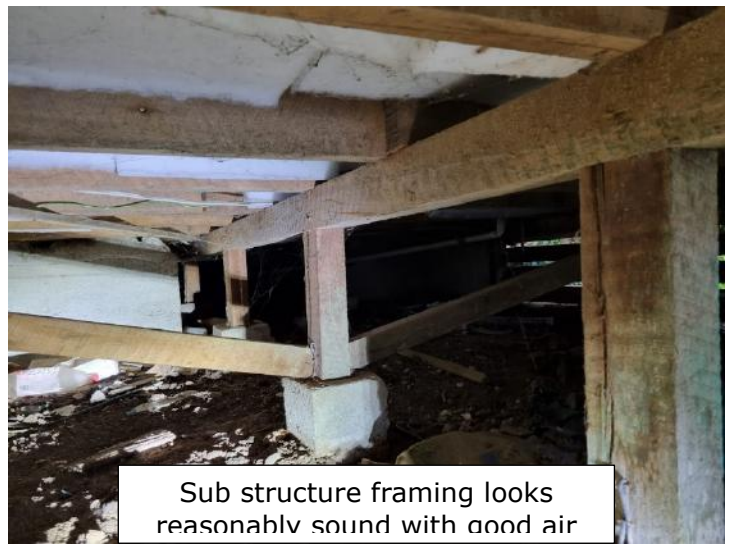
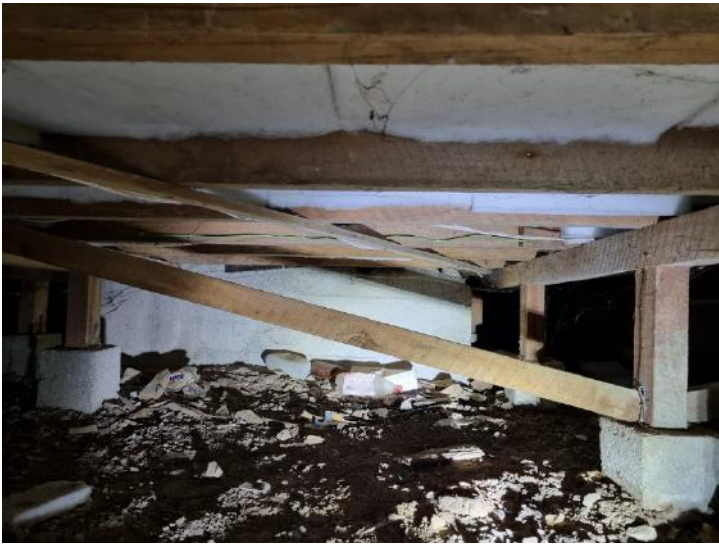
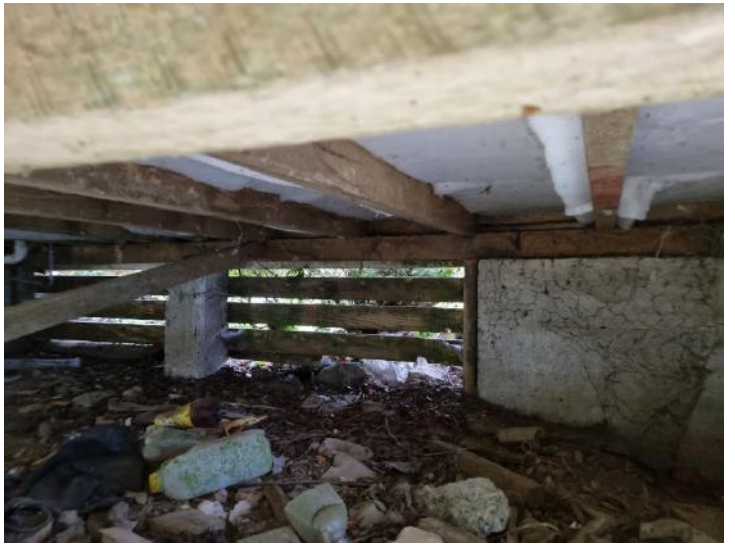
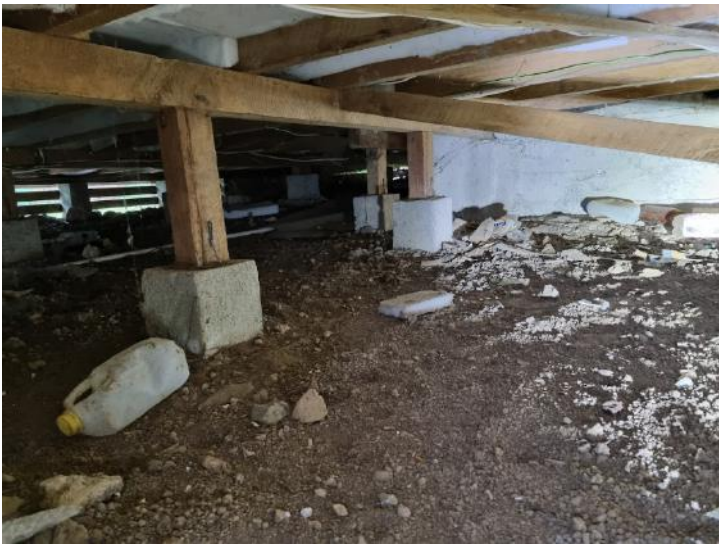
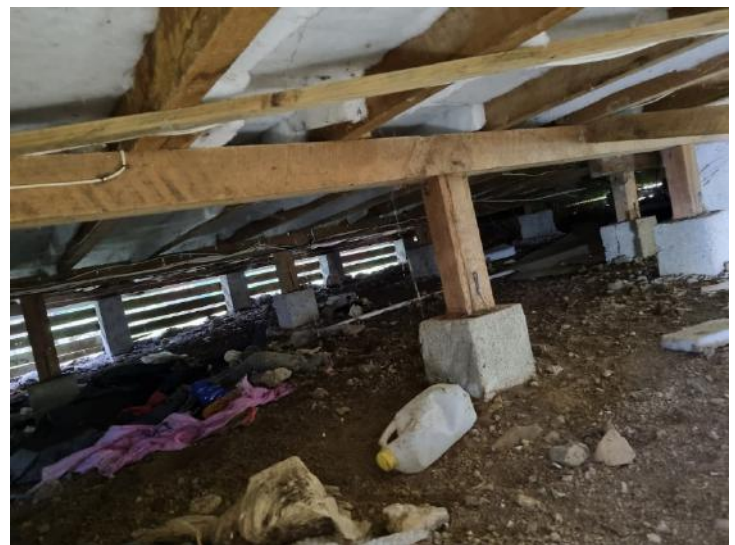
Sub structure framing looks reasonably sound with good air
