Building Inspection Report

Client: Paul Sumich
Location: 101 Maunu Road, Woodhill
Whangarei

Inspection Date: 20/10/2021

RE: Building Inspection Report, 101 Maunu Road, Woodhill, Whangarei.

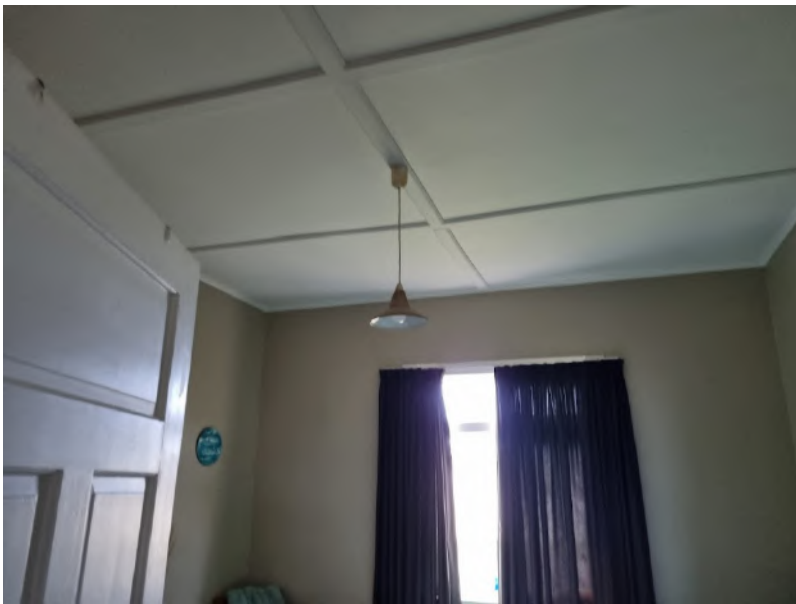
Floor is a little up and down in places due to minor pile movement over the years

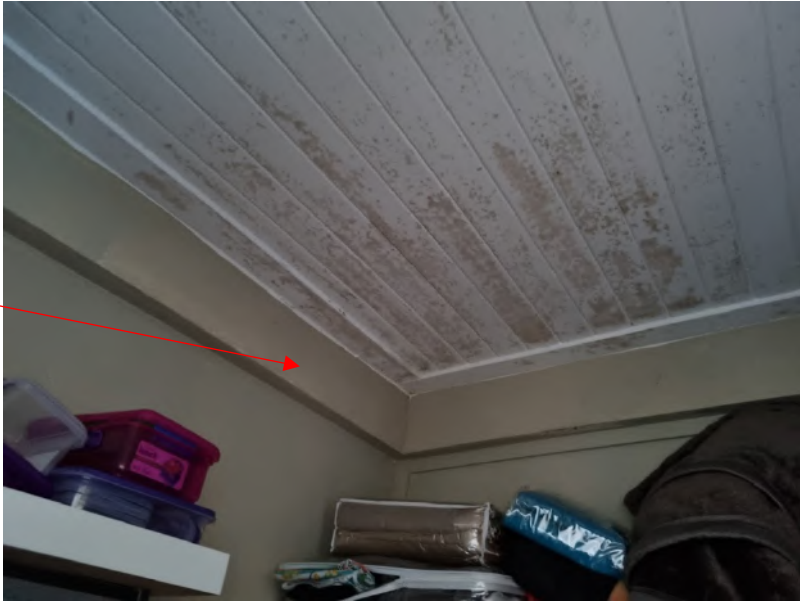
Mould visible on the ceiling in the walk-in wardrobe of bedroom 3

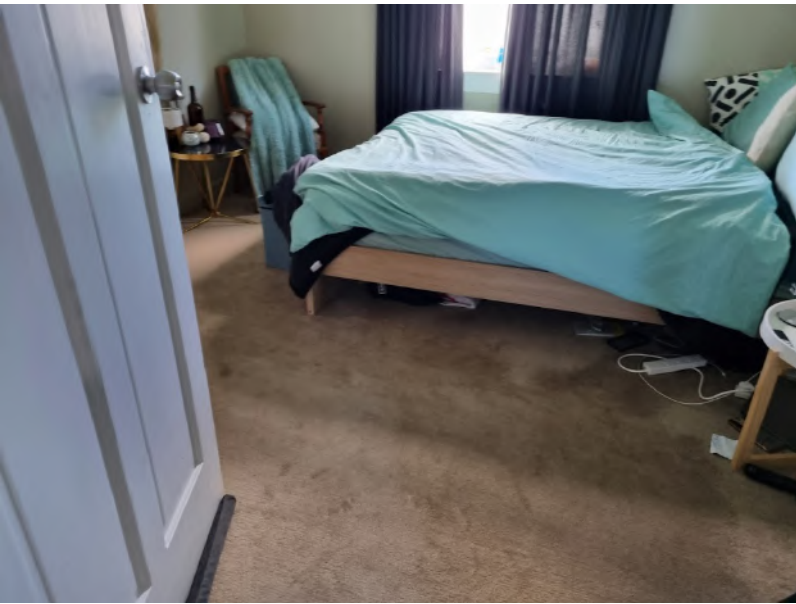
Very noticeable drop in the floor height in bedroom 3 from the bedroom to the walk-in wardrobe. This could potentially be the old porch that was enclosed to form the office and walk in robe.

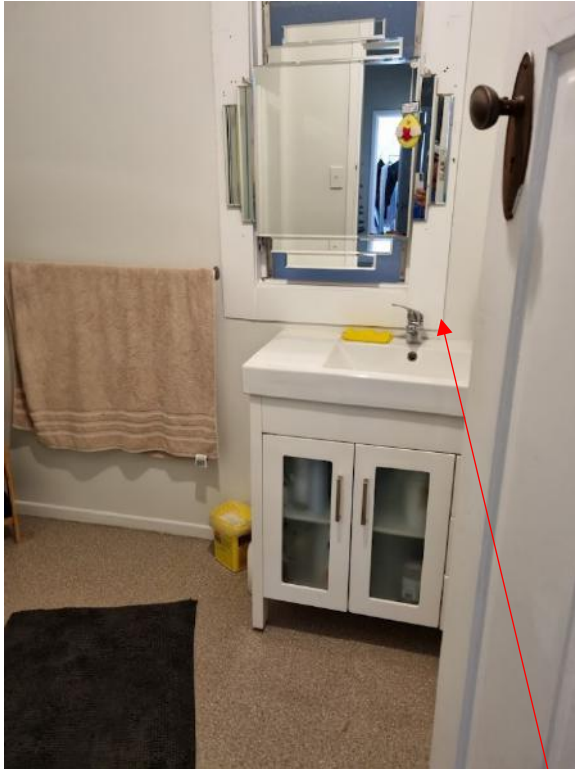
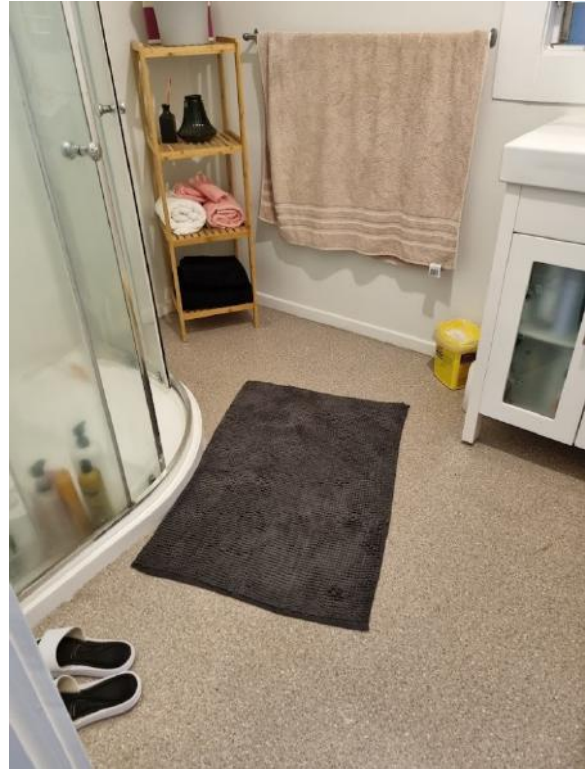
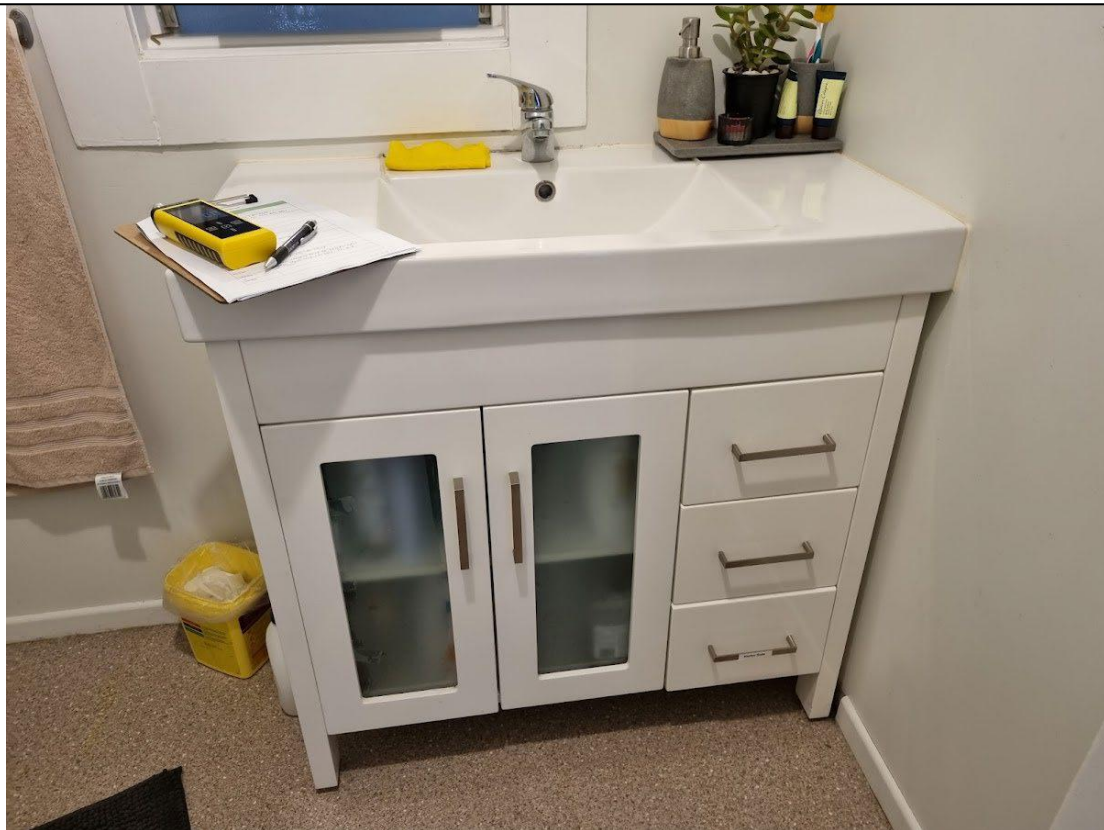
Bathroom has no exterior windows Bathroom has no exterior windows which will contribute to the visible mould

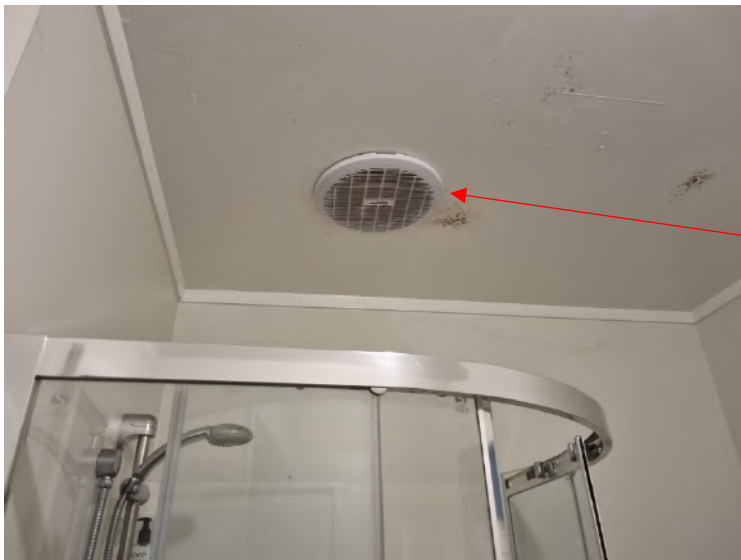
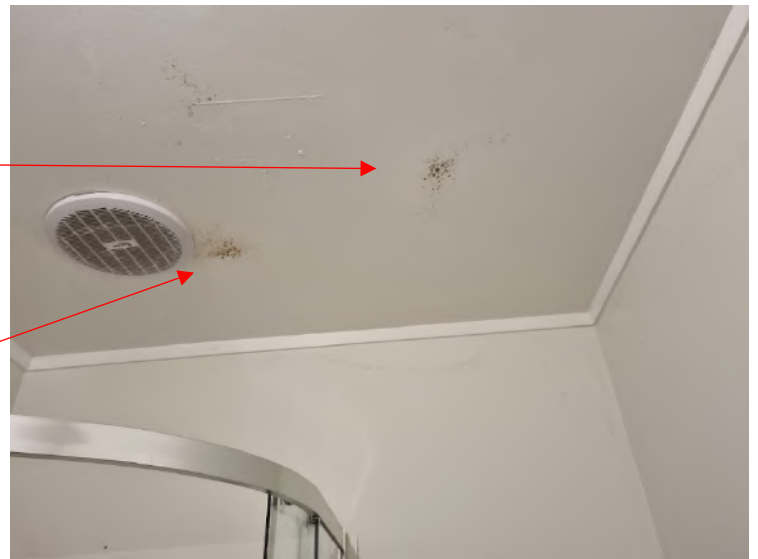
Unsure if bathroom extraction is working correctly – further investigation is required

Mould present in bathroom even with an extractor fan installed. Is it working? Further investigation is required as this may be due to a leaking roof or an incorrectly working extractor fan

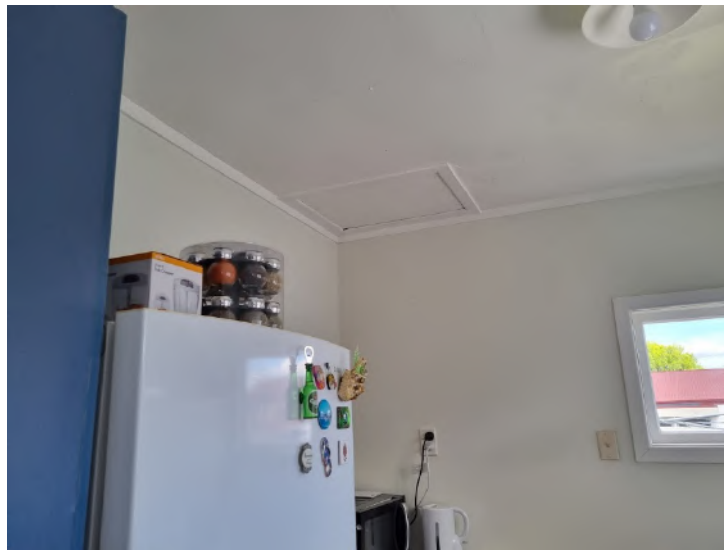
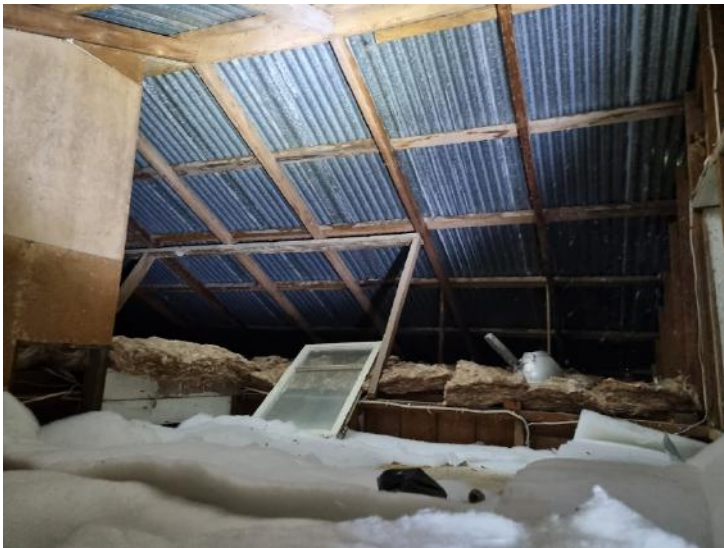
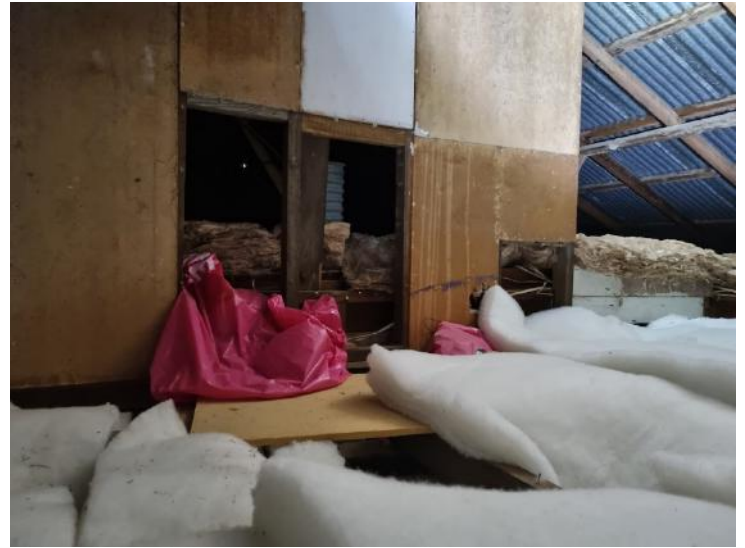
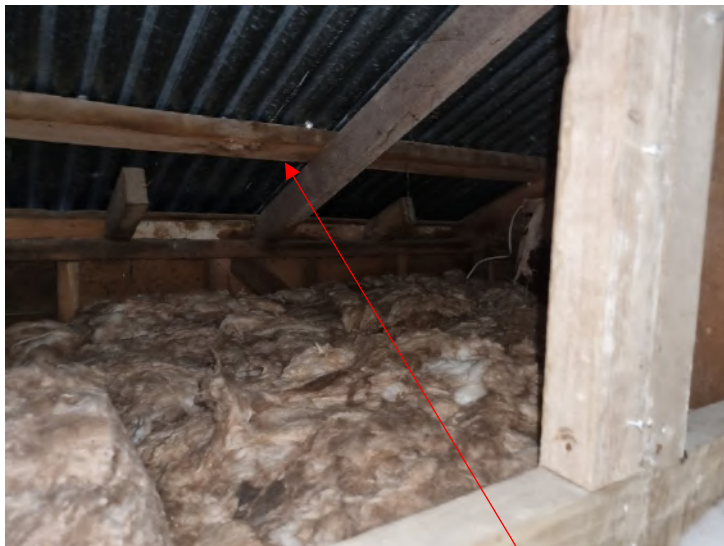
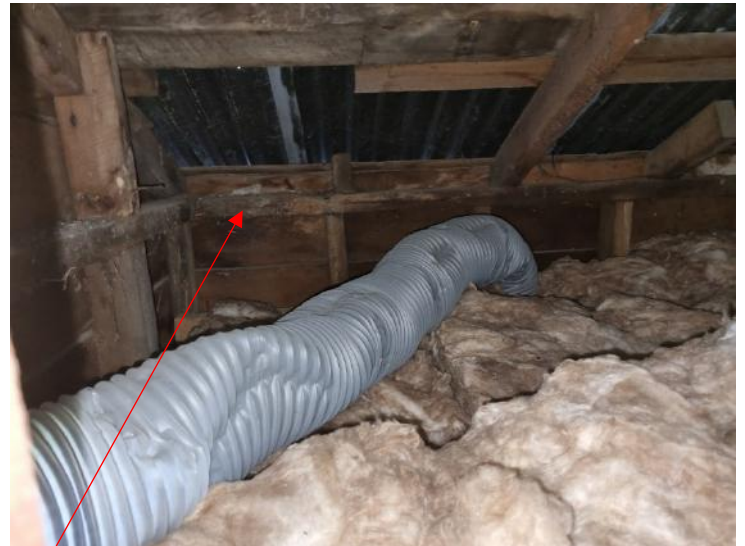
Ceiling

Roof purlins showing signs of previous water ingress – this can be rectified when the house gets re-roofed, also vent ducting needs the ding in the side to be pushed out to maintain sufficient airflow.

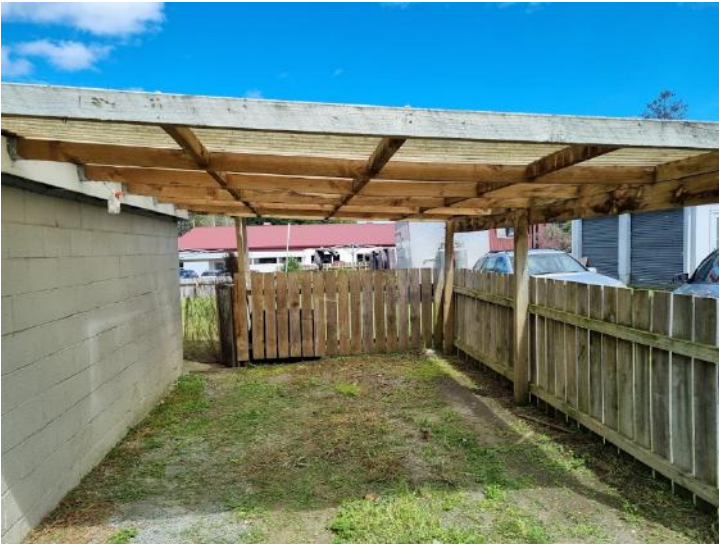
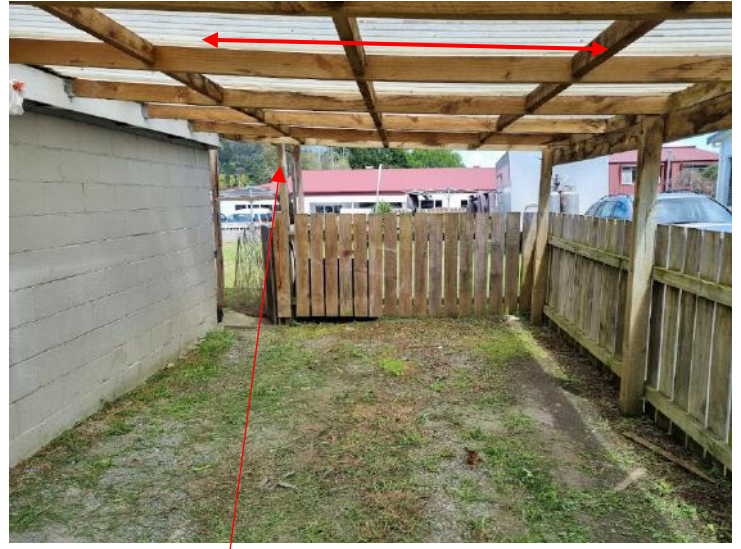
Carport rafters are sagging as the span is too much for the size of the timber. This is 100x50 and should be a minimum of 150x50

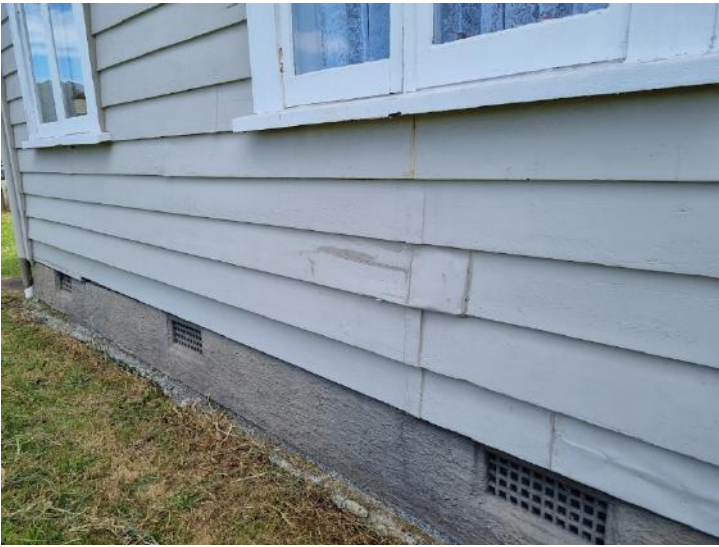
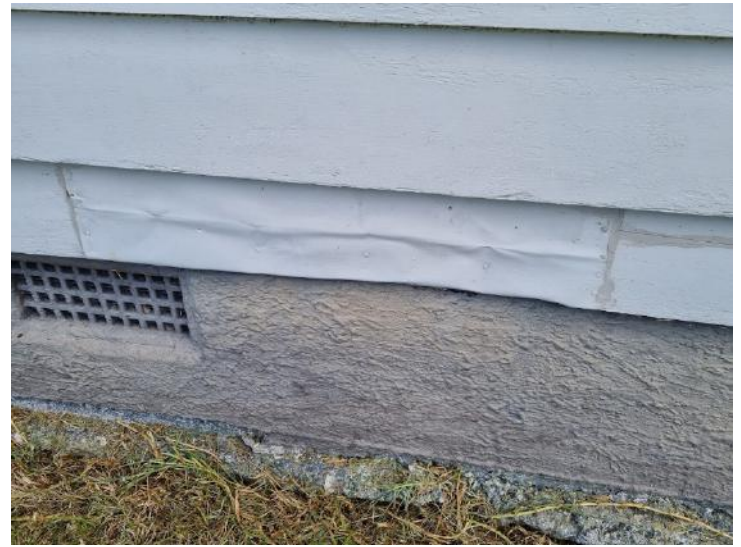
Weatherboard's showing signs of deterioration and recent unsatisfactory repairs have taken place, further investigation in places for repair

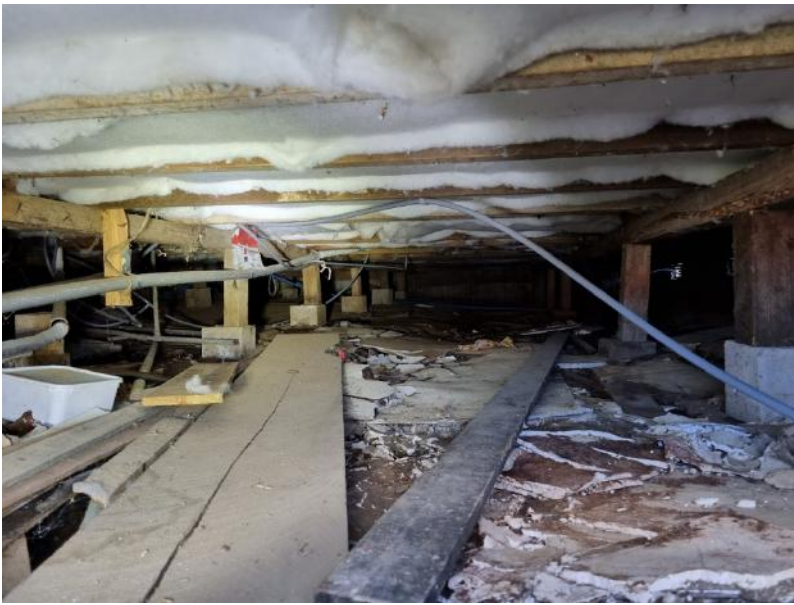
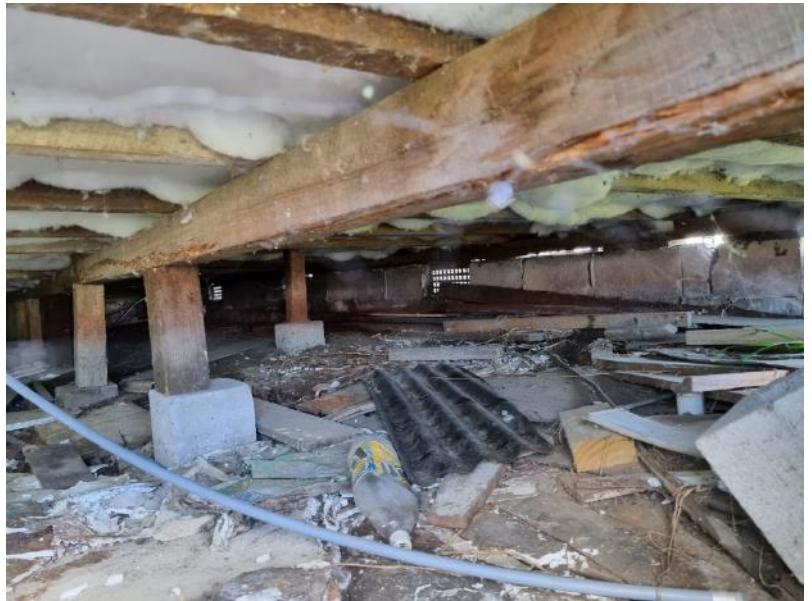
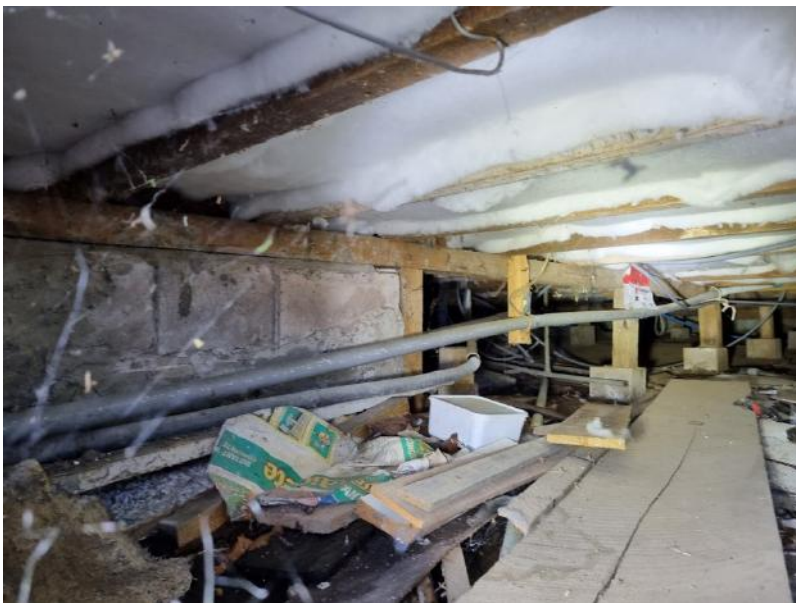
Bearer needs further investigation under the house as it is showing signs of deterioration
