## **Property Condition Report**

**1 Drummond Street  
Regent  
Whangarei District**

**Client:** Paul Sumich

**Inspection Date:** 15/01/2021

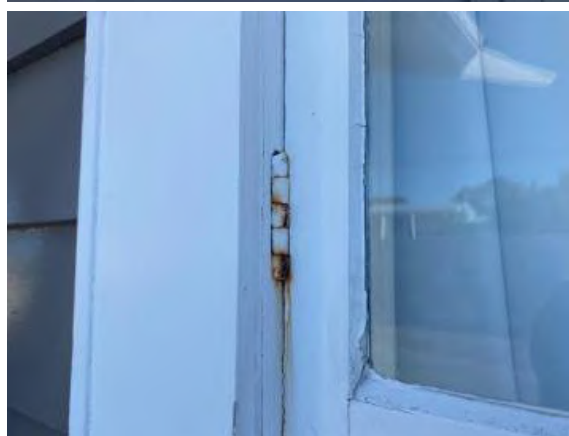
Evidence of corrosion to window hinges. Corroded hinges may affect window operation. We recommend engaging a builder or joiner to inspect hinges further and treat with a suitable rust inhibitor where necessary. If hinges are beyond repair replacement may be required. M.
