## **Property Condition Report**

**30 First Avenue  
Whangarei Central  
Whangarei District**

**Inspection Date:** 14/10/2020

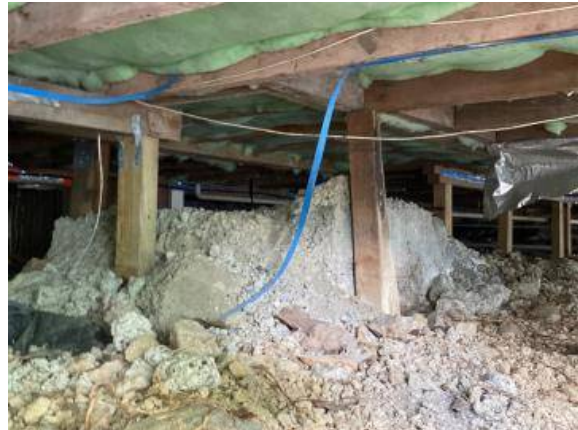
Timber pile direct fixed to joist, no bearer. We recommend engaging the services of a licensed building practitioner to inspect this detail further. Pile may require modification or replacement.

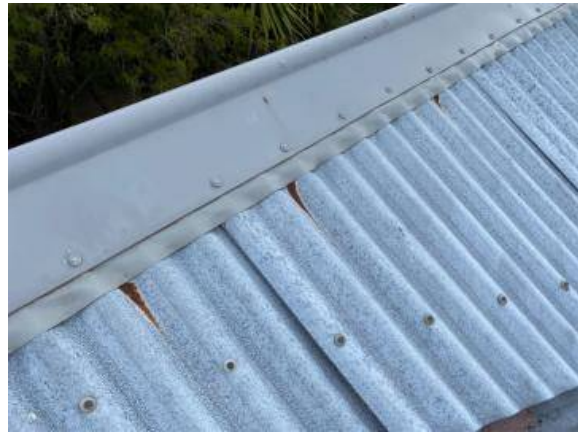
Evidence of corrosion to galvanized roof covering at ridge flashing junction. We recommend engaging the services of a suitably qualified roofer to inspect this area further. Corroded areas may require treatment with a suitable rest inhibitor to prevent further damage.

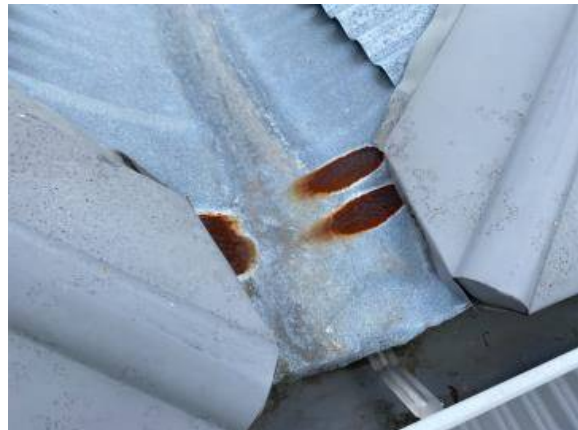
Evidence of corrosion to galvanized roof covering at galvanised metal Gutter system . We recommend engaging the services of a suitably qualified roofer to inspect this area further. Corroded areas may require treatment with a suitable rest inhibitor to prevent further damage.

Evidence of corrosion to galvanized roof covering at galvanized metal Gutter system . We recommend engaging the services of a suitably qualified roofer to inspect this area further. Corroded areas may require treatment with a suitable rust inhibitor to prevent further damage.

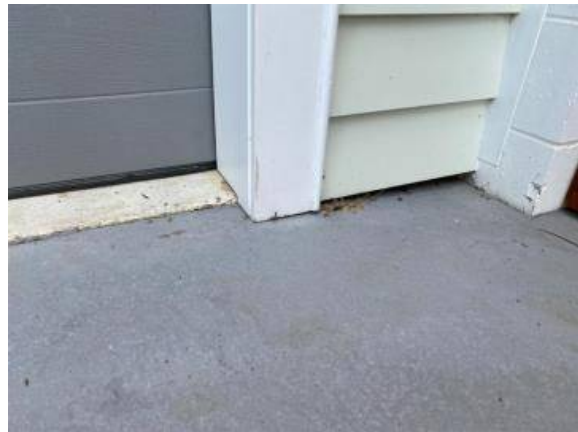
Garage door facings in close proximity to paved ground. We recommend engaging a builder to modify clearance to reduce the risk of moisture damage to cladding.
