## **Property Condition Report**

**356 Bull Road  
Waiotira  
Whangarei District**

**Client:** Paul Sumich

**Inspection Date:** 11/01/2021

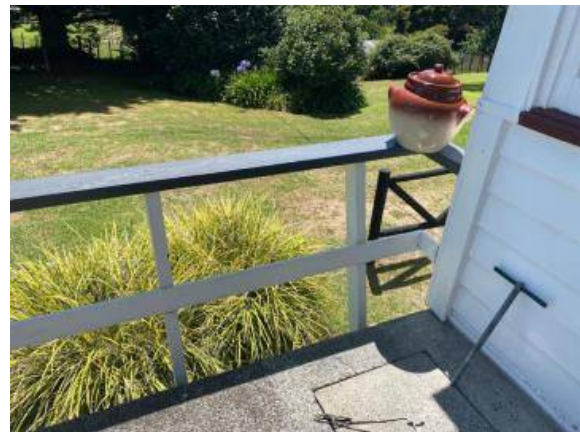
Excessive horizontal movement to timber handrail. This may present a potential safety risk. We recommend engaging a Builder to install additional fixings/bracing or repair/replace handrail as required. Handrail openings are greater than 100mm in diameter. This presents a potential fall hazard. Minimum recommendations require openings not greater than 100mm to reduce potential fall hazards. We recommend engaging the services of a builder to modify this detail where possible.

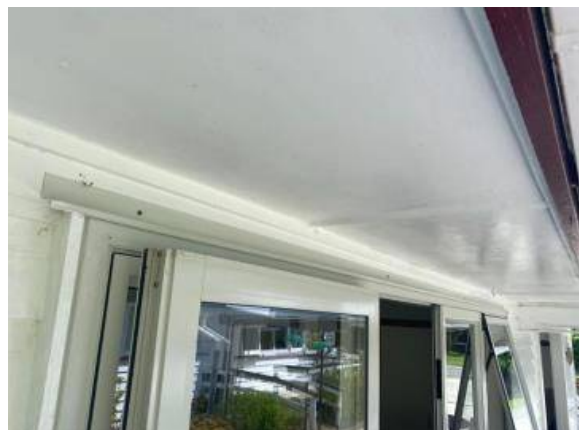
Aluminium head flashing face fixed to cladding. This may increase the risk of moisture ingress. We recommend modifying this detail to ensure head flashing runs behind cladding,

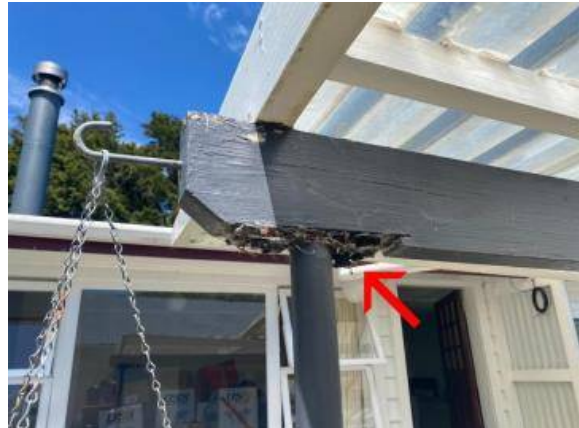
Heavy corrosion to top of steel posts. Corrosion may compromise the structural integrity of carport. We recommend replacing posts and installing suitable structural connections were required.

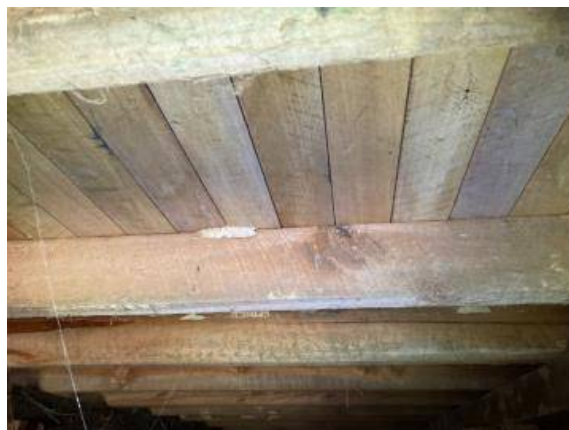
Description: No vapour barrier present.

Description: Nil.

No Subfloor insulation present at the time of inspection. We recommend engaging the services of an insulation specialist to install subfloor insulation.

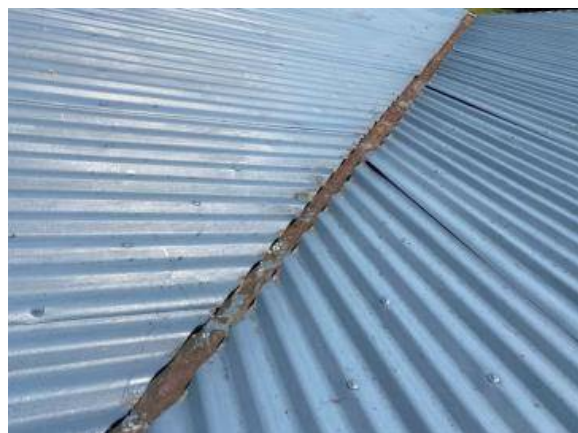
Evidence of corrosion to roof covering. We recommend engaging the services of a roofer to inspect covering further. Corrosion should be treated with a suitable rust inhibitor and painted to reduce the risk of damage to covering.

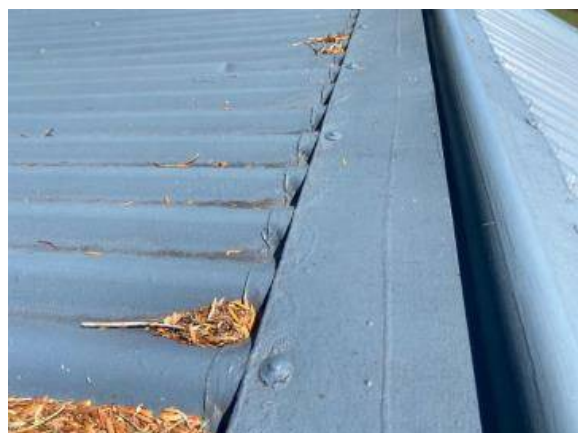
Numerous roof fixings have walked. These fixings will require tightening or replacement to ensure fixing penetrations remain watertight.

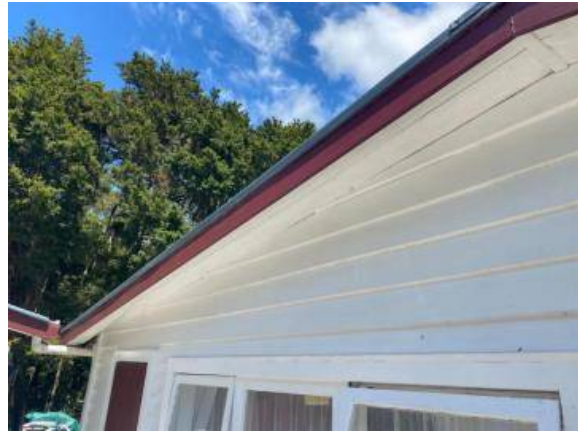
No scribed detail to cladding soffit junction. This is a potential moisture ingress point. We recommend sealing this junction to reduce the risk of moisture ingress.

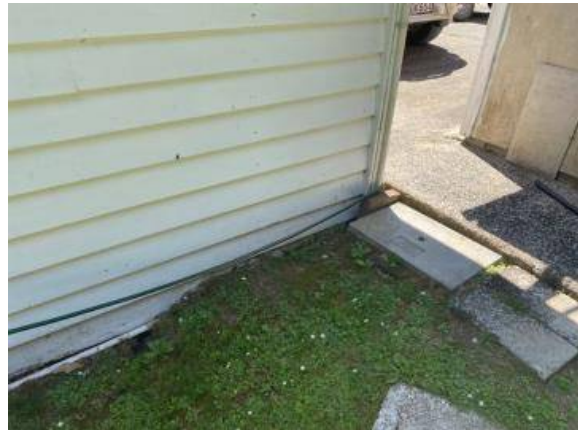
Unpaved ground level in close proximity to cladding base. A clearance of 180mm is recommended from cladding base to finished ground level to allow adequate cladding drainage. Finished ground level should be adjusted to meet minimum recommendations and reduce the risk of damage to cladding.
