Property Condition Report

**58 Keyte Street
Kensington
Whangarei District**

Inspection Date: 13/02/2021

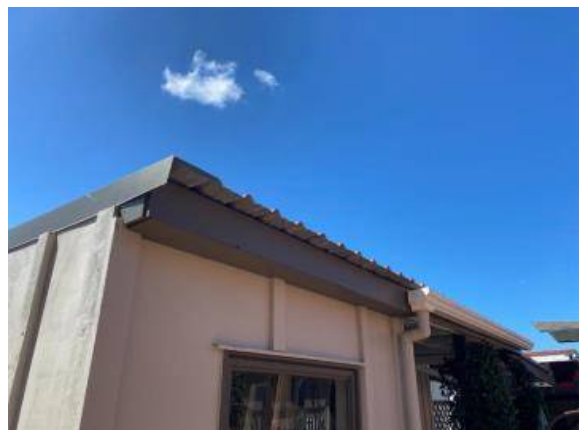
Gutter system to sleepout not complete. We recommend the installation of a gutter system to ensure rain water is diverted away from the building.

Gutter system to sleepout not complete. We recommend the installation of a gutter system to ensure rain water is diverted away from the building.

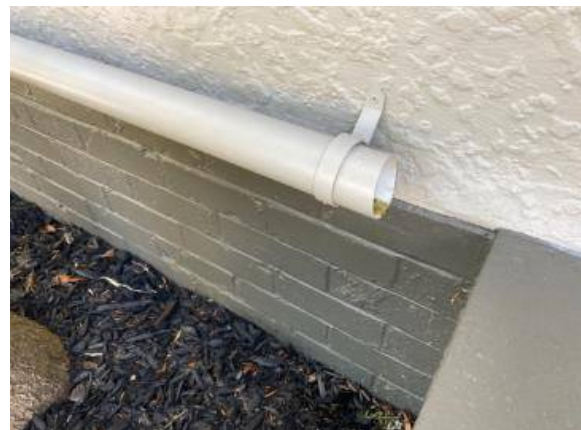
Pergola down pipe discharging to open ground. We recommend connecting to storm water service to ensure rain water is diverted away from building.

Pergola down pipe discharging to open ground. We recommend connecting to storm water service to ensure rain water is diverted away from building.

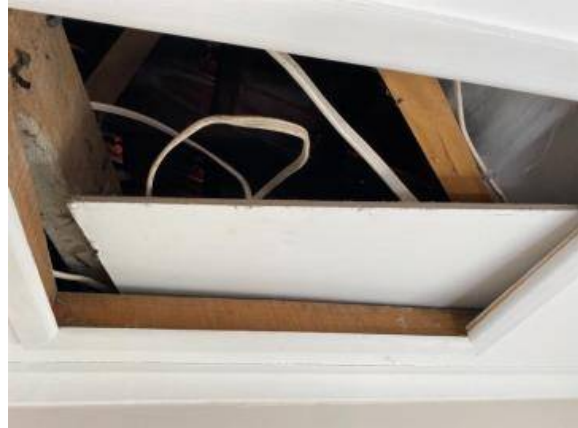
Unable to gain entry, access obstructed by timber batten.

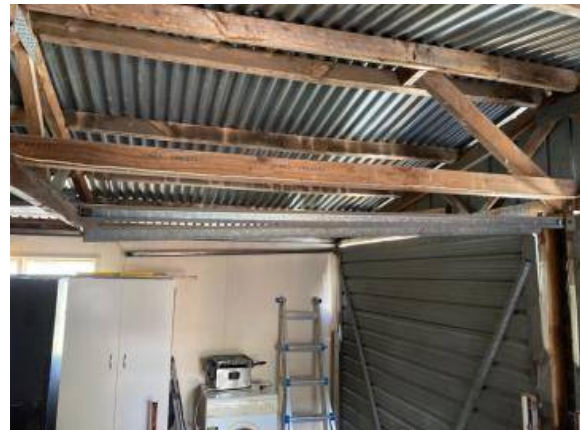
Door runners hung from rafters with chain. We recommend the installation of additional framing to ensure doors are safely secured.
