## **Property Condition Report**

**926 Whangarei Heads Road  
Parua Bay  
Whangarei District**

**Inspection Date:** 9/01/2021

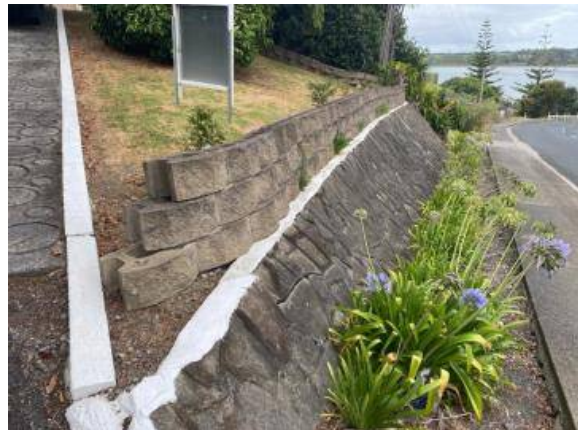
Visible settlement cracks to road facing retaining wall. We recommend monitoring these areas, if condition worsens engage the services of a structural engineer to inspect further.

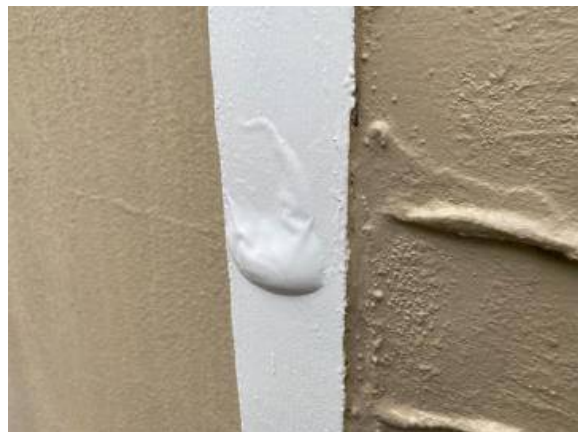
Blister in paint work holding moisture. We recommend engaging the services of a suitably qualified painter to repair this area. Isolated repair to this area may be achievable.

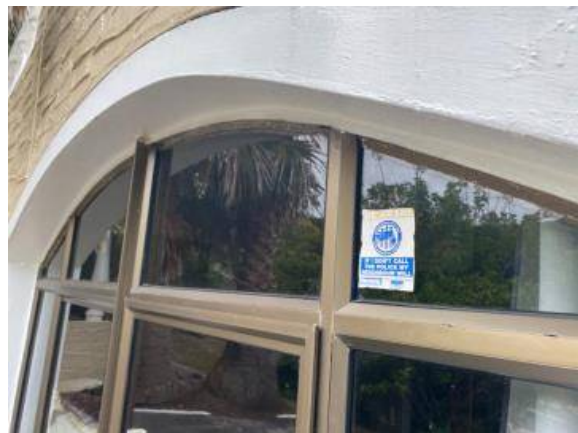
No head flashings to window joinery. Joinery has been face sealed to concrete. This may increase the risk of moisture ingress. We recommend monitoring this area. Further investigation may be required in these areas.

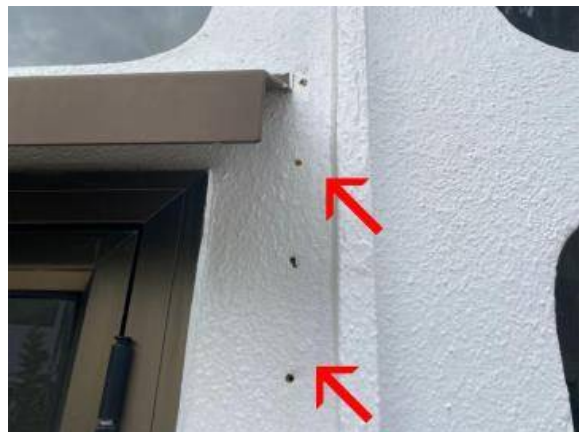
Redundant penetrations to cladding. Redundant penetrations may increase the risk of moisture ingress. We recommend sealing these details to ensure cladding remains weathertight.

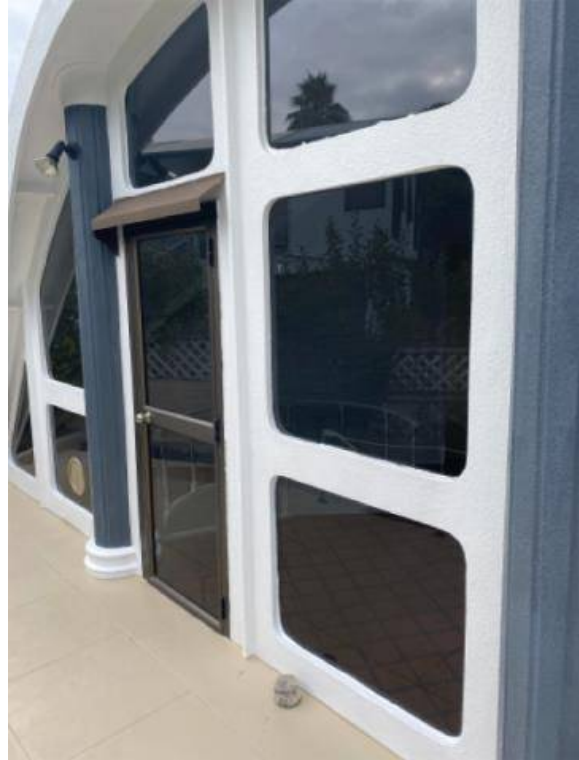
Glazing face sealed to cladding. This is considered a high risk moisture ingress point. We recommend monitoring these areas for signs of ingress. Sealant should be regularly checked and replaced as required.

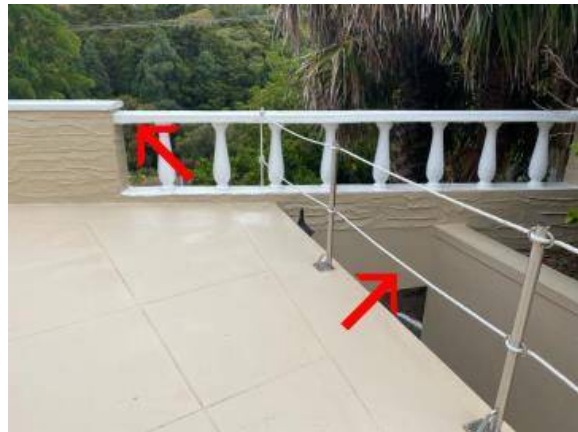
Handrail below 1m in height, handrail openings are greater than 100mm in diameter. This is a potential fall

hazard. We recommend upgrading hand rails to meet minimum recommendations.

Handrail below 1m in height, handrail openings are greater than 100mm in diameter. This is a potential fall hazard. We recommend upgrading hand rails to meet minimum recommendations.

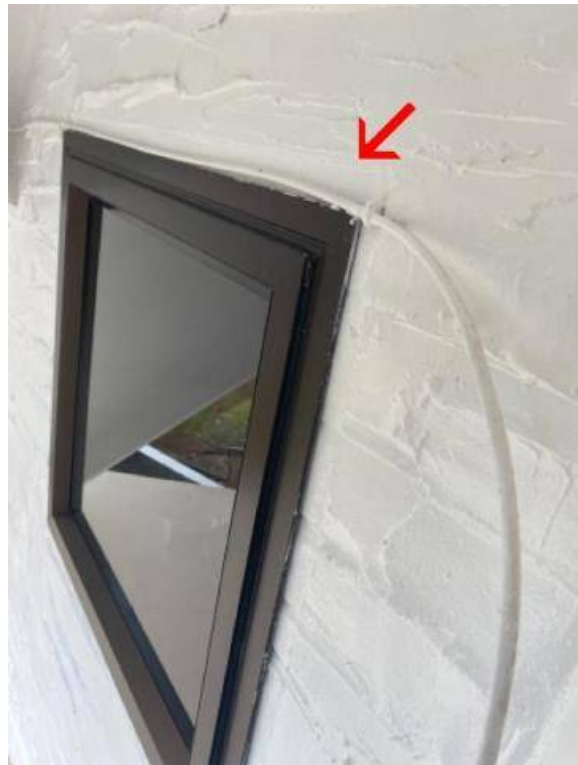
Aluminium joinery face sealed, no head flashing. This is considered a high risk moisture ingress detail. We recommend monitoring this area for signs of ingress. The installation of a suitable head flashing should be considered.

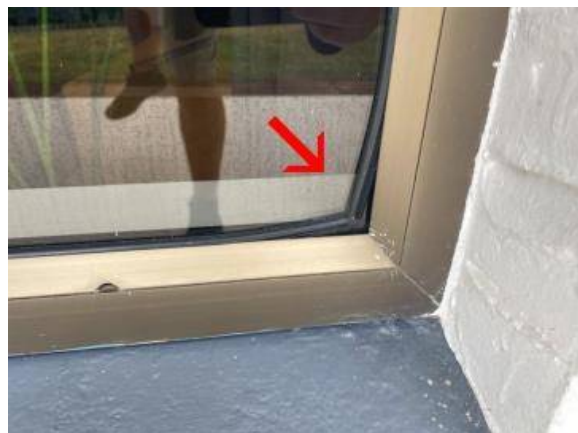
Joinery glazing rubbers have shrunk. Loose rubbers increase the risk of moisture ingress. We recommend engaging the services of a glazier to replace damaged rubbers to ensure glazing remains weathertight and secure.

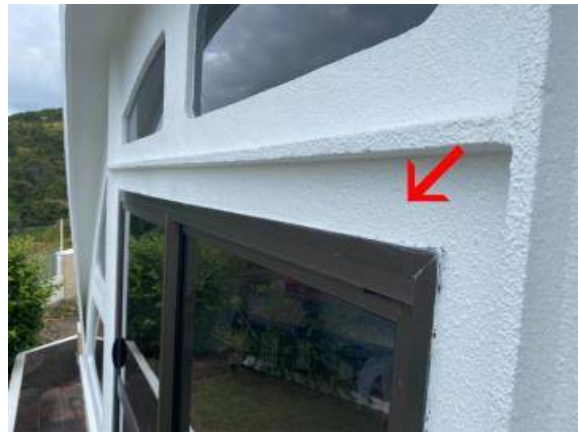
Aluminium joinery face sealed, no head flashing. This is considered a high risk moisture ingress detail. We recommend monitoring this area for signs of ingress. The installation of a suitable head flashing should be considered.

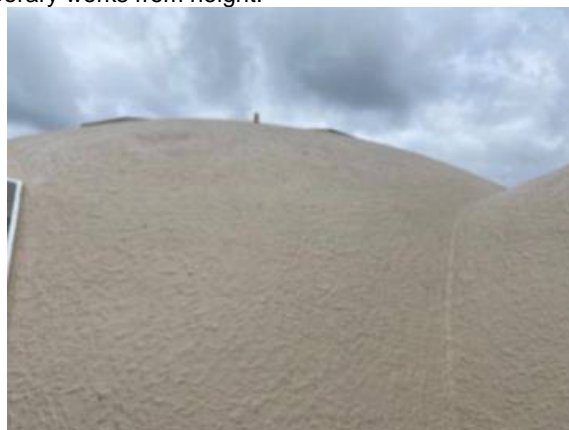
Roof covering consists of painted stucco. Due to the nature of design we recommend engaging the services of a suitably qualified weathertight specialist to inspect further and confirm condition.

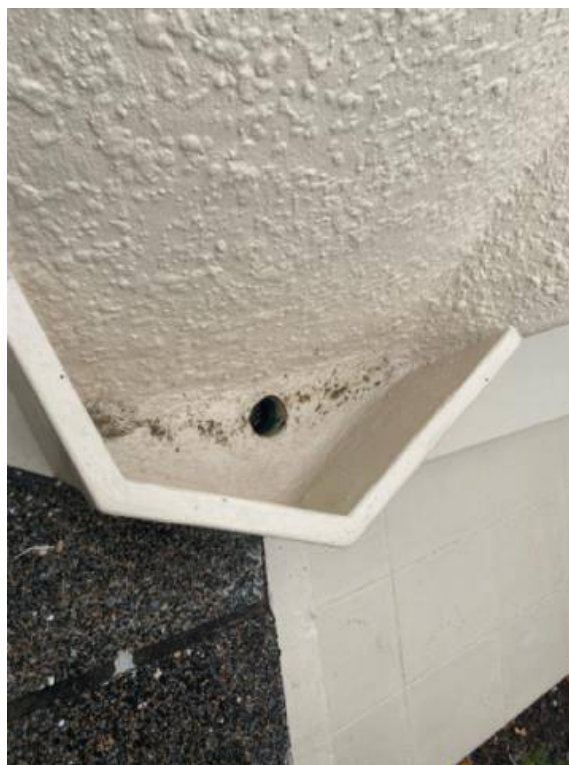
Water is diverted via curved roof to concrete troughs at base of roof line. Unable to confirm specific design is sufficient for roof catchment. Further investigation by a suitably qualified weathertight specialist recommended.

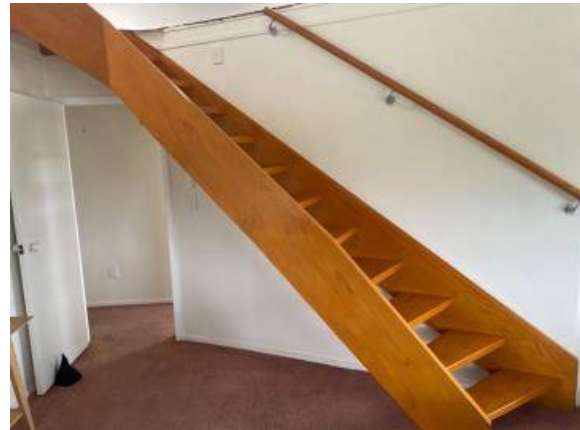
No handrail/barrier to side of staircase, this presents a potential fall hazard of 1m or more. Minimum recommendations require the installation of a barrier where people could fall 1mtr or more. We recommend engaging a Builder to install a suitable handrail/barrier as required.

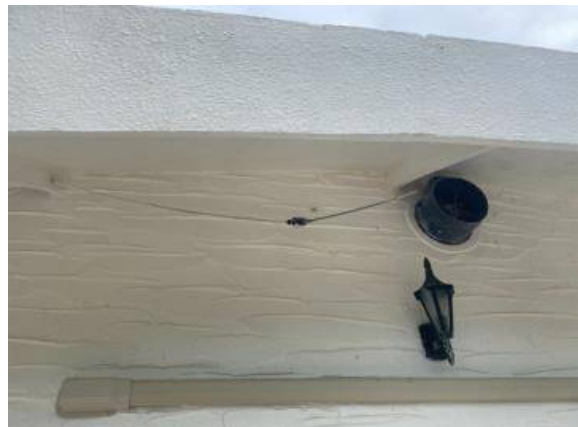
Power lead run externally to supply extraction unit. We recommend engaging the services of an electrician to install an external RCD supply.

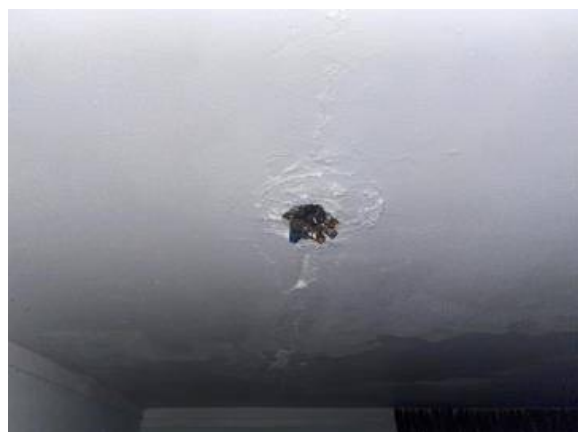
Redundant wiring to ceiling in garage. We recommend engaging the set of an electrician to inspect and isolate as required.
