Land Information Memorandum

LAND INFORMATION MEMORANDUM NO: LM2400453

Property ID: 165537
Street Address: 6 Pahau Avenue, Whangarei 0112
Legal Description: LOT 26 DP 492043

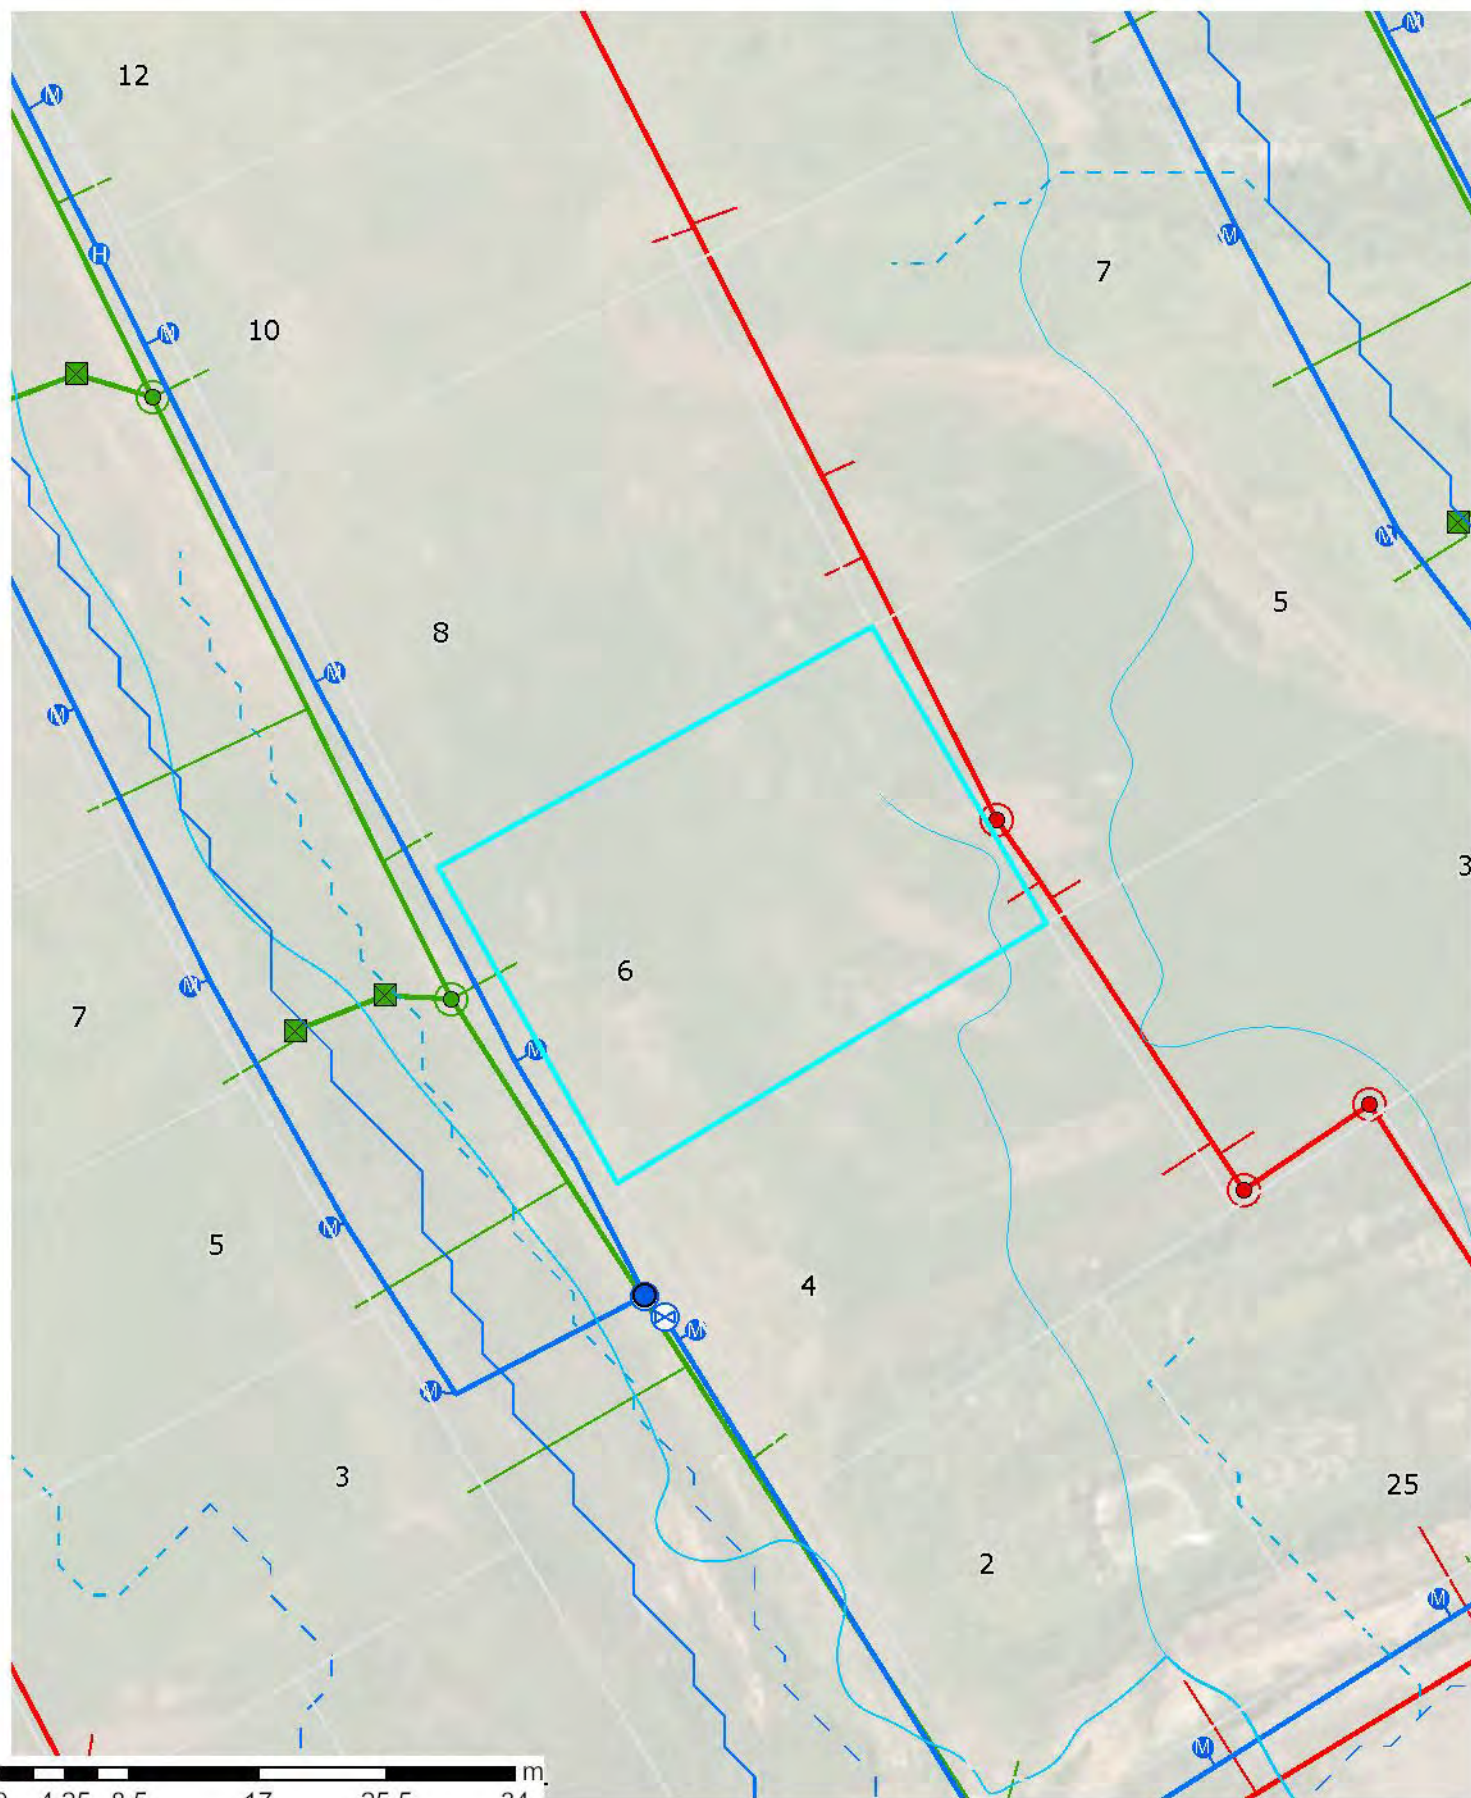
Water, Wastewater and Stormwater

This information is generalized and shows the approximate location of the Public pipeline services.
For digging, the As-Built engineering drawings must be used to accurately locate the services.
See WDC Customer Services.

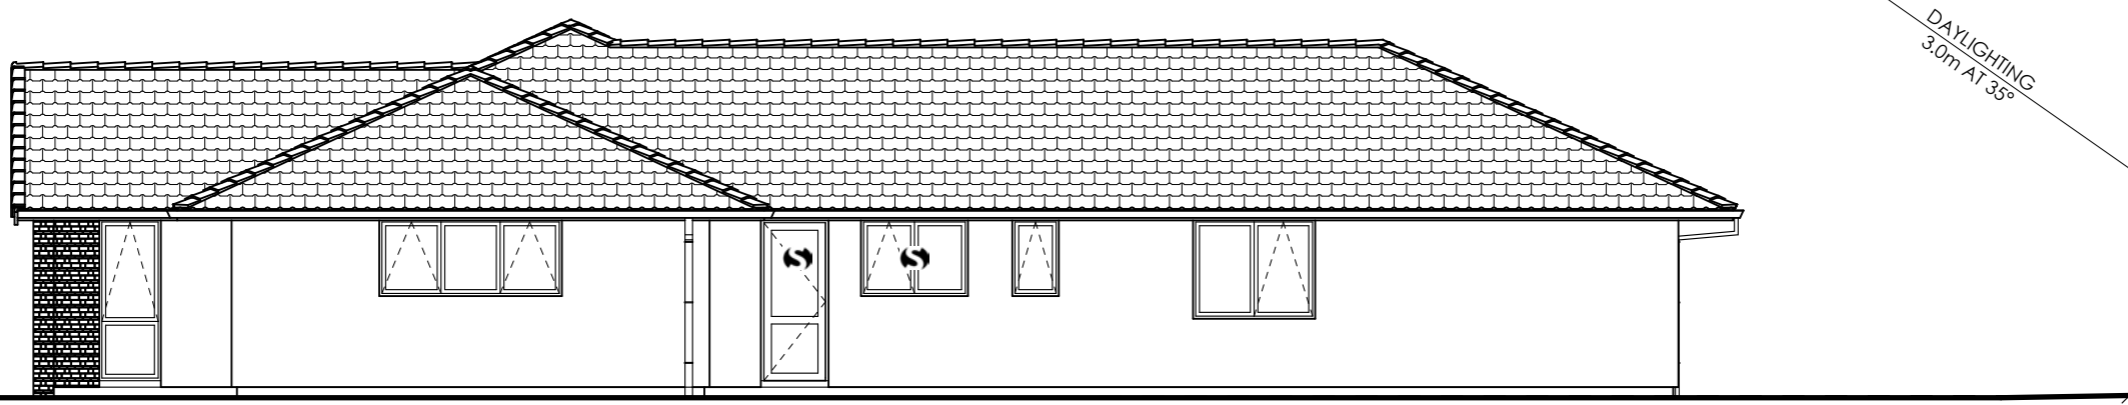
ELEVATION 1
(SOUTHERN)

BUILDING ENVELOPE RISK MATRIX		
ELEVATION 1		
Risk Factor	Risk Severity	Risk Score
Wind zone (per NZS 3604)	High risk	1
Number of storeys	Low risk	0
Roof/wall intersection design	Low	0
Eaves width	Low risk	0
Envelope complexity	Low risk	0
Deck design	Low	0
Total Risk Score:		1

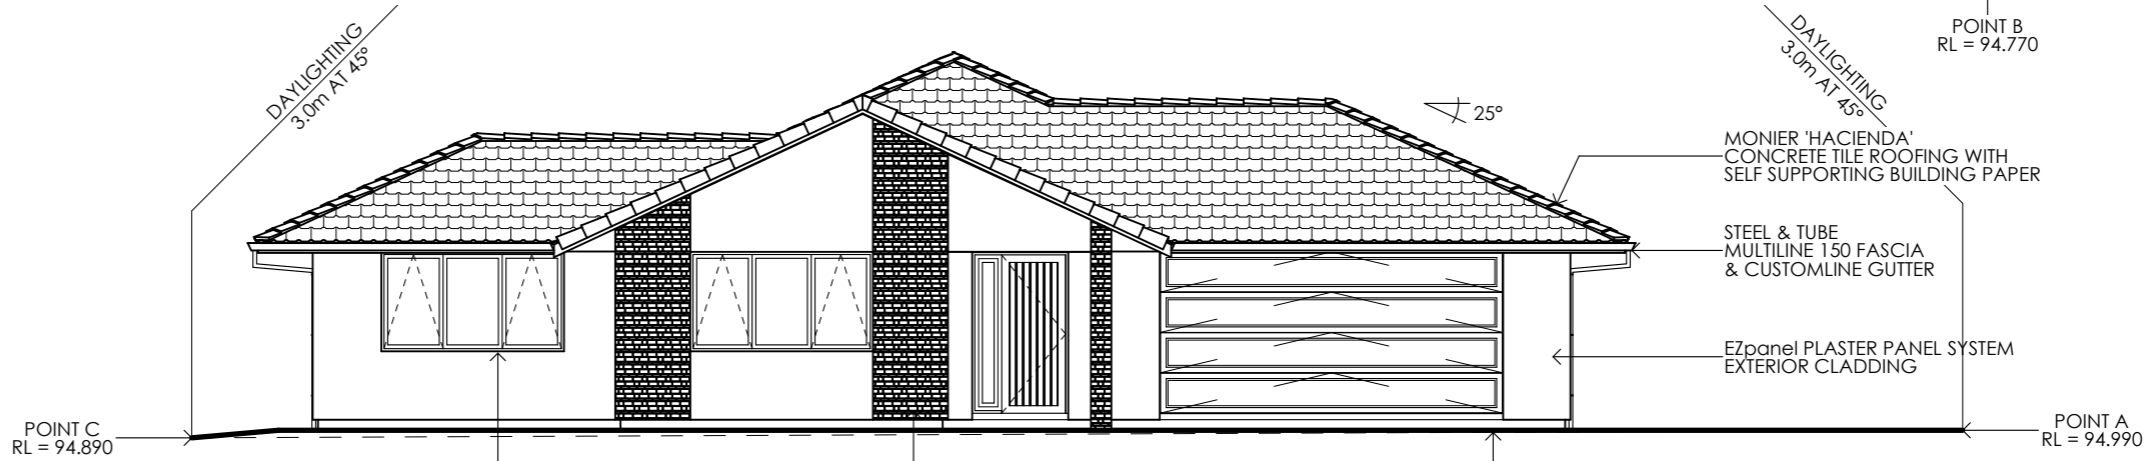
ELEVATION 2
(WESTERN)

BUILDING ENVELOPE RISK MATRIX		
ELEVATION 2		
Risk Factor	Risk Severity	Risk Score
Wind zone (per NZS 3604)	High risk	1
Number of storeys	Low risk	0
Roof/wall intersection design	Low	0
Eaves width	High risk	2
Envelope complexity	Low risk	0
Deck design	Low	0
Total Risk Score:		3

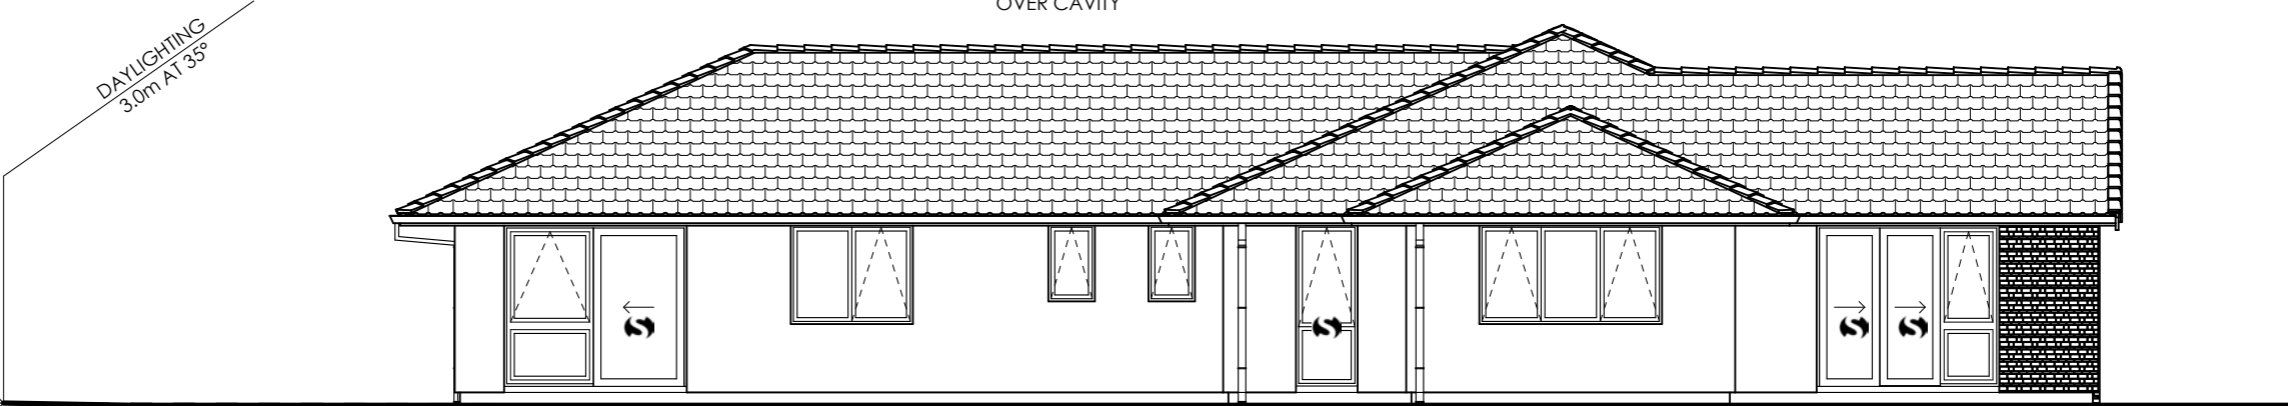
ELEVATION 3
(NORTHERN)

BUILDING ENVELOPE RISK MATRIX		
ELEVATION 3		
Risk Factor	Risk Severity	Risk Score
Wind zone (per NZS 3604)	High risk	1
Number of storeys	Low risk	0
Roof/wall intersection design	Low	0
Eaves width	Low risk	0
Envelope complexity	Low risk	0
Deck design	Low	0
Total Risk Score:		1
