Land Information Memorandum

LAND INFORMATION MEMORANDUM NO: LM2200153**Received: 26 Jan 2022****Issued: 09 Feb 2022****Section 44A, Local Government Official Information
And Meetings Act 1987****APPLICANT**

Property ID: 167120
Street Address: 56 Bush Haven Drive
Kamo 0112
Legal Description: LOT 45 DP 507433

EARTHWORKS COMPLETION REPORT

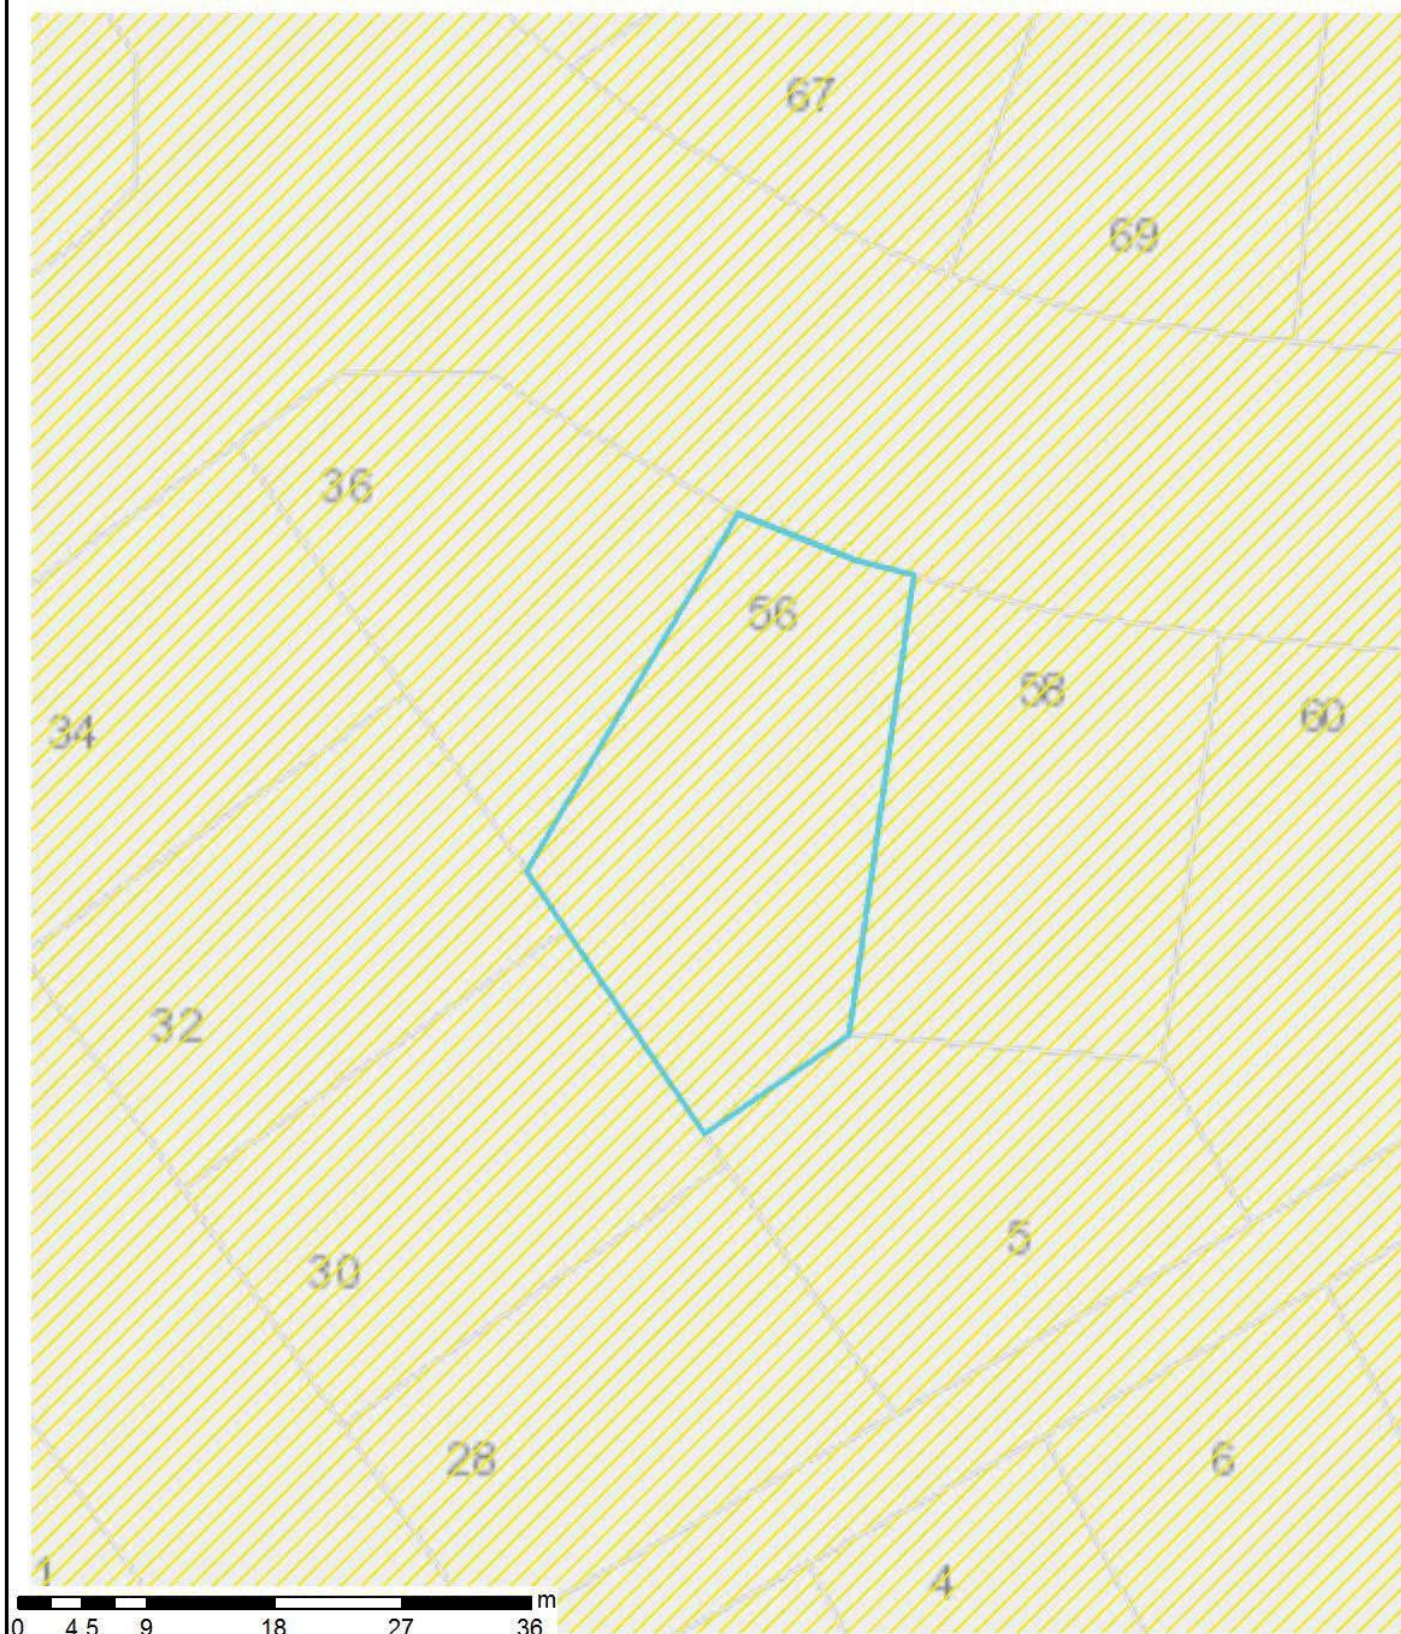
- Stability Hazards map - showing low stability hazard

This Land Stability hazard information was prepared by Tonkin and Taylor Engineers Ltd.

This property is located in an area that is included in a report by Tonkin & Taylor Ltd on stability hazard potential, see map attached and refer
