# Building Inspection Report

Client: Harcourts Whangarei  
Location: 10 Louisa Lane, Kamo  
Whangarei

Inspection Date: 06/05/2020

RE: Building Inspection Report, 10 Louisa Lane, Kamo, Whangarei.

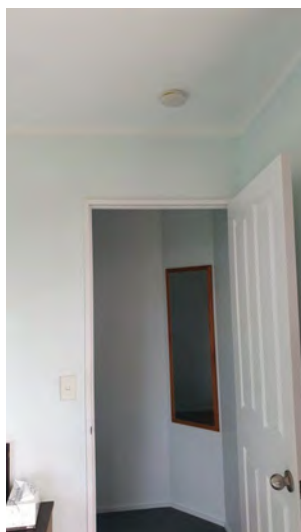
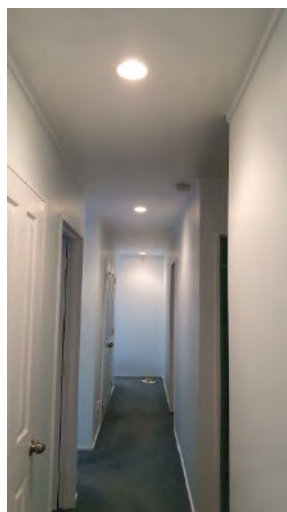
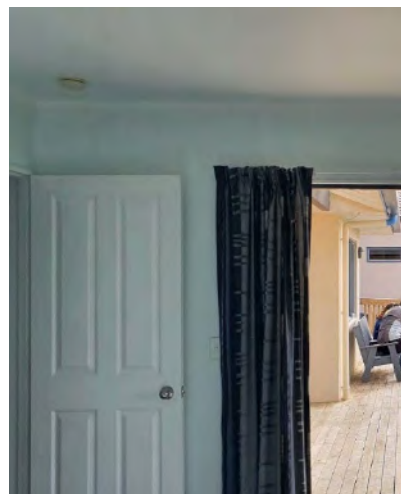
No testing was done on the alarms to check if they are working.

Present in master bedroom, hallway and lounge

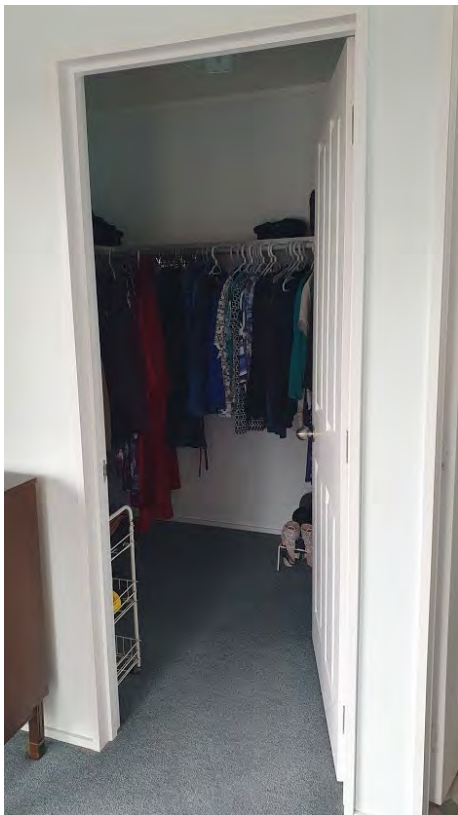
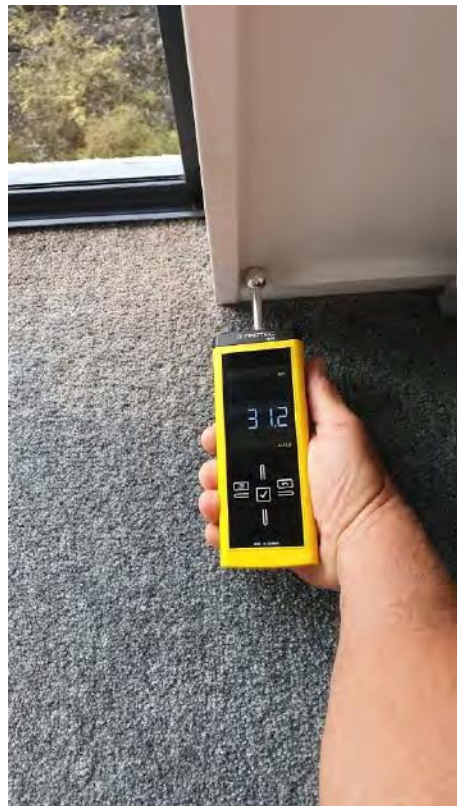
Master bedroom window: Under current building requirements, this glass would be safety glass. Recommendation is to swap out and replace the existing glass panel to safety glass.

- Master bedroom window: Under current building requirements, this glass would be safety glass. Recommendation is to swap out and replace the existing glass panel to safety glass.

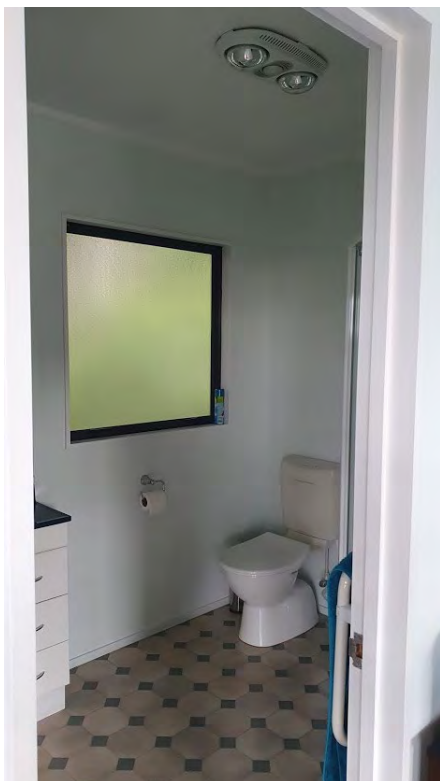
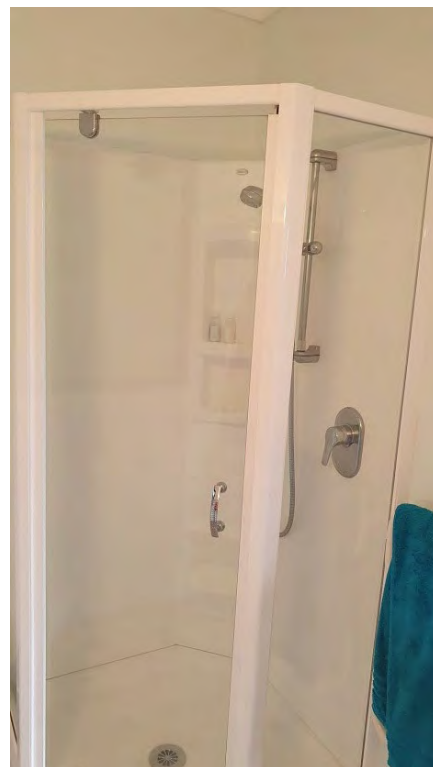
Ensuite window requires security stays to protect from falling- a simple fix for a builder or Aluminium joiner to comply with today's building standards

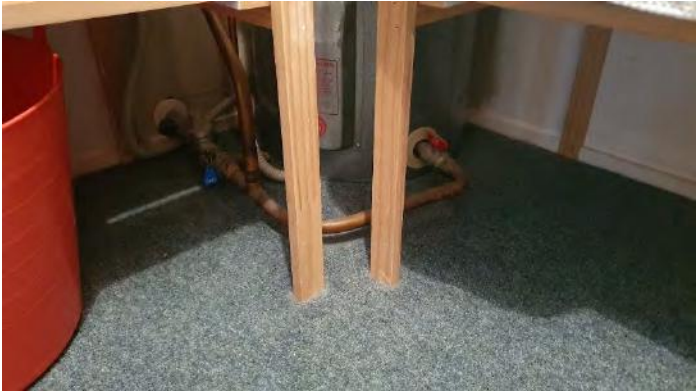
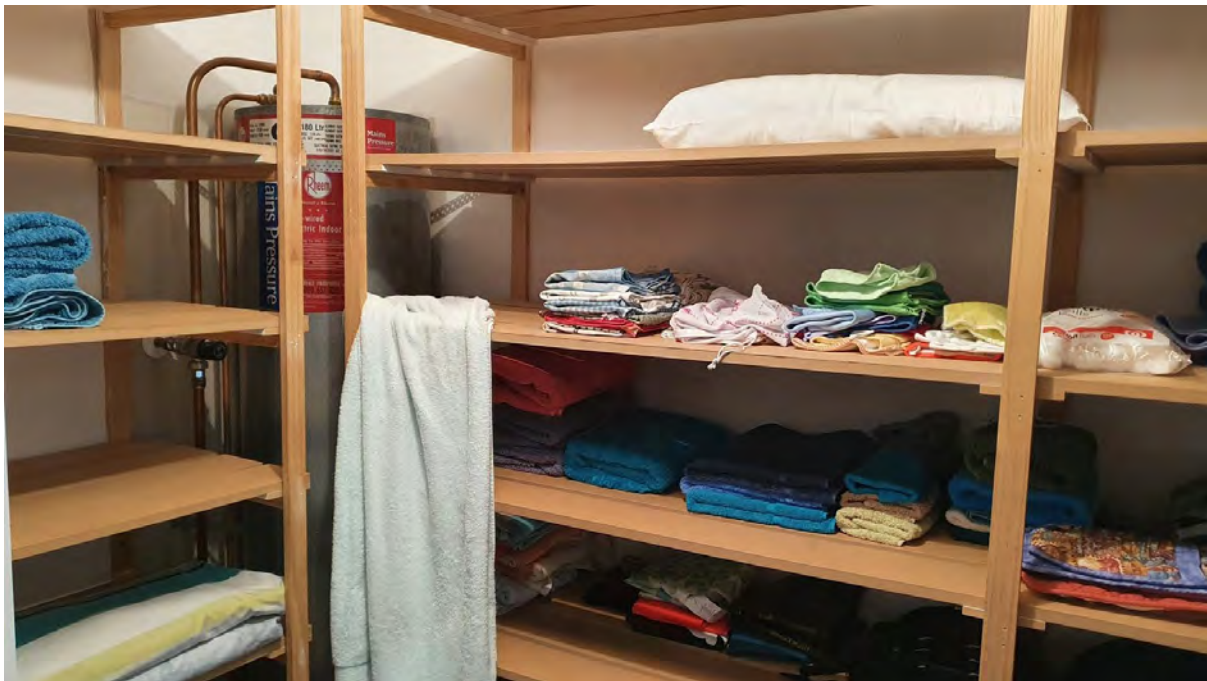
For best practice, hot water cylinder should be on a tray in case it ever leaks

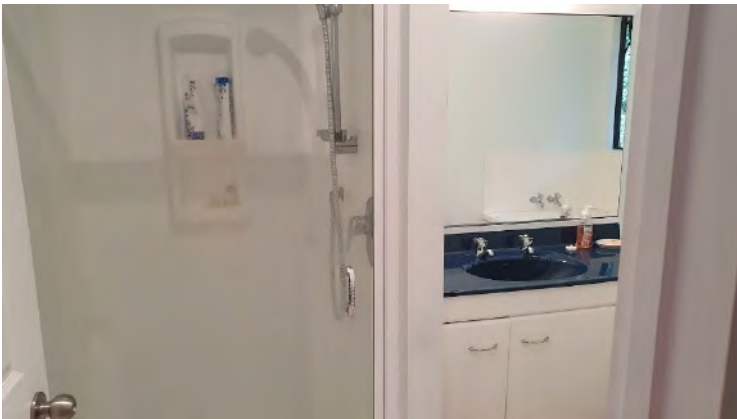
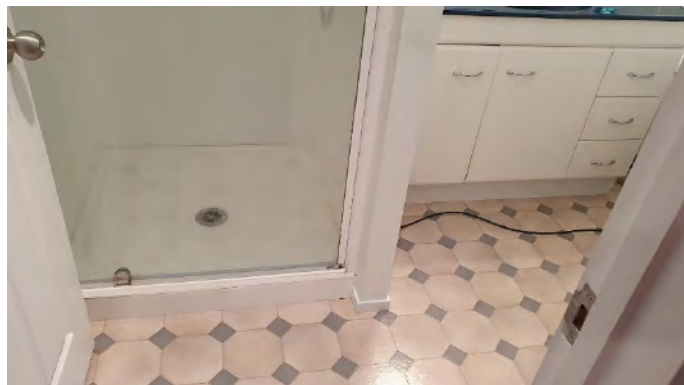
Looks to be a dehumidifier in bathroom on day of inspection.

Moisture meter readings were in acceptable range for a bathroom

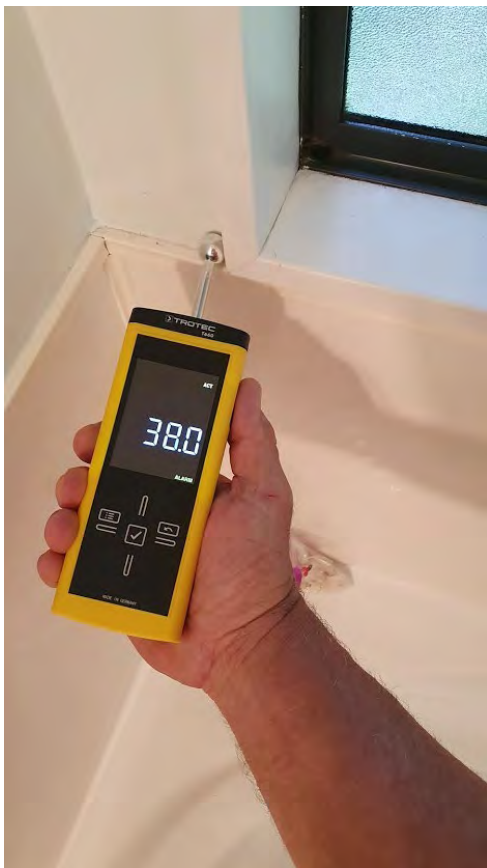
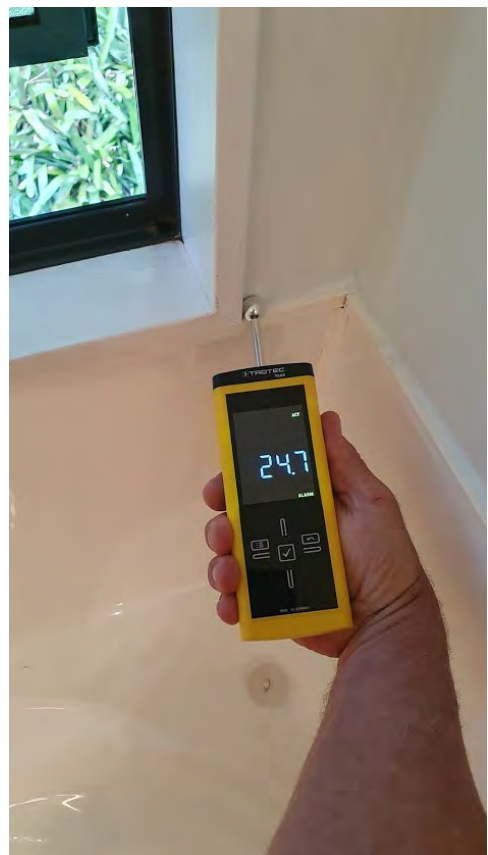
Main bathroom window requires security stays to protect from falling- a simple fix for a builder or Aluminium joiner to comply with today's building standards

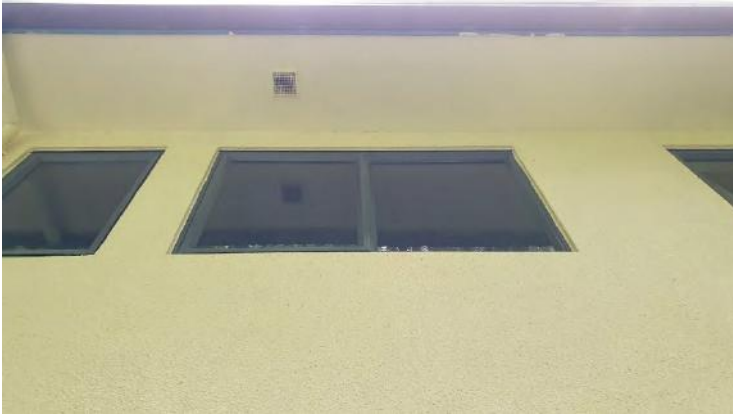
Insuclad does not sit on a cavity. This is how these homes were built late 90s early 2000s. Current standards, you would have a cavity. Visually, I cannot see any problems with moisture ingress.

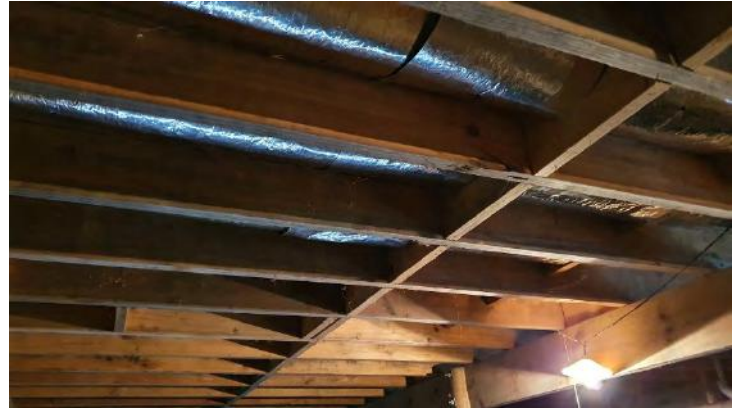
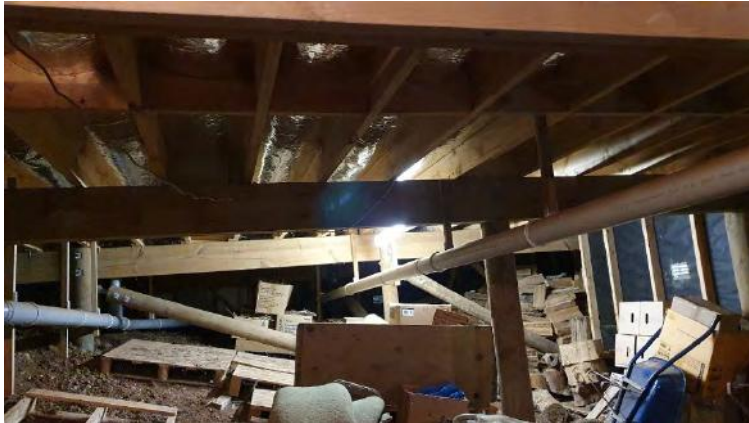
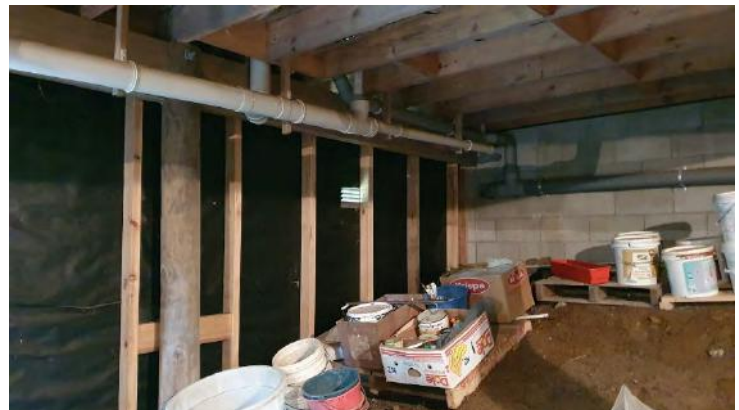
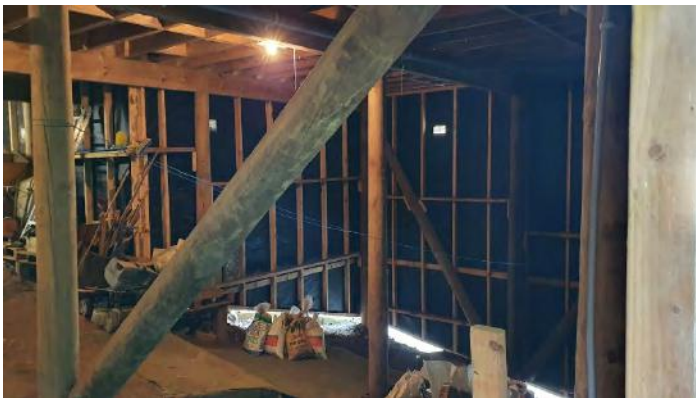
No underfloor insulation

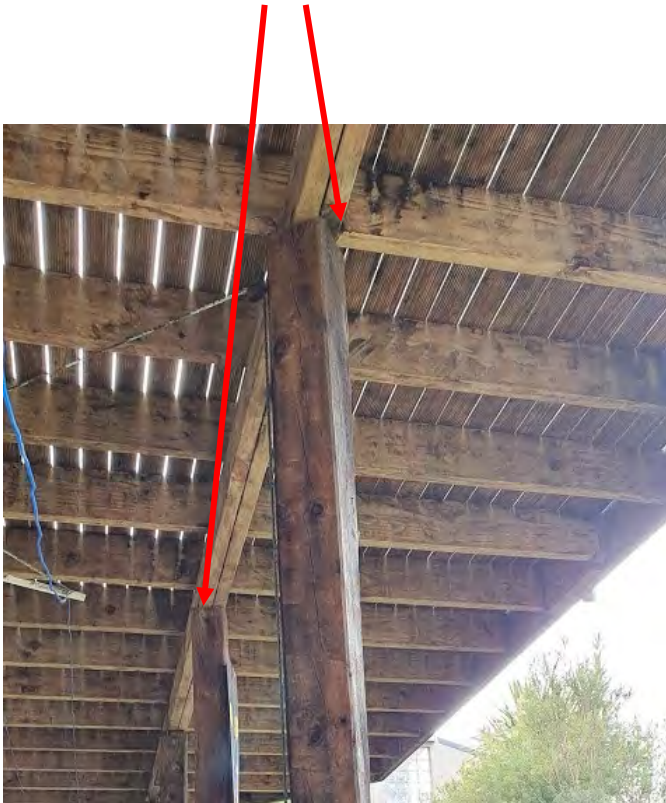
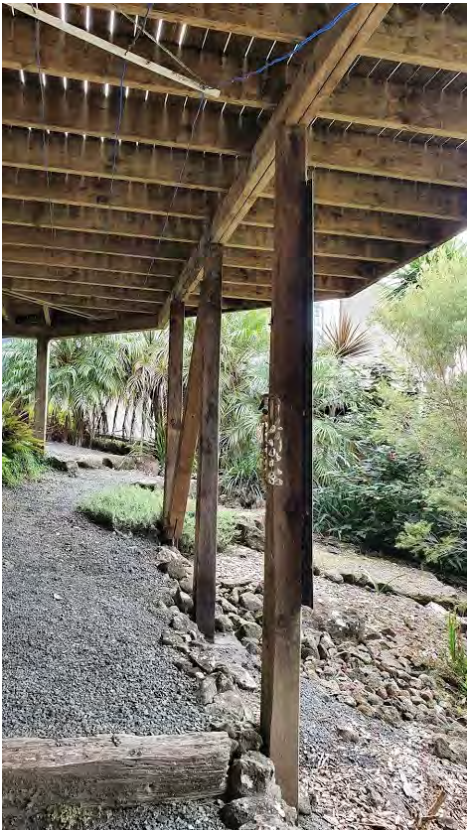
Deck posts to rear have twisted and recommend replacing.
