Property Condition Report

**94 Cemetery Road
Maunu
Whangarei District**

Inspection Date: 13/02/2021

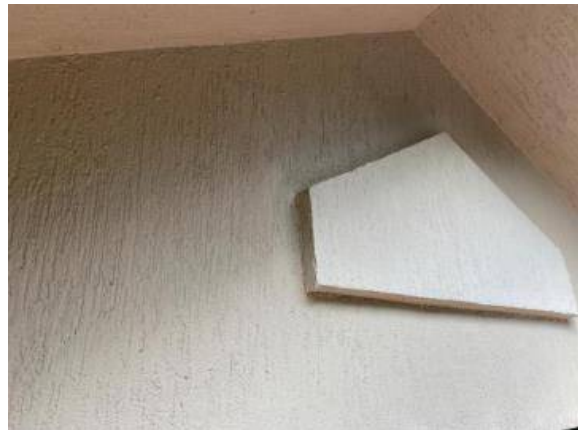
Paved ground level in close proximity to cladding base. A clearance of 100mm is recommended from cladding base to paved ground level to allow adequate cladding drainage. We recommend modifying paving height to meet minimum recommendations and reduce the risk of damage to cladding. Unable to confirm the condition of internal framing in this area at the time of inspection.

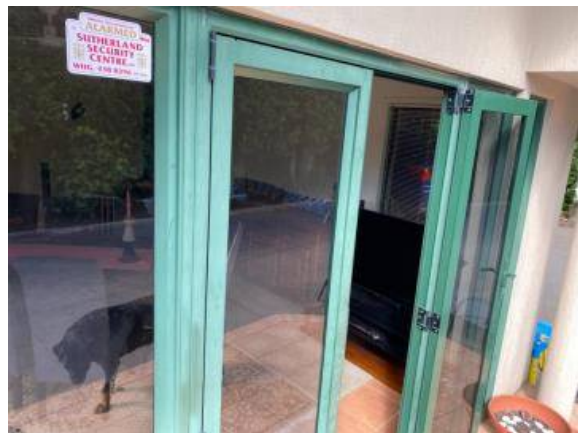
Poor threshold to joinery/patio junction. Joinery base has been sealed against tiles. This is considered a high risk moisture ingress point. We recommend engaging the services of a suitably qualified contractor to modify this detail as required.

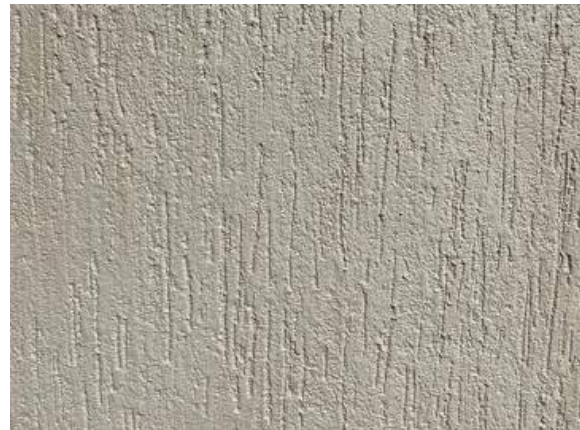
Unpaved ground level in close proximity to cladding base. A clearance of 180mm is recommended from cladding base to unpaved ground to allow adequate cladding drainage. We recommend modifying finished ground level to meet minimum recommendations and reduce the risk of damage to cladding. Unable to confirm the condition of internal framing in this area at the time of inspection.

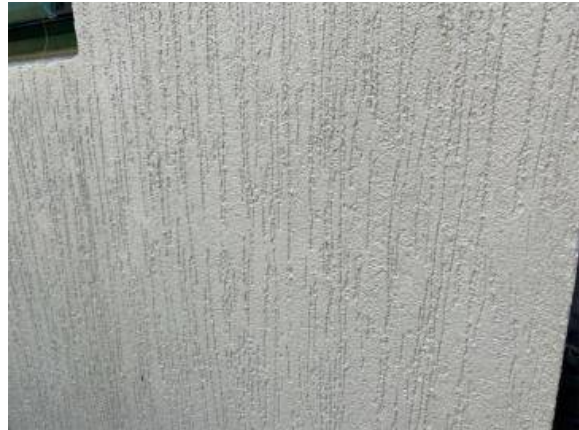
Void between cladding and metal barge board. This may increase the risk of moisture ingress or vermin entry. We recommend engaging the services of a suitably qualified contractor to modify or repair this detail as required.

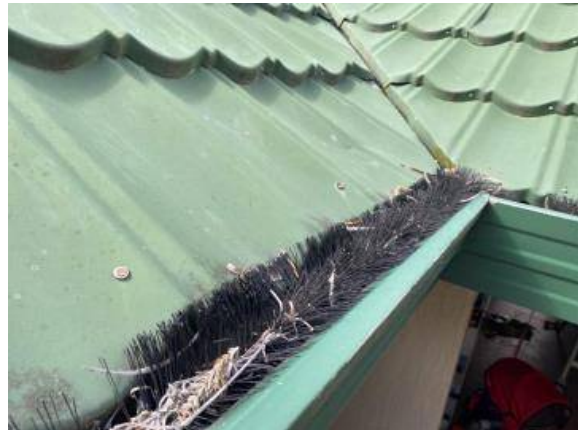
Internal gutter system, unable to inspect due to installation of debris guard. We recommend frequent inspection of gutter system to confirm condition. Gutter system failure can cause water to back flow into roof space.

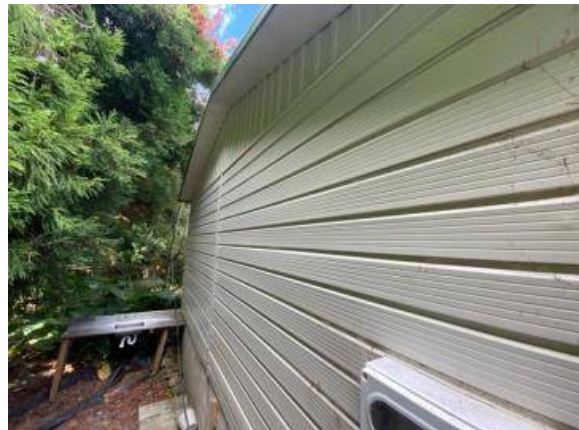
Meter box penetrates exterior cladding. No head flashing detail. This is a considered a high risk detail. Where possible we recommend engaging the services of a suitably experienced cladding specialist to modify this detail and ensure the appropriate flashing details are installed.

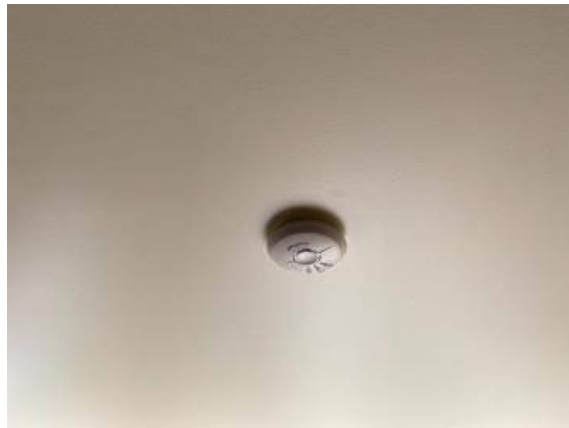
Individual Smoke detection devices. Not tested as part of this inspection. Periodic inspection is advise to ensure all devices are in working order.

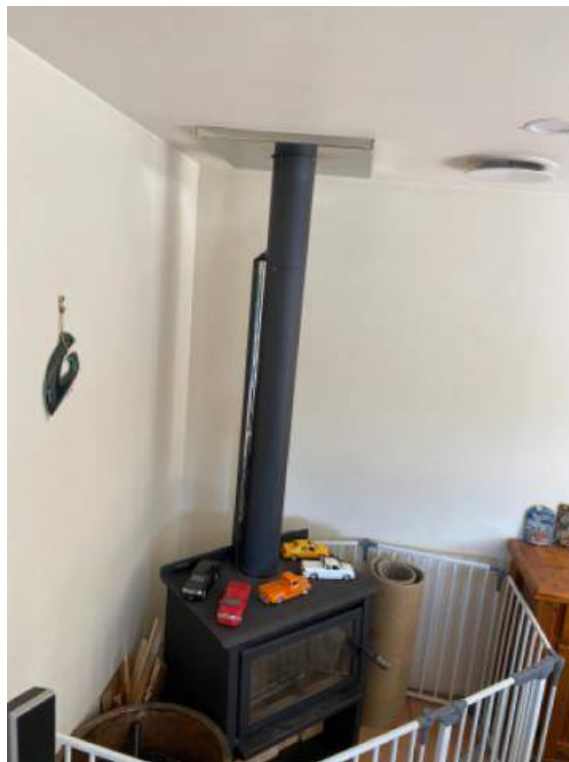
Freestanding log Burner. This unit was not assessed as it falls outside the scope of this inspection, further inspection from a heating specialist is recommended.

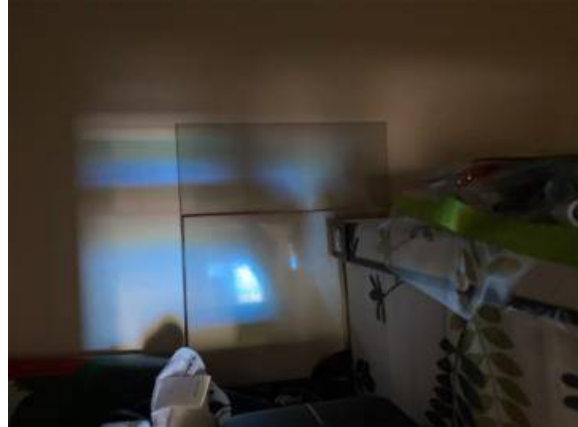
RCD switchboard
located in bedroom first
right closet.

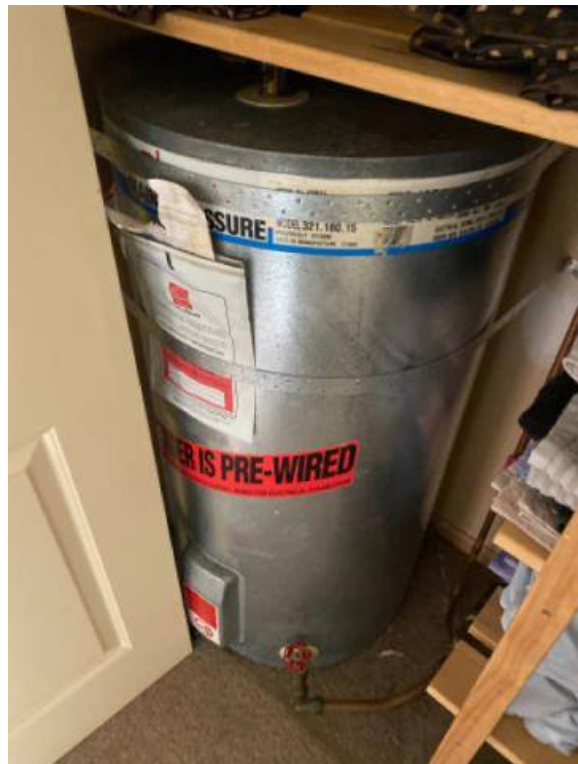
Hot water cylinder.
Cylinder is restrained.
