Building Inspection Report

Client: Paul Sumich
Location: 25 Tapper Crescent, Tikipunga
Whangarei

Inspection Date: 09/11/2021

RE: Building Inspection Report, 25 Tapper Crescent, Tikipunga, Whangarei.

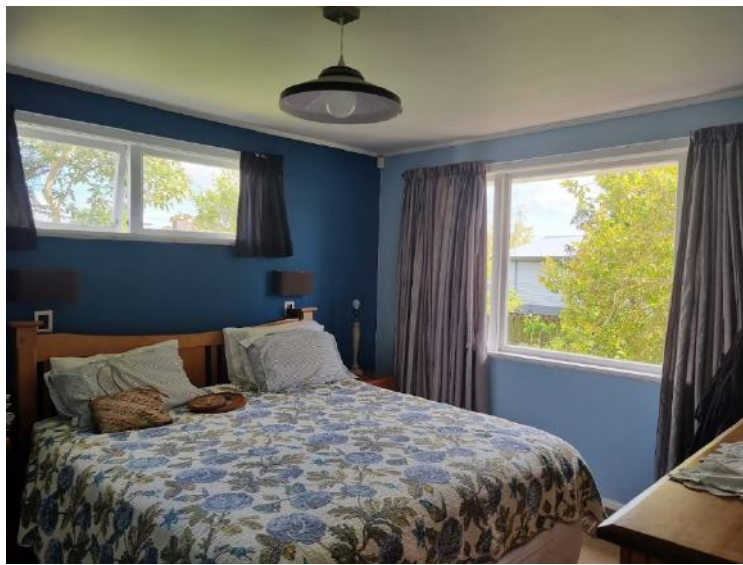
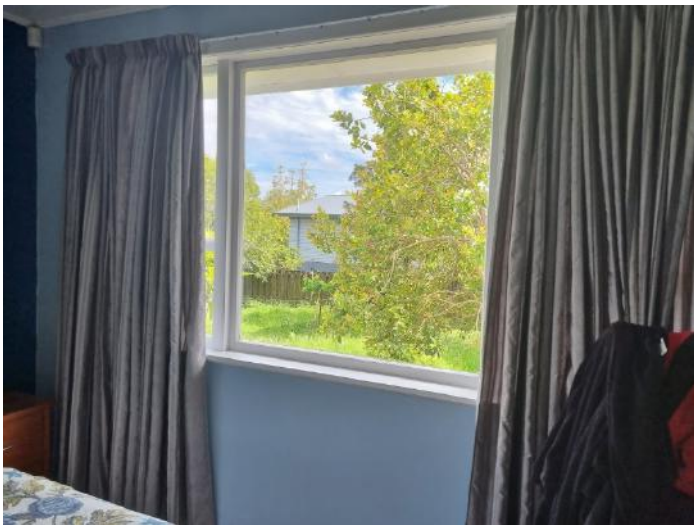
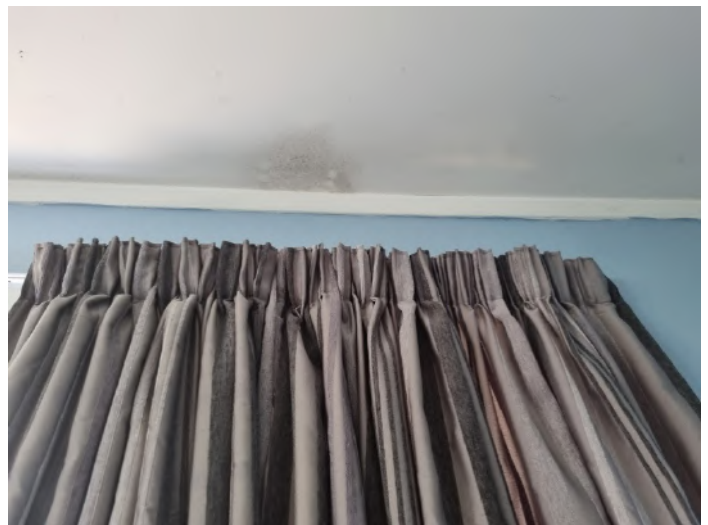
Bedroom 3

Patch of mould present to right hand side of main window in bedroom 3 (Master). Moisture reading is 4.5 and is not showing any signs of damp.

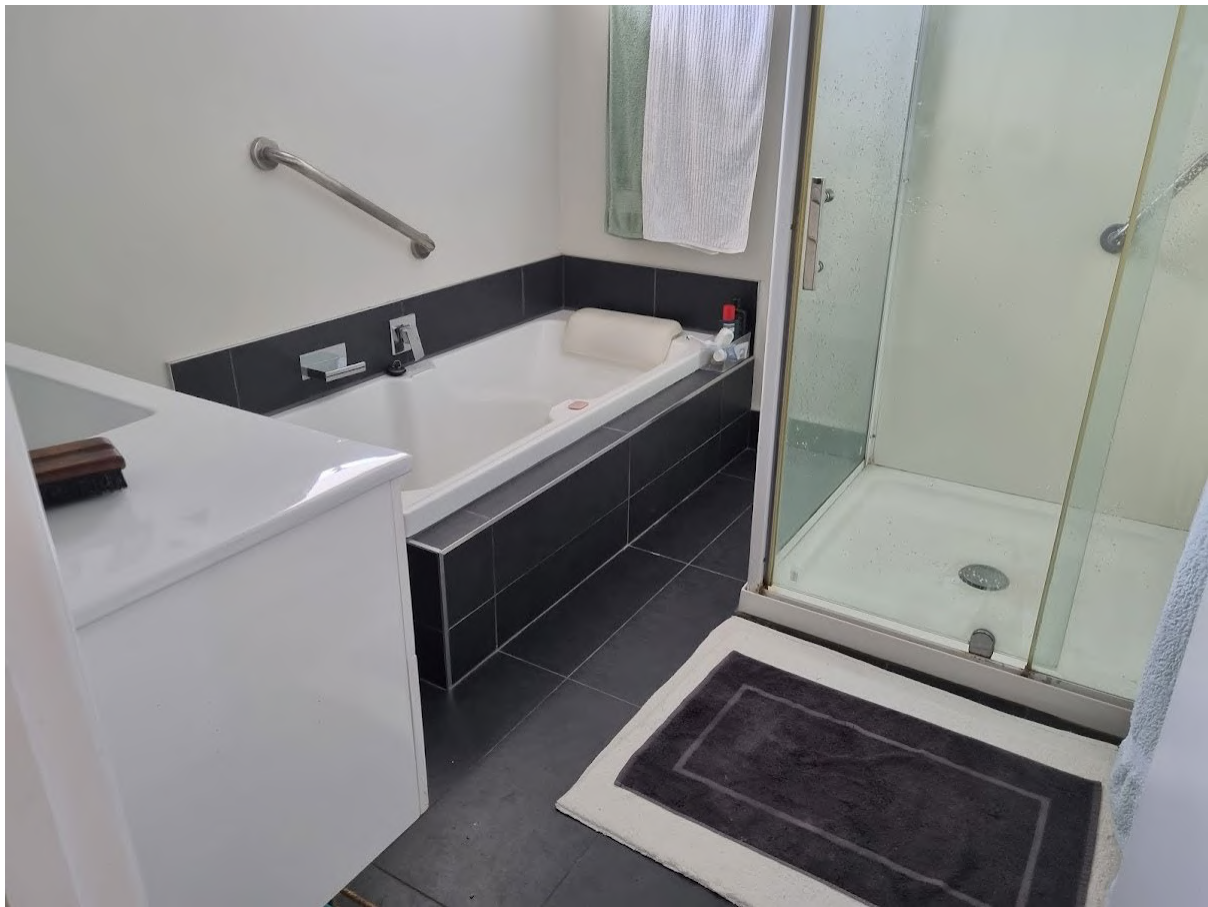
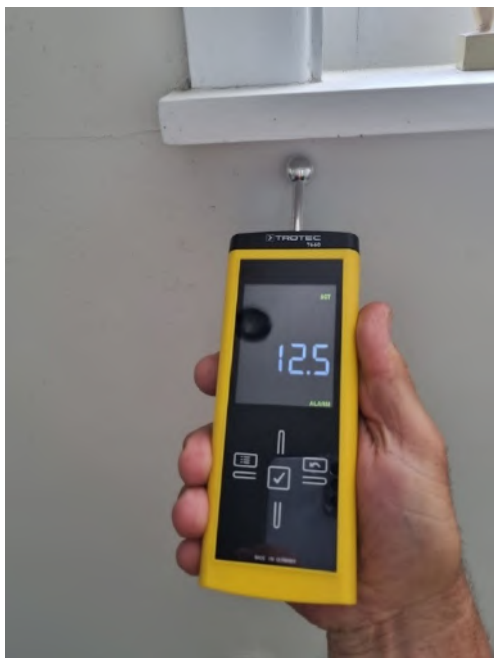
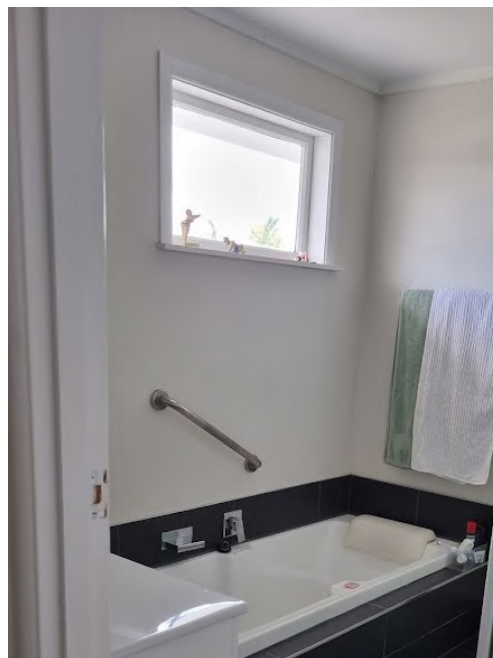
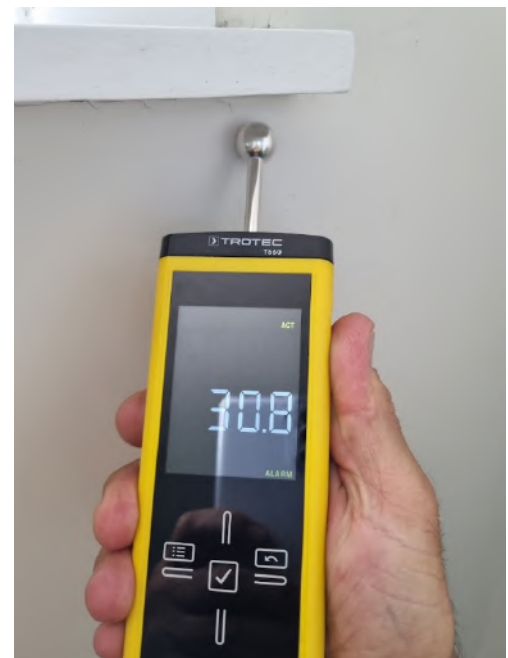
- Bathroom is showing signs of mould to the ceiling and upper wall area, ventilation system and a clean is recommended.
- Mould present to ceiling and on wall at the top in the separate toilet – ventilation system and a clean is recommended

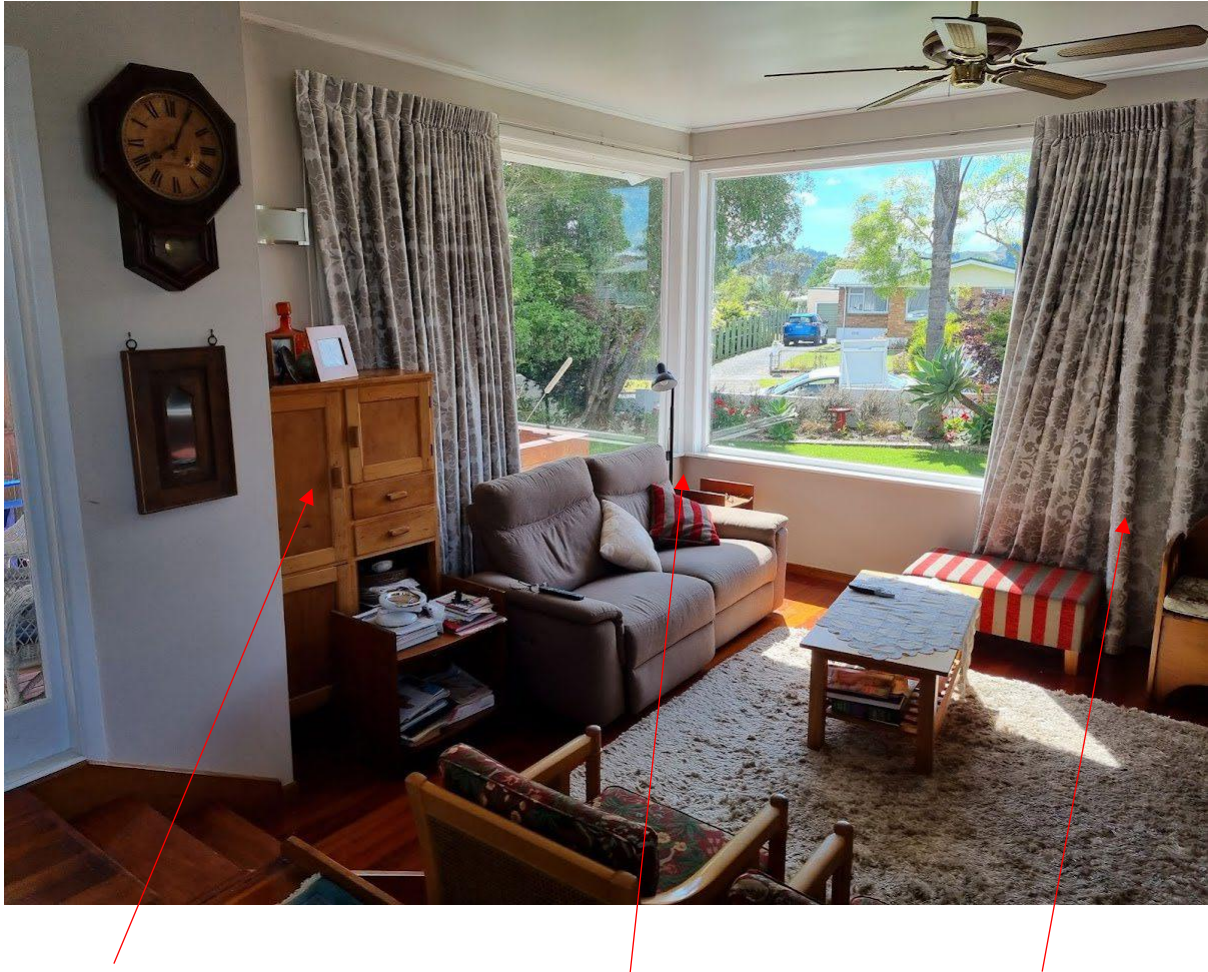
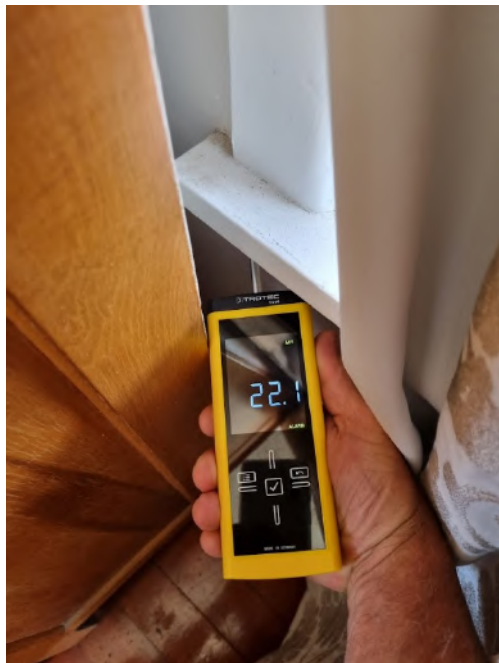
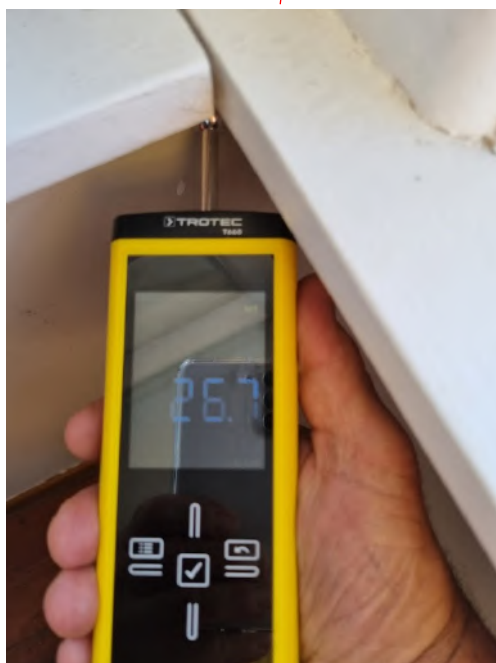
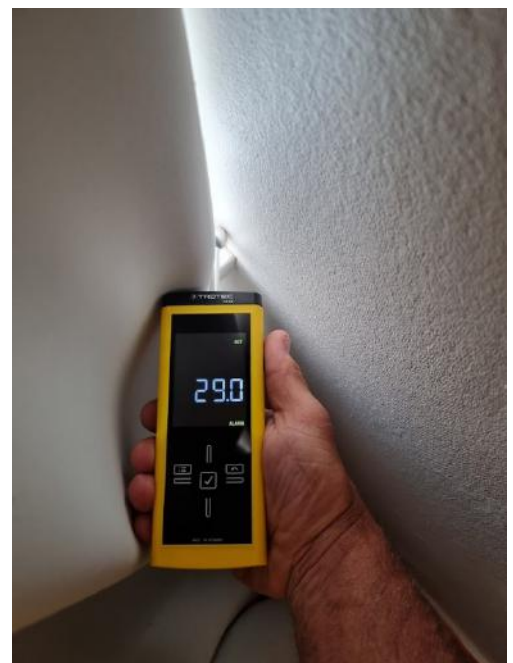
Lounge

- Crack in the lounge ceiling where it shows slight sagging, unable to obtain a moisture reading. Could be a result for several reasons, it does appear dry at this point.

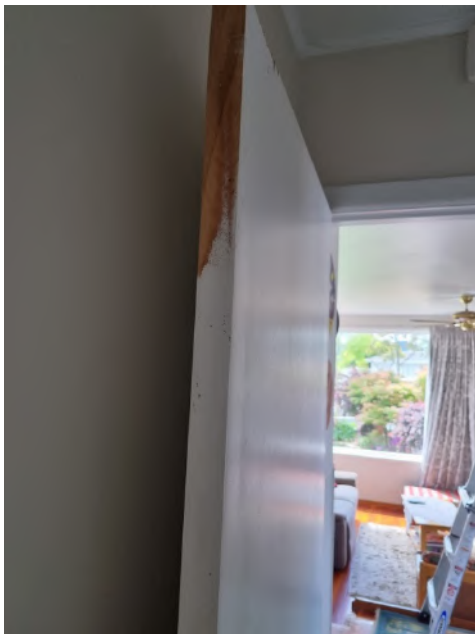
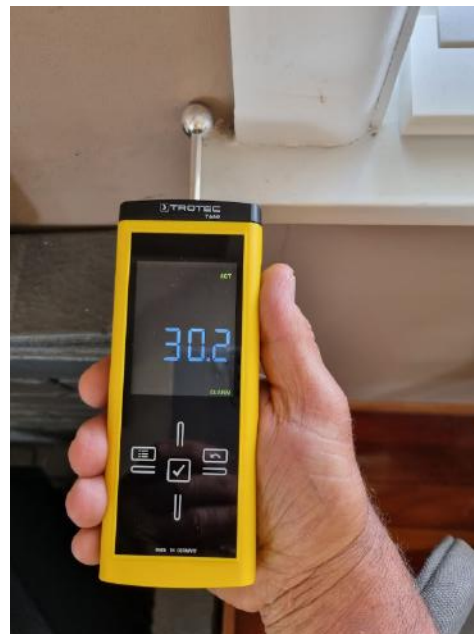
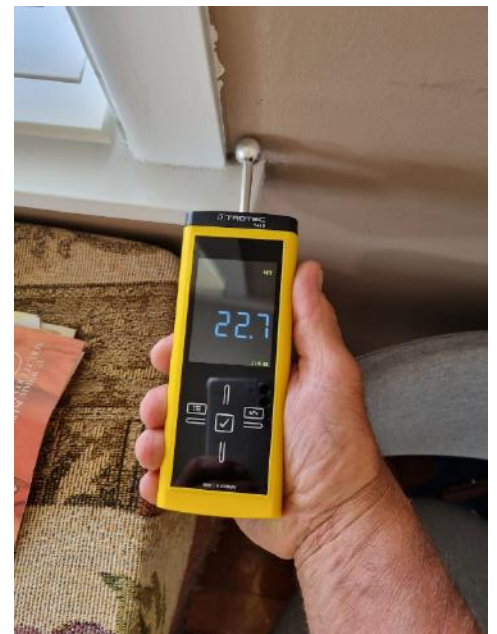
Dining

Door is sticking from the hallway to the living area

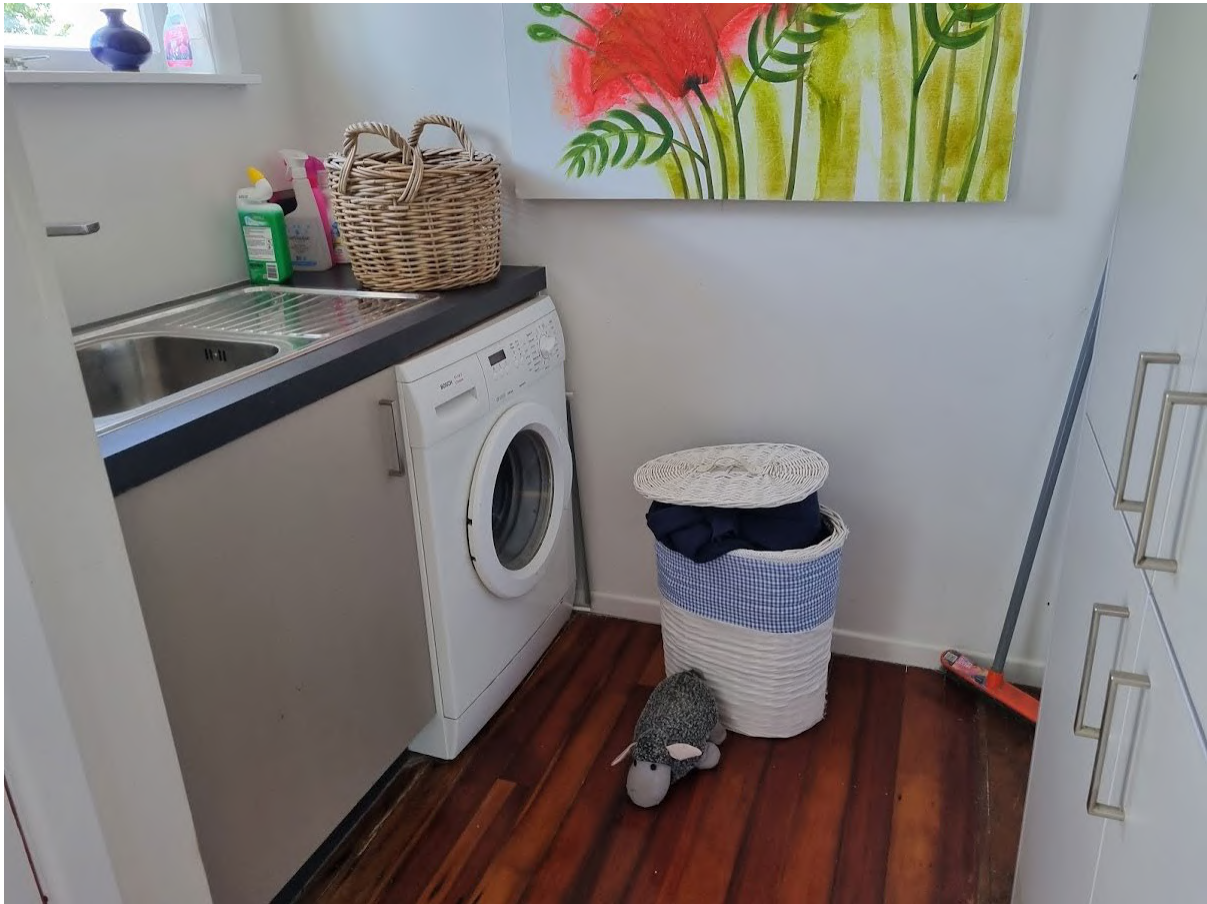
Laundry

Cannot find manhole to inspect the roofing space, this means it is unknown if the ceiling is insulated or the condition of the roof structure.

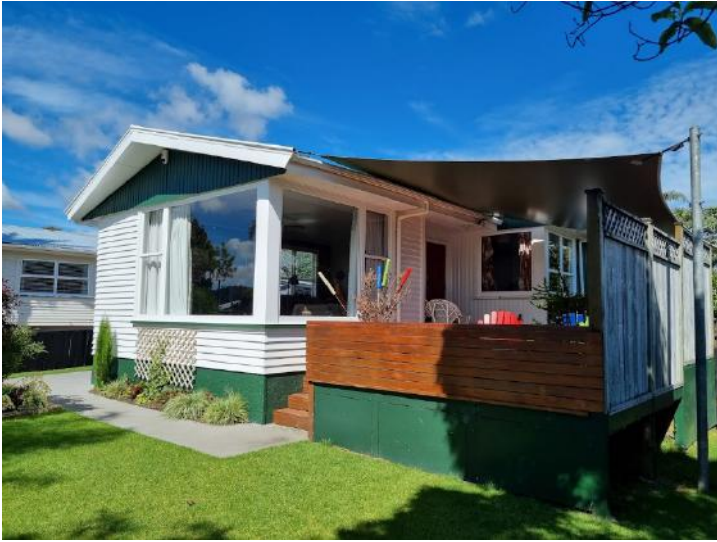
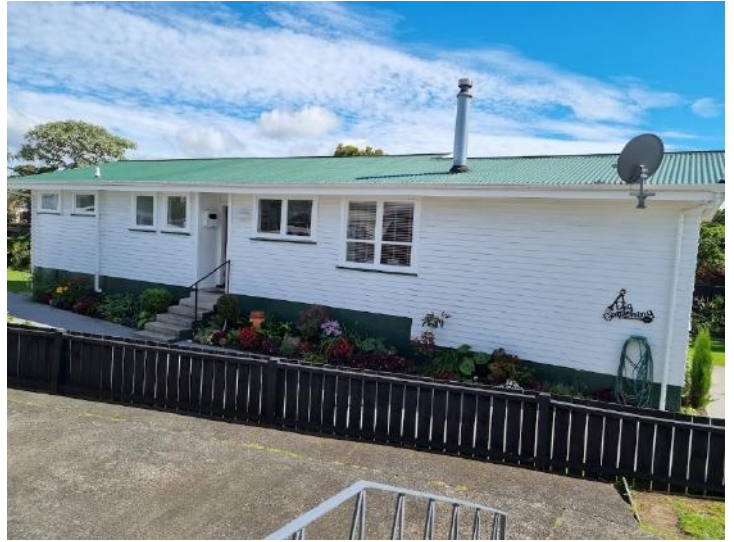
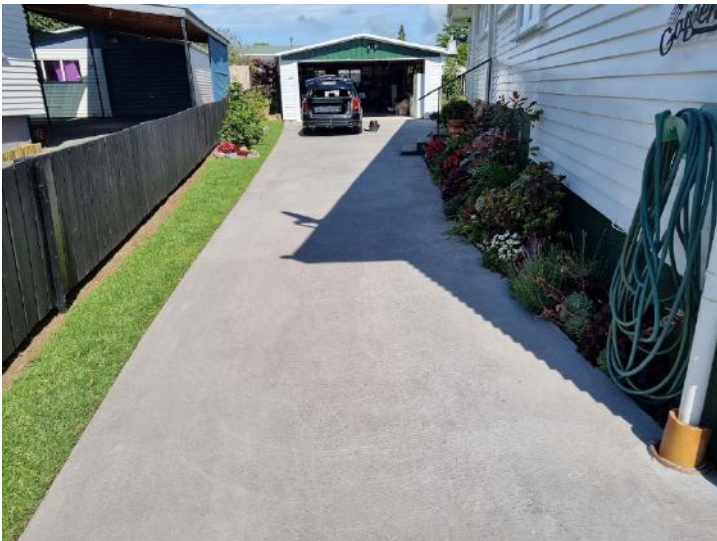
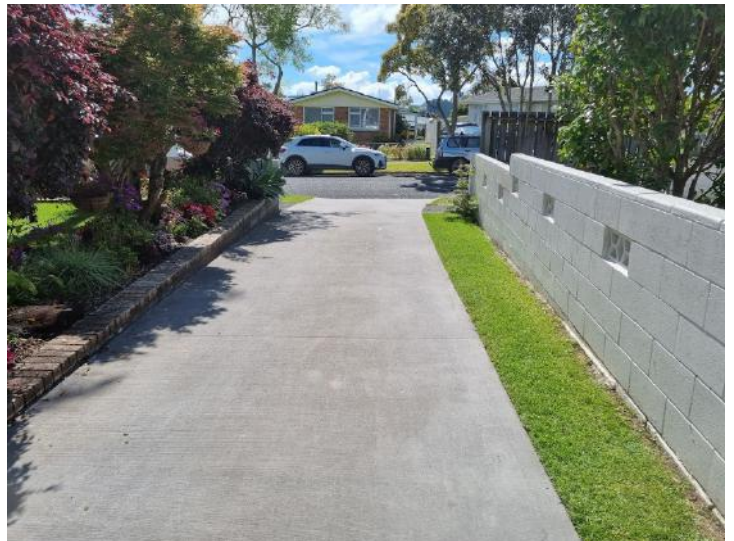
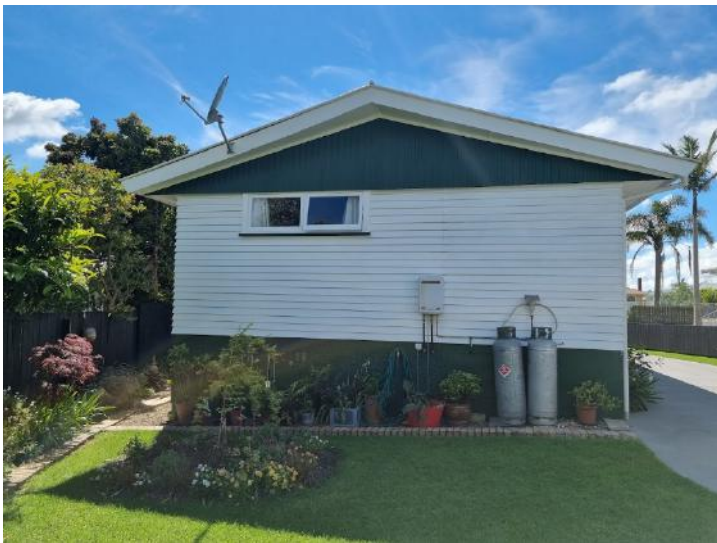
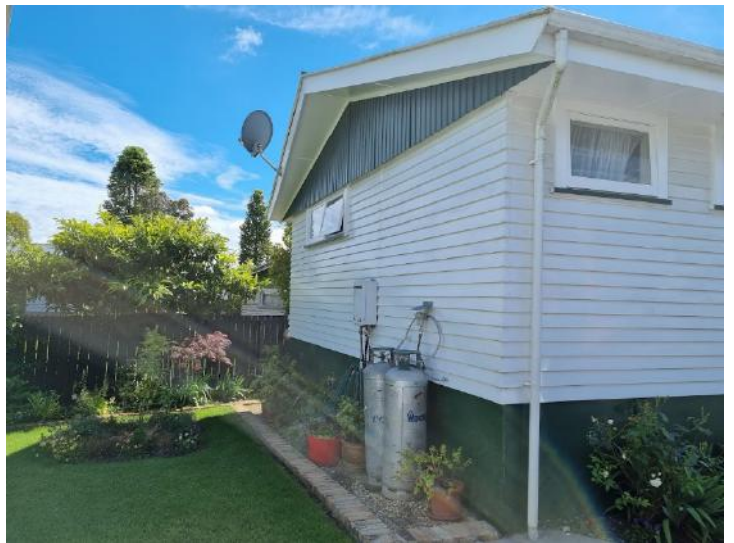
Dwelling front outside and driveway

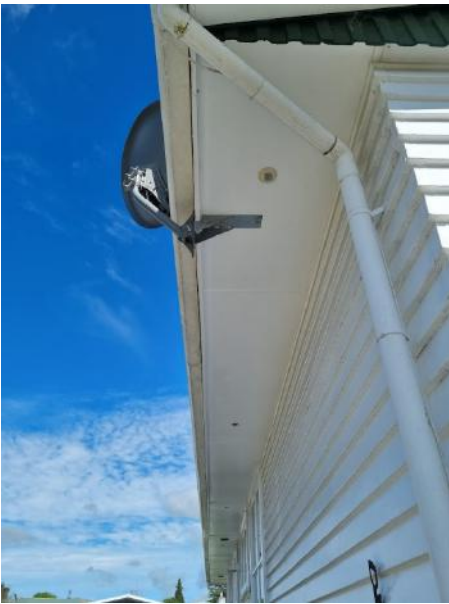
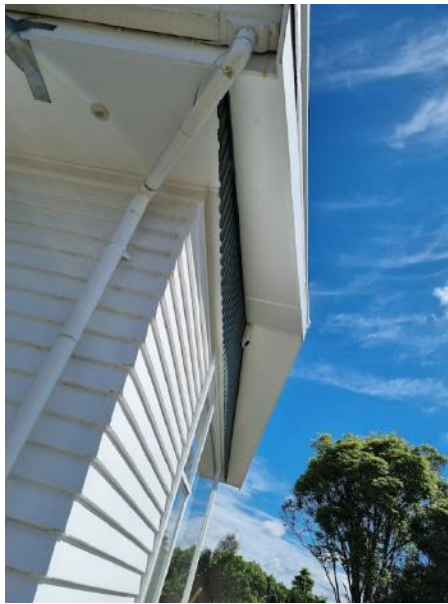
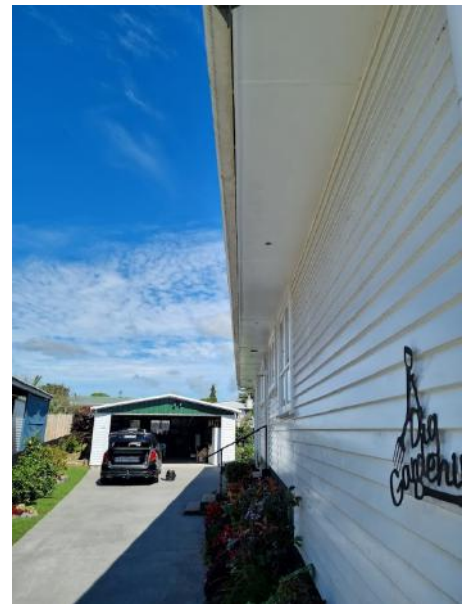
Fibrolite will most likely contain asbestos, present to the base, gable, and entryway
