Building Inspection Report

Client: Jo Green and Paul Teahon
Location: 64 Crossett Road, Ruatangata
Whangarei

Inspection Date: 10/11/2021

RE: Building Inspection Report, 64 Crossett Road, Ruatangata, Whangarei.

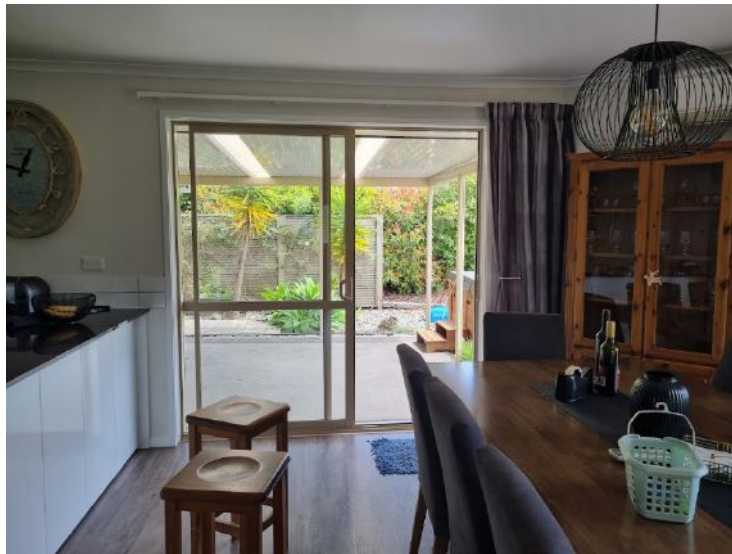
Missing Transition Bar
