RED LBP PRE-PURCHASE REPORT

PRE-PURCHASE BUILDING REPORT

Property Address	7 Highfield Way, Maunu, Whangarei, Northland, 0110, NZL		
Client	Lucy Evans		
Date of Inspection	19th April 2024	Time	9:30 am
Inspector	Jamie Mackintosh Licensed Building Practitioner Brick & Block		
LBP Number	116085		
Additional Information			
People Present	Inspector, Agent		
House Occupied	Staged

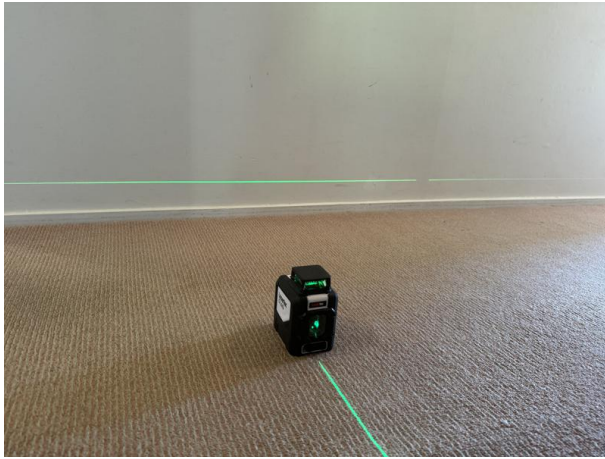
Photo 3

The floor levels were checked using a self-levelling laser, all measurements checked are within BRANZ or MBIE recommendations.

Floor levels checked with a self levelling laser level.

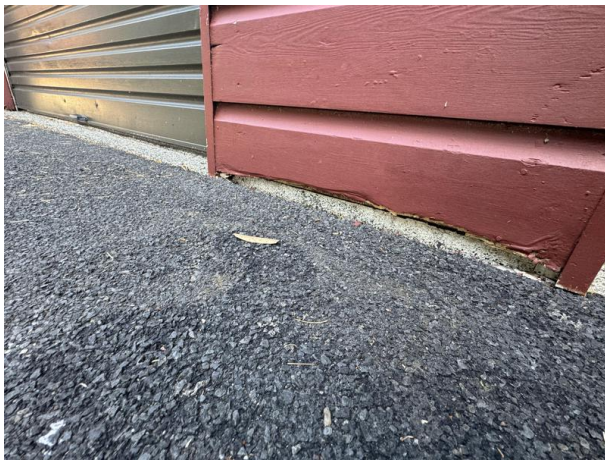
Photo 4

Minimal ground clearance on the east facing garage wall. Recommend installing strip drainage.

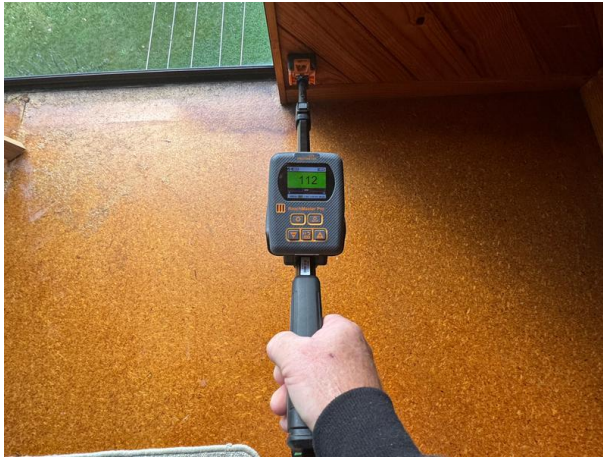
Photo 7

Supplementary moisture testing photos, indications of normal moisture readings.

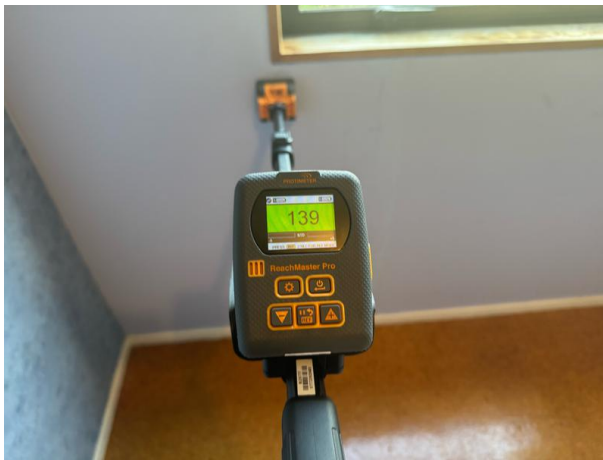
Photo 8

Supplementary moisture testing photos, indications of normal moisture readings.

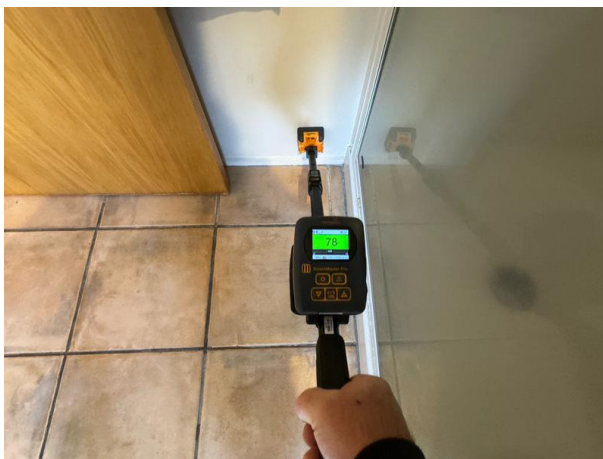
Photo 9

Supplementary moisture testing photos, indications of normal moisture readings.

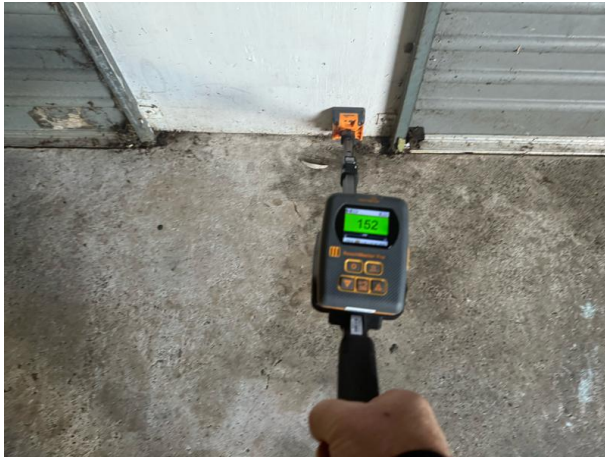
Photo 10

Supplementary moisture testing photos, indications of normal moisture readings.

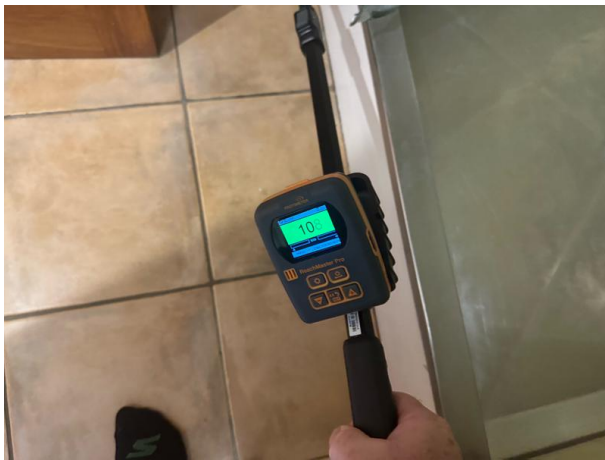
Photo 11

Supplementary moisture testing photos, indications of normal moisture readings.

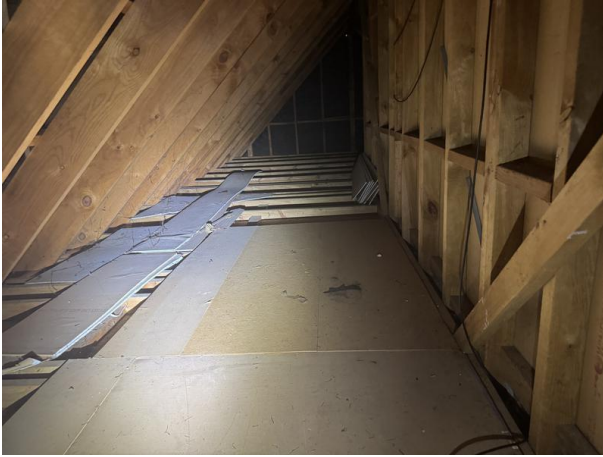
Photo 12

Roof space area accessed from bedroom four.

Recommend installing a suitable insulation to the roof space.

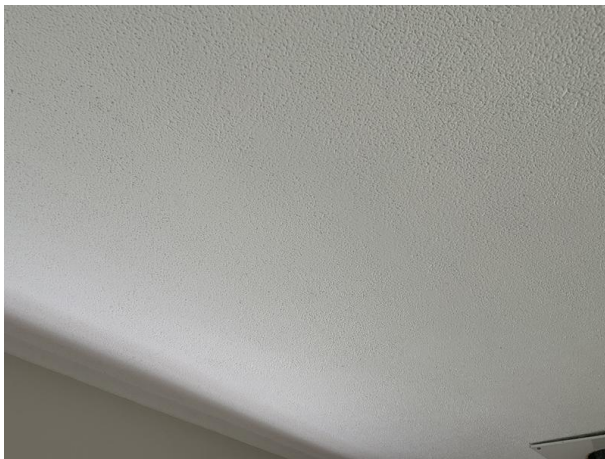
Photo 14

Example of textured ceiling finish. This is typically achieved by using a thick/spongy roller.

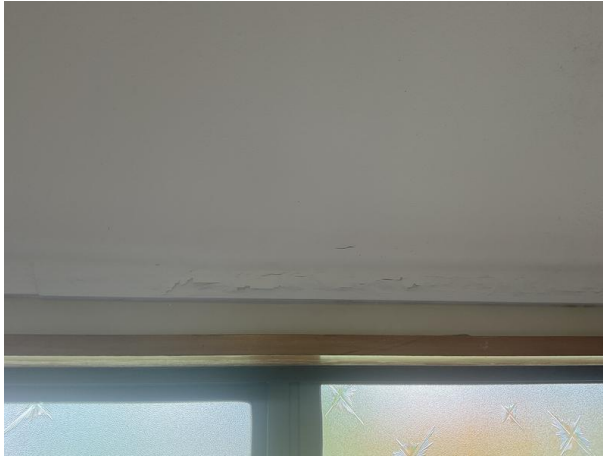
Photo 31

Moisture damage above the window. Elevated moisture readings around this area.

Recommend further investigation into the moisture damage above the window.

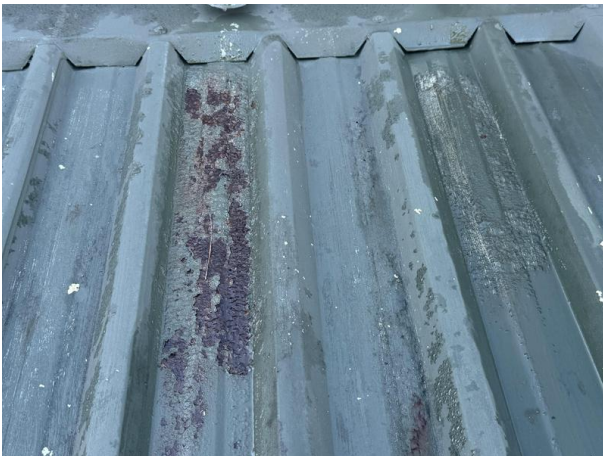
Photo 36

Visible rusting under the west facing downpipes.

It is recommended to obtain a thorough assessment of the roof's condition by engaging a Licensed Building Practitioner (LBP) specialising in roofing to conduct a comprehensive inspection and prepare a detailed report.

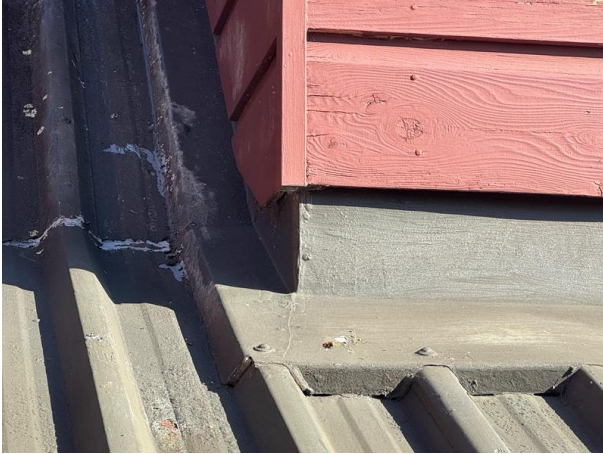
Photo 39

Differential movement can happen at the change of pitch junction, This can cause noise and deterioration to the coating from the sheets rubbing together. Future maintenance could include the installation of a change of pitch junction apron flashing.

Example of a metal apron flashing.

It is recommended to obtain a thorough assessment of the roof's condition by engaging a Licensed Building Practitioner (LBP) specialising in roofing to conduct a comprehensive inspection and prepare a detailed report.

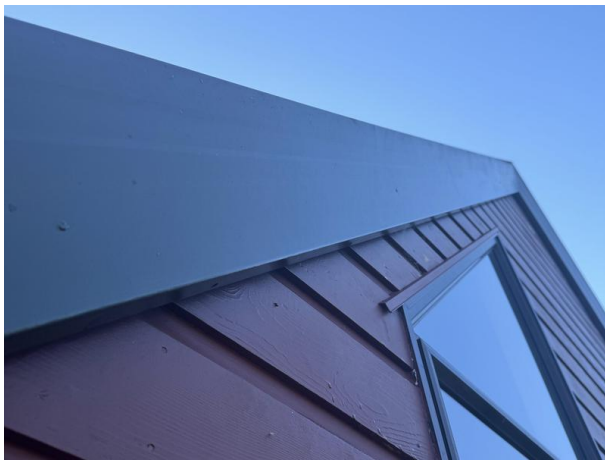
Photo 42

Example of a metal barge flashing.

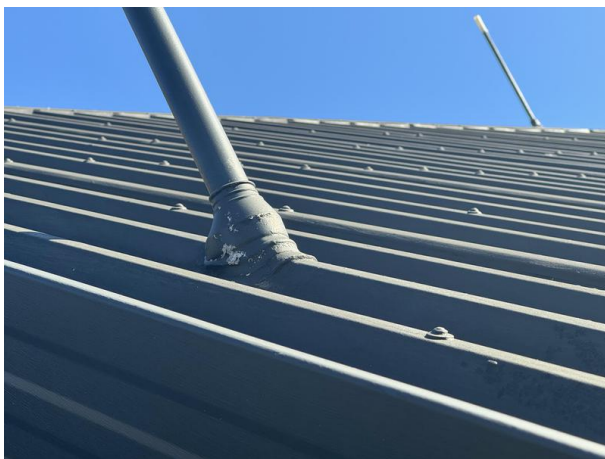
Photo 43

Vent penetration with rubber boot flashing.

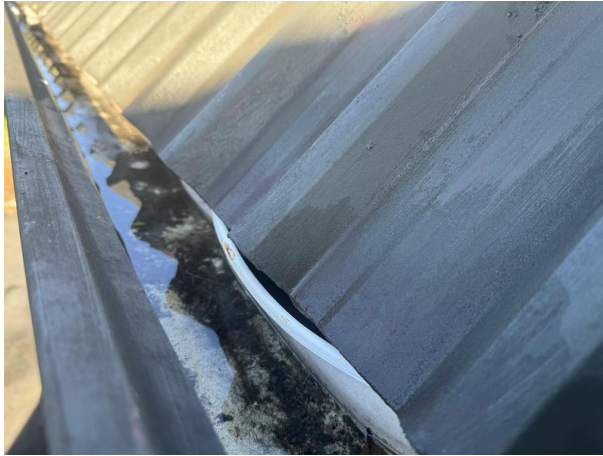
Photo 45

Example of concealed guttering. The PVC insert has bulged in a number of places. This can cause water ingress into the soffits.

There is moisture damage to the soffits and rusted guttering to several areas, it is recommended to have an LBP in carpentry report on the repairs/maintenance required.

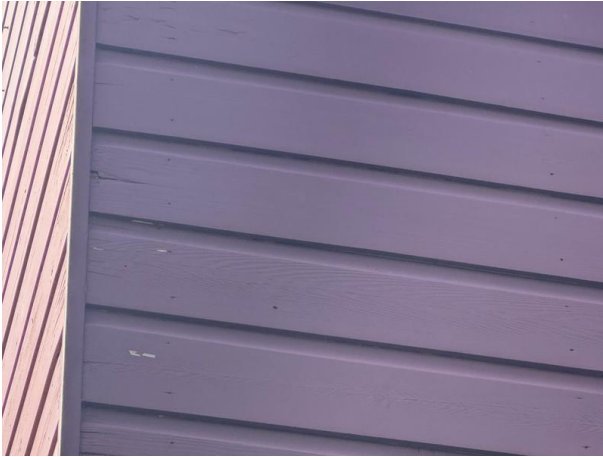
Photo 52

Visible rot to several areas of the first floor weatherboards.

There is significant rot to most areas of the timber weatherboards, it is recommended to have an LBP in carpentry investigate and report on the repairs/maintenance required.

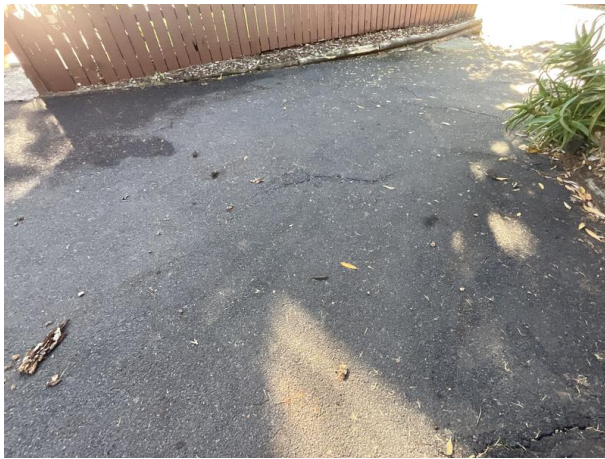
Photo 70

Asphalt with concrete edging.
Cracking - Areas of cracking visible.

Asphalt driveway.

General upkeep and maintenance of driveway by cleaning and keeping free of debris.

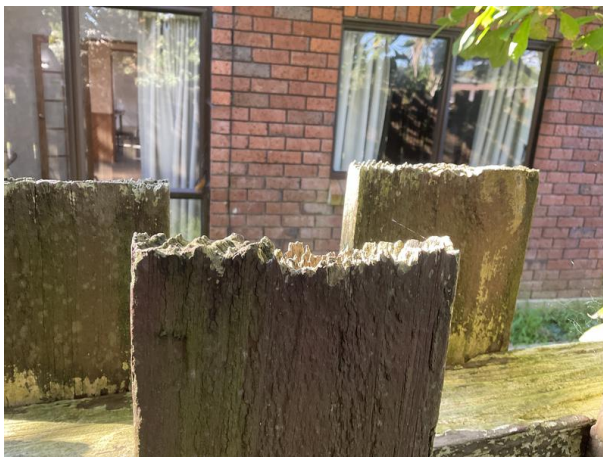
Photo 72

Visible rot on top of the palings.

General upkeep and maintenance, keep vegetation and soils clear of timbers as these timbers are only exterior treated and will rot if vegetation or soils are up against them.

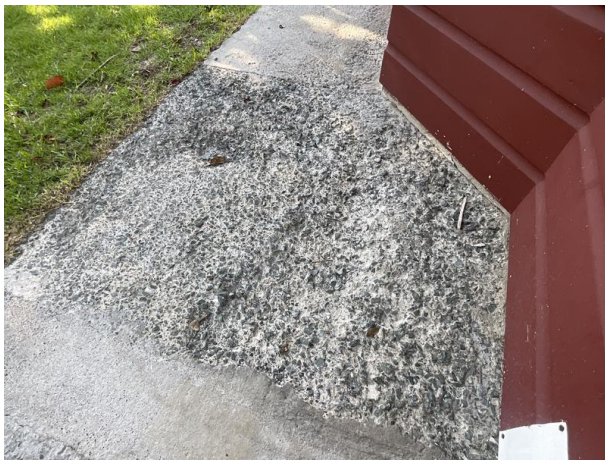
Photo 83

Example of pitting in the concrete.

Paths are cracked which would be expected for the age of the property and are aesthetic issues only.

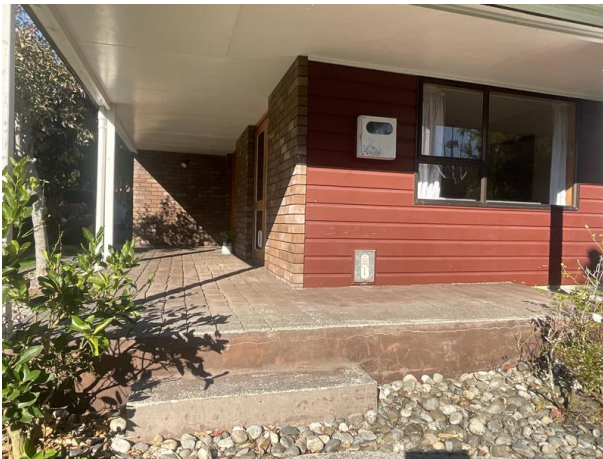
Photo 84

Stamped concrete patio and stairs off the front entrance and living room on the east and part of the north side of the house.

The concrete patio has no clearance to the exterior cladding, While there was no issues observed during the inspection. This configuration may lead to moisture issues due to capillary action. It is advisable to regularly monitor this area for potential issues and ensure it remains free of debris.

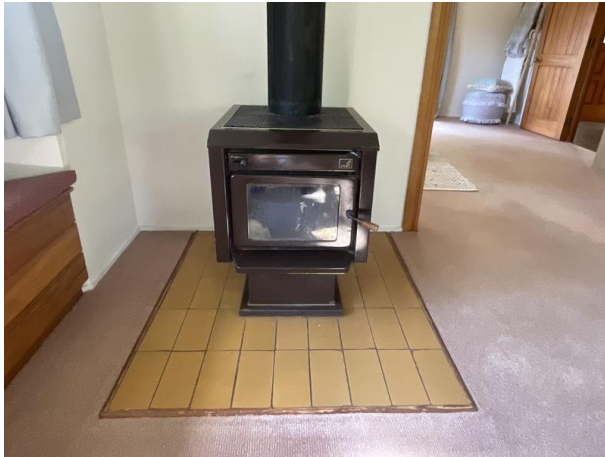
Photo 94

Kent freestanding wood burner located in the living room.

Have a heating specialist investigate and report on the firebox condition.

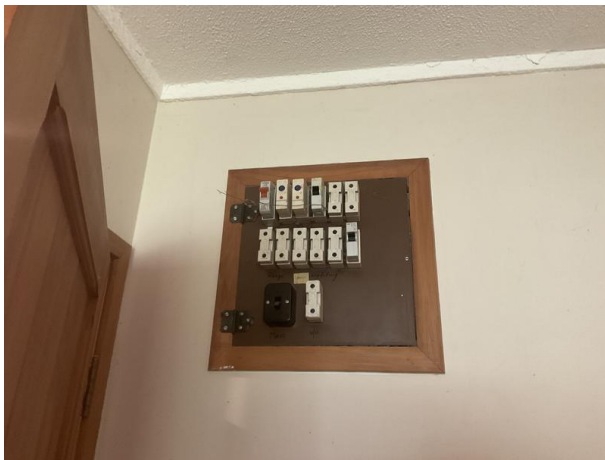
Photo 102

This type of distribution board is of the age that if any upgrades were required to the electrical system it would be required to be upgraded to a new board.

Distribution board located in the laundry.

It is recommended to have a registered electrician advise on the electrical system.
