Property Condition Report

**12 Cross Street
Regent
Whangarei District**

Inspection Date: 31/07/2020

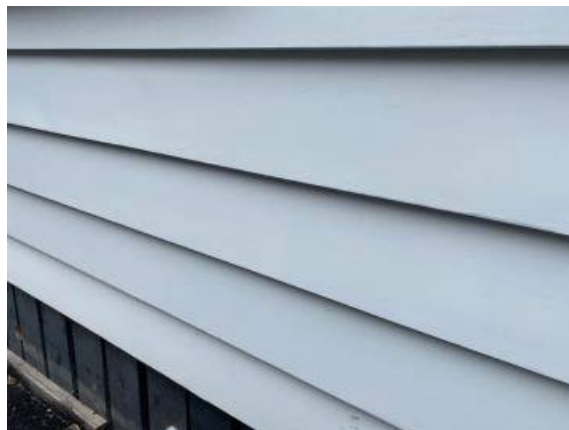
Visible cladding void to exterior kitchen wall. We recommend sealing this junction to reduce the risk of moisture ingress. There were no elevated moisture readings in this area at the time of inspection.

Visible cladding void to exterior kitchen wall. We recommend sealing this junction to reduce the risk of moisture ingress. There were no elevated moisture readings in this area at the tie of inspection.

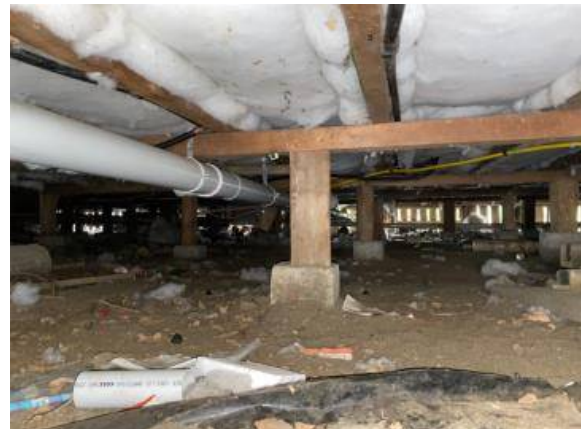
Timber pile visible from access appears to be damaged. We recommend engaging the services of a LBP to replace this pile as required.

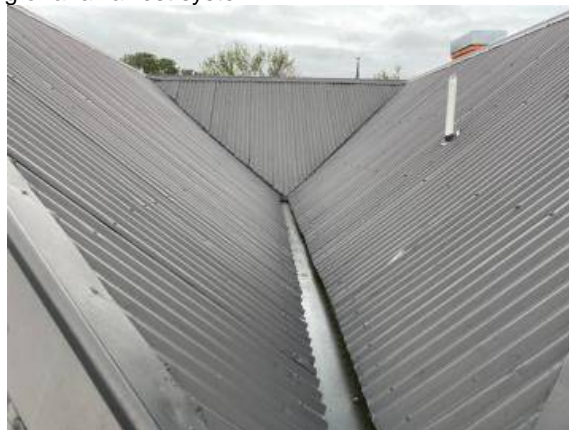
Visible corrosion around lead head fixings. Lead heads should be removed and replaced with new fixings. Roof covering should be inspected for signs of corrosion and treated with a suitable rust inhibitor where required.

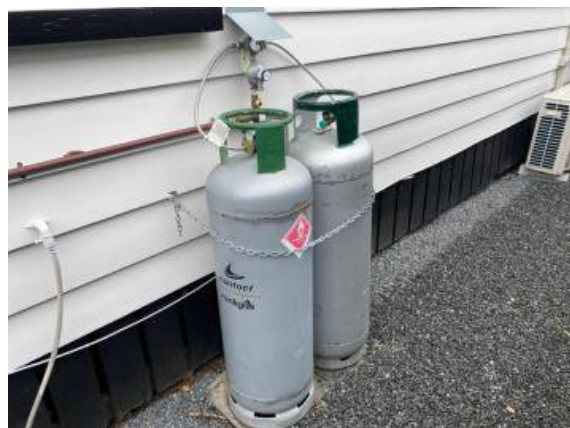
Gas supplied from removable tank.

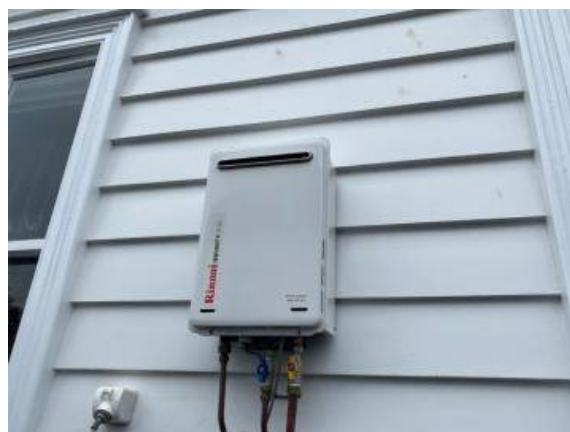
Gas Calfont. This unit was not assessed as it falls outside the scope of this inspection, further inspection from a heating specialist is recommended.
