Property Condition Report

**26 Zealandia Street
Kensington
Whangarei District**

Inspection Date: 7/10/2020

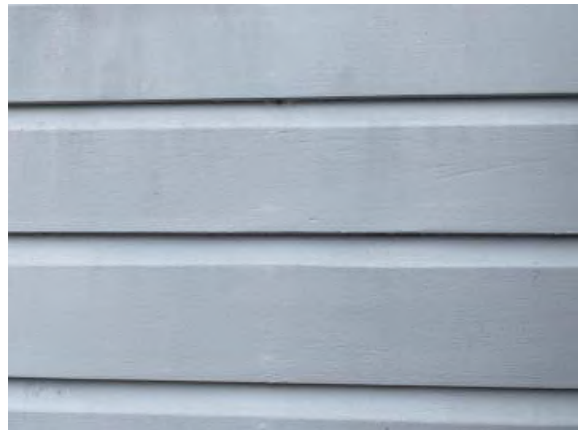
Paint lifting from timber weatherboards. Weatherboards will require appropriate preparation and paint to ensure cladding remains well sealed. Failure to maintain paint coating increases the risk of exposure

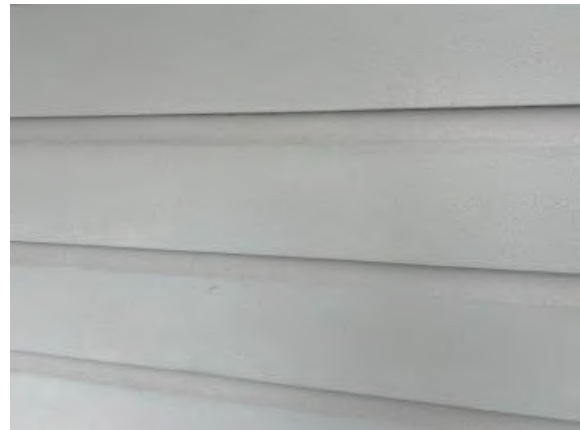
Separation between scribe and facing. This is a possible ingress point. We recommend sealing scribed details to ensure cladding junctions remain weathertight. Unable to condition of internal framing.

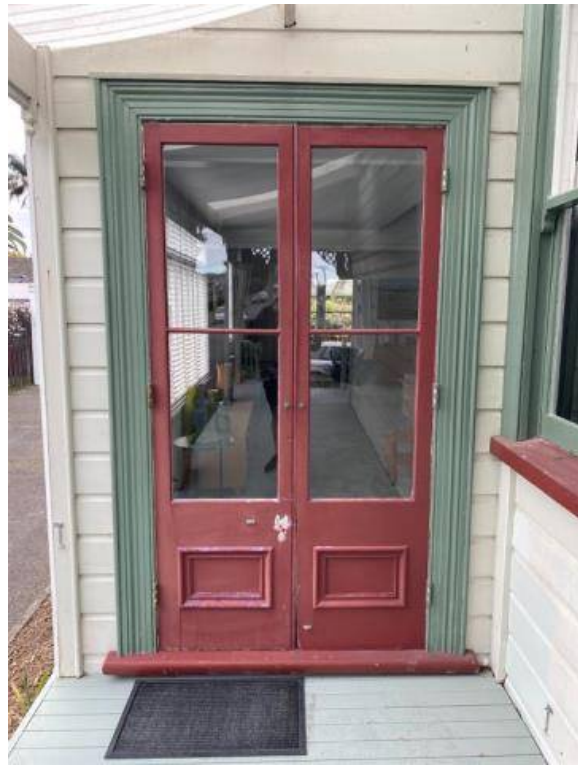
Visible paint lift from timber window joinery. Paint lift increases the risk of exposure to timber. We recommend engaging the services of a painter to prep and paint joinery as required. Failure to maintain may result in joinery failure.

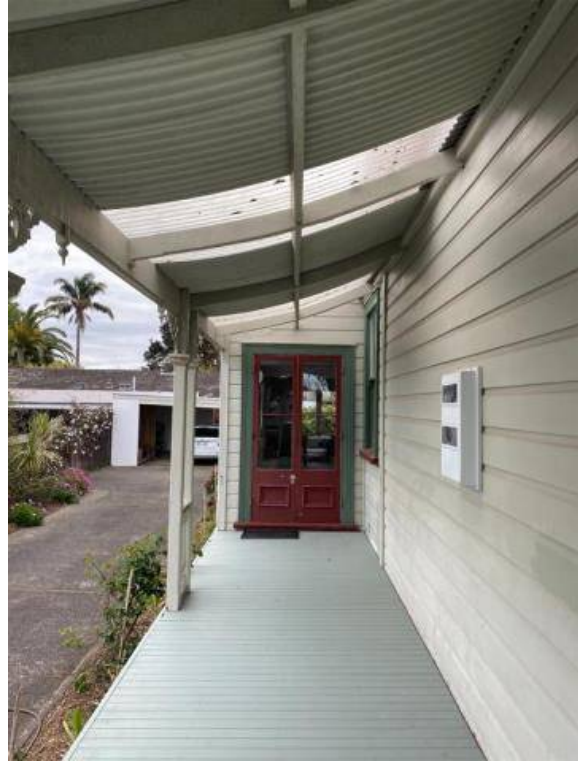
Visible decay to base of veranda posts. We recommend engaging the services of a LBP to inspect further. If posts have been compromised we recommend replacement.

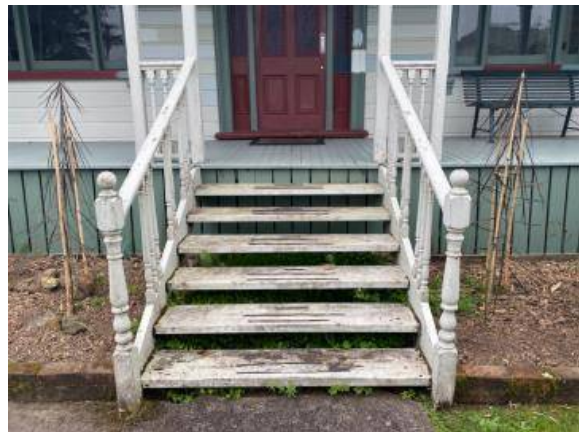
Evidence of decay to timber stringer and treads. This is a potential safety hazard. We recommend engaging a Builder to inspect further and replace decayed treads as required to ensure safe access via staircase.

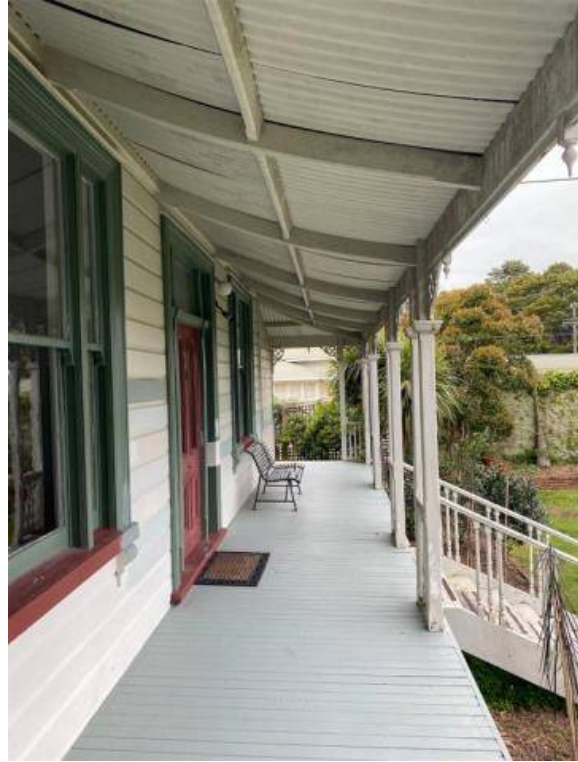
Visible decay to base of veranda posts. We recommend engaging the services of a LBP to inspect further. If posts have been compromised we recommend replacement.

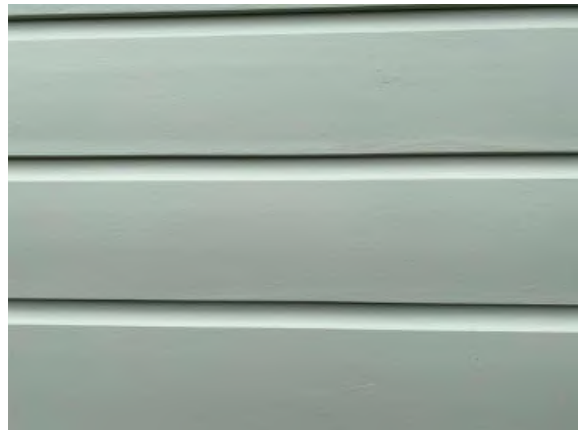
Poor seal to window joinery/cladding junction. We recommend engaging the services of a LBP builder to modify this detail to ensure a weathertight seal.

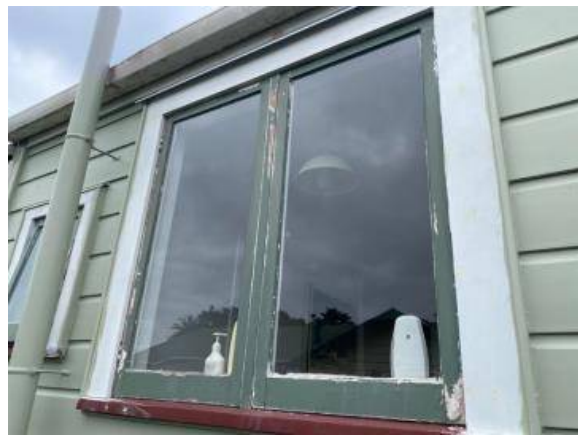
Visible paint lift from timber window joinery. Paint lift increases the risk of exposure to timber. We recommend engaging the services of a painter to prep and paint joinery as required. Failure to maintain may result in joinery failure.

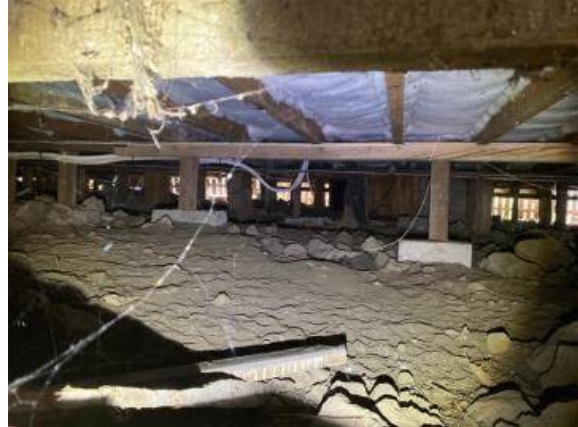
A number of piles have been packed over the years. We recommend engaging a LBP to inspect these piles further, replacing packed piles will likely be the most viable option.

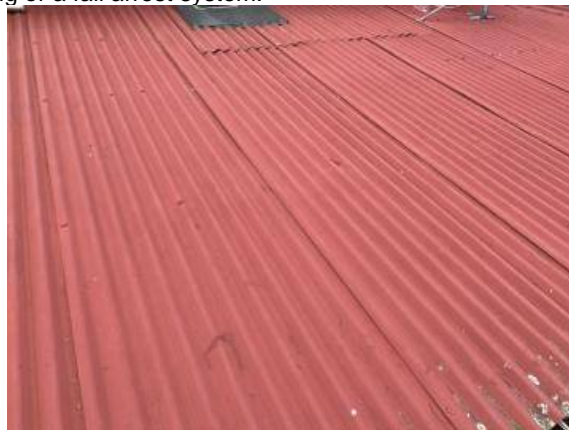
Visible corrosion around lead head fixings. Lead heads should be removed and replaced with new fixings. Roof covering should be inspected for signs of corrosion and treated with a suitable rust inhibitor where required.

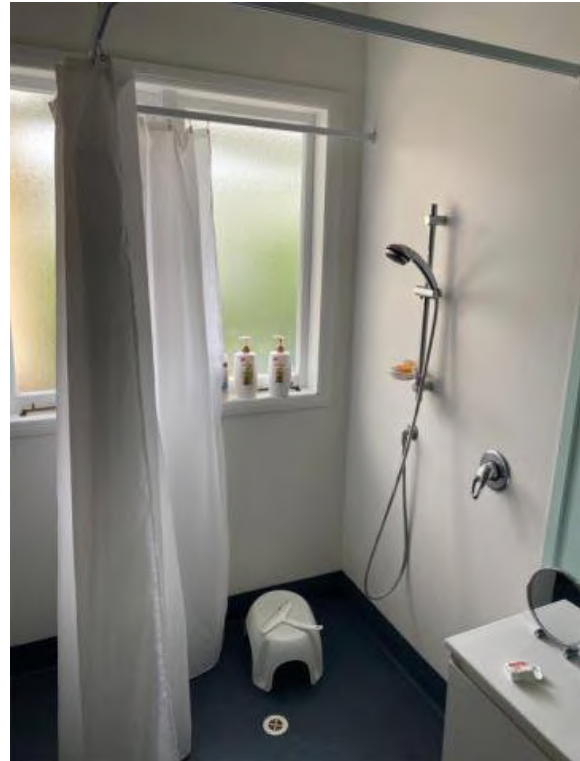
Wet floor type shower with composite wall lining.

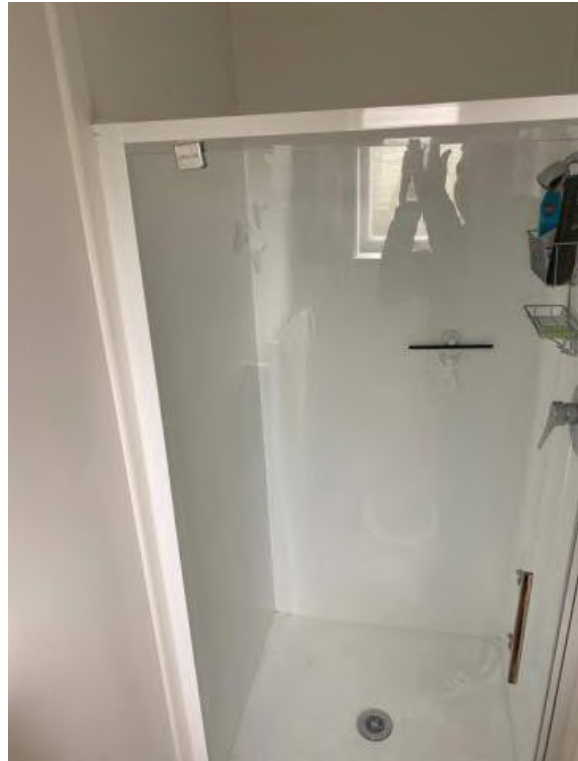
Shower unit with composite base and moulded wall liner.

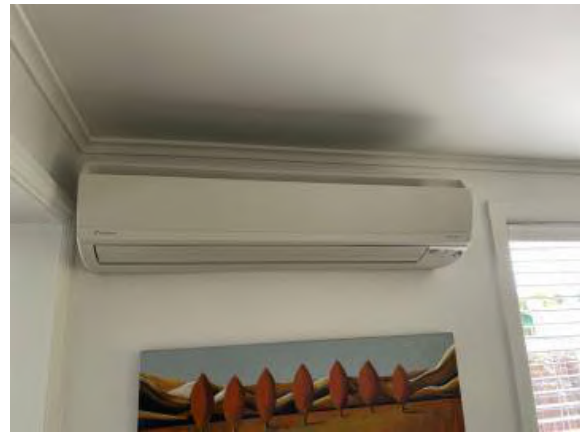
Heating systems were not assessed as it falls outside the scope of this inspection, further inspection from a heating specialist is recommended.

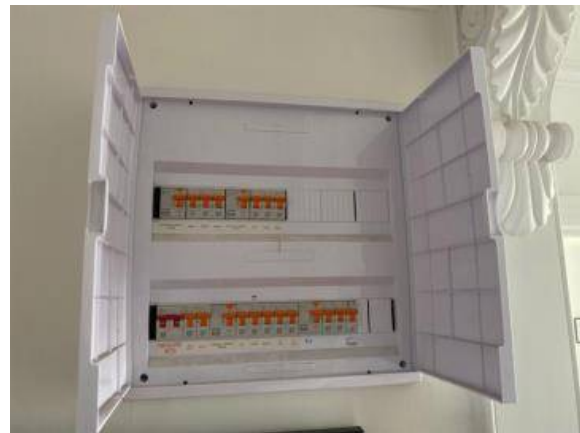
RCD switchboard.
