## **Property Condition Report**

**66a King Street  
Kensington  
Whangarei District**

**Client:** Paul Sumich C/- Bayleys Whangarei

**Inspection Date:** 9/03/2022

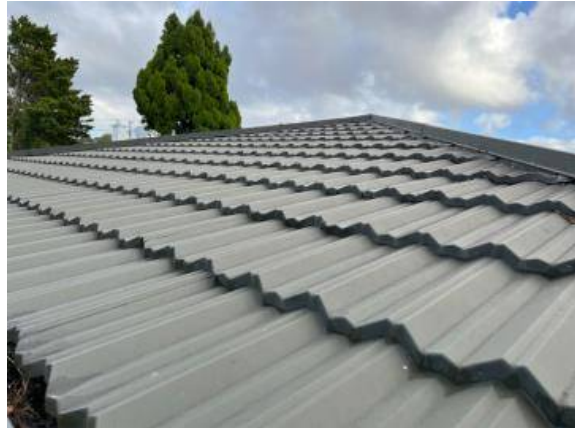
Contaminant build up to roof covering. We recommend cleaning roof covering annually or as required during periodic maintenance to ensure the finished coating is not compromised by growth and airborne contaminants.

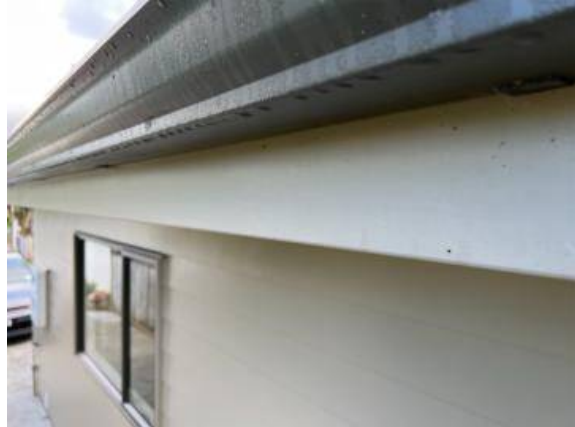
Evidence of decay to timber fascia board above kitchen. Decayed fascia may increase the risk of moisture ingress to roof space. We recommend engaging the services of a Builder to replace damaged Fascia as required.

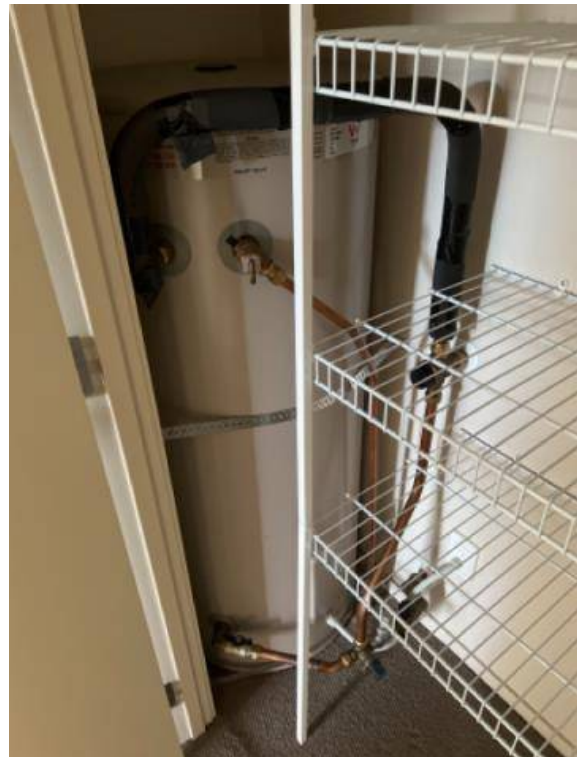
Description:

Hot water cylinder.  
Cylinder is restrained.

Size:  
Year of manufacture:

Approximately 135ltr.  
Unable to confirm.
