Building Report

Building Inspection Report

Client: Paul Sumich - C/o Bayleys
Location: 1 Kentia Lane, Whau Valley
Whangarei
Inspection Date: 01/02/2022

RE: Building Inspection Report, 1 Kentia Lane, Whau Valley, Whangarei.

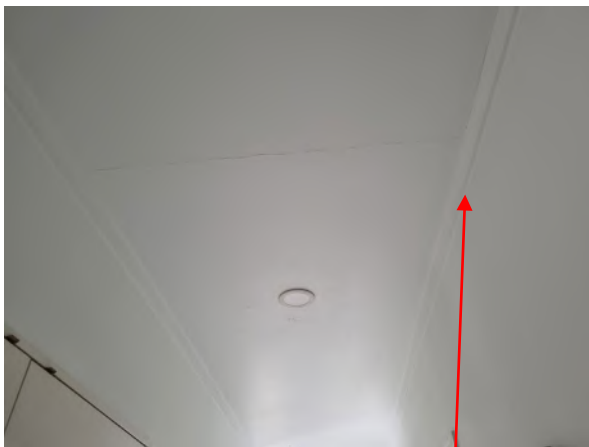
Hallway has surface crack in ceiling

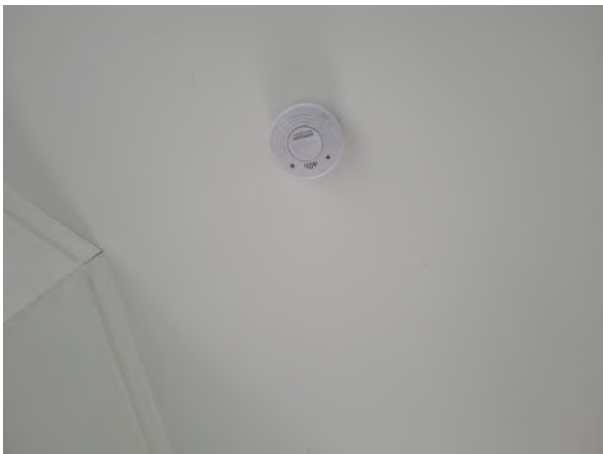
Smoke alarm present in Hallway
