Building Inspection Report

Client: Paul Sumich
Location: 101 Maunu Road, Woodhill
Whangarei

Inspection Date: 20/10/2021

RE: Building Inspection Report, 101 Maunu Road, Woodhill, Whangarei.

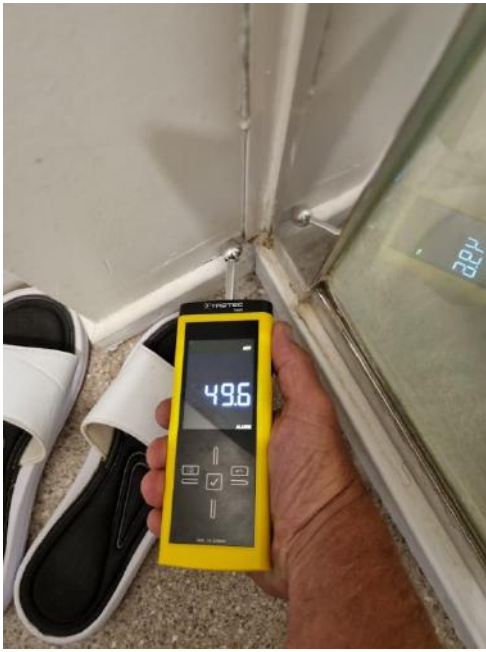
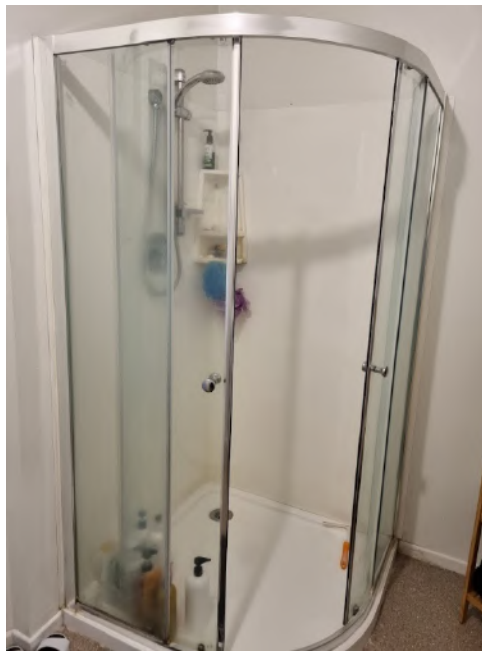
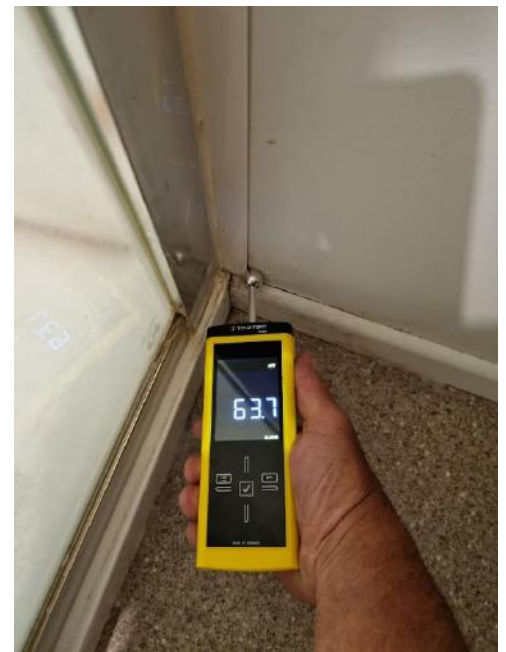
Unsure if bathroom extraction is working correctly – further investigation is required

Mould present in bathroom even with an extractor fan installed. Is it working? Further investigation is required as this may be due to a leaking roof or an incorrectly working extractor fan

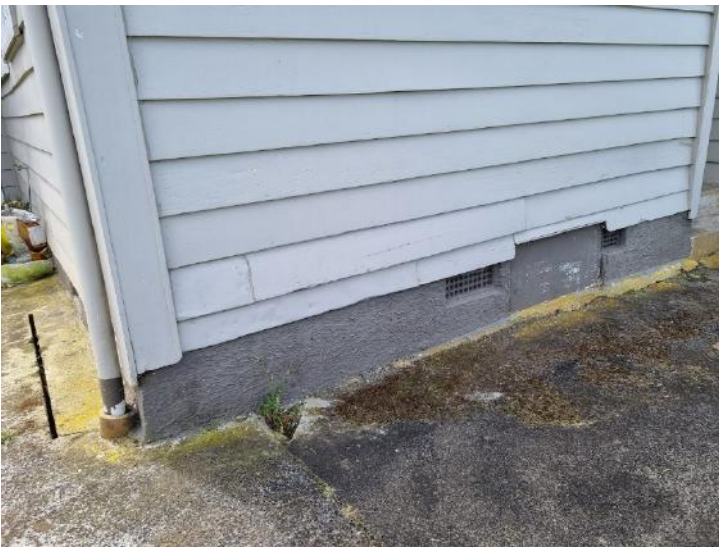
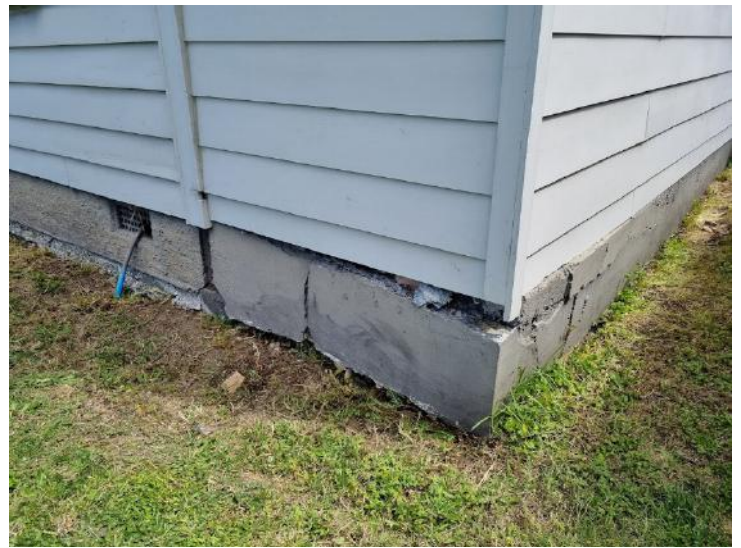
Weatherboard's showing signs of deterioration and recent unsatisfactory repairs have taken place, further investigation in places for repair

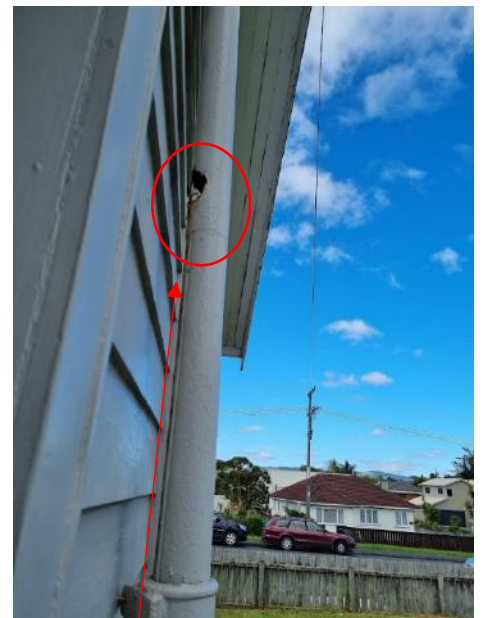
Steel terminal vent to the rear needs replacing as rusted through in places as per photos
