## **Property Condition Report**

**1 Drummond Street  
Regent  
Whangarei District**

**Client:** Paul Sumich

**Inspection Date:** 15/01/2021

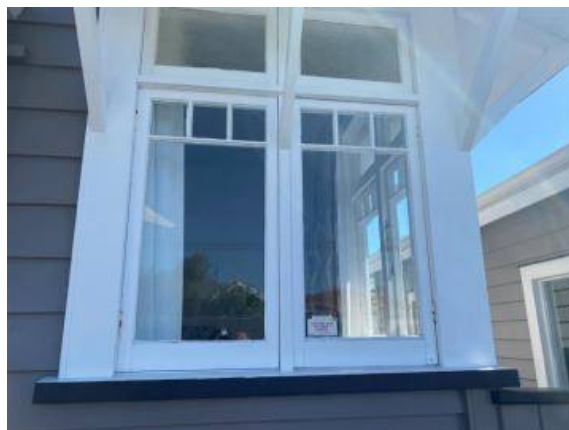
Timber joinery, painted and single glazed.

Evidence of corrosion to window hinges. Corroded hinges may affect window operation. We recommend engaging a builder or joiner to inspect hinges further and treat with a suitable rust inhibitor where necessary. If hinges are beyond repair replacement may be required. M.
