## **Property Condition Report**

**30 First Avenue  
Whangarei Central  
Whangarei District**

**Inspection Date:** 14/10/2020

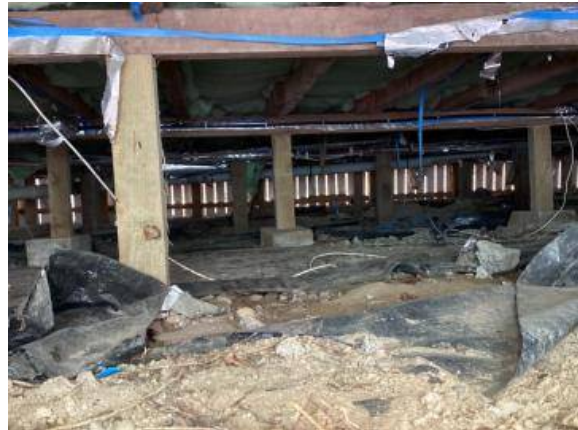
Timber pile direct fixed to joist, no bearer. We recommend engaging the services of a licensed building practitioner to inspect this detail further. Pile may require modification or replacement.

Description: Timber piles.

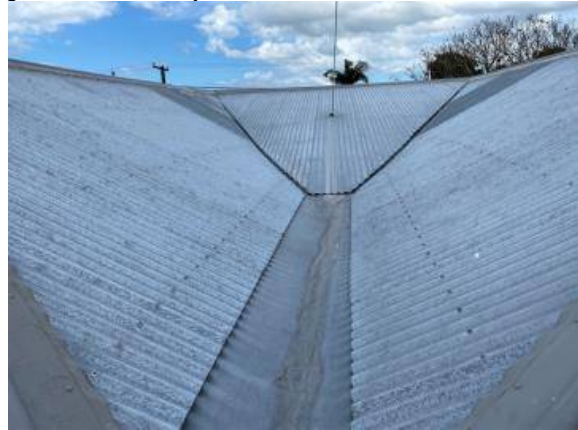
Evidence of corrosion to galvanized roof covering at ridge flashing junction. We recommend engaging the services of a suitably qualified roofer to inspect this area further. Corroded areas may require treatment with a suitable rest inhibitor to prevent further damage.

Profiled Colorsteel roofing, Galvanised Rolled Metal.

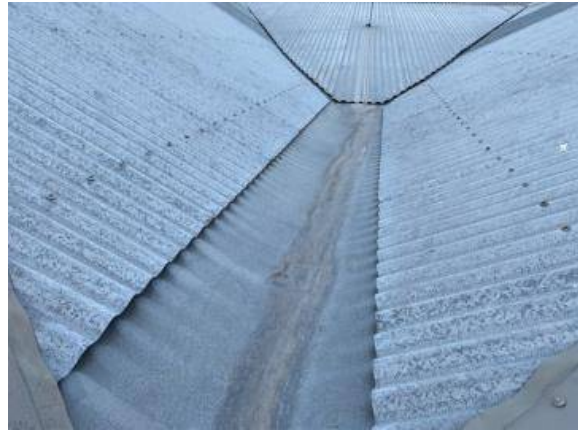
Evidence of corrosion to galvanized roof covering at galvanised metal Gutter system . We recommend engaging the services of a suitably qualified roofer to inspect this area further. Corroded areas may require treatment with a suitable rest inhibitor to prevent further damage.

Galvanized internal gutter system.

Evidence of corrosion to galvanized roof covering at galvanized metal Gutter system . We recommend engaging the services of a suitably qualified roofer to inspect this area further. Corroded areas may require treatment with a suitable rust inhibitor to prevent further damage.

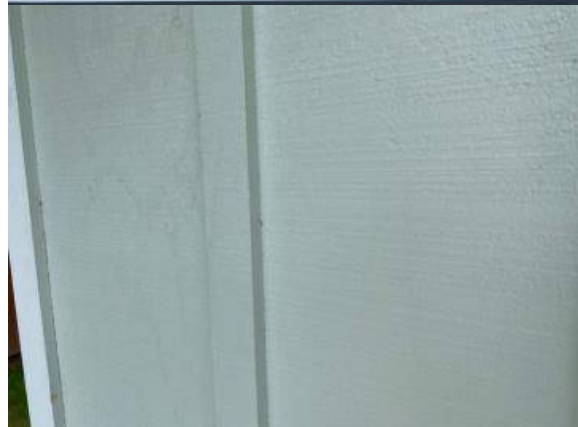
Plywood & Batten cladding.

**Findings:**

Garage door facings in close proximity to paved ground. We recommend engaging a builder to modify clearance to reduce the risk of moisture damage to cladding.

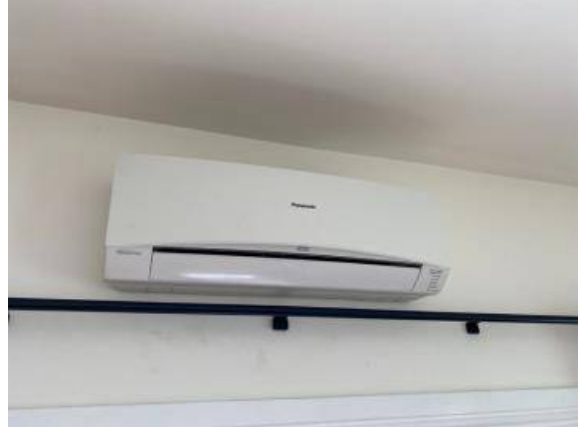
Heat pump. This unit was not assessed as it falls outside the scope of this inspection, further inspection from a heating specialist is recommended.

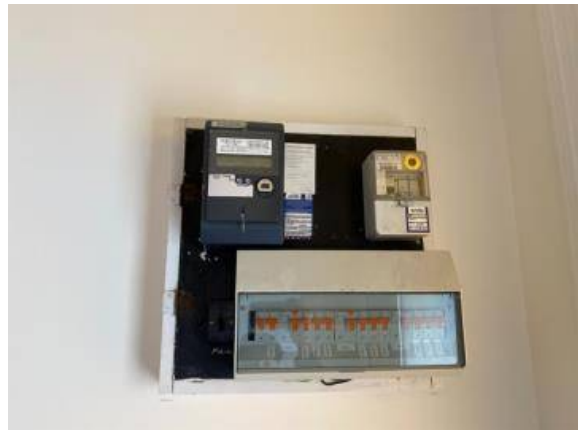
RCD switchboard, Due to the age of the building, we recommend engaging the services of a registered electrician to conduct an electrical inspection.
