## **Property Condition Report**

**356 Bull Road  
Waiotira  
Whangarei District**

**Client:** Paul Sumich

**Inspection Date:** 11/01/2021

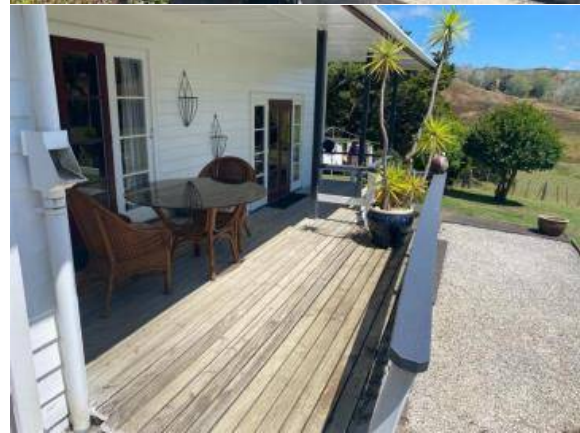
Raised timber frame deck.

Excessive horizontal movement to timber handrail. This may present a potential safety risk. We recommend engaging a Builder to install additional fixings/bracing or repair/replace handrail as required. Handrail openings are greater than 100mm in diameter. This presents a potential fall hazard. Minimum recommendations require openings not greater than 100mm to reduce potential fall hazards. We recommend engaging the services of a builder to modify this detail where possible.

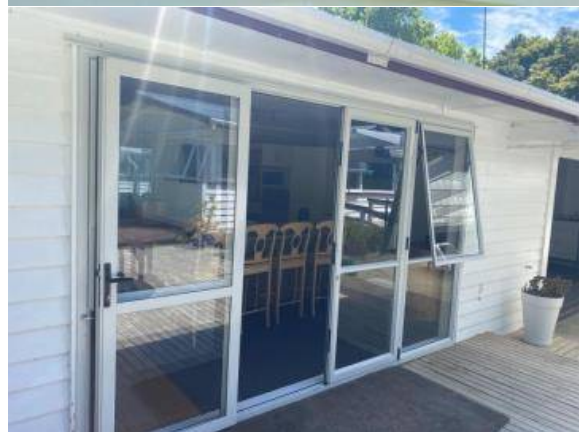
Aluminium joinery, single glazed.

Aluminium head flashing face fixed to cladding. This may increase the risk of moisture ingress. We recommend modifying this detail to ensure head flashing runs behind cladding,

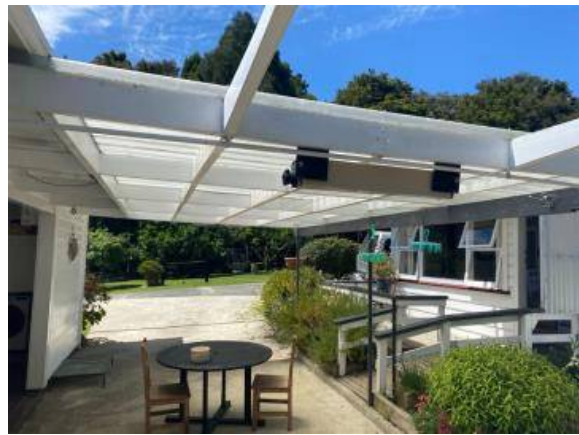
Heavy corrosion to top of steel posts. Corrosion may compromise the structural integrity of carport. We recommend replacing posts and installing suitable structural connections were required.

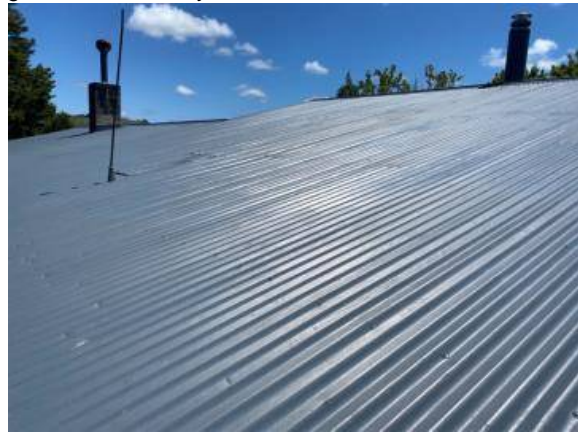
Evidence of corrosion to roof covering. We recommend engaging the services of a roofer to inspect covering further. Corrosion should be treated with a suitable rust inhibitor and painted to reduce the risk of damage to covering.

Numerous roof fixings have walked. These fixings will require tightening or replacement to ensure fixing penetrations remain watertight.

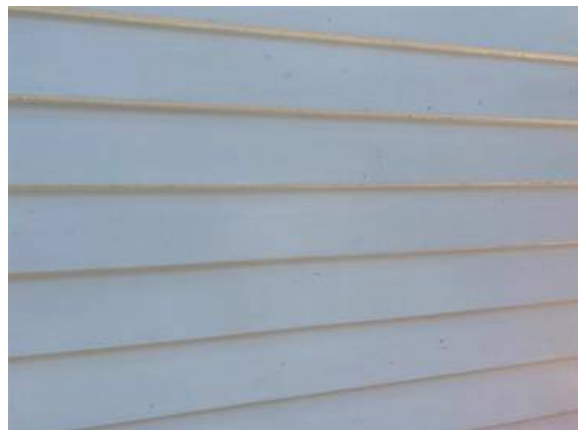
No scribed detail to cladding soffit junction. This is a potential moisture ingress point. We recommend sealing this junction to reduce the risk of moisture ingress.

Unpaved ground level in close proximity to cladding base. A clearance of 180mm is recommended from cladding base to finished ground level to allow adequate cladding drainage. Finished ground level should be adjusted to meet minimum recommendations and reduce the risk of damage to cladding.

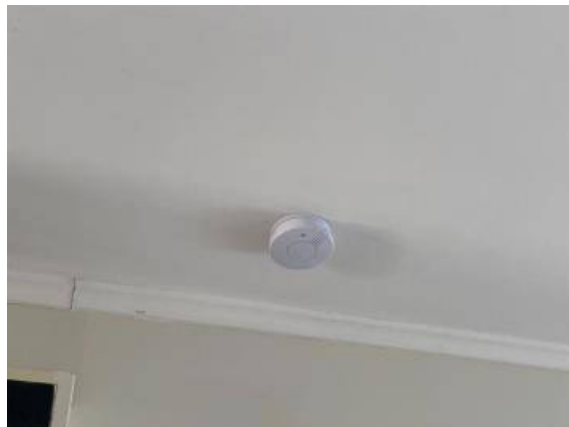
Individual Smoke detection devices. Not tested as part of this inspection. Periodic inspection is advise to ensure all devices are in working order.

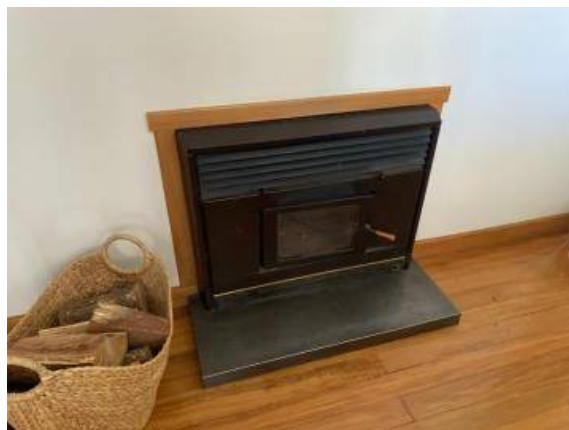
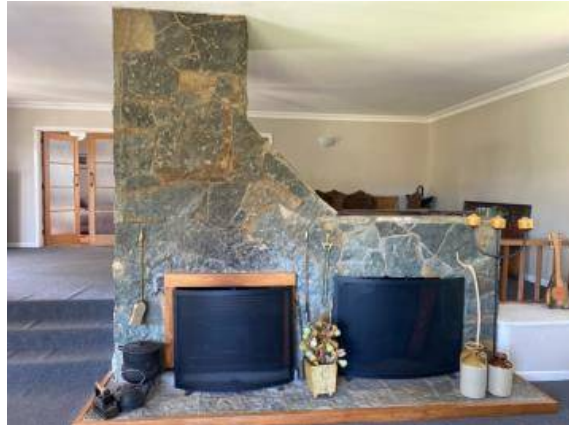
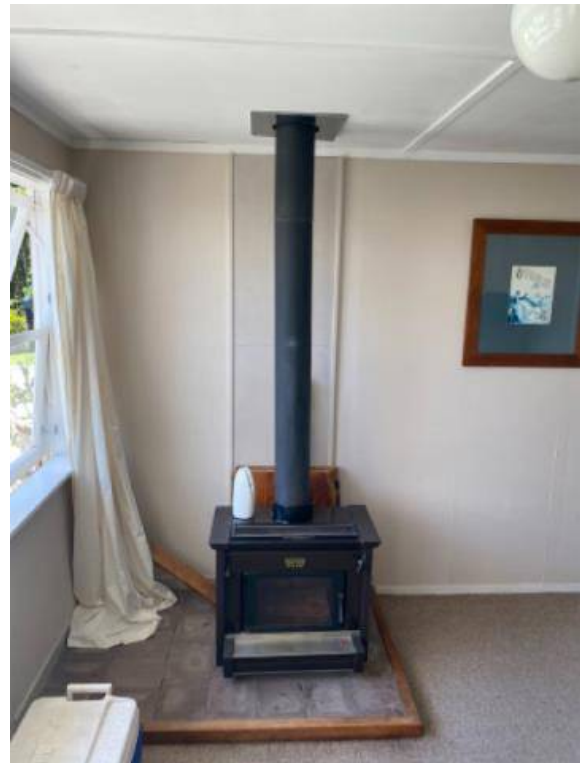
Freestanding log Burner to sleep out, 2 x fireplaces to main dwelling. These units were not assessed as it falls outside the scope of this inspection, further inspection from a heating specialist is recommended.

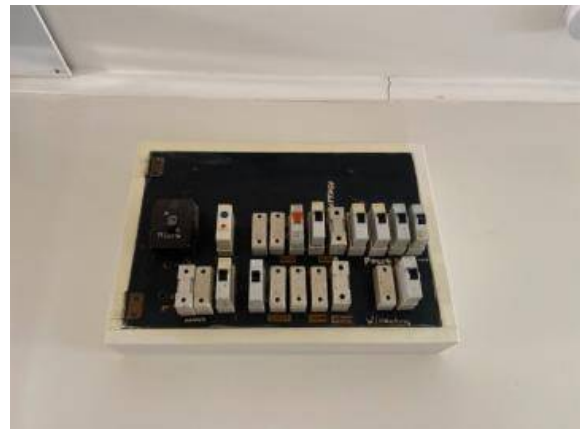
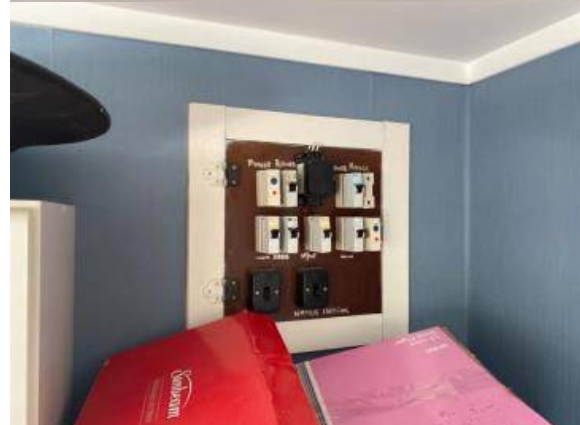
RCD switchboard. Due to the age of the building, we recommend engaging the services of a registered electrician to conduct an electrical inspection.
