Property Condition Report

**58 Keyte Street
Kensington
Whangarei District**

Inspection Date: 13/02/2021

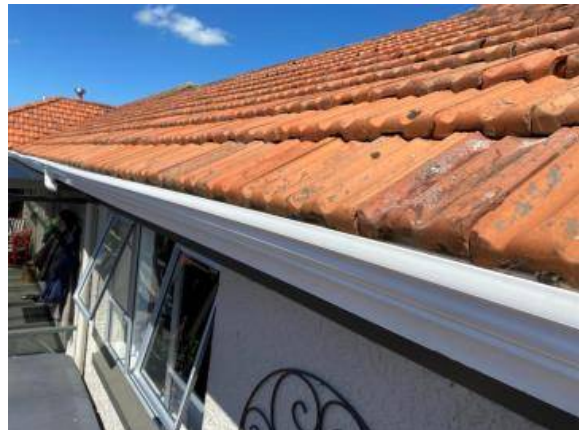
PVC gutter system.

Findings:

Gutter system to sleepout not complete. We recommend the installation of a gutter system to ensure rain water is diverted away from the building.

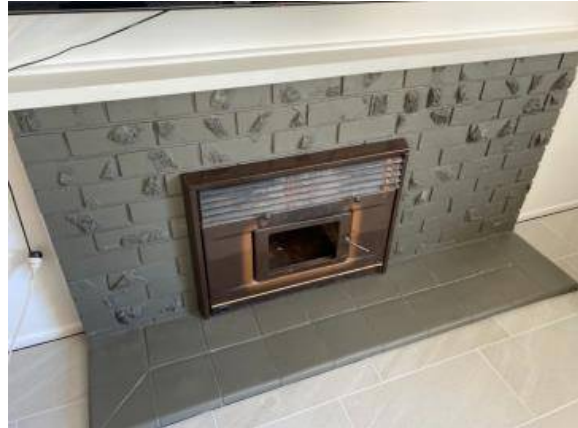
Recessed log burner, exhaust via external chimney. This unit was not assessed as it falls outside the scope of this inspection, further inspection from a heating specialist is recommended.

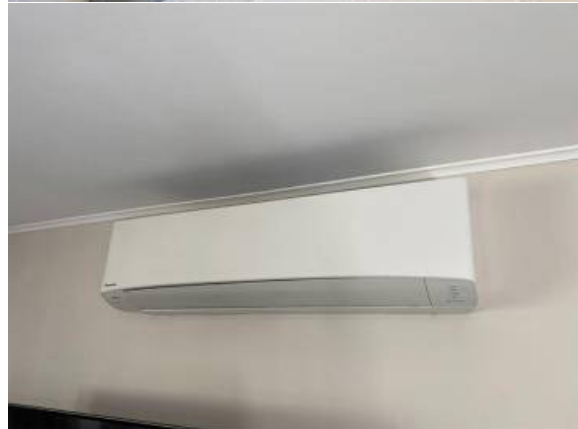
Heat pump. This unit was not assessed as it falls outside the scope of this inspection, further inspection from a heating specialist is recommended.

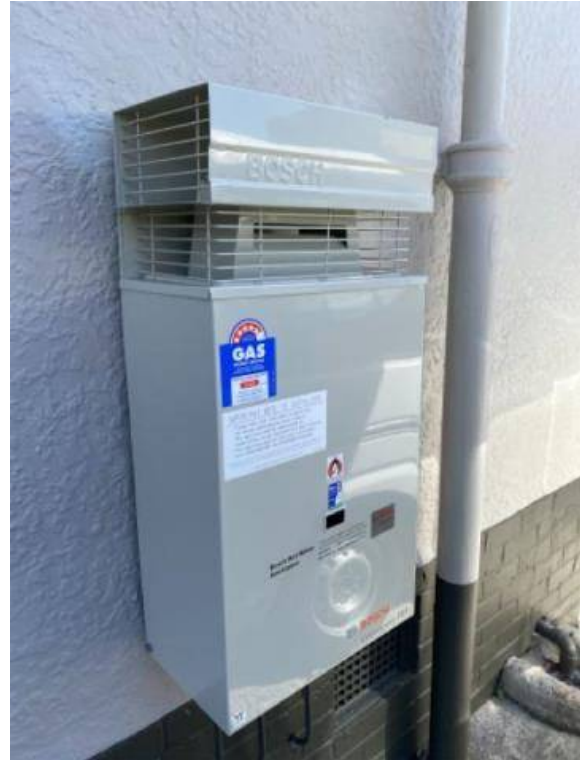
Gas Califont. This unit was not assessed as it falls outside the scope of this inspection, further inspection from a heating specialist is recommended.
