## **Property Condition Report**

**926 Whangarei Heads Road  
Parua Bay  
Whangarei District**

**Inspection Date:** 9/01/2021

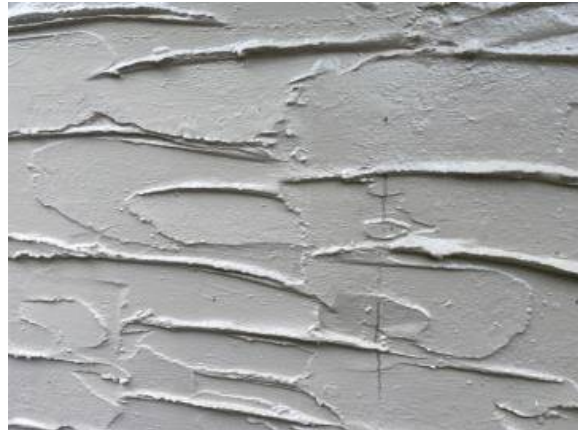
Blister in paint work holding moisture. We recommend engaging the services of a suitably qualified painter to repair this area. Isolated repair to this area may be achievable.

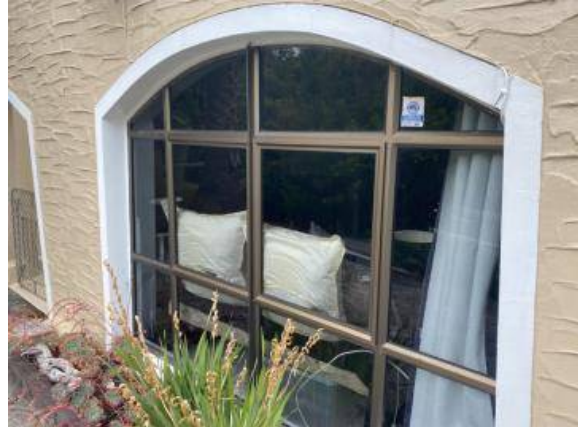
No head flashings to window joinery. Joinery has been face sealed to concrete. This may increase the risk of moisture ingress. We recommend monitoring this area. Further investigation may be required in these areas.

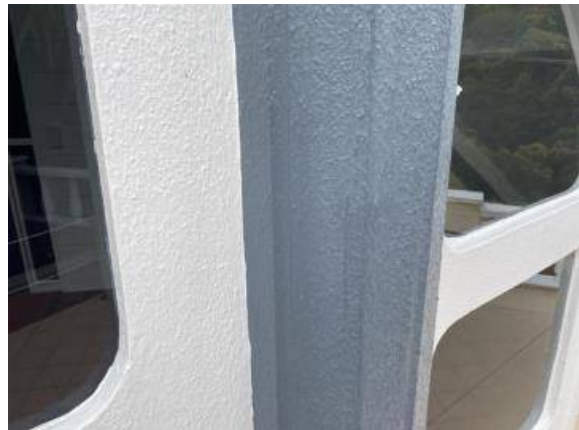
Redundant penetrations to cladding. Redundant penetrations may increase the risk of moisture ingress. We recommend sealing these details to ensure cladding remains weathertight.

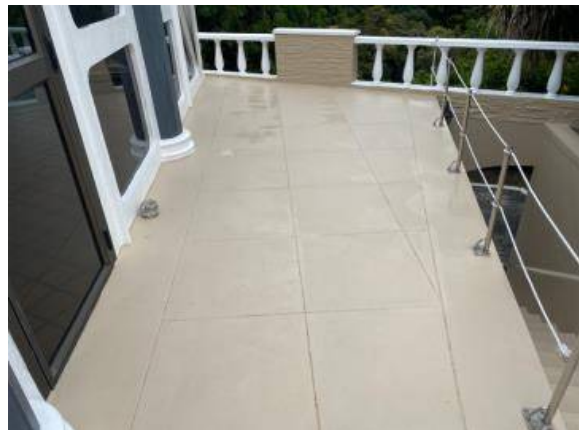
Handrail below 1m in height, handrail openings are greater than 100mm in diameter. This is a potential fall hazard. We recommend upgrading hand rails to meet minimum recommendations.

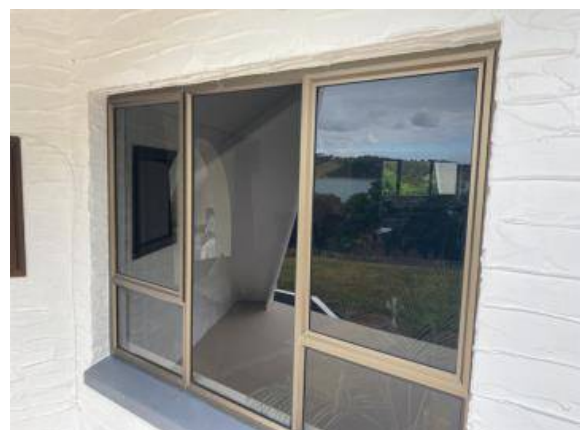
Aluminium joinery face sealed, no head flashing. This is considered a high risk moisture ingress detail. We recommend monitoring this area for signs of ingress. The installation of a suitable head flashing should be considered.

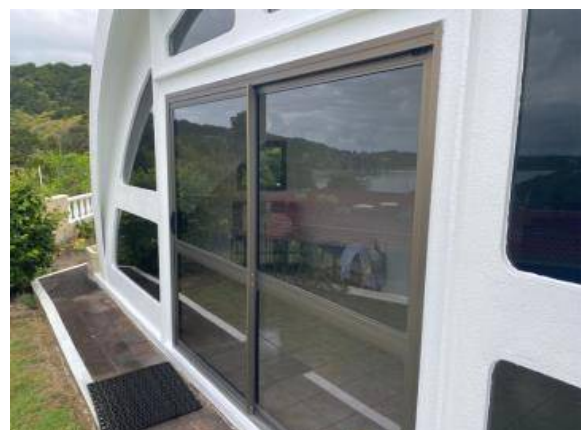
Aluminium joinery face sealed, no head flashing. This is considered a high risk moisture ingress detail. We recommend monitoring this area for signs of ingress. The installation of a suitable head flashing should be considered.
