SUBDIVISION SUITABILITY REPORT

**83 Mackesy Road
Whangarei**

(Proposed subdivision of Lot 4 DP 90063)

Report reference: 18012

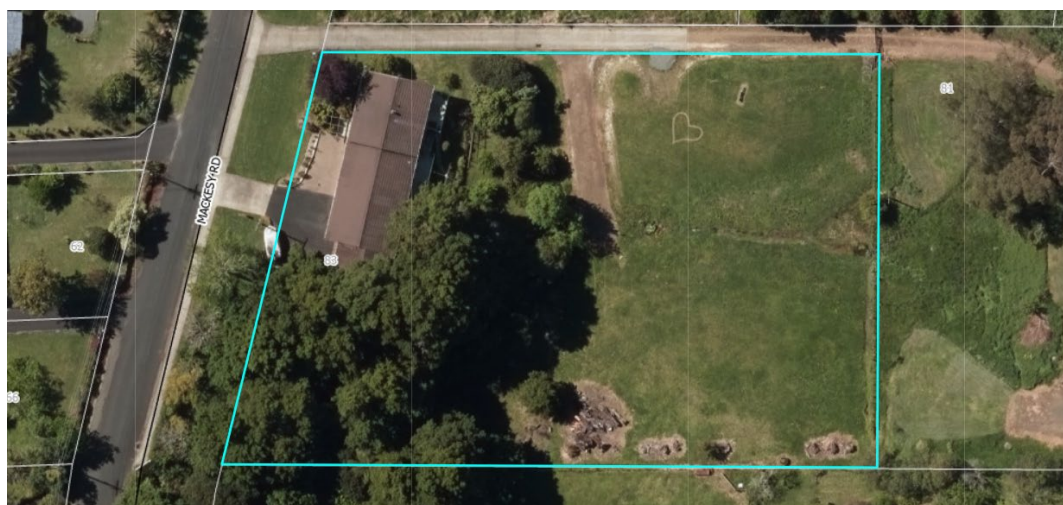
Figure 1: Lot 4 DP 90063 (WDC GIS)

The site is located 75m down Mackesy Road from the Konini Street intersection and has a slight to moderate slope. An existing dwelling is located on the western side of the site. Groundcover is lawn and mature native bush. A small stormwater drain runs through the site along the proposed boundary of lots 1 and 2. Lots 2 and 3 are slight to moderately sloping, and ground cover is pasture. A small drain runs along the proposed boundary of Lots 2 and 3 and joins up with the stormwater drain. This drain is fed from a spring on the neighbouring property.

The client proposes to subdivide Lot 4 into three lots. Lot 1 (2229m²) will be accessed from Mackesy Road, while Lot 2 (942m²) and Lot 3 (1620m²) will gain access from a shared right of way.

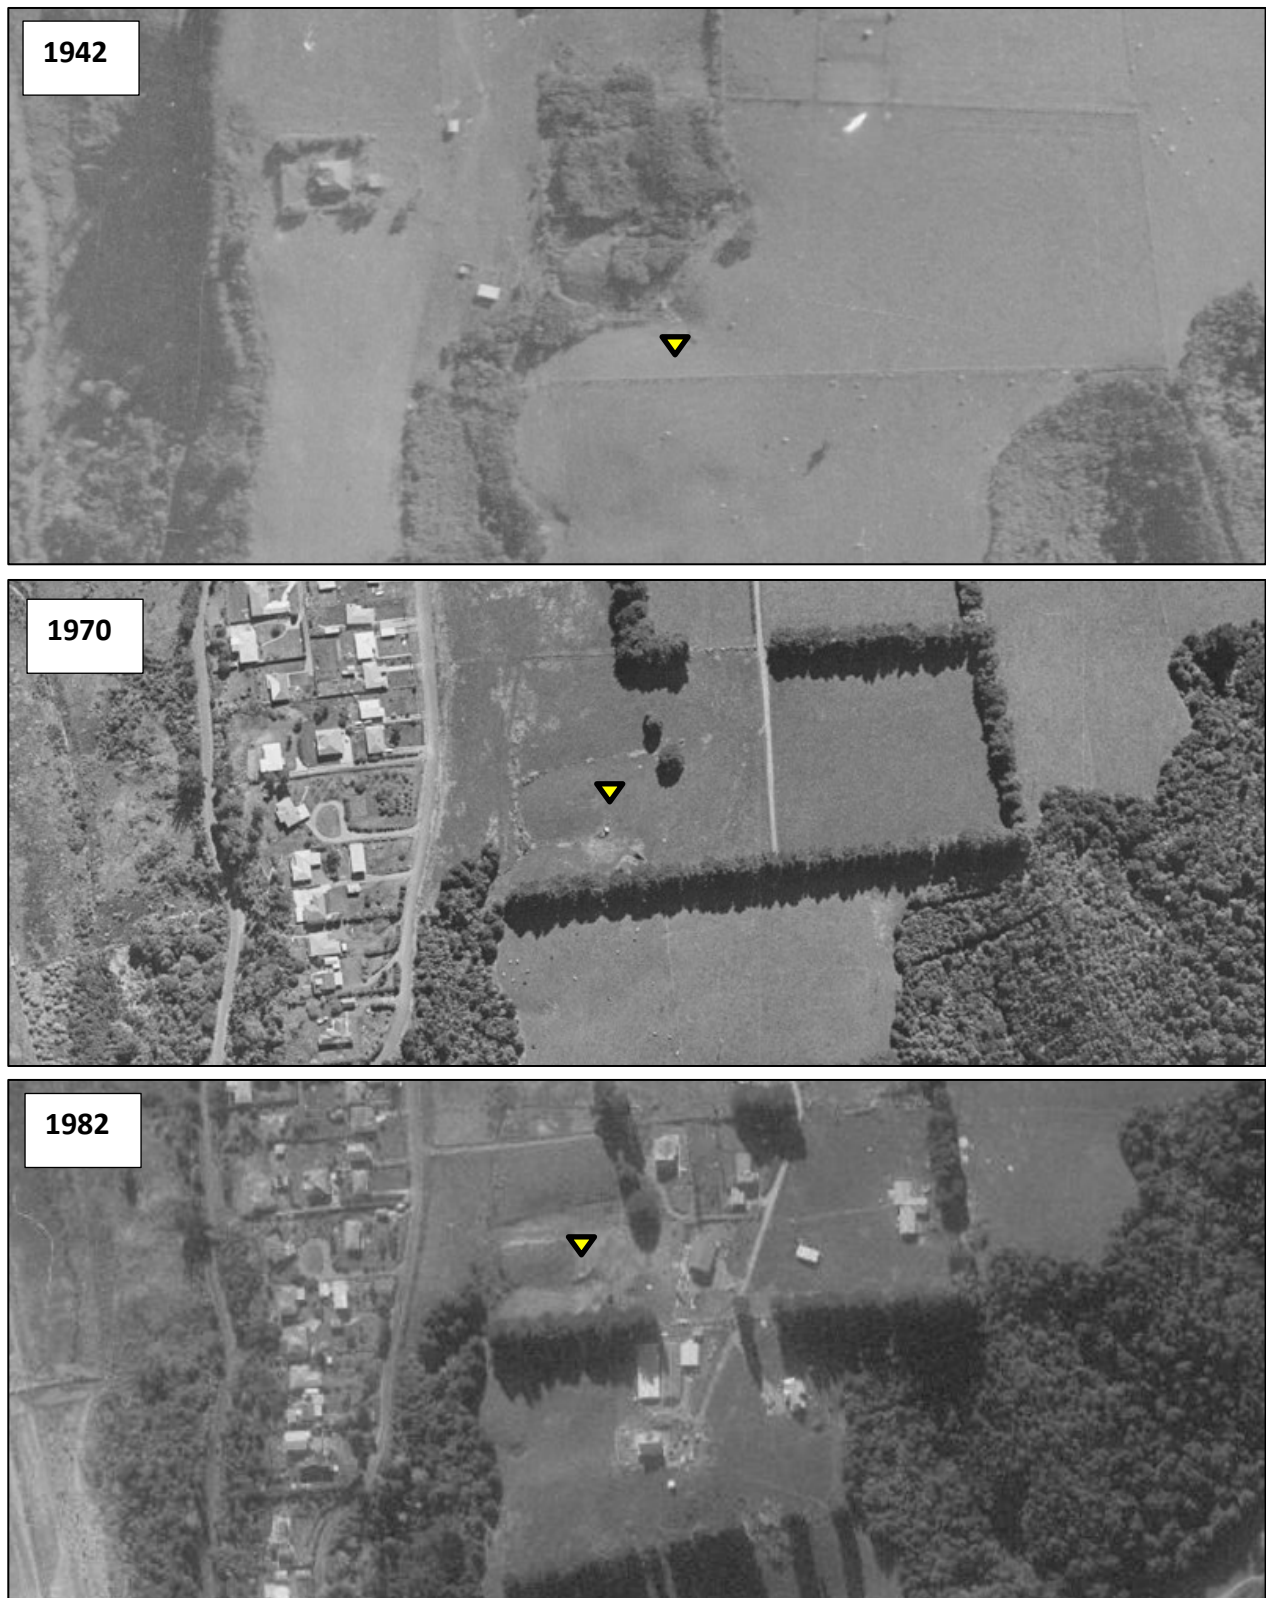
Figure 2: 1942, 1970. 1982 Aerial Images (Source: www.retrolens.nz)

RS Eng has undertaken a review of historical aerial photography. See Figure 1 below of the 1942, 1970 and 1982 aerial images. Several notable features were observed, listed below.

- 1942 – the property is covered in rank pasture with no dwellings constructed yet. There are no signs of shallow or deep relic slope failures.
- 1970 - the property is still covered in rank pasture with no dwellings constructed. Some farming has taken place evidenced by farm tracks and fencing. There are no signs of shallow or deep relic slope failures.
- 1982 – a dwelling has been constructed on the property. Further farming has taken place evidenced by farm tracks and fencing. There are no signs of shallow or deep relic slope failures.
- 2001-2021 – no significant change has occurred on the property except for a right of way constructed around 2011 and continued vegetation growth.

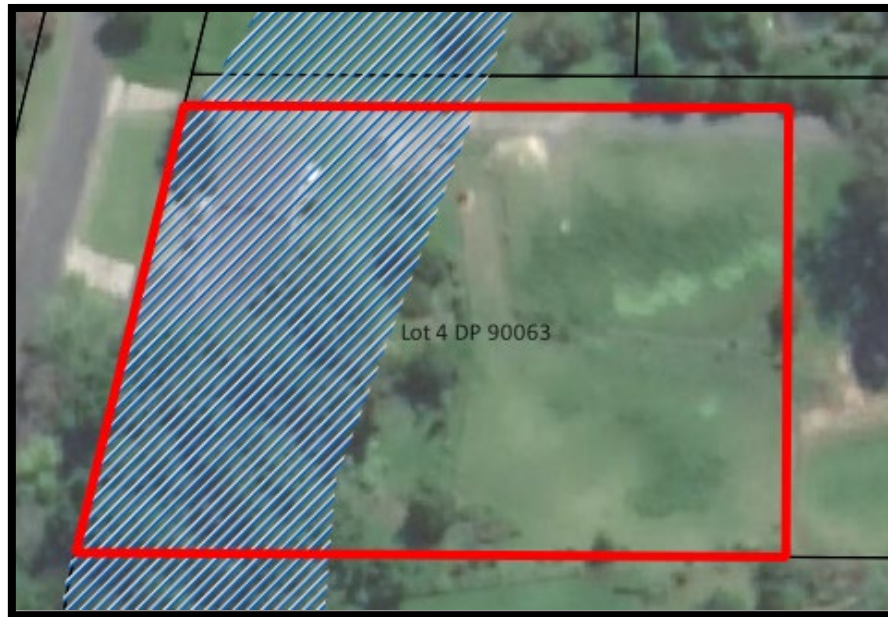
Figure 3: WDC Flood Hazard

The WDC have mapped a flood hazard across the low-lying part of the property, shown in Figure 3 below. This flood hazard is associated with the overland flow path / open drain which runs through the western end of the property.

The identified building areas on proposed Lot 2 and 3 are well elevated above the overland flow path, having a free board greater than 5m. RS Eng assess the risk of inundation to the identified building areas on the proposed lots as low.
