Building Inspection Report

Client: Paul Sumich - Bayleys Real Estate
Location: 1 Butler Place, Kamo
Whangarei

Inspection Date: 22/03/2021

RE: Building Inspection Report, 1 Butler Place, Kamo, Whangarei.

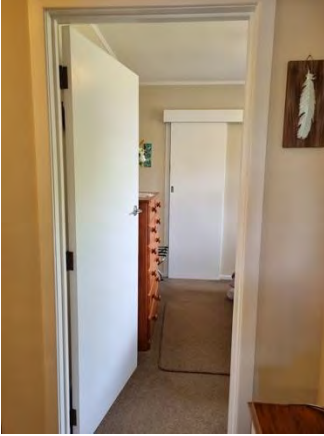
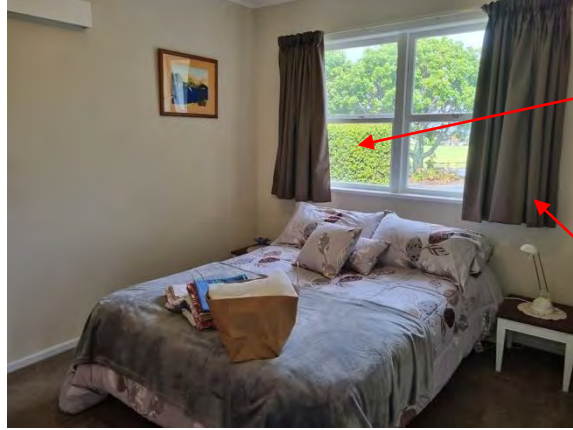
Bedroom 1 door requires shaving to avoid carpet wear

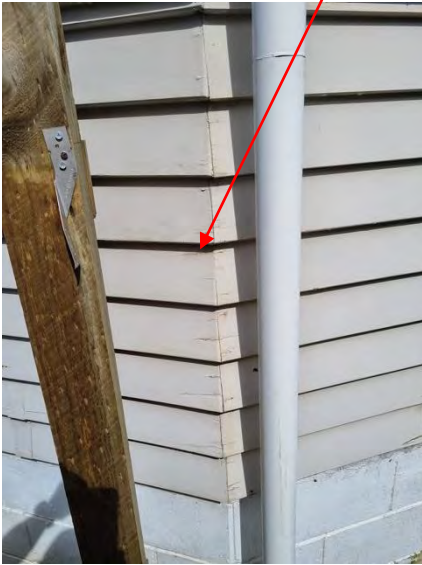
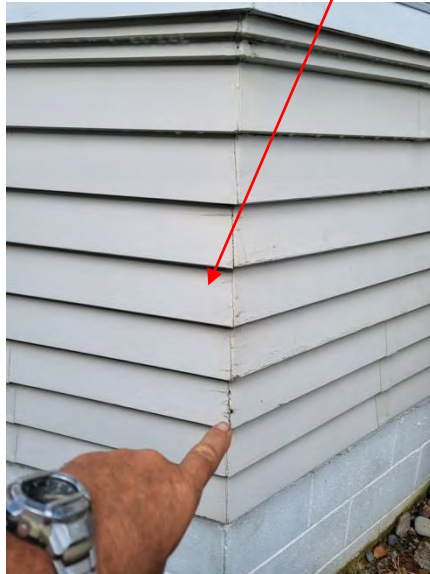
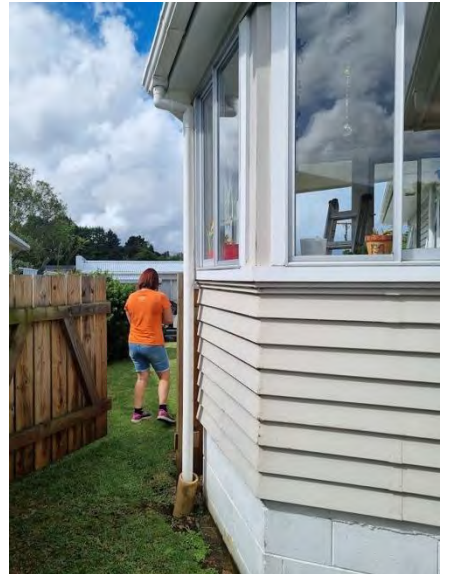
Sunroom side of the house has some rotten timber boards

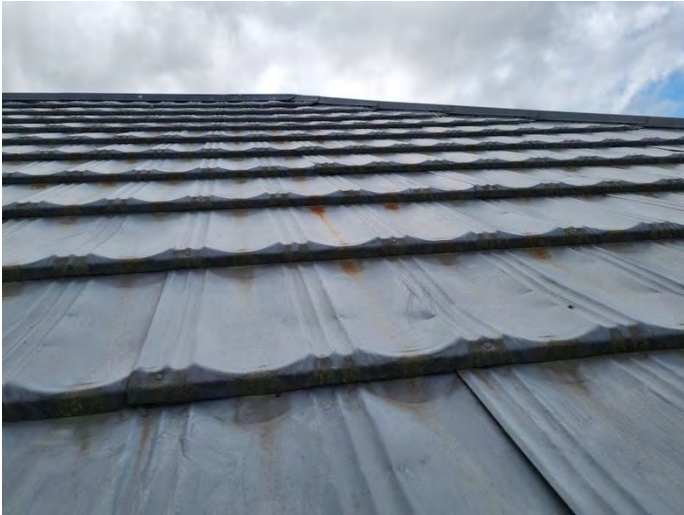
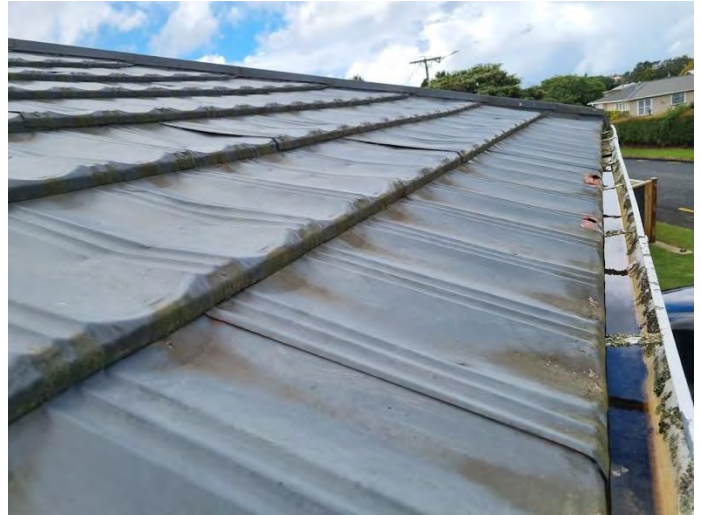
Some roofing tiles are showing signs of rust and need maintenance. Further investigation is required.
