# **Building Inspection Report**

Client: Harcourts Whangarei Location: 25F Tutukaka Block Road,

Inspection Date: 05/05/2021

RE: Building Inspection Report, 25F Tutukaka Block Road, Tutukaka, Whangarei.

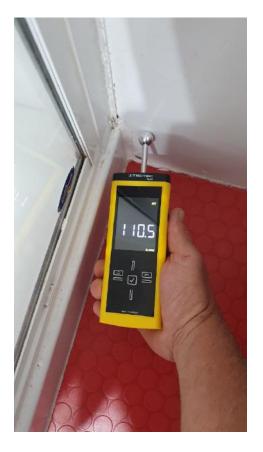
High moisture meter reading beside shower was noted.
