Pre-sale Building Inspection Report

RED LBP PRE-PURCHASE REPORT

PRE-PURCHASE BUILDING REPORT

Property Address	33 Kotare Crescent, Maunu, Whangarei, Northland, 0110, NZL		
Client	Tam Whitehorn		
Date of Inspection	29th February 2024	Time	1:00 pm
Inspector	Jamie Mackintosh Licensed Building Practitioner Brick & Block		
LBP Number	116085		
Additional Information			
People Present	Inspector, Owner		
House Occupied	Yes

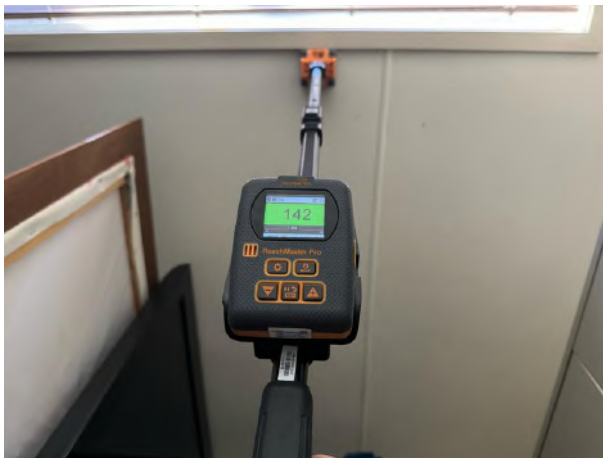
Photo 5

No elevated moisture readings at the time of inspection.

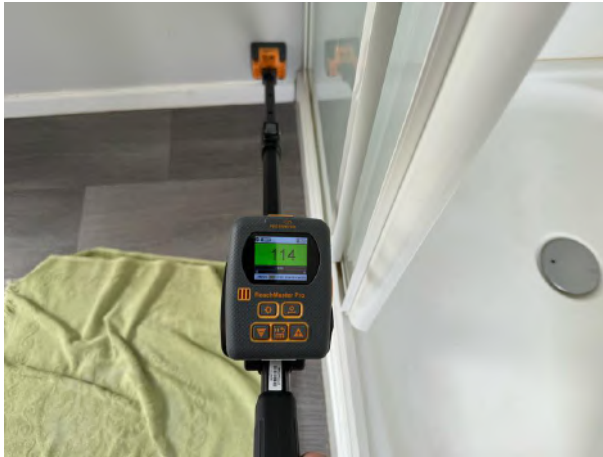
Photo 6

No elevated moisture readings around the wet areas at the time of inspection.

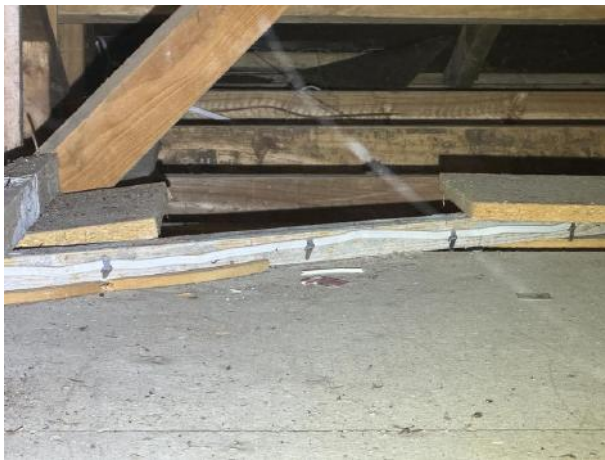
Photo 8

Roof space showing no insulation. Modern electrical wiring visible.

Recommend installing a suitable insulation to the roof space.

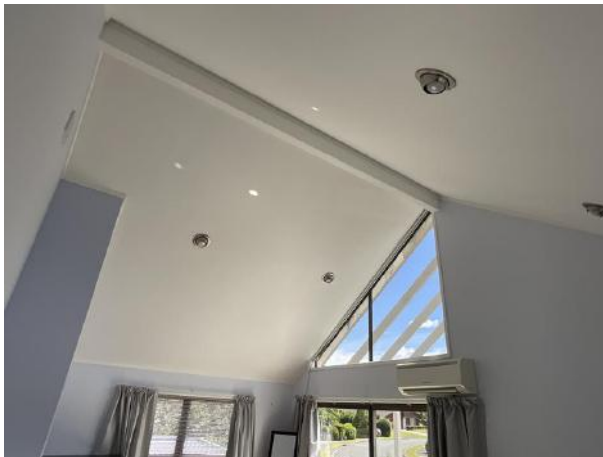
Photo 24

The condition of the roof framing is unknown.

Skillion roof design.

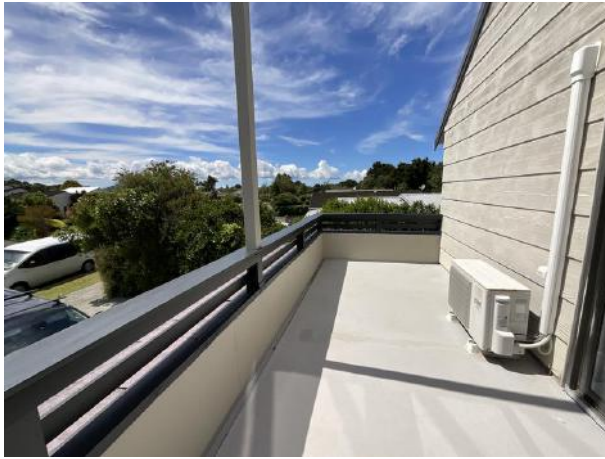
Photo 26

Balcony.

Recommend sealing around all balustrade to cladding junctions to maintain weather-tightness.

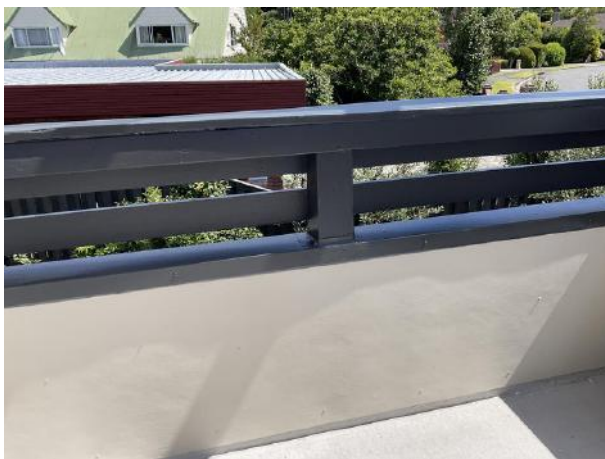
Photo 28

Timber balustrade.

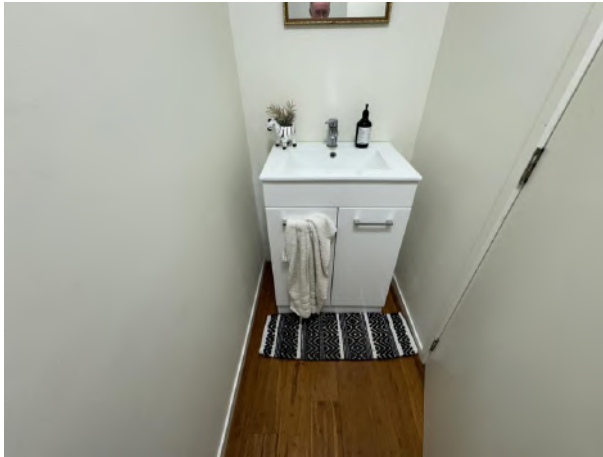
Photo 32

Vanity.

It is recommended that a water resistant splashback be installed behind the vanity to protect the painted wallboard from water damage.

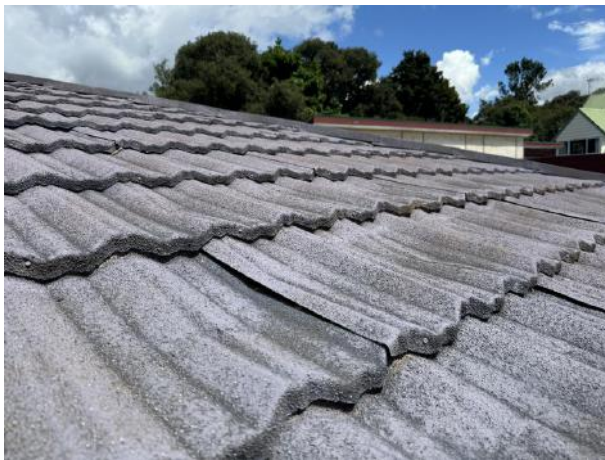
Photo 36

Dented tiles on the north elevation.

Dented tin tiles should be repaired or replaced. The dents will deteriorate the tile's coating, which can cause ponding of water and worst case leaks may occur. Have an LBP in roofing undertake any repairs & maintenance outside of the homeowner's skill level.

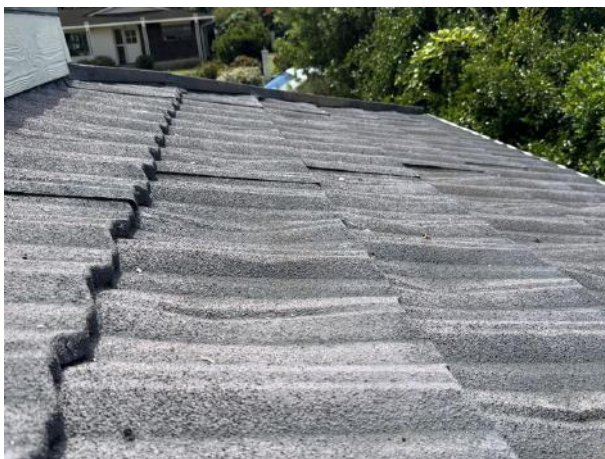
Photo 37

Dented tiles on the east elevation above the garage.

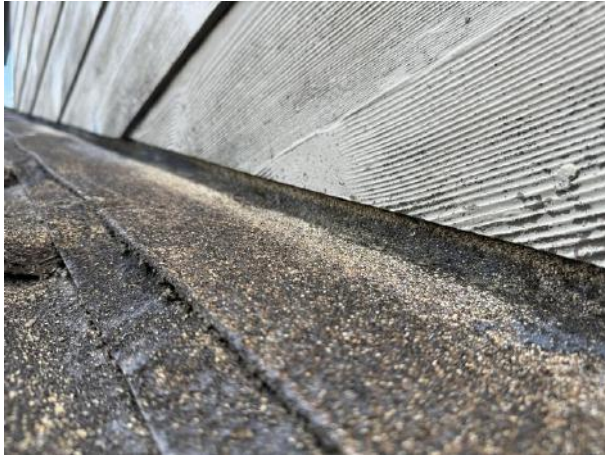
Photo 38

Example of a metal apron flashing. Functional.

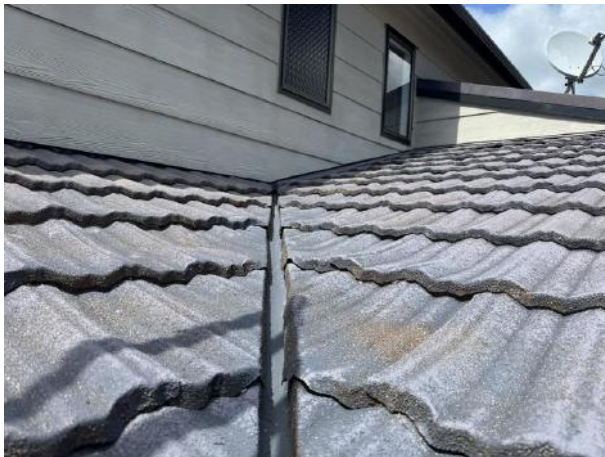
Photo 39

Example of a metal valley flashing. Clear at the time of inspection.

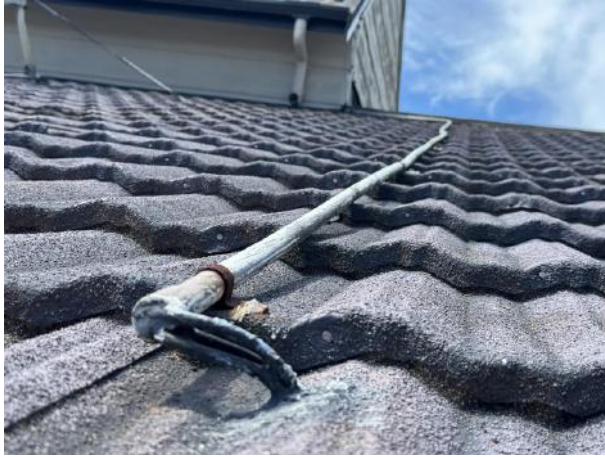
Photo 43

Data penetration. Sealed.

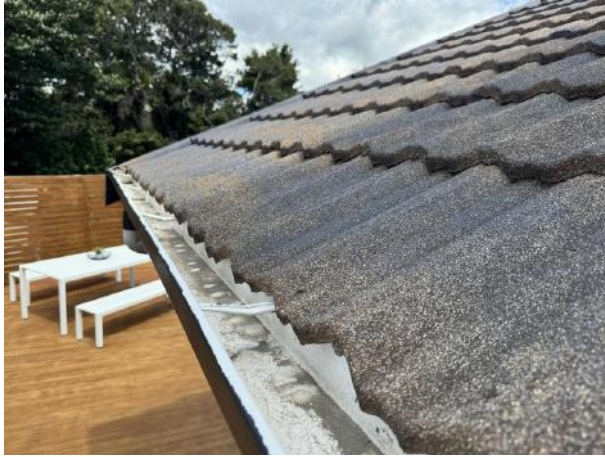
Photo 44

Example of PVC guttering. Clear at the time of inspection.

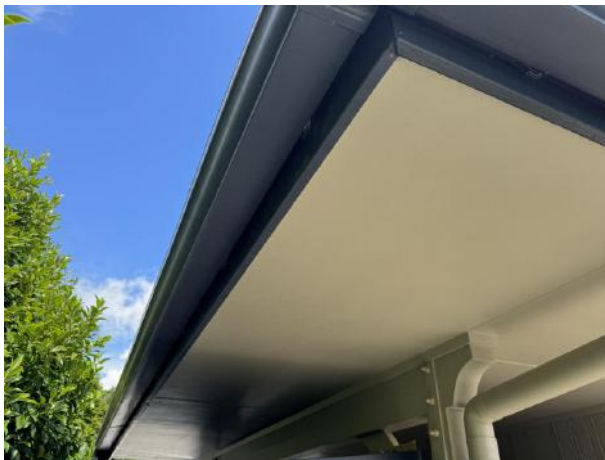
Photo 47

Example of timber fascia boards and fibre cement soffits.

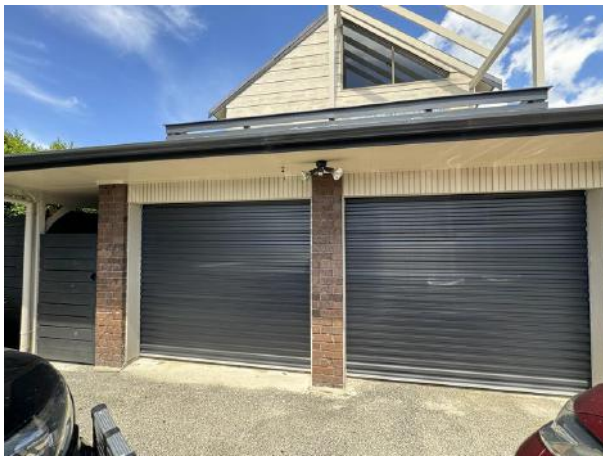
Photo 48

North elevation.

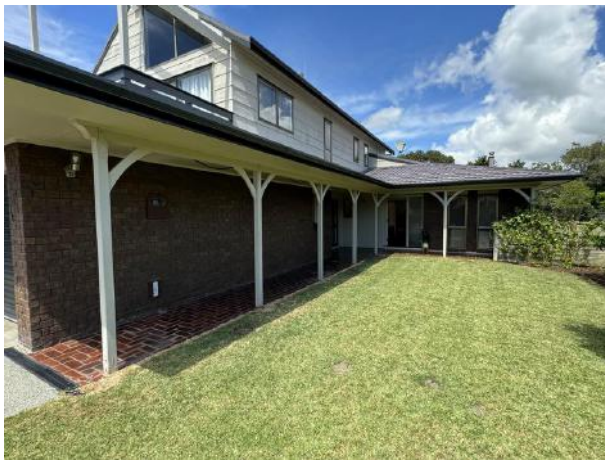
Photo 50

West elevation. Brick veneer on the ground floor with fibre cement weather boards on the first floor.

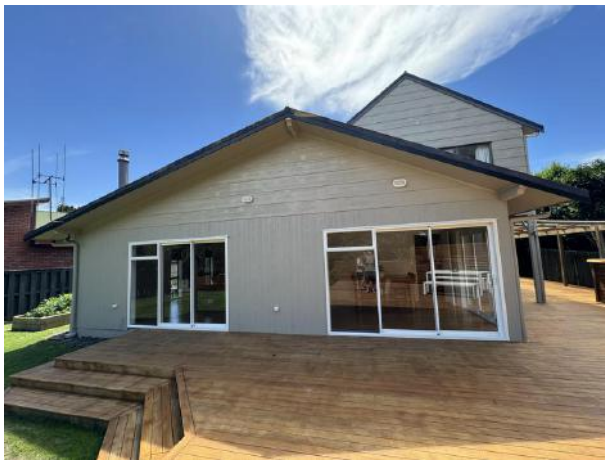
Photo 53

South elevation. Fibre cement sheeting on the ground floor with fibre cement weather boards on the first floor.

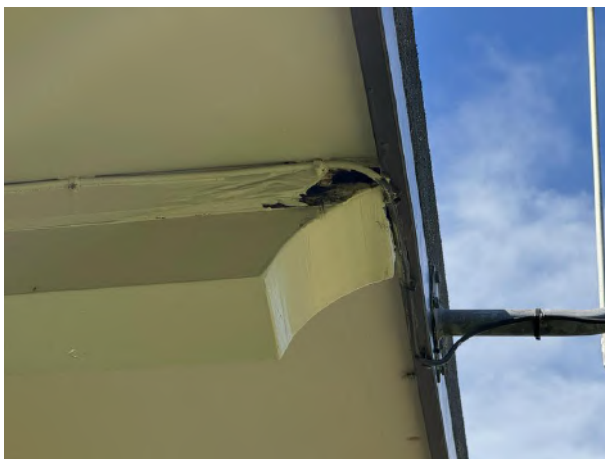
Photo 54

Rotten timber trim on the southwest soffit.

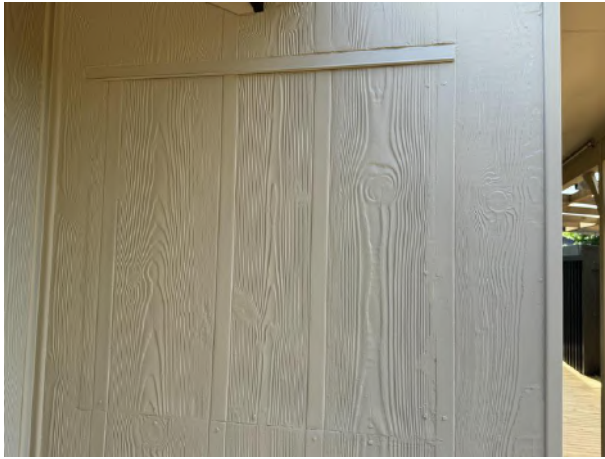
Photo 55

Window has been boarded over by the kitchen. Functional.

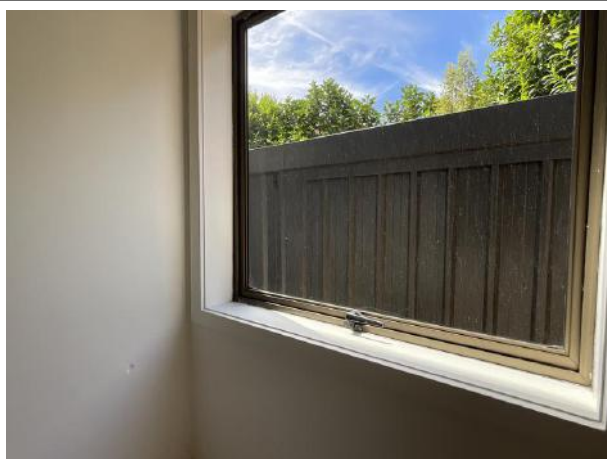
Photo 60

Example of aluminium joinery with timber reveals.

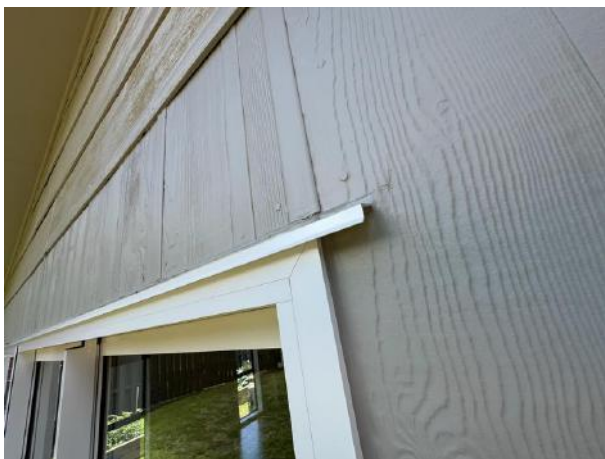
Photo 63

Example of typical modern aluminium joinery detail. Metal head flashings and sealed down the sides. Functional.

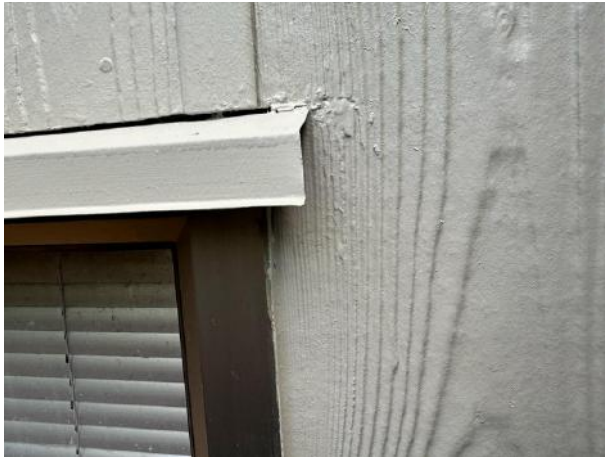
Photo 64

Example of typical original ground floor aluminium joinery detail. Metal head flashings and sealed down the sides.

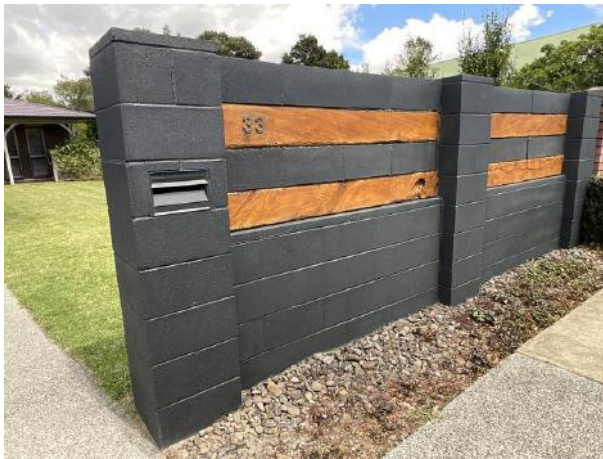
Photo 68

Masonry block wall with timber inserts, located on the northern boundary.

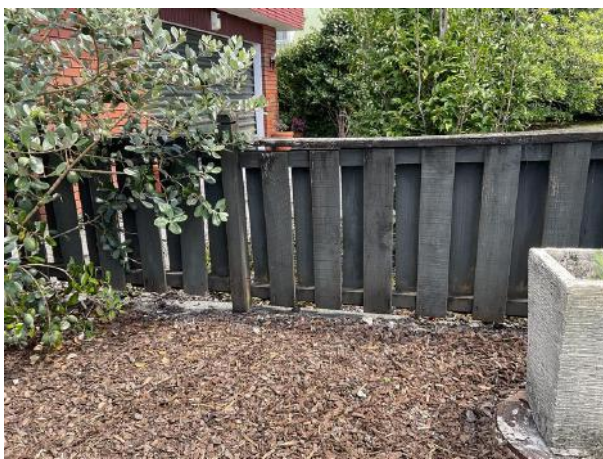
Photo 69

Timber paling fence located on the western boundary.

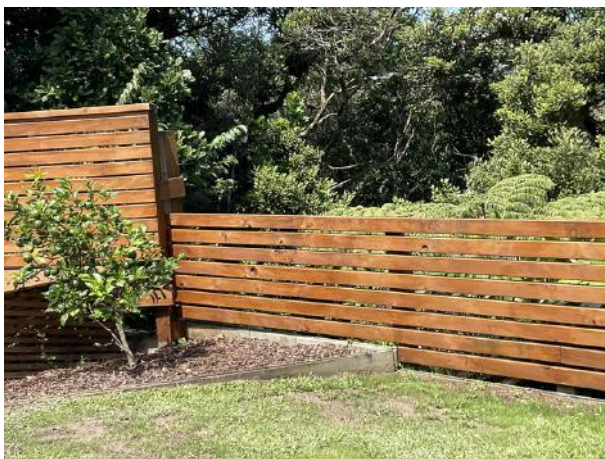
Photo 72

Timber post and rail fence located on the southern boundary.

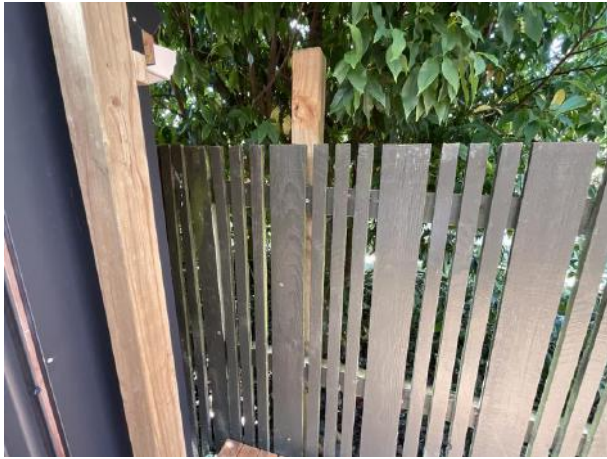
Photo 76

Some of the timber posts have been replaced.

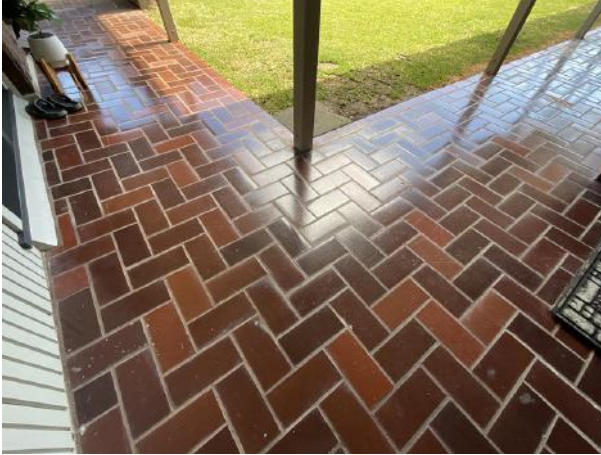
Photo 77

Tiled paths are located along the west side off the house of the front entrance.

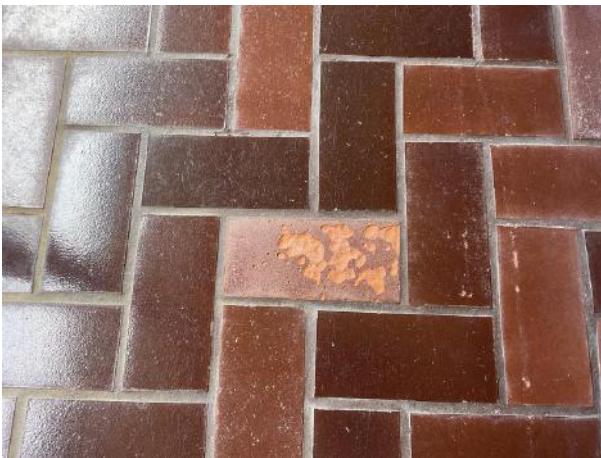
Photo 78

Chipping on the top of the tile.

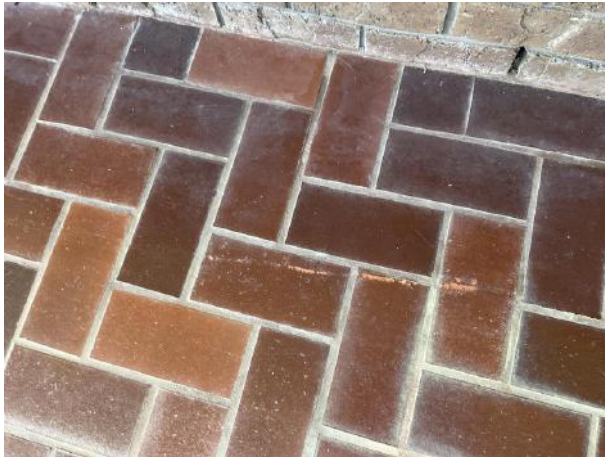
Photo 79

Chipping in some of the tiles.

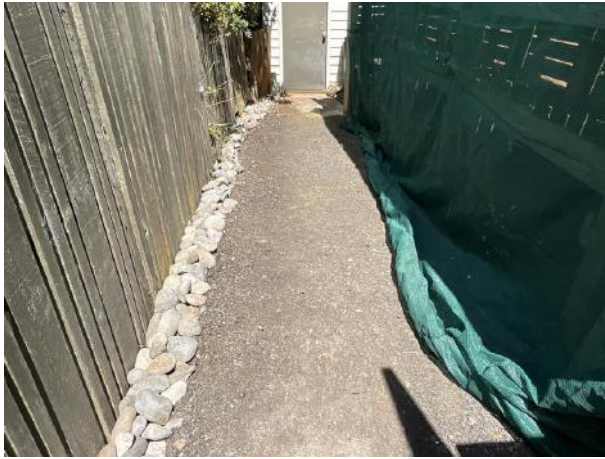
Photo 82

Path with rock edging, located on the east side of the house leading to the shed.

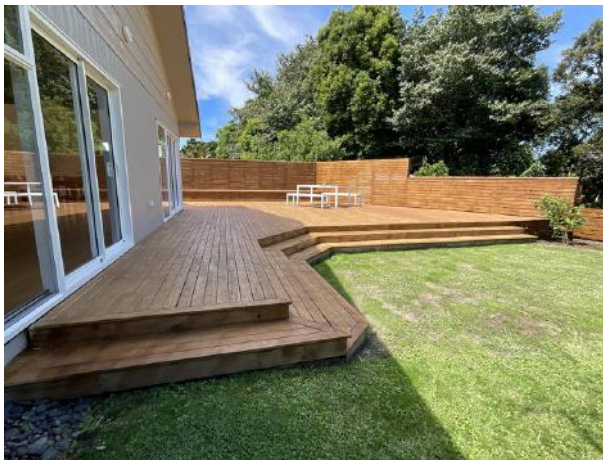
Photo 83

Timber deck and stairs off the living and dining room on the south side of the house.

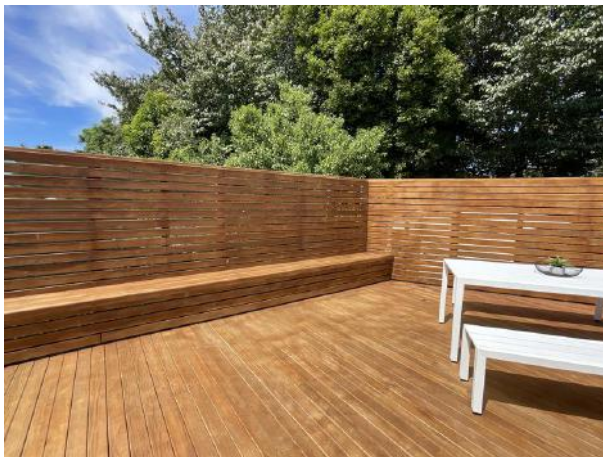
Photo 84

Timber privacy wall and seating located on the south and east side of the deck.

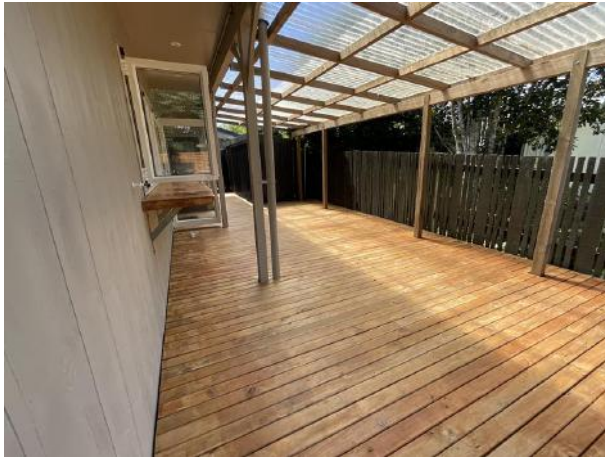
Photo 85

Timber deck off the kitchen on the east side of the house.

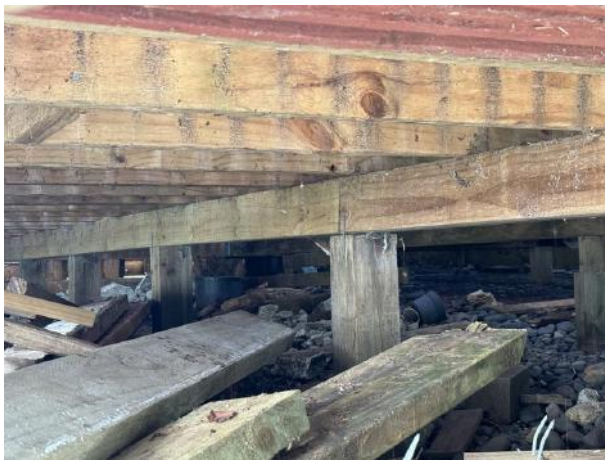
Photo 89

Timber framed decks.

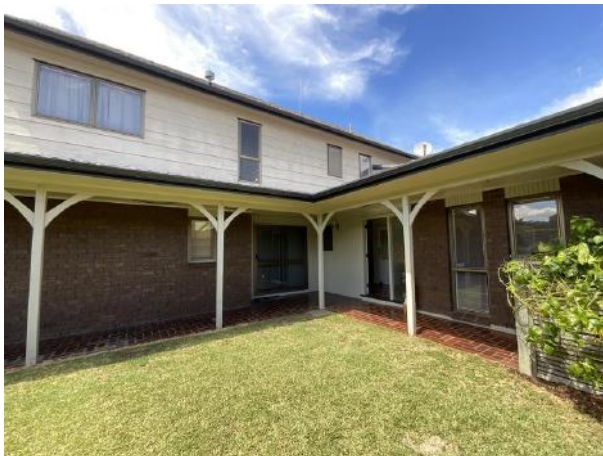
Photo 91

Timber framed verandah located on the west side of the house.

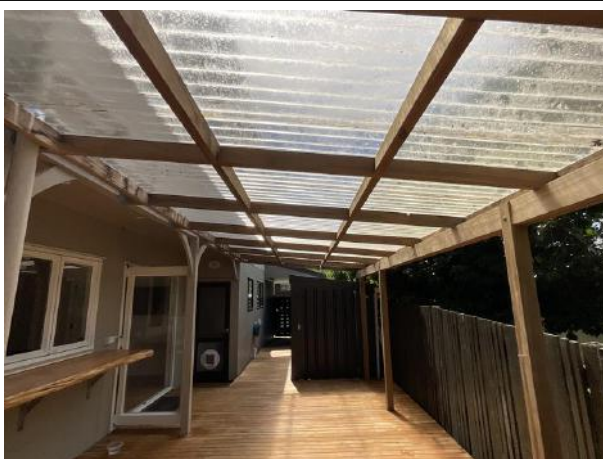
Photo 92

Timber verandah with polycarbonate roofing over the east deck.

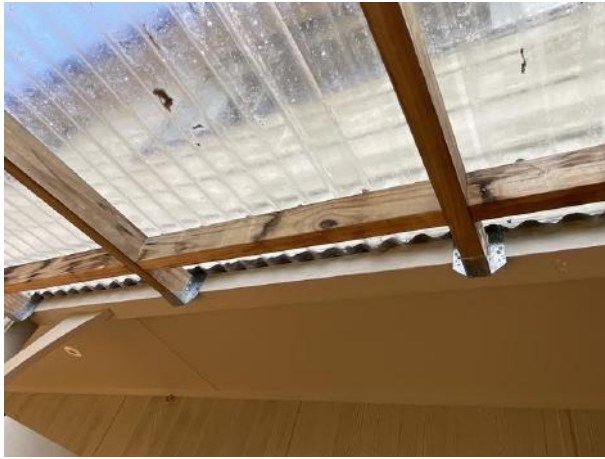
Photo 93

100 x 50 purlins attached to the fascia with galvanised joist hangers. Functional.

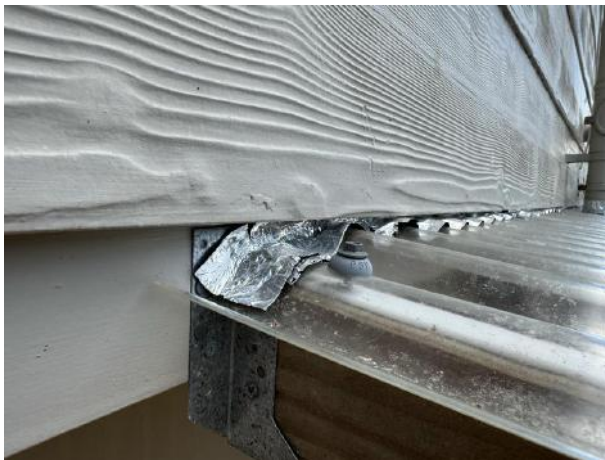
Photo 94

Tape along the verandah to wall junction.

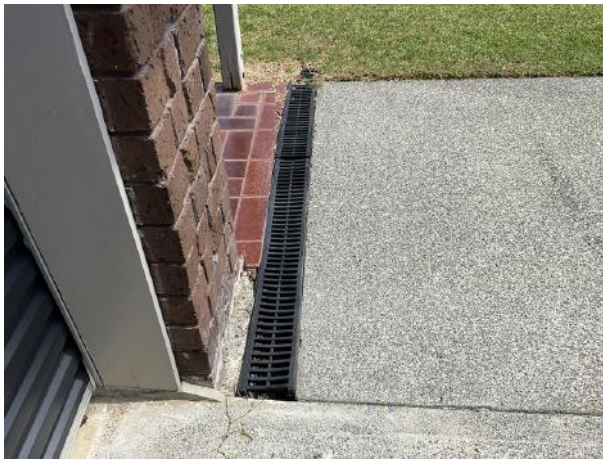
Photo 95

Channel drain running in front of the tiled path.

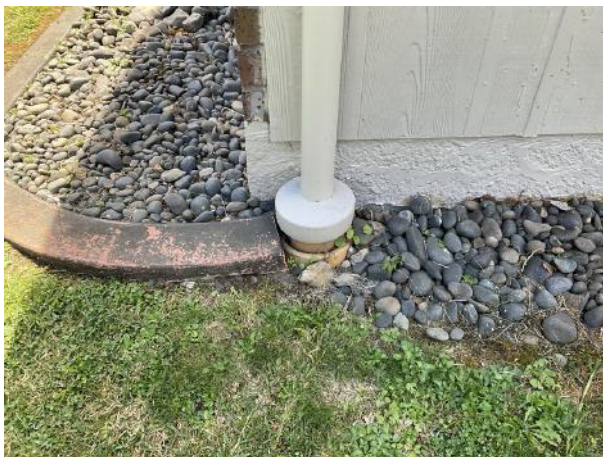
Photo 96

Example of a stormwater sump.

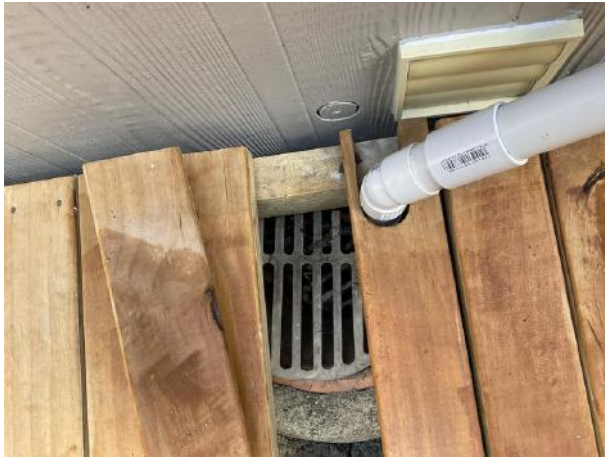
Photo 97

Gully trap located under the eastern deck.

Gully traps should be accessible for cleaning and maintenance.

A deck may be built over a gully trap, but at least 600 mm of clear access space above the trap must be provided. This is for access to the gully trap for drainage inspections and maintenance in the event of blockages.

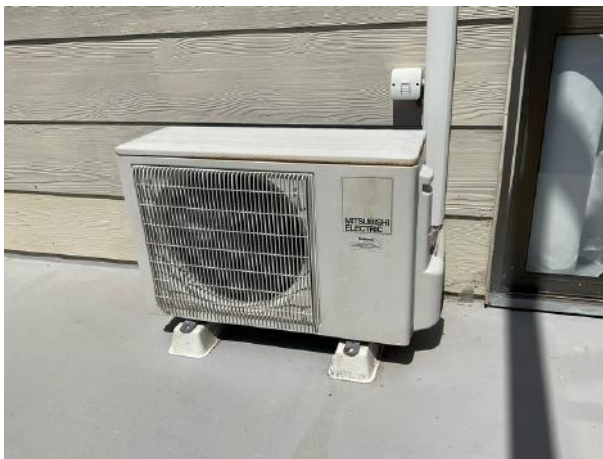
Photo 98

Outdoor heat pump unit located on the northern balcony.

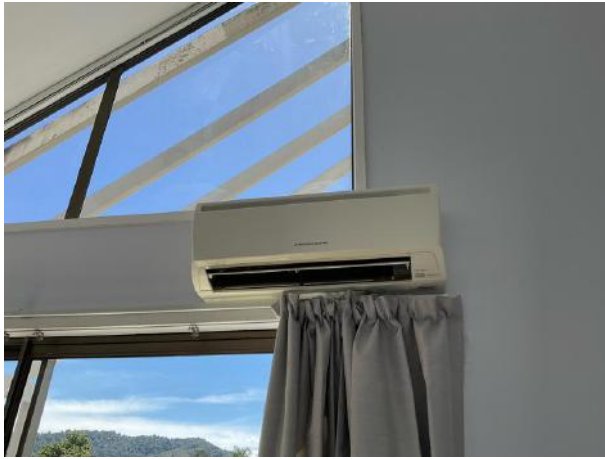
Photo 99

Mitsubishi electric heat pump located in bedroom four.

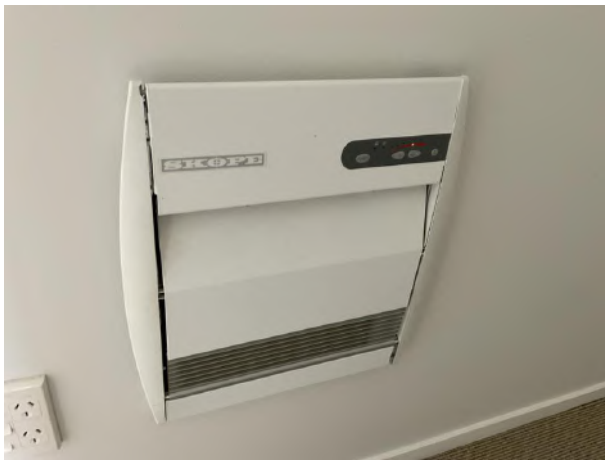
Photo 100

Scope wall heater located in these first floor hallway.

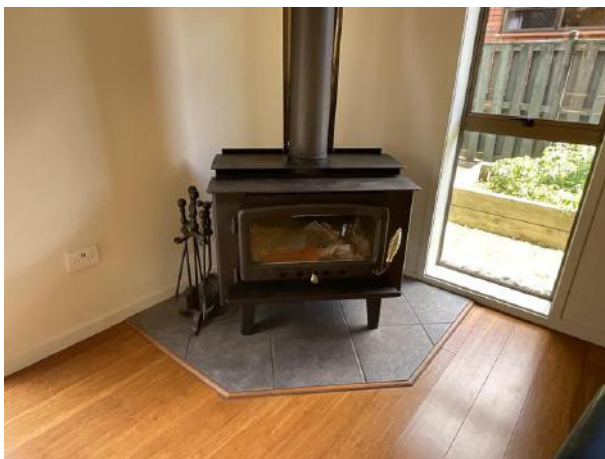
Photo 101

Nectre freestanding woodburner located in the living room.

It is recommended to have the wood burner flue cleaned and checked annually.

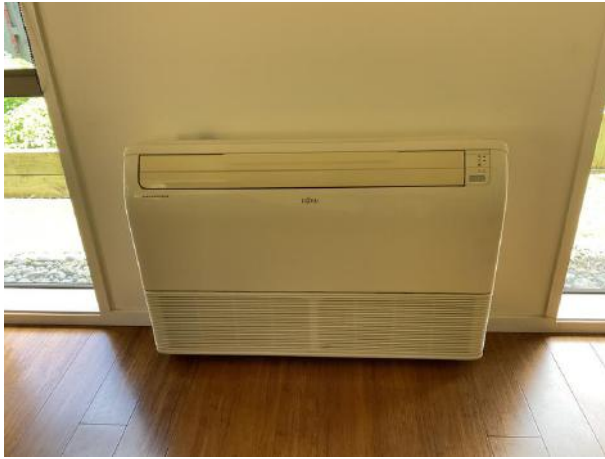
Photo 102

Fujitsu Inverter wall heatpump located in the living room.

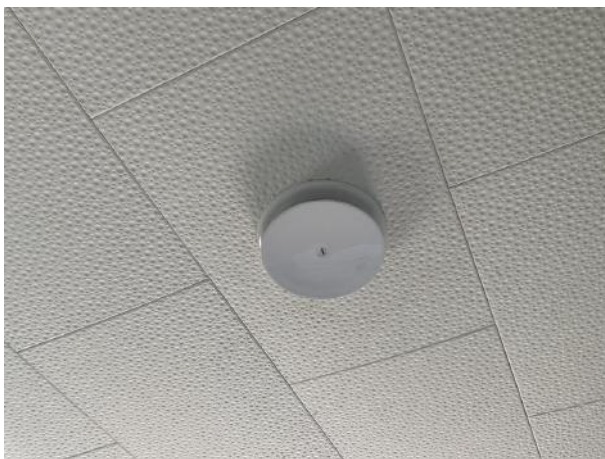
Photo 104

Example of a ventilation vent located throughout the house.

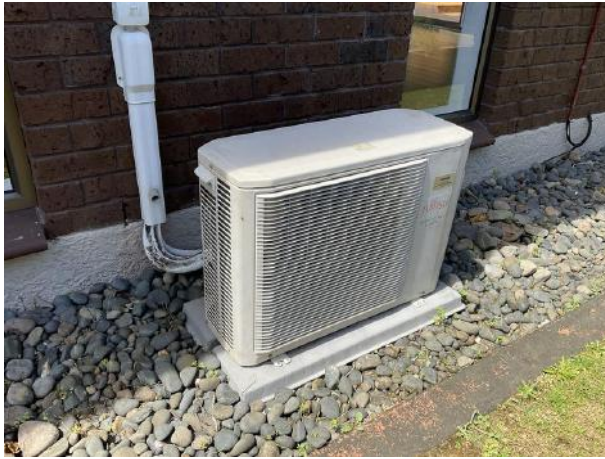
Photo 105

Outdoor heat pump unit located on the west side of the house.

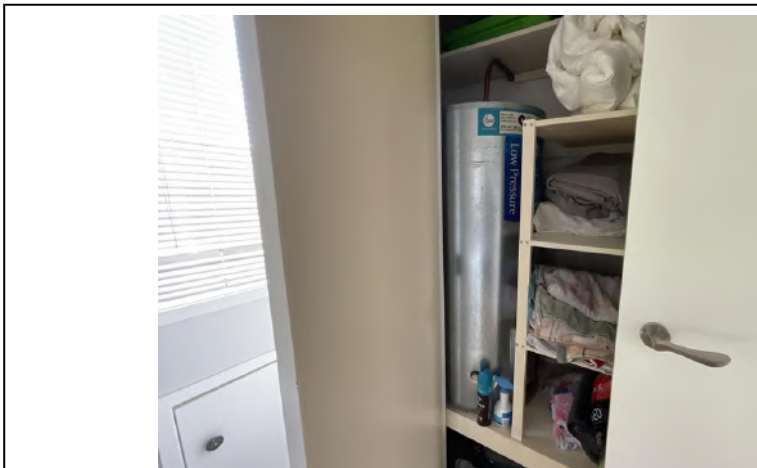
Photo 106

Hot water cylinder located in the first floor hallway cupboard.

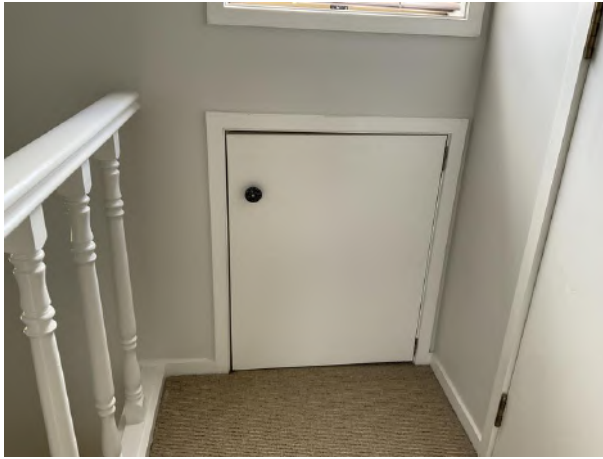
Photo 107

Roof space access located in the first floor hallway.

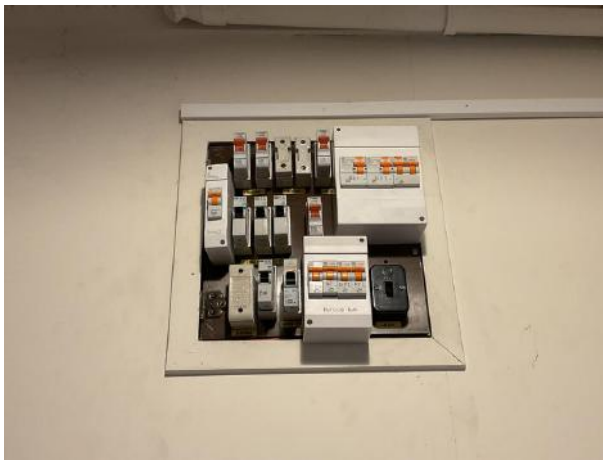
Photo 108

Distribution board located in the garage.
