Pre-sale Building Inspection Report

PRE-PURCHASE BUILDING REPORT

Property Address	956D Whangarei Heads Road, Parua Bay, Northland, 0174, NZL		
Client	Penny Bradford		
Date of Inspection	17th March 2024	Time	1:00 pm
Inspector	Jamie Mackintosh Licensed Building Practitioner Brick & Block		
LBP Number	116085		
Additional Information			
People Present	Inspector, Agent		
House Occupied	Yes

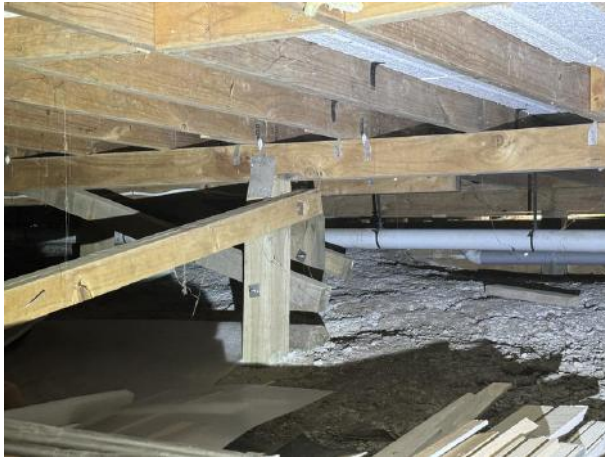
Photo 3

Subfloor showing timber bearers on timber piles. Stainless fixings.

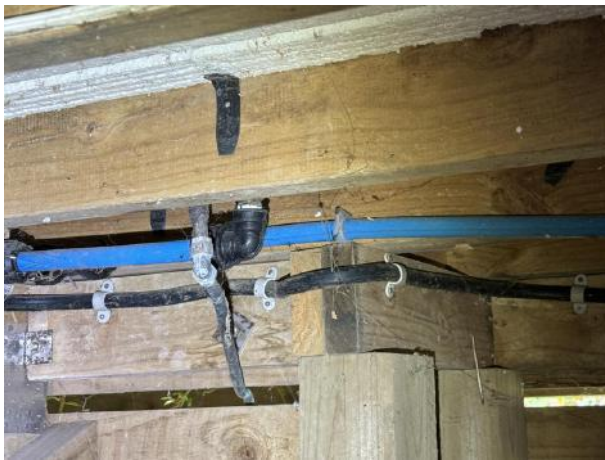
Photo 4

Subfloor showing blue and copper water pipes.

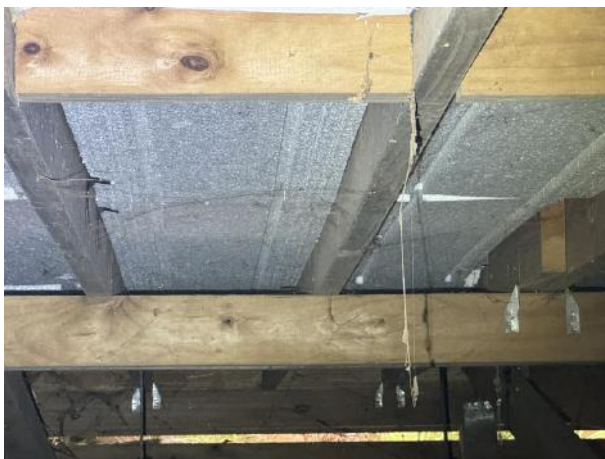
Photo 5

Subfloor showing polystyrene insulation.

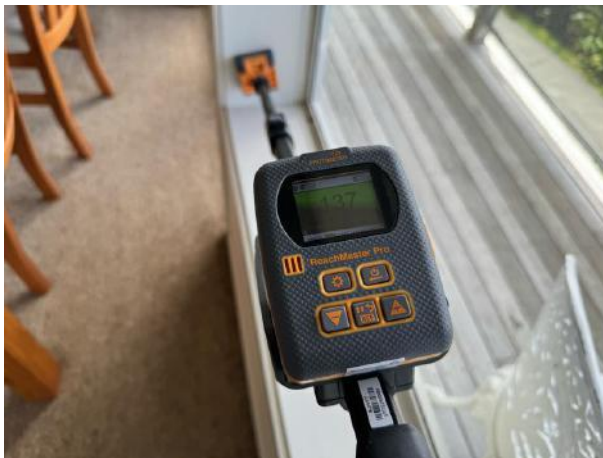
Photo 7

No elevated moisture readings at the time of inspection.

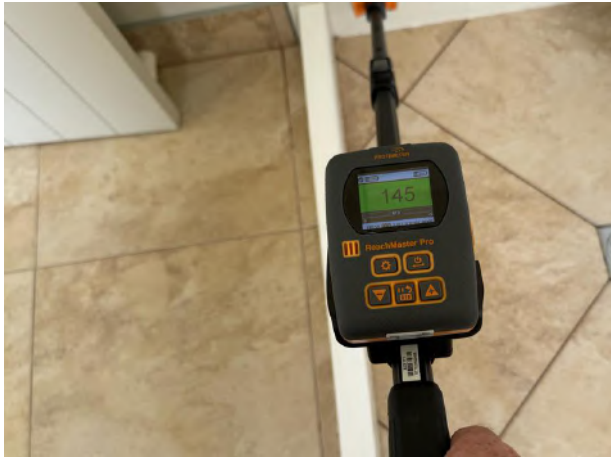
Photo 8

No elevated moisture readings around the wet areas at the time of inspection.

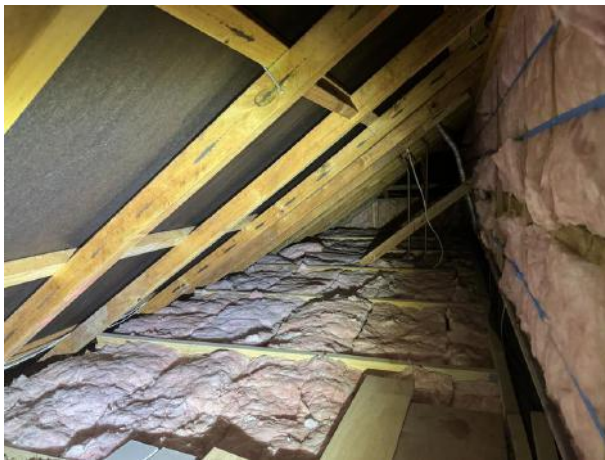
Photo 10

Roof space showing manufactured timber trusses and glasswool insulation.

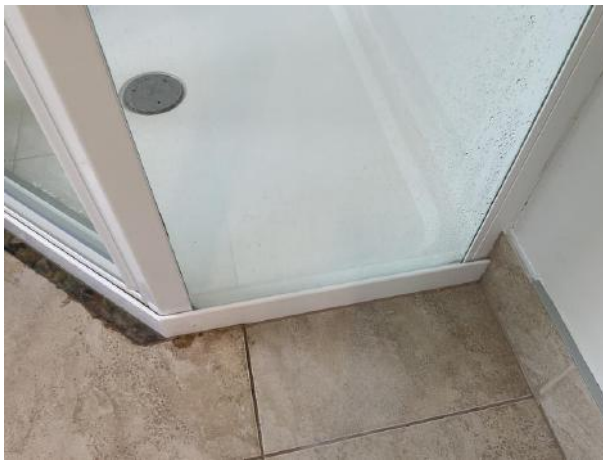
Photo 17

Shower has been replaced.

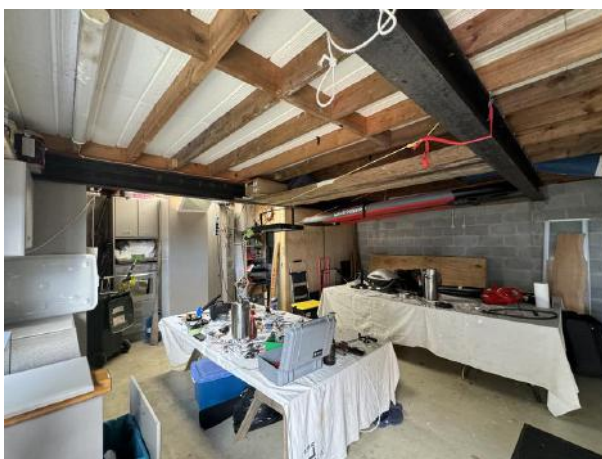
Photo 26

Masonry block walls and timber framed ceiling. No ceiling linings.

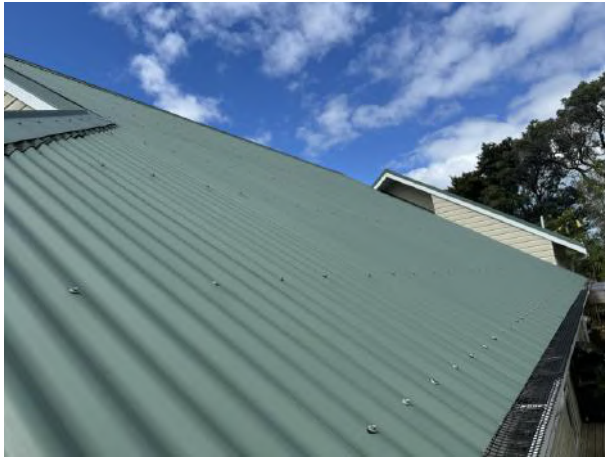
Photo 27

Profiled metal roof with screw fixings.

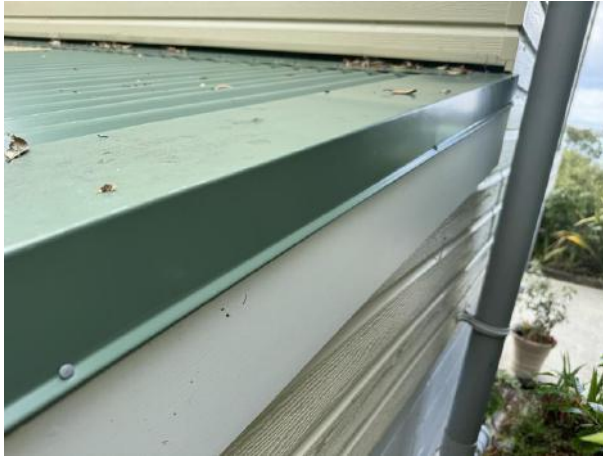
Photo 29

Example of a metal barge flashing. Functional.

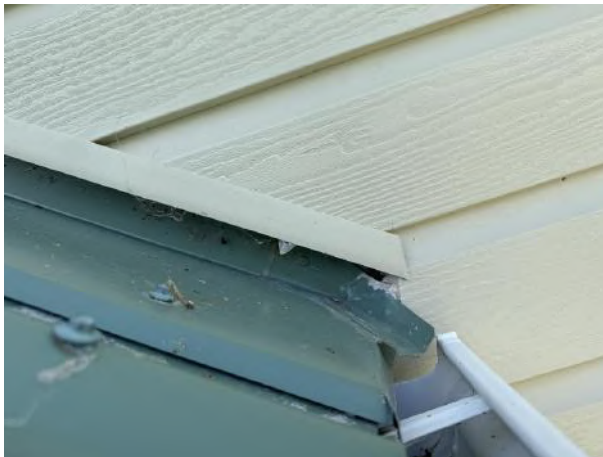
Photo 30

Example of a metal apron flashing with kick out. Functional.

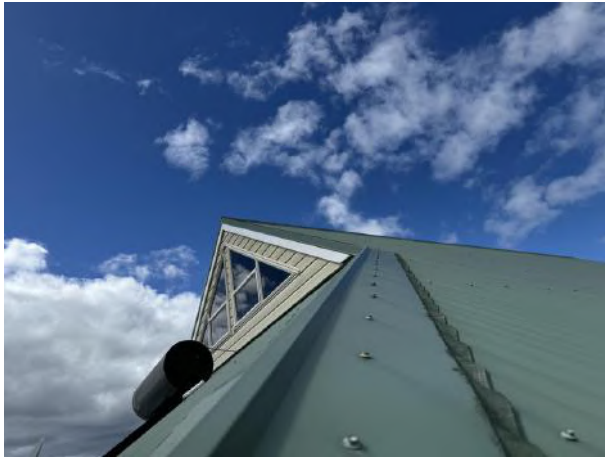
Photo 31

Example of a metal hip flashing. Functional.

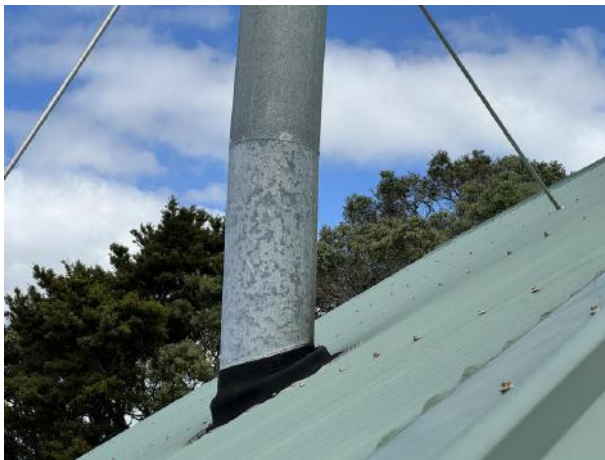
Photo 32

Flue penetration with rubber boot flashing.

Although the roof penetrations may have been compliant at the time of construction it is recommended that future maintenance would include the installation of a watershed back flashing is installed under any EPDM boot flashing with a pipe diameter over 85mm, as per, E2/AS1 permits the use of boot flashings where: the maximum roof pitch is 45°, the minimum pitch is 10°, or if the base of the flange covers one or more complete troughs or if the pipe diameter is no more than 85 mm.

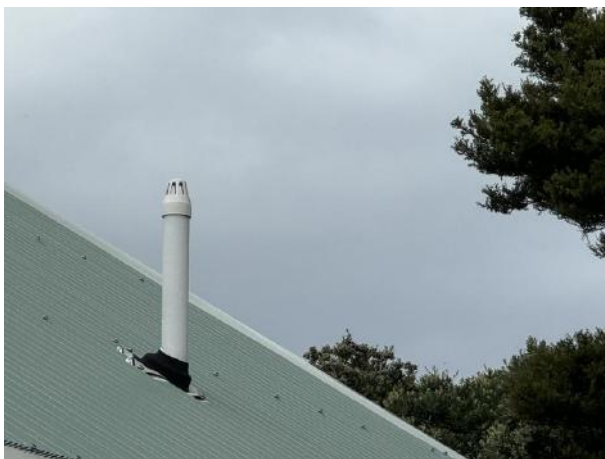
Photo 33

Vent penetration with rubber boot flashing.

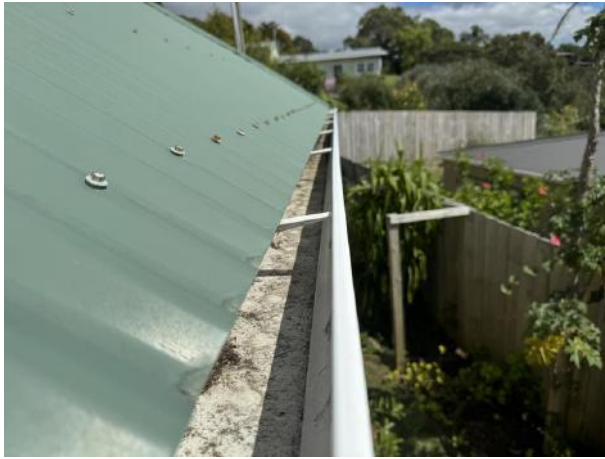
Photo 34

Example of PVC guttering. Clear at the time of inspection.

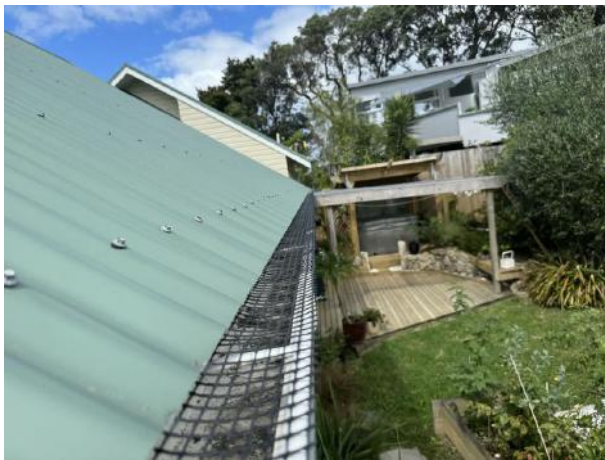
Photo 35

Gutter guard installed on the west facing gutters.

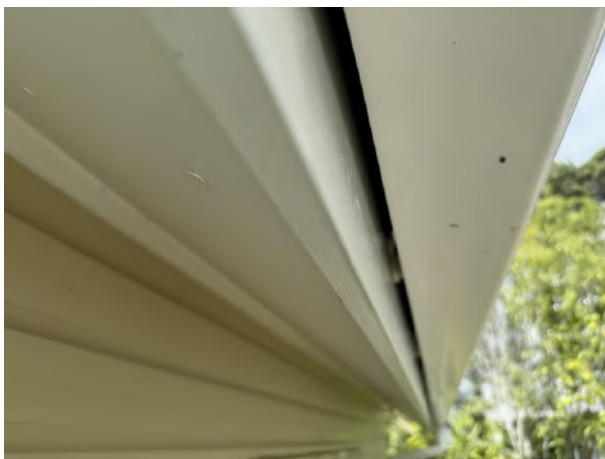
Photo 36

Example of fibre cement soffits and timber fascia boards.

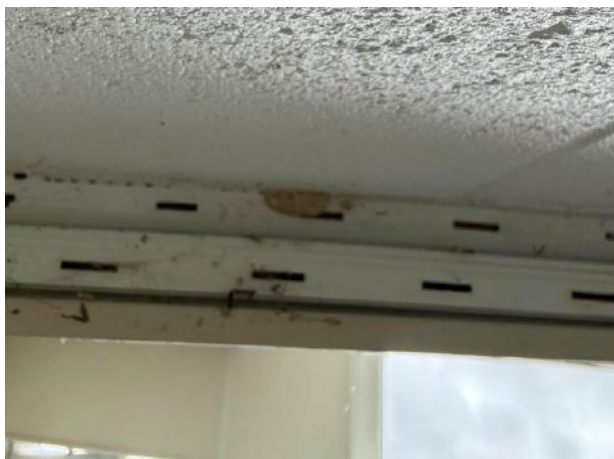
Photo 43

Example of vented cavity strips.

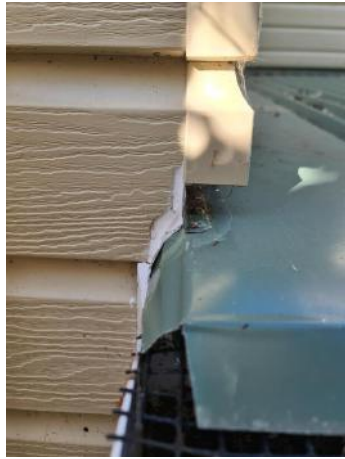
Photo 44

Recommend sealing the cladding to roof junction on the west side.

Update 20-3-24 - Cladding to roof junction has now been sealed. Functional.

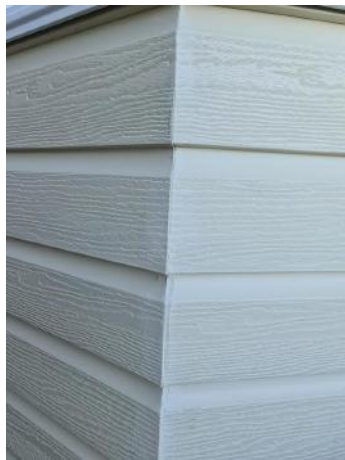
Photo 45

Seperation in the sealer on the angle junctions by the front door. Recommend re-sealing.

Update 20-3-24 - Angle junctions by the front door have been sealed. Functional.

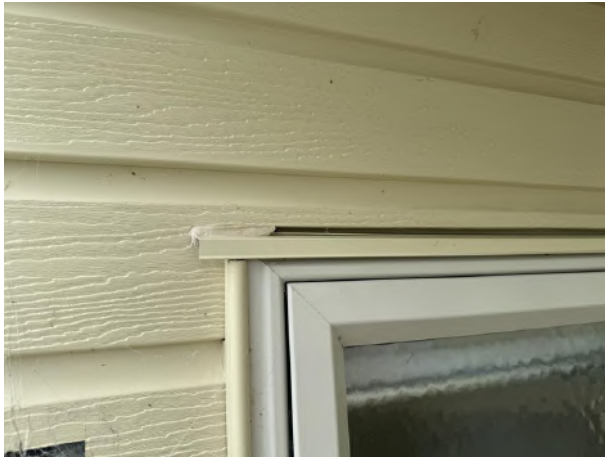
Photo 50

Example of aluminium joinery detail. Metal head flashing and PVC scribes.

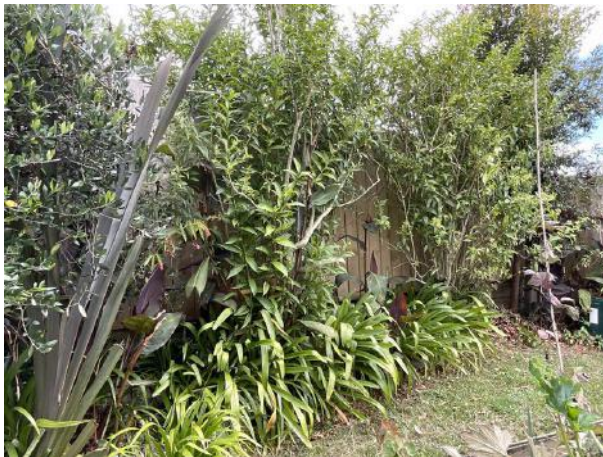
Photo 54

Timber paling fence located on top of a timber retaining wall on the western boundary. Some of this fence could not be inspected due to vegetation.

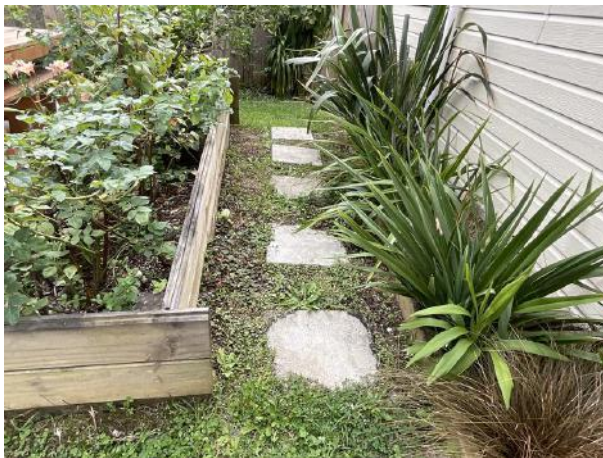
Photo 56

Uneven, concrete paver path located along the west side of the house.

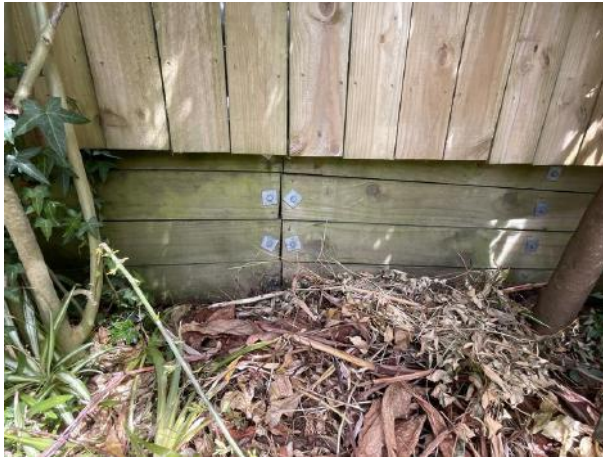
Photo 60

Timber retaining wall located on the western boundary. Most of this retaining wall could not be inspected due to vegetation.

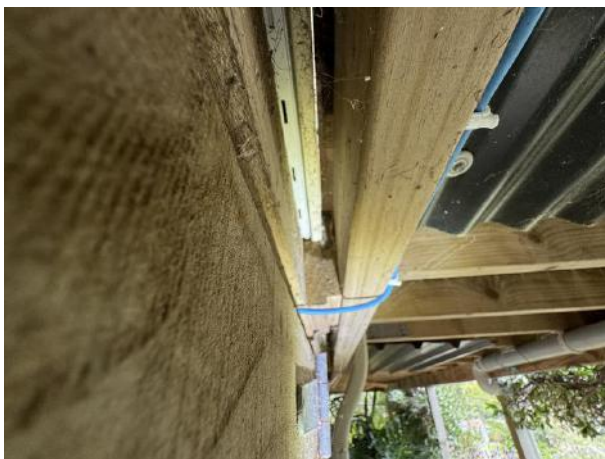
Photo 71

Timber framed decks are packed off the dwelling.

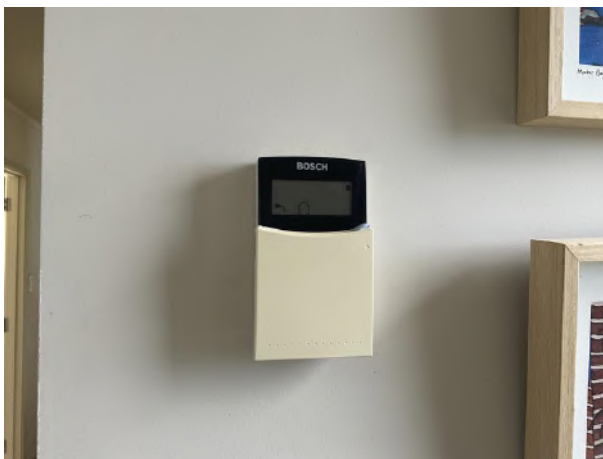
Photo 89

Security alarm panel located in the front entrance hallway. Currently not a use.

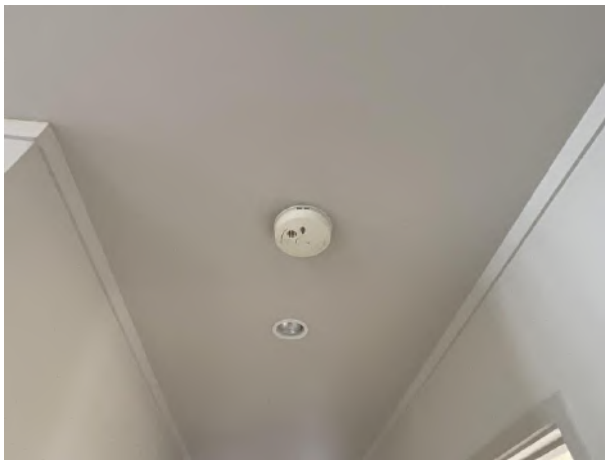
Photo 91

Smoke alarms located in the hallway and rumpus room.

It is recommended to install smoke detectors within 3 metres of any sleeping space and a minimum of one per level/story.
