Building Inspection Report

Client: Jo Green and Paul Teahon
Location: 64 Crossett Road, Ruatangata
Whangarei

Inspection Date: 10/11/2021

RE: Building Inspection Report, 64 Crossett Road, Ruatangata, Whangarei.

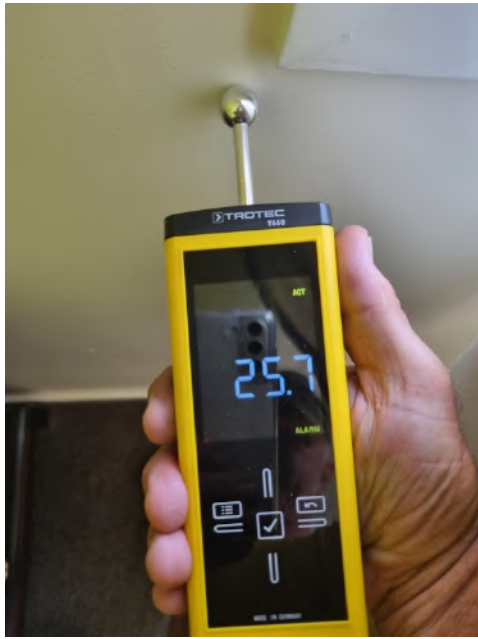
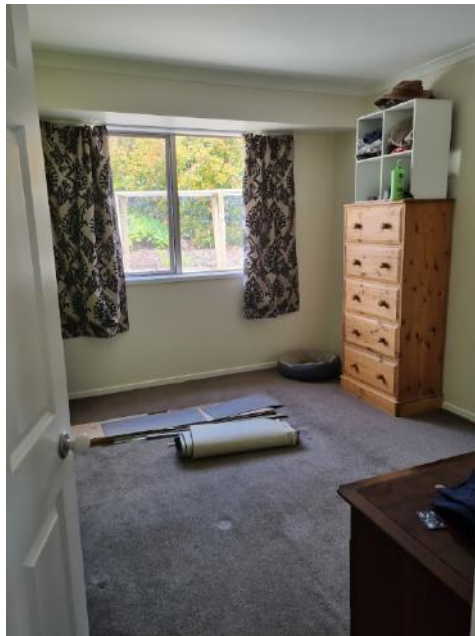
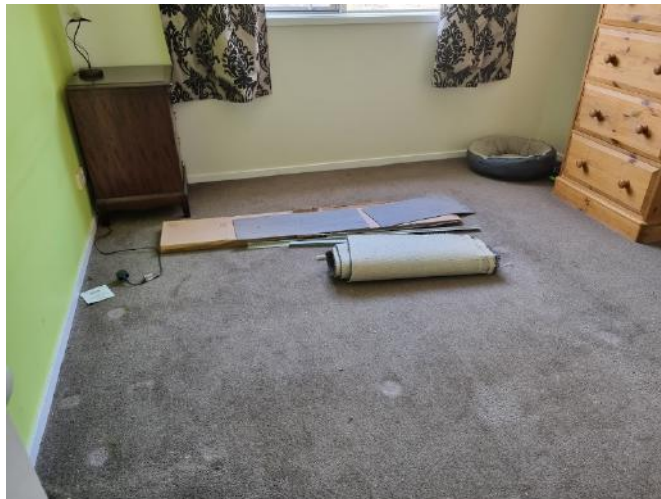
Bedroom 1

Missing Transition Bar

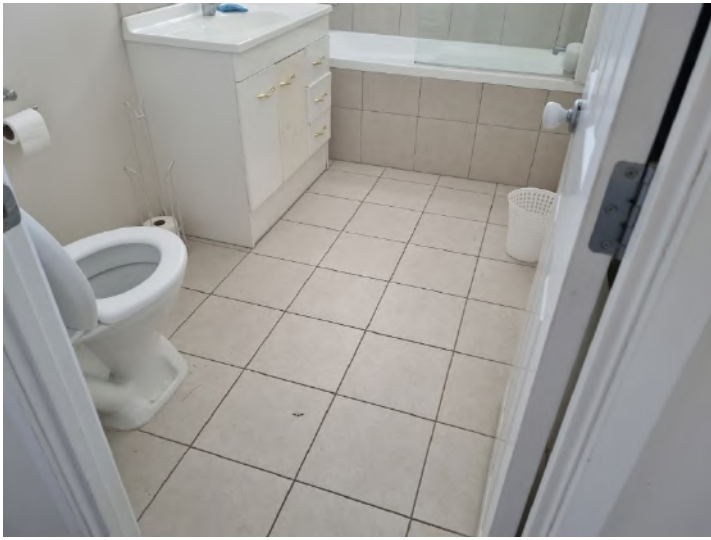
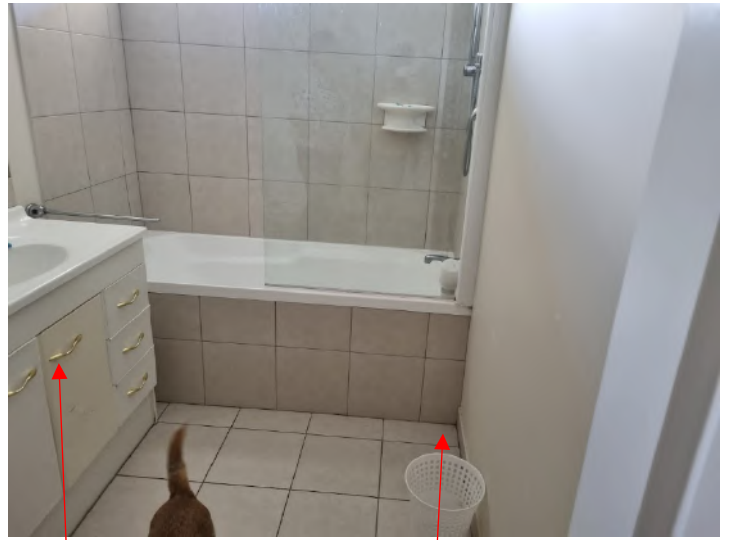
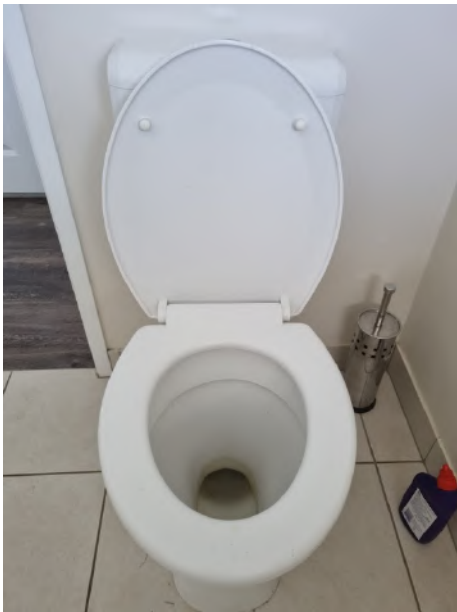
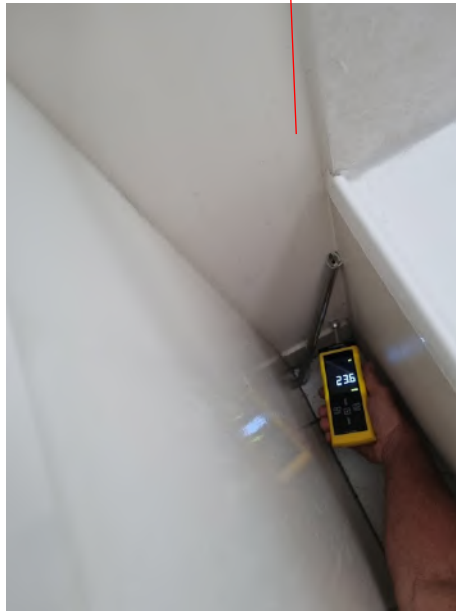
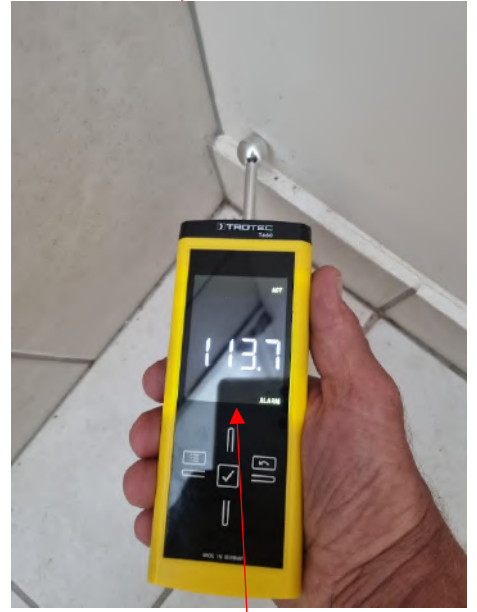
Vanity in main bathroom has damage to the cabinetry

Moisture reading is greater than 80, this means there is wet material and is at risk – further investigation is required

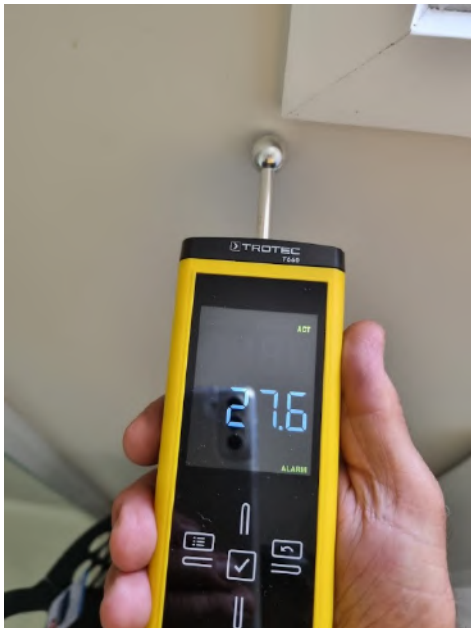
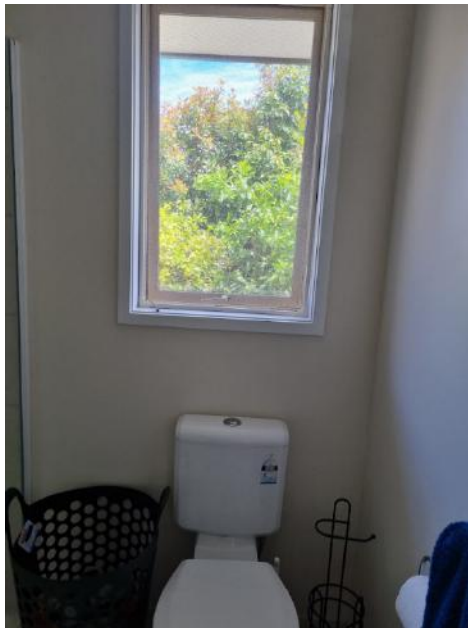
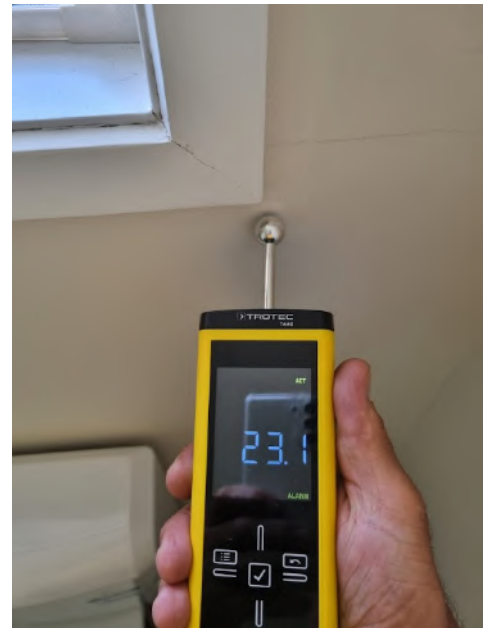
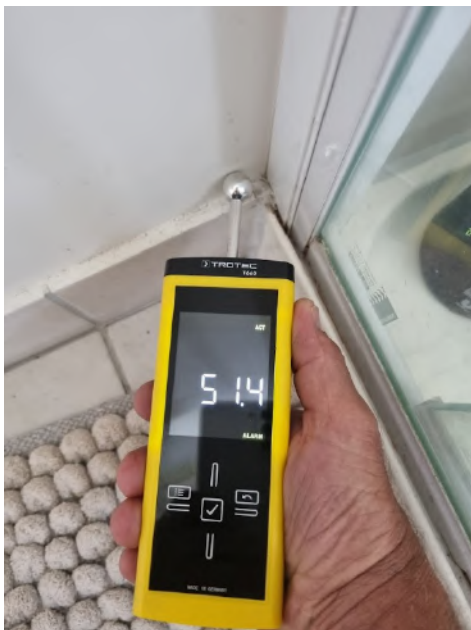
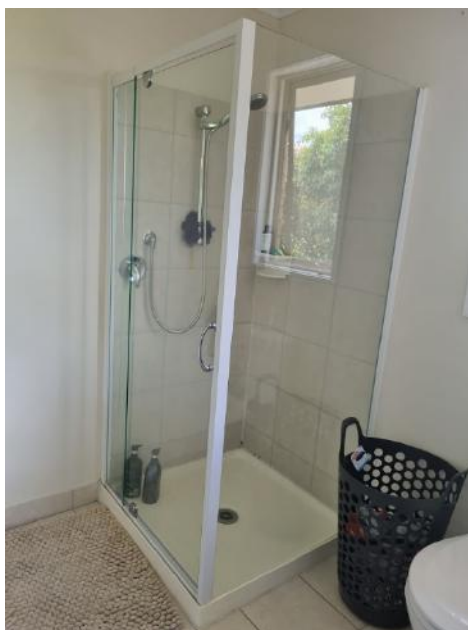
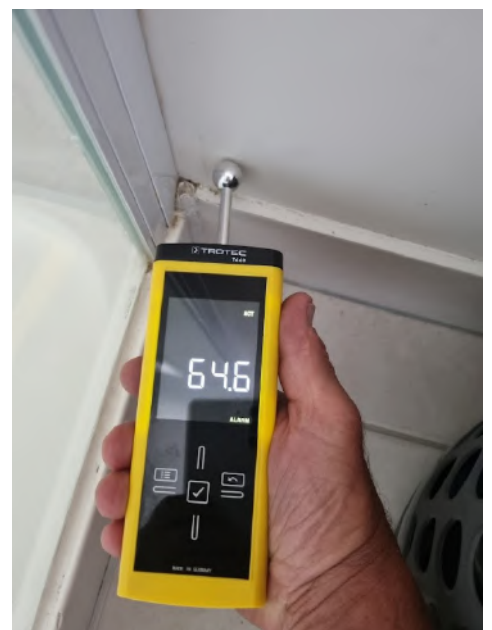
Bathroom 2 (Ensuite)

Vanity in the Ensuite has damage to the cabinetry

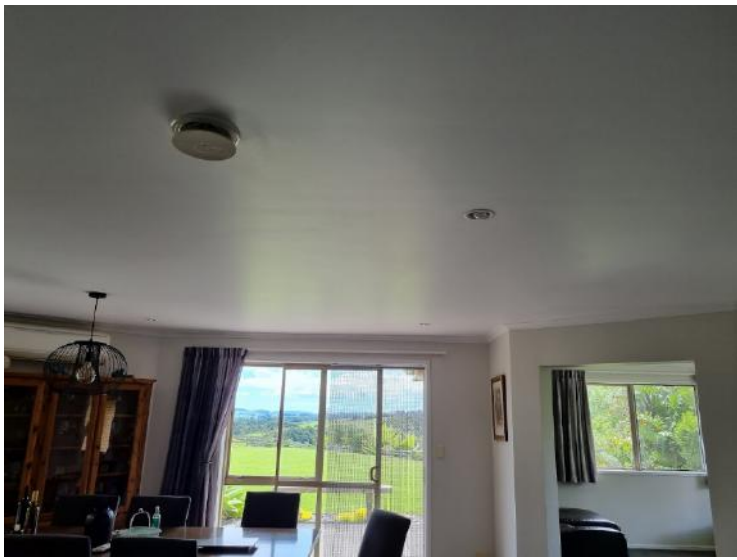
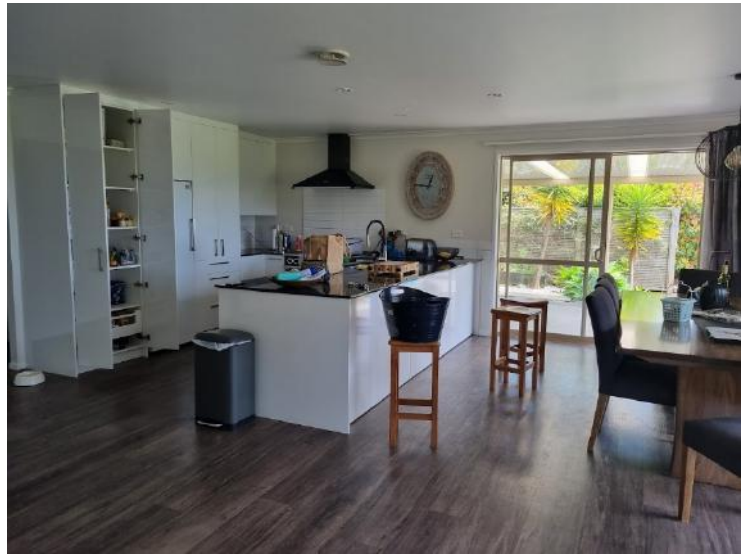
Missing Transition Bar

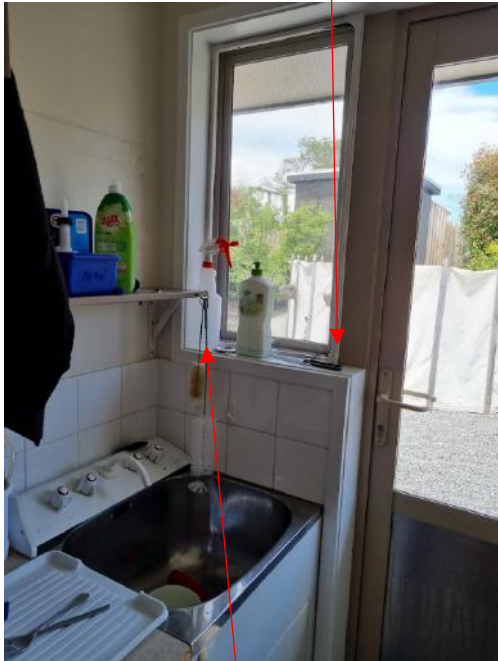
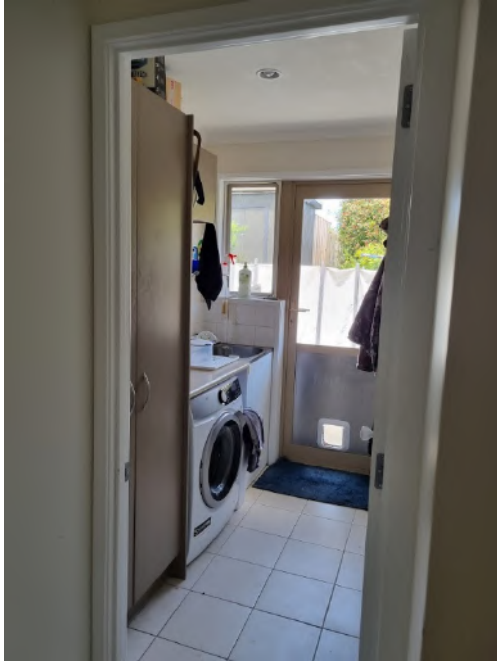
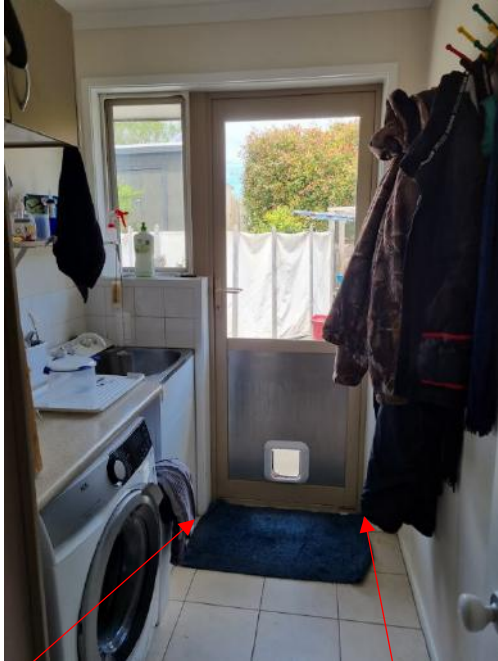
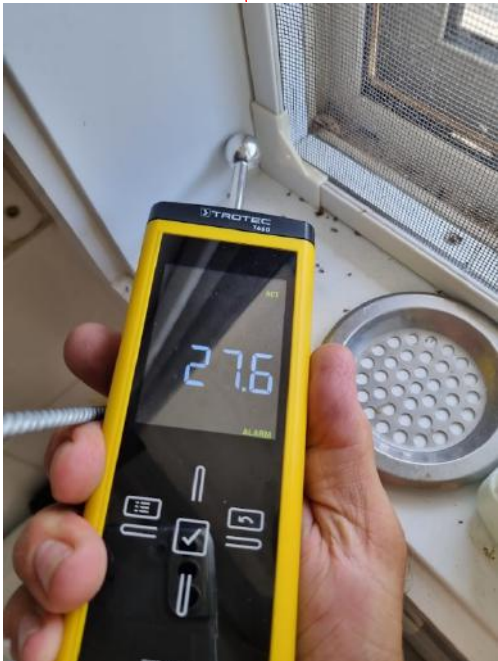
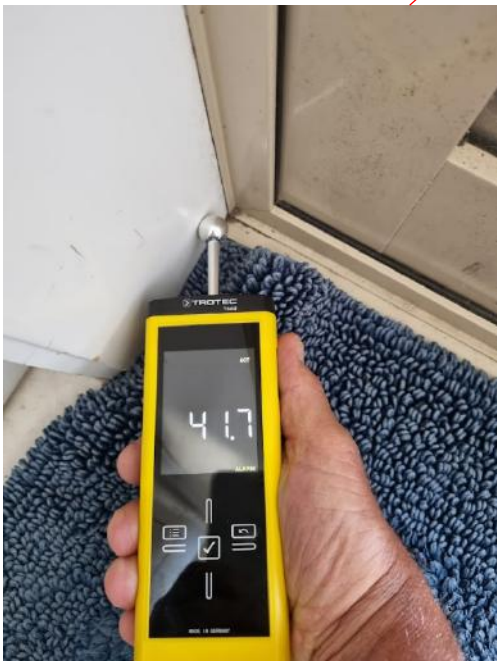
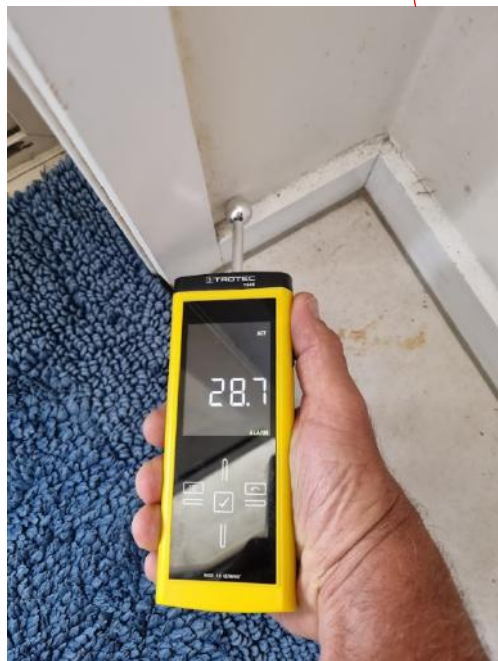
Laundry

Cannot access right hand side of laundry window for moisture meter reading

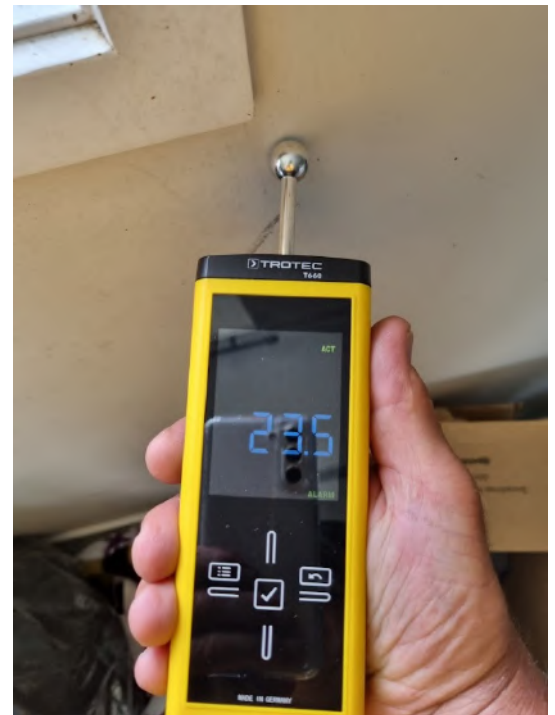
Cannot access left hand side of garage window due to cabinet blocking the moisture meter reading point.

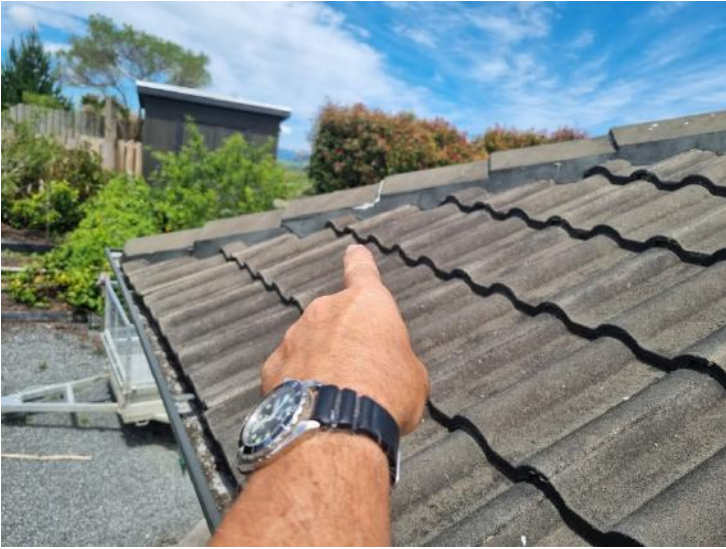
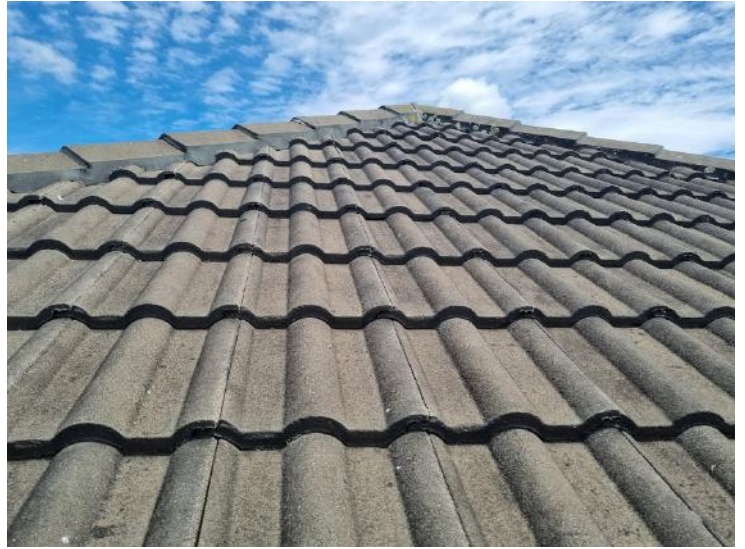
Concrete tile roof at ridges plaster work needs to be sealed to prevent water ingress. Appears in reasonable condition

The plastered in ridge and hip capping require repair in place where they have cracked right hand side of garage and broken to prevent water ingress. Overall Appears in reasonable condition
